REMEDIATION SUMMARY & RISK-BASED SITE CLOSURE REQUEST

**BOPCO, LP
POKER LAKE UNIT #78 SWD TANK BATTERY
Eddy County, New Mexico
Unit Letter "A" (NE/NE), Section 25, Township 24 South, Range 30 East
Latitude 32.194069° North, Longitude 103.827614° West
NMOCD Reference #'s: 2RP-1190 & 2RP-1234**

January 2014

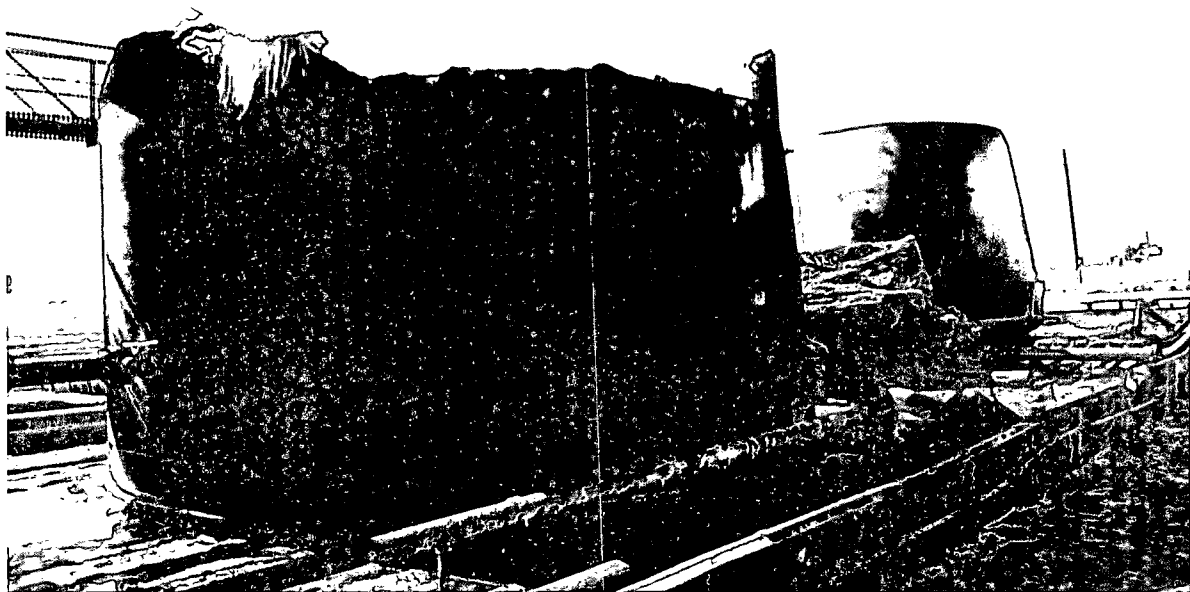
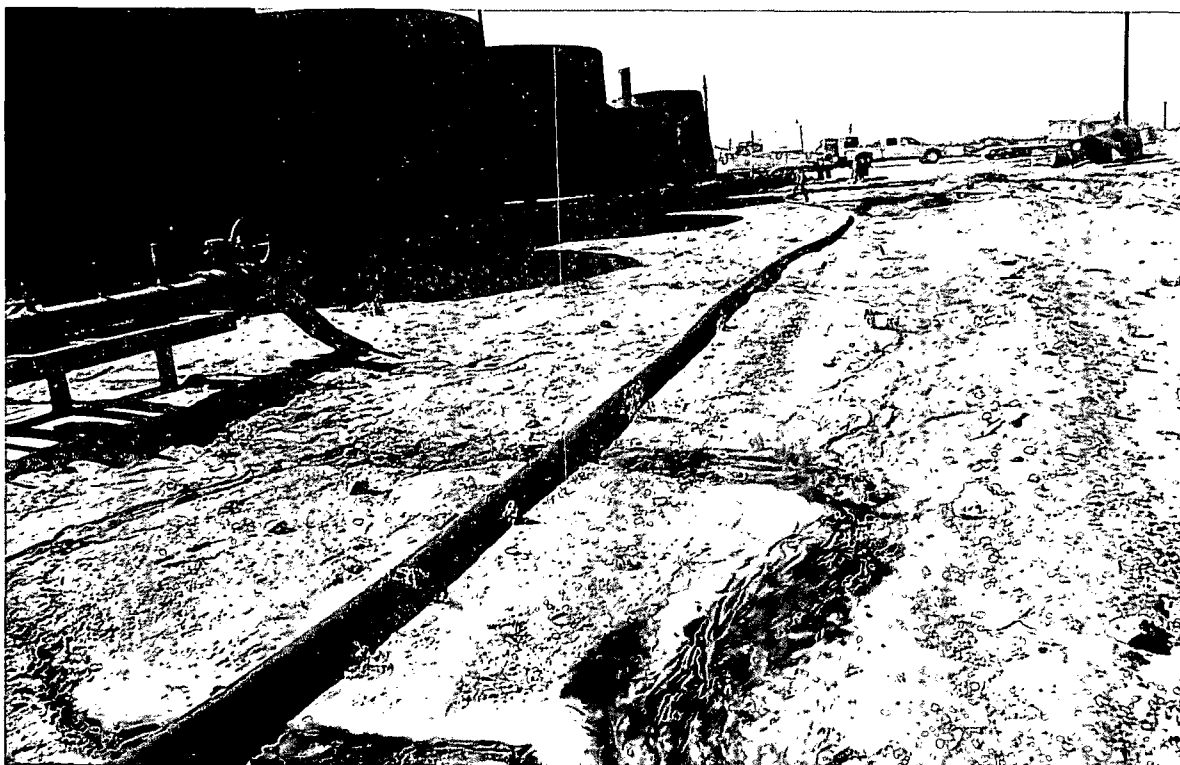
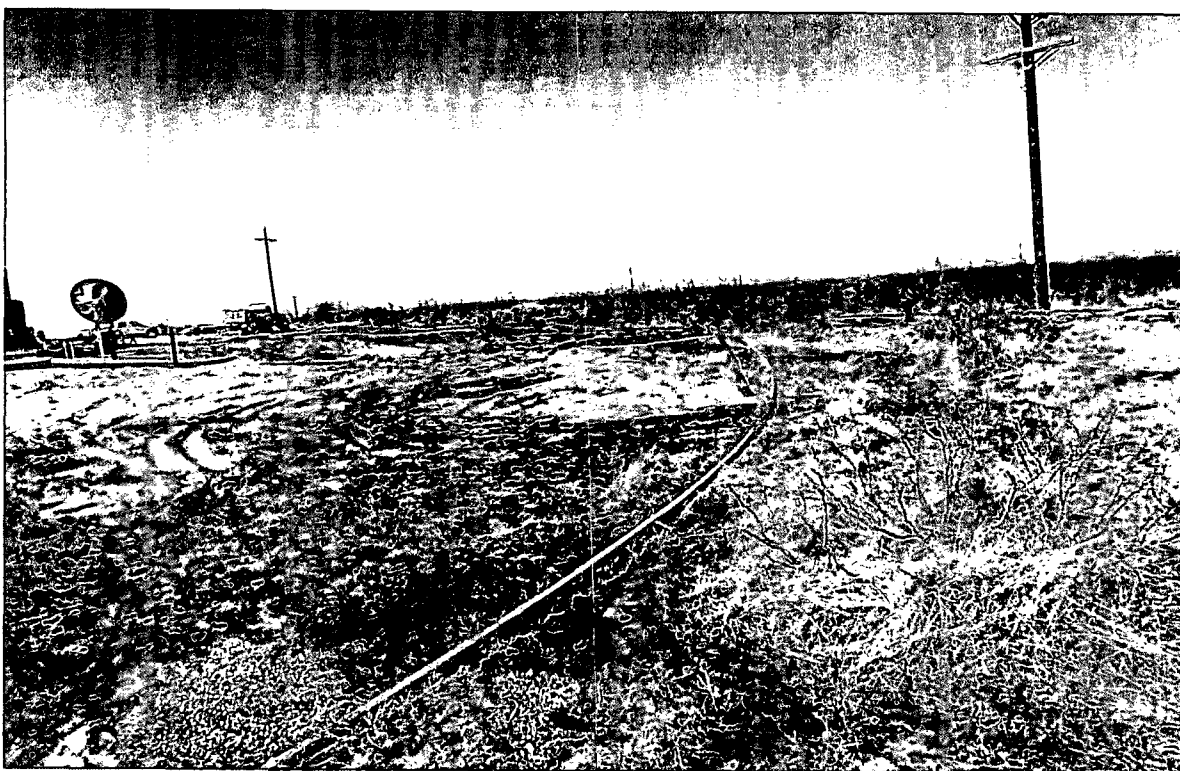
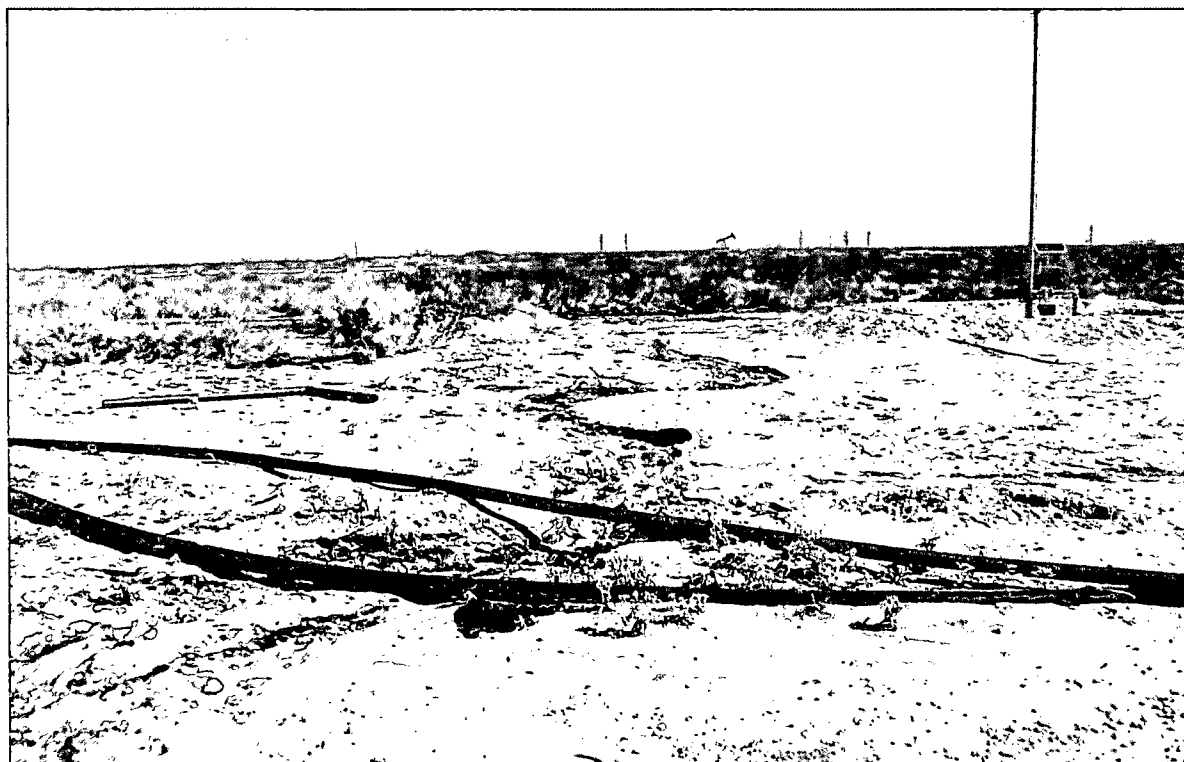
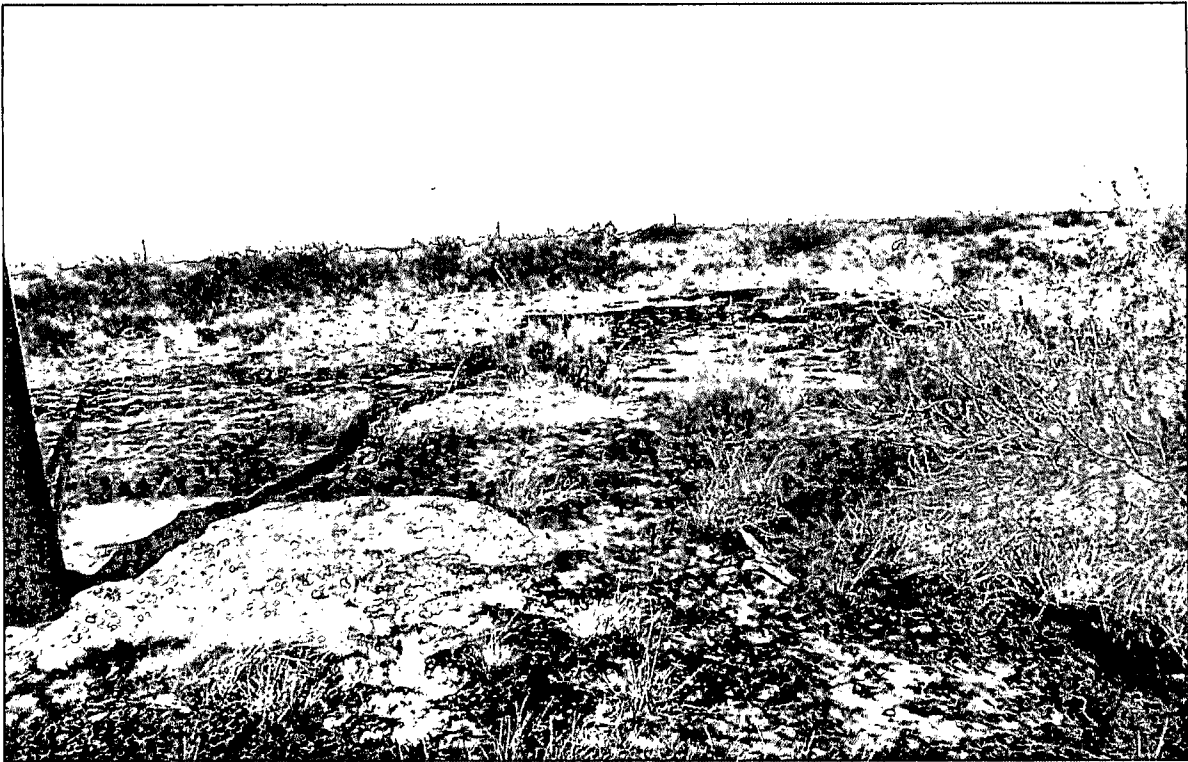
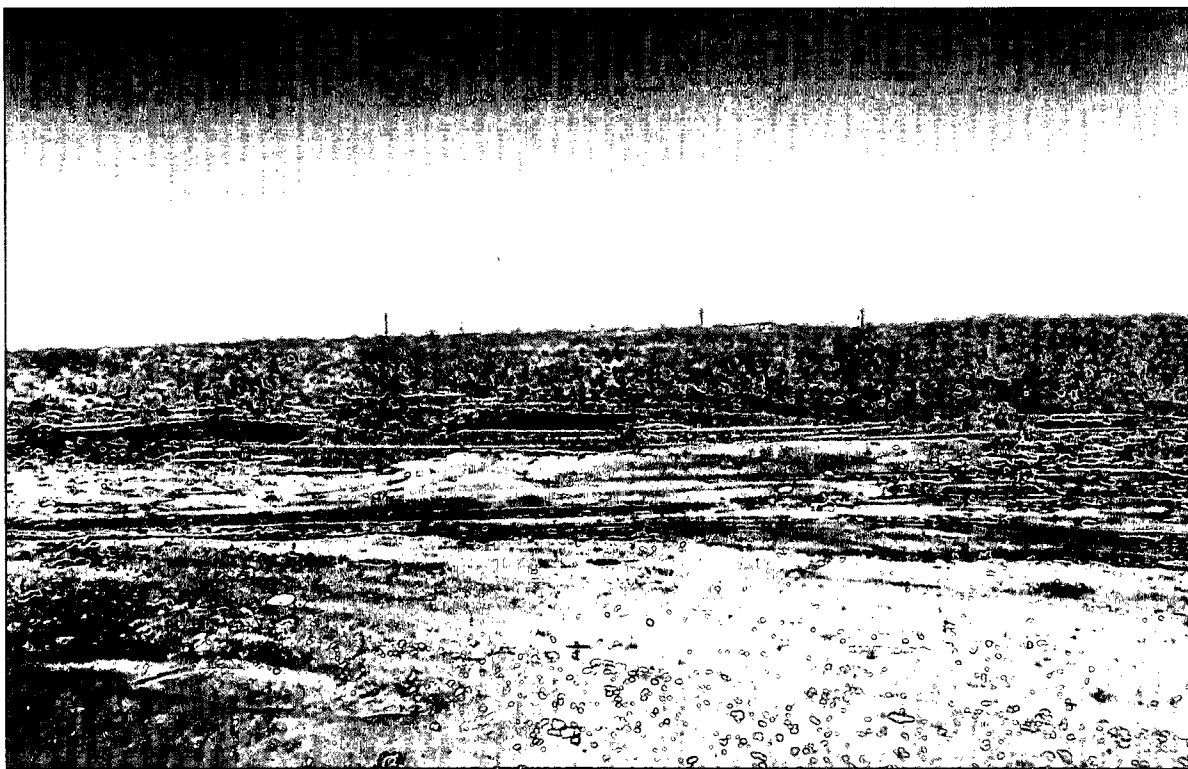
Poker Lake Unit #78 SWD Tank Battery - 5/26/2012 Release

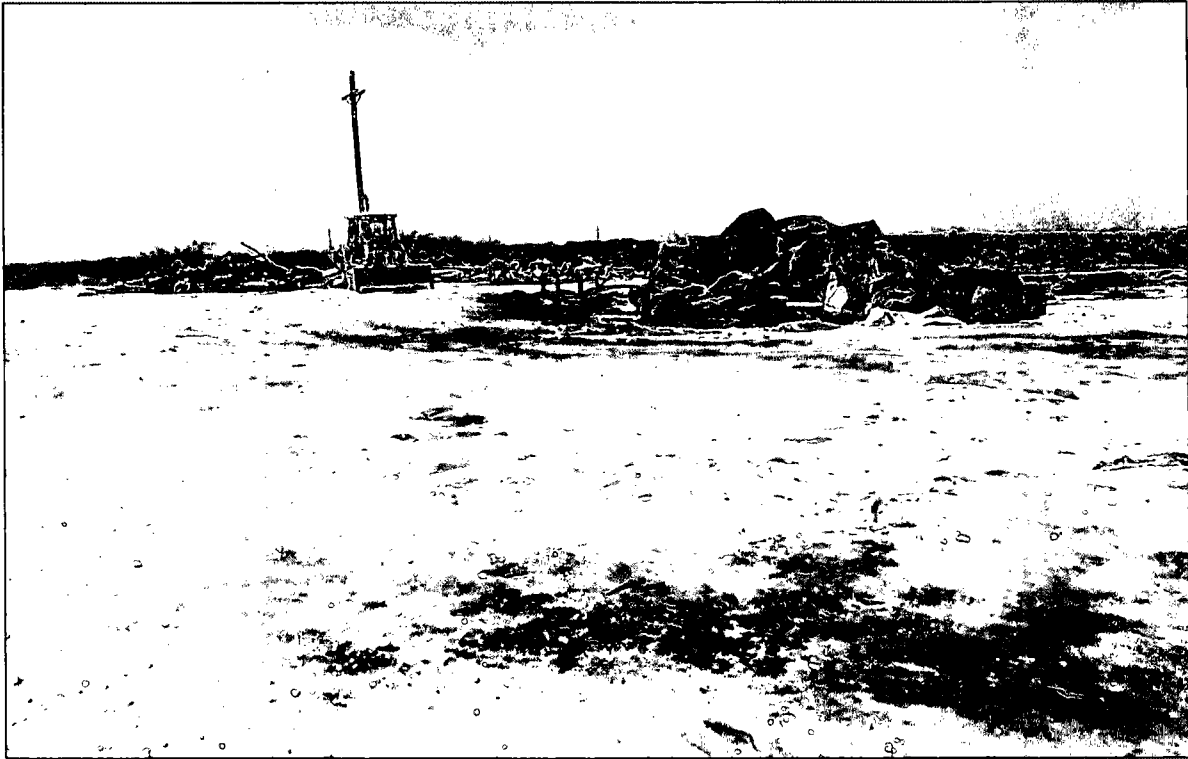
Poker Lake Unit #78 SWD Tank Battery - 5/26/2012 Release Site
(Following Removal of Heavily Impacted Soil on Battery Pad)

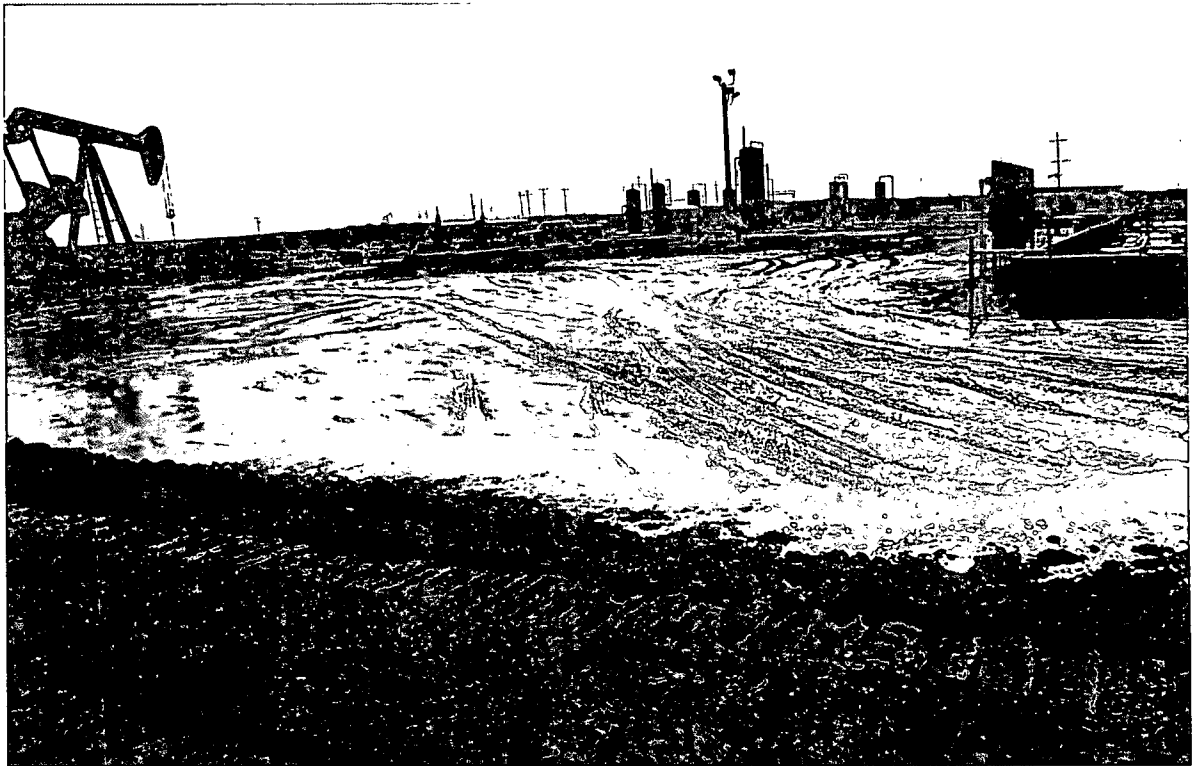
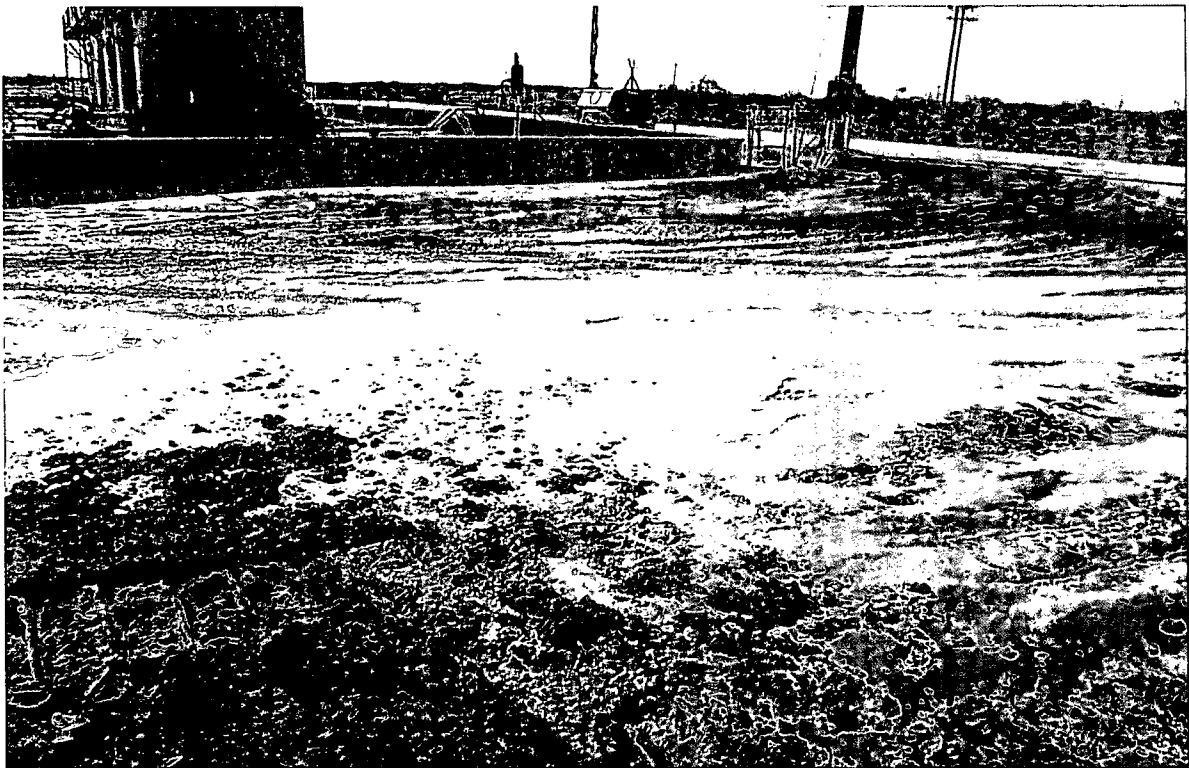
Poker Lake Unit #78 SWD Tank Battery - 7/11/2012 Release

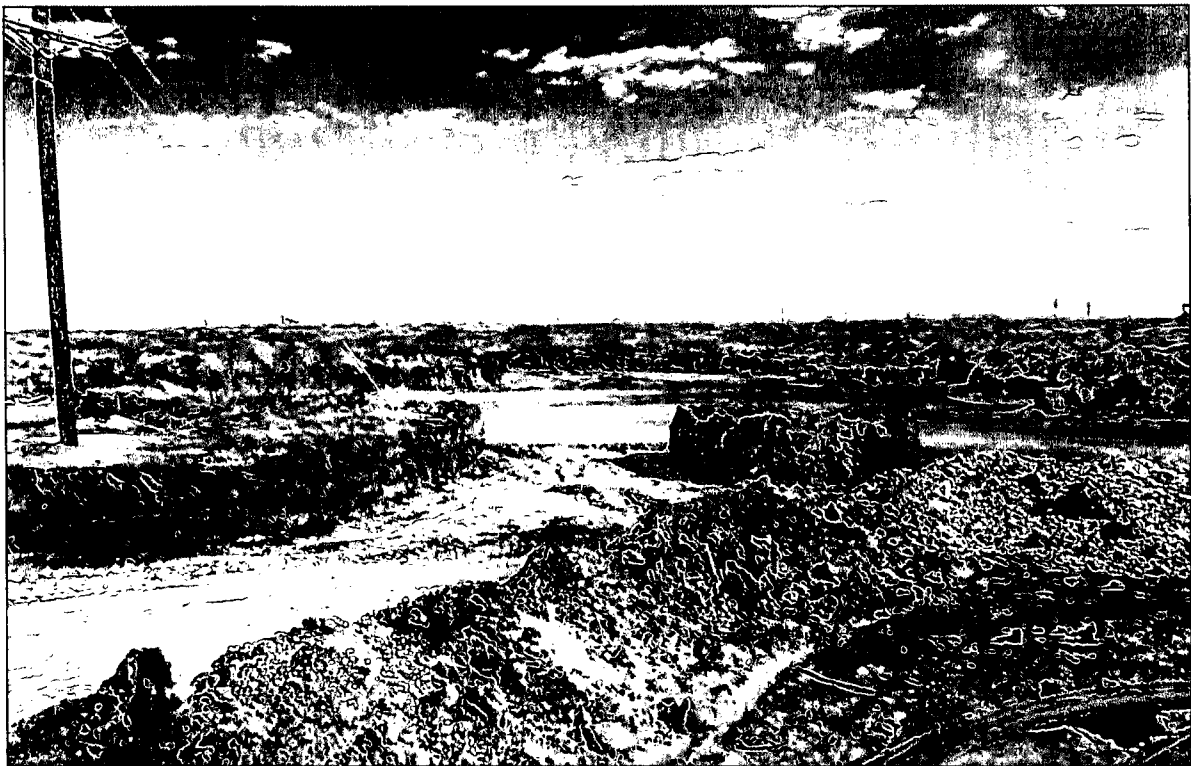
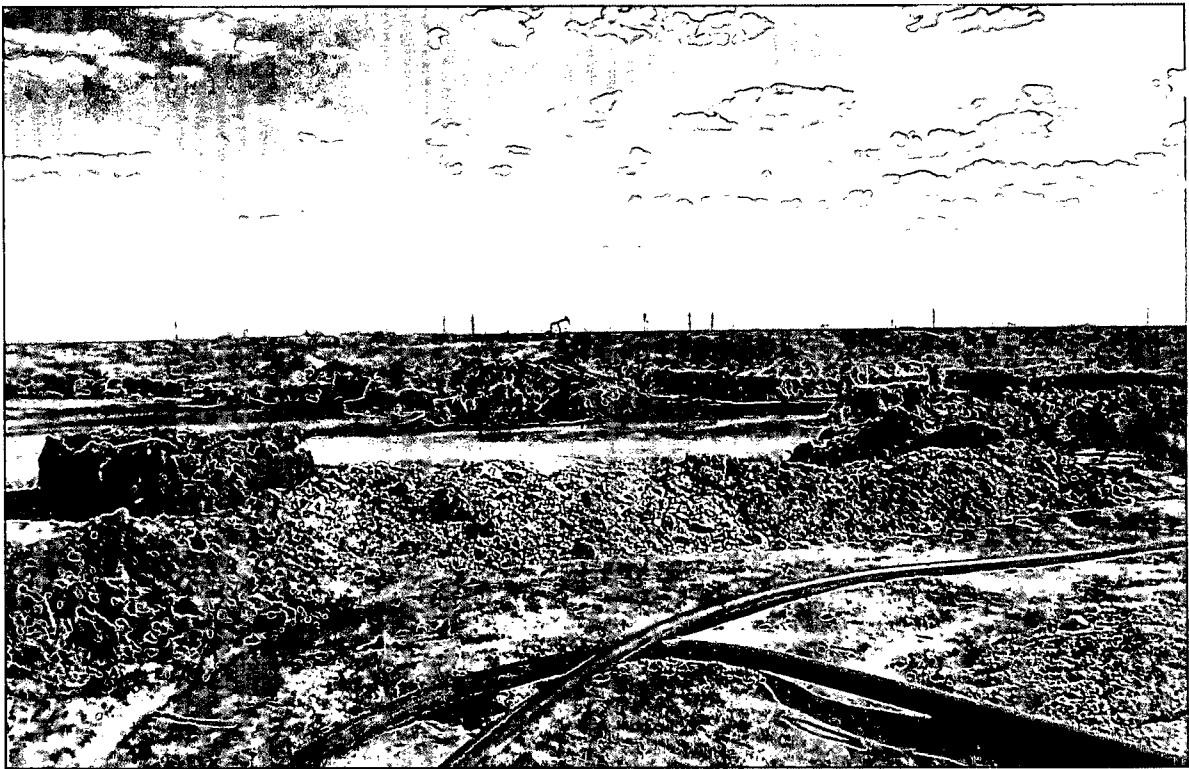
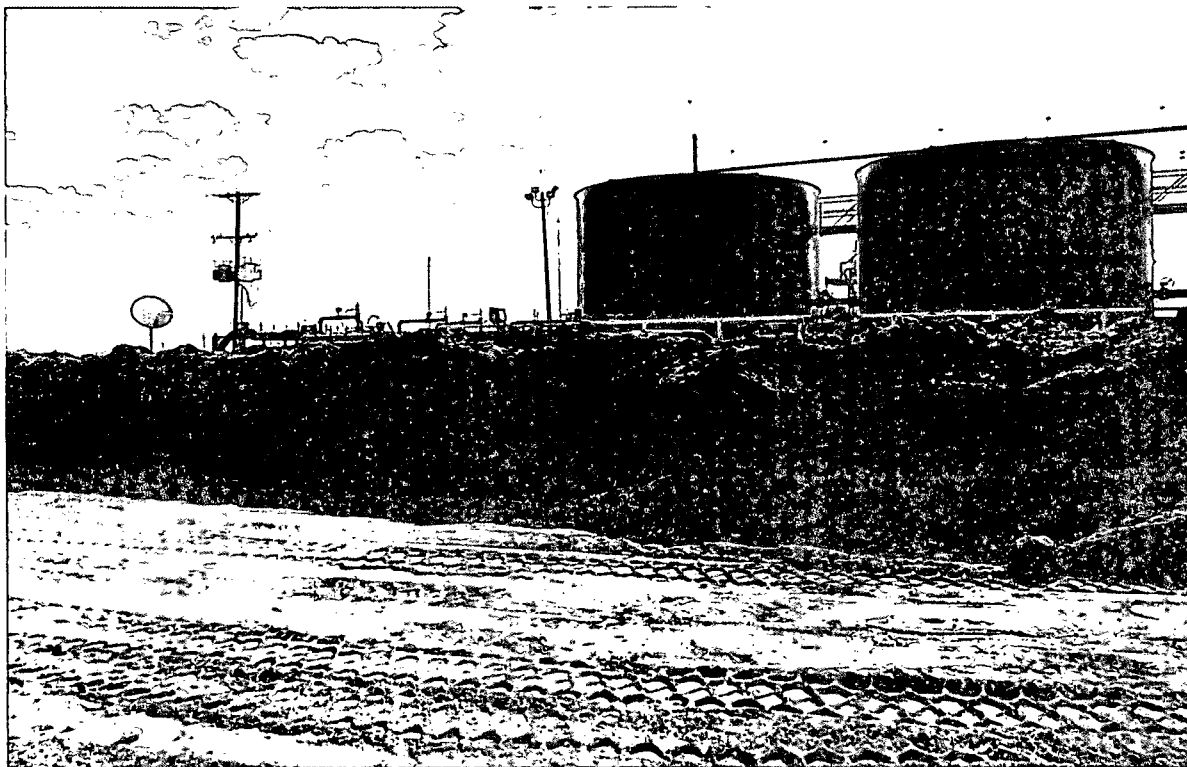
Poker Lake Unit #78 SWD Tank Battery - Pasture Excavation (Looking North)

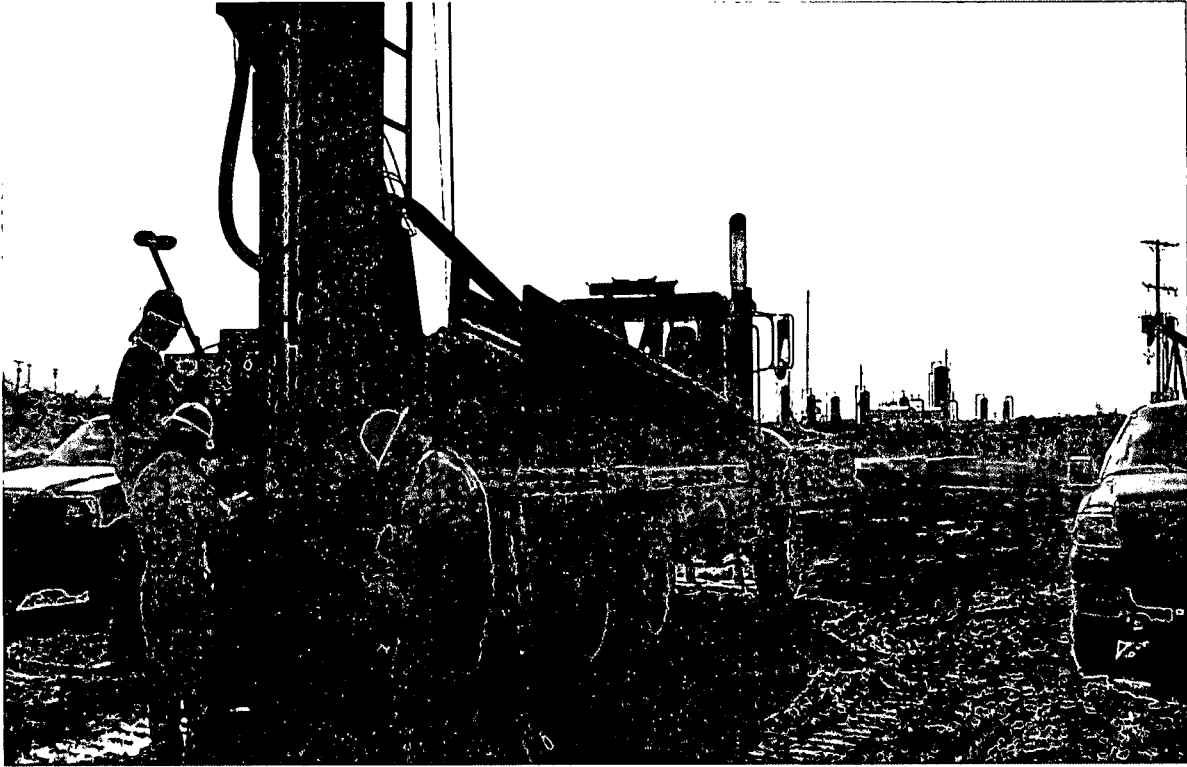
Poker Lake Unit #78 SWD Tank Battery - Advancement of Soil Boring SB-1
(Looking Southwest)

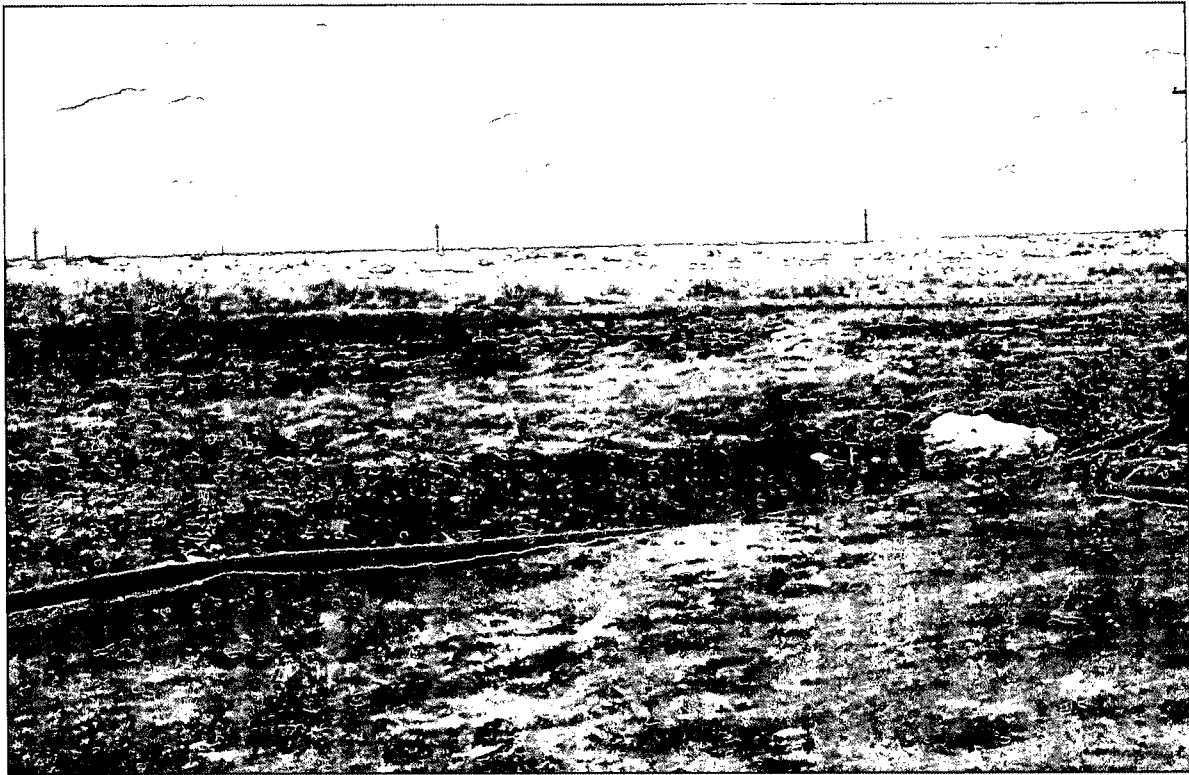
Poker Lake Unit #78 SWD Tank Battery - Pasture Excavation
(Following Backfill; Looking North)

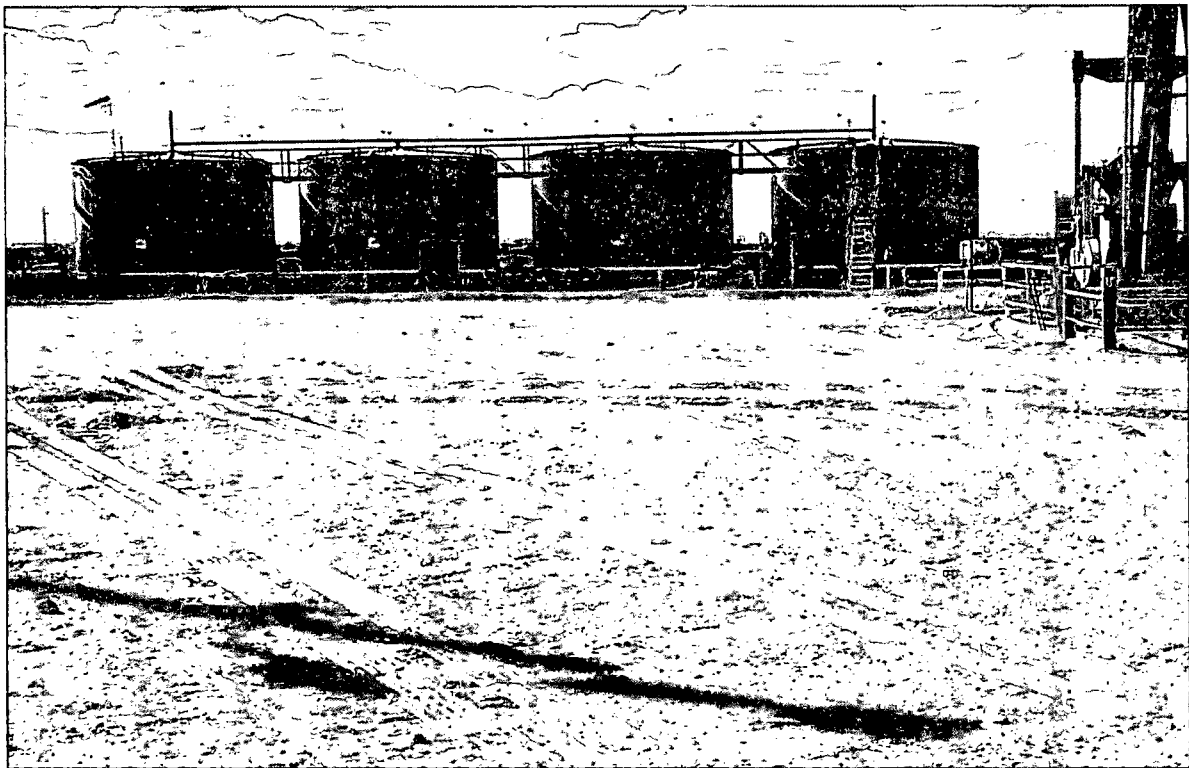
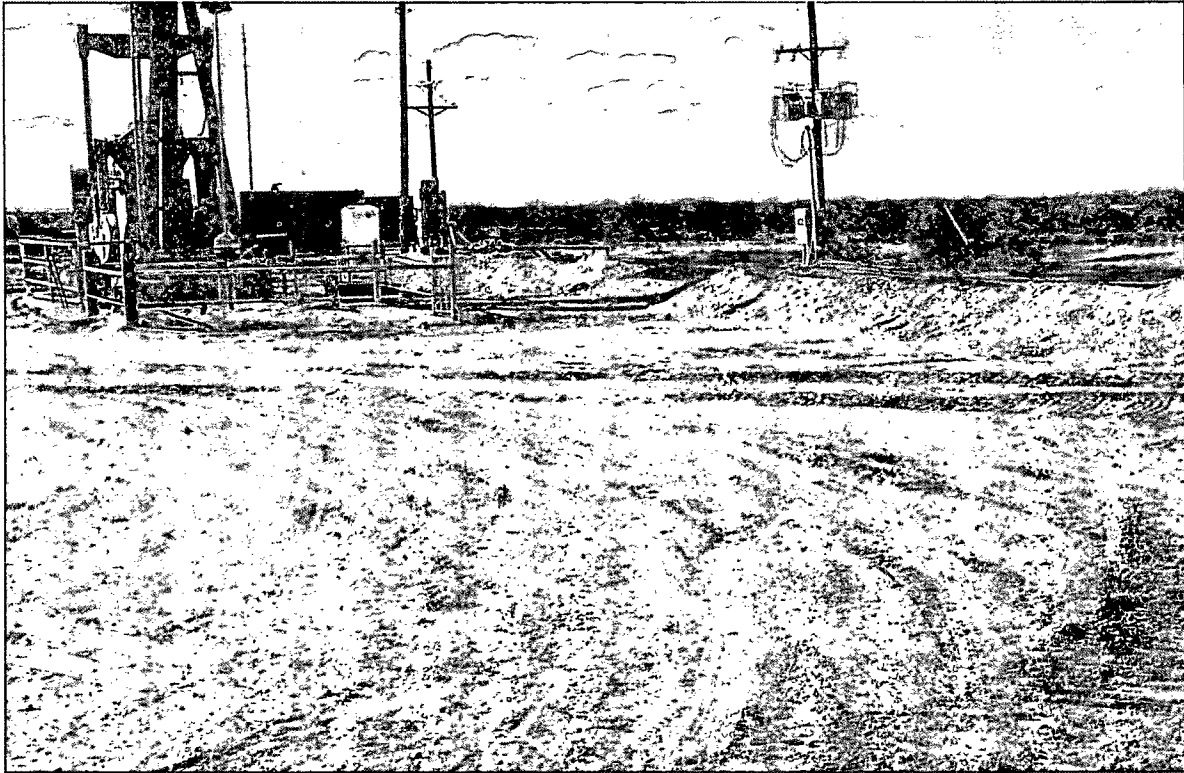
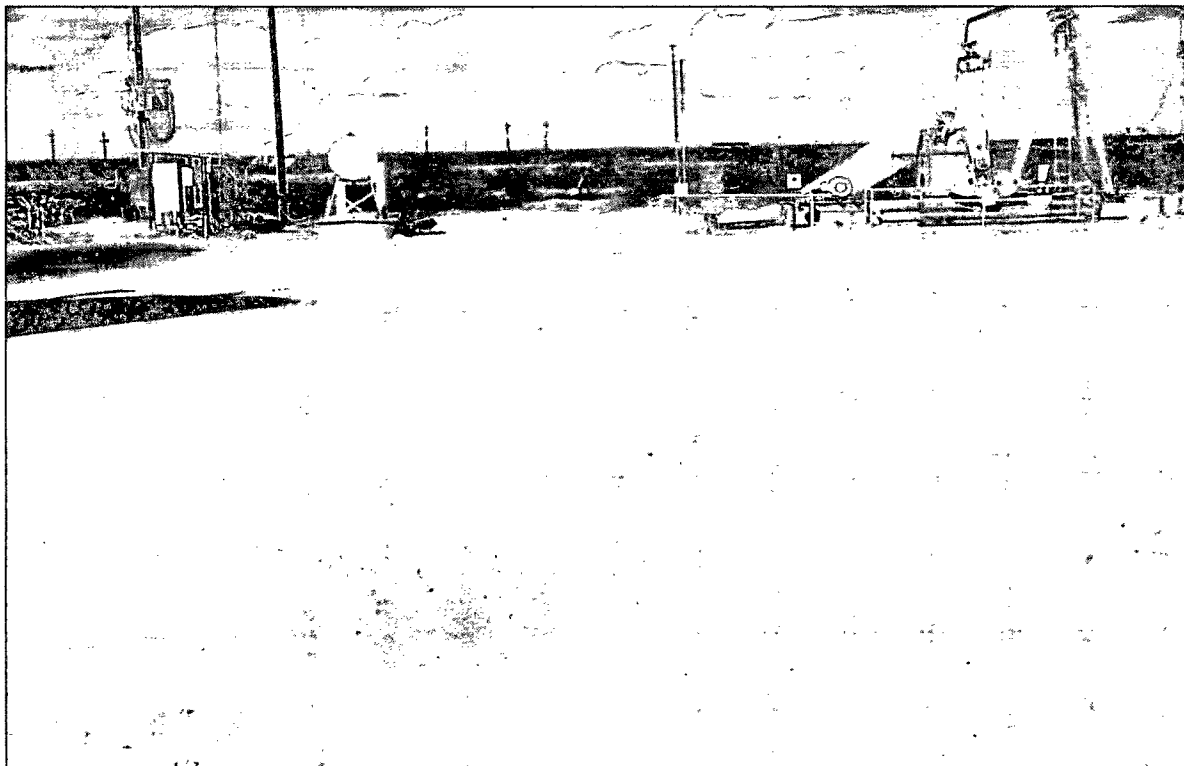
Poker Lake Unit #78 SWD Tank Battery - Pad Excavation
