## **REMEDIATION SUMMARY & RISK-BASED SITE CLOSURE REQUEST**

**BOPCO, LP**  
**BASS 3 FEDERAL WELL #4 8-16-11**  
**Eddy County, New Mexico**  
**Unit Letter "I" (NE/SE), Section 3, Township 22 South, Range 28 East**  
**Latitude 32.419979° North, Longitude 104.070256° West**

**July 2012**

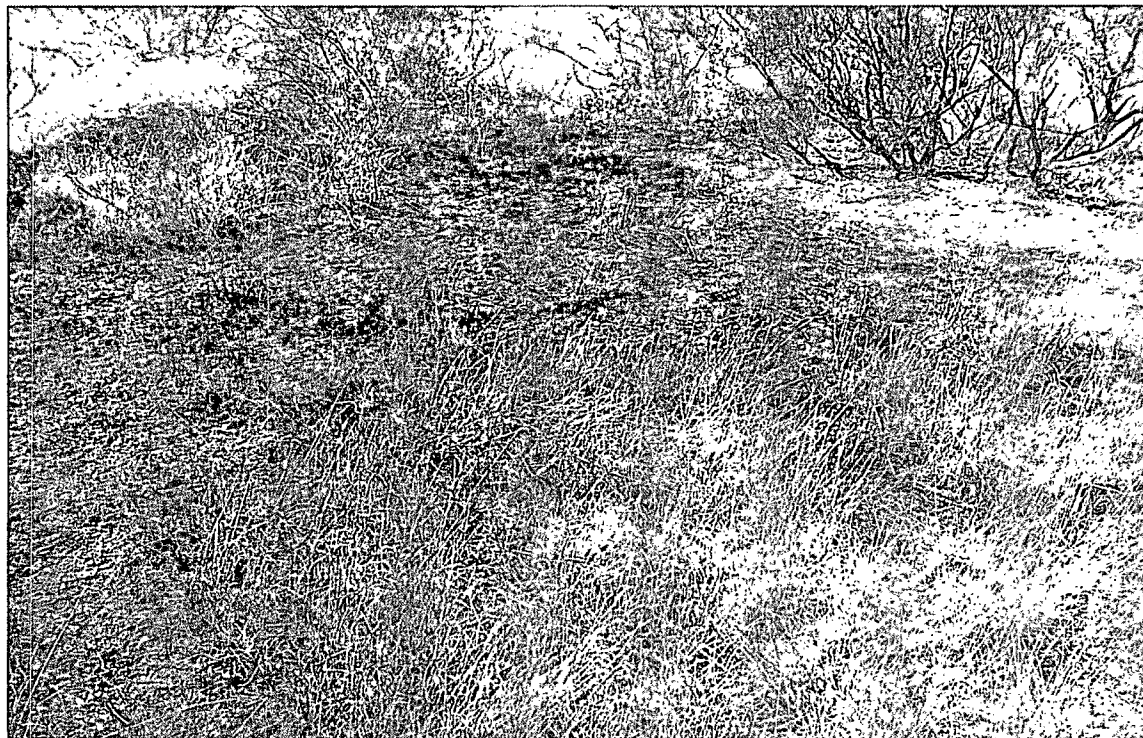
Bass 3 Federal Well #4 8-16-11 - Release Site

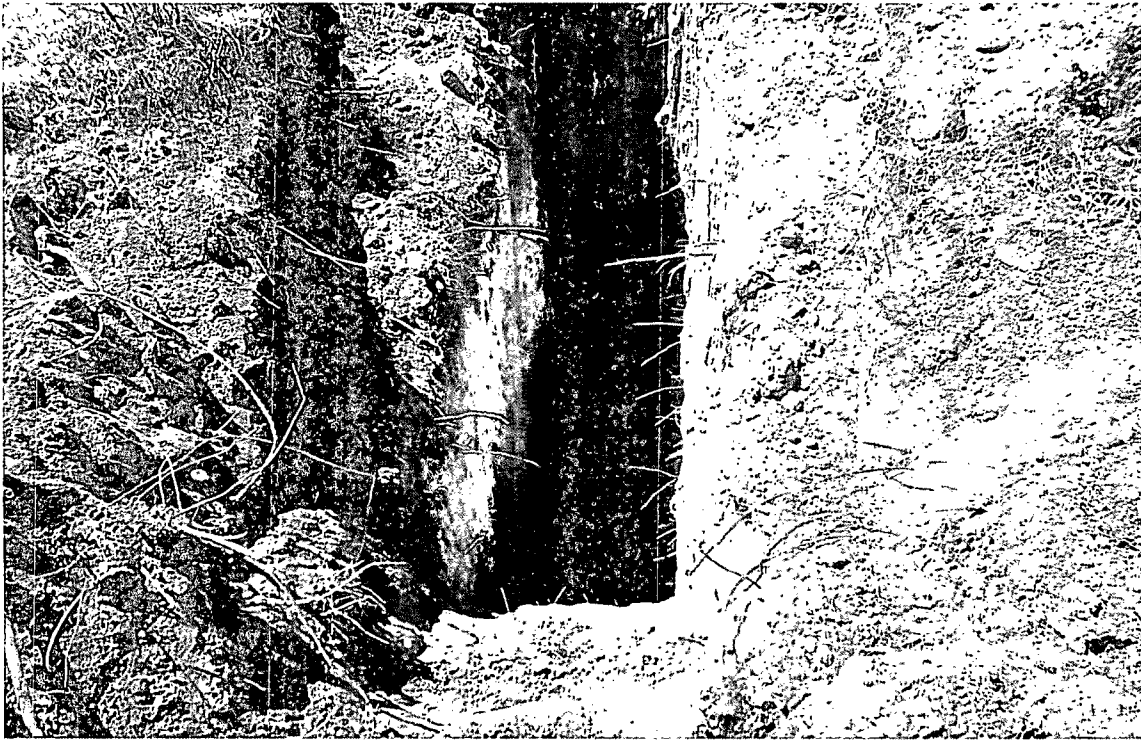
Bass 3 Federal Well #4 8-16-11 - Delineation Trench

Following initial response activities, on September 6, 2011, delineation of the release site commenced. Two (2) delineation trenches (East Trench and West Trench) were advanced at the site to investigate the vertical and horizontal extent of hydrocarbon impact. Trench "East Trench" was advanced at the release point to a total depth of approximately twelve feet (12') bgs. Trench "West Trench" was advanced at the terminus of the flow path to a total depth of approximately fourteen feet (14') bgs.

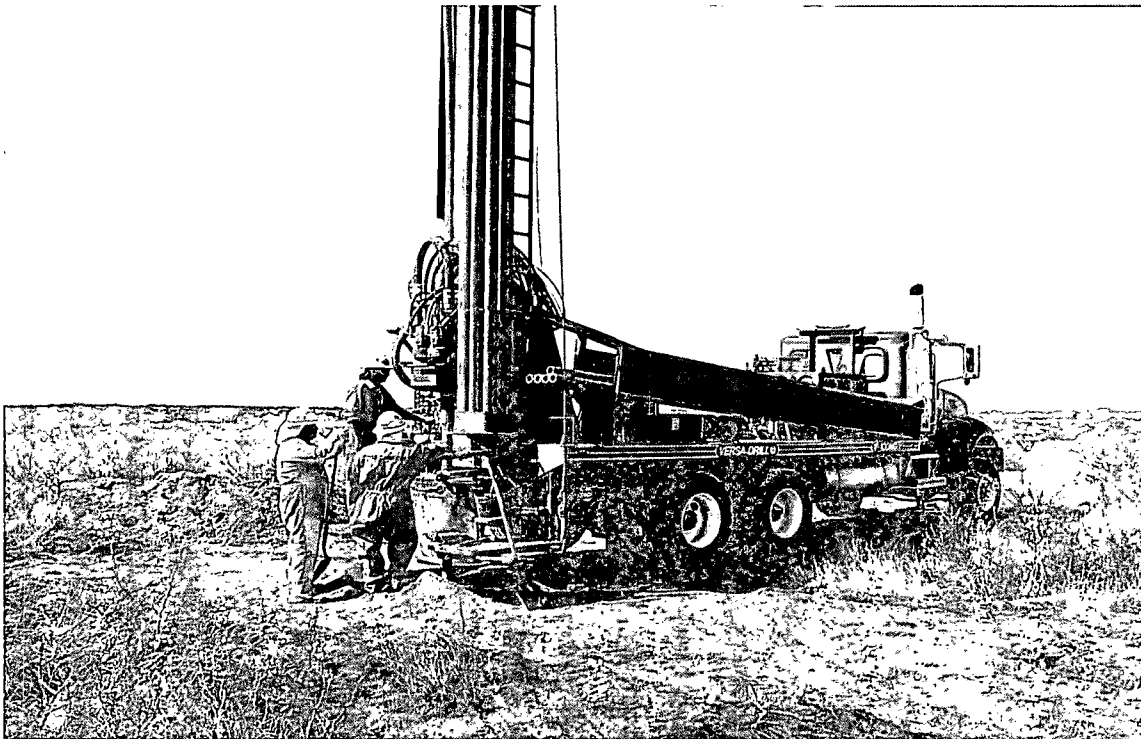
Bass 3 Federal Well #4 8-16-11 - Advancement of Soil Boring SB-2

Soil boring "SB-2" was located at the terminus of the flow path of the release, in the area defined by delineation trench "West Trench". The soil boring was advanced to a total depth of approximately ninety feet (90'). Soil samples collected at drilling depths of five feet (5'), ten feet (10'), twenty feet (20'), forty feet (40'), sixty feet (60'), eighty-five feet (85'), and ninety feet (90') were submitted to the laboratory for analysis of TPH and/or chloride concentrations. The soil sample collected at five feet (5') bgs was also analyzed for BTEX concentrations. Laboratory analytical results indicated TPH concentrations ranged from less than the appropriate laboratory MDL in soil sample SB-2 @ 10' to 53.4 mg/Kg in soil sample SB-2 @ 5'. Chloride concentrations ranged from 48.0 mg/Kg in soil sample SB-2 @ 90' to 10,600 mg/Kg in soil sample SB-2 @ 5'. The benzene concentration in soil

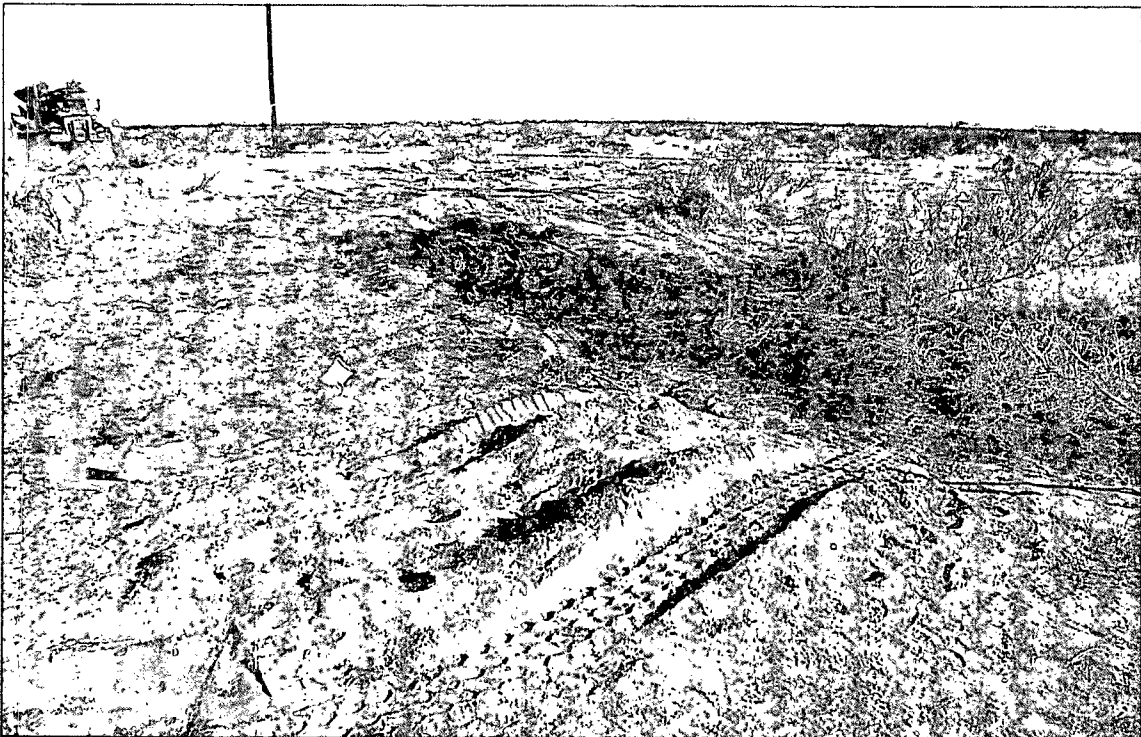
Bass 3 Federal Well #4 8-16-11 - Soil Boring SB-2 (following P&A; bore hole flagged)

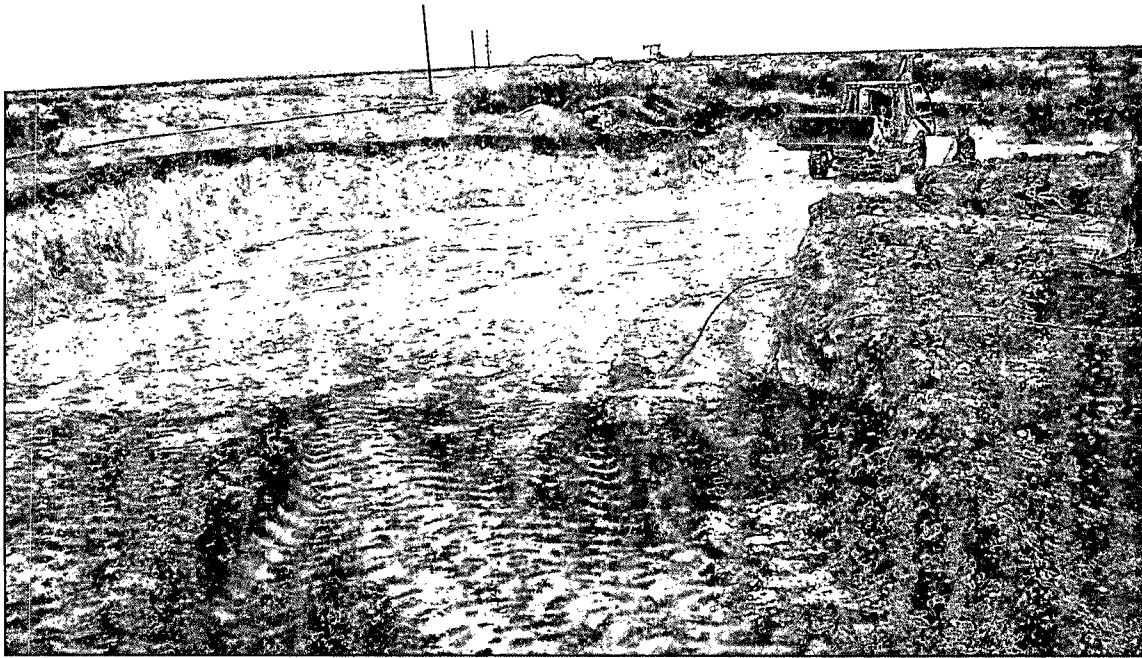
Bass 3 Federal Well #4 8-16-11 - Excavation

On January 4, 2012, excavation of impacted soil commenced at the site. Hach Quantab Chloride Low Range (30-600 mg/Kg) Titrators were used to field-screen the horizontal extent of impacted soil and to guide the excavation. Excavated soil was stockpiled on-site, pending final disposition.

From January 4 through January 6, 2012, approximately one thousand, four hundred and twenty cubic yards (1,420 yd<sup>3</sup>) of impacted soil was excavated and stockpiled on-site, pending final disposition.

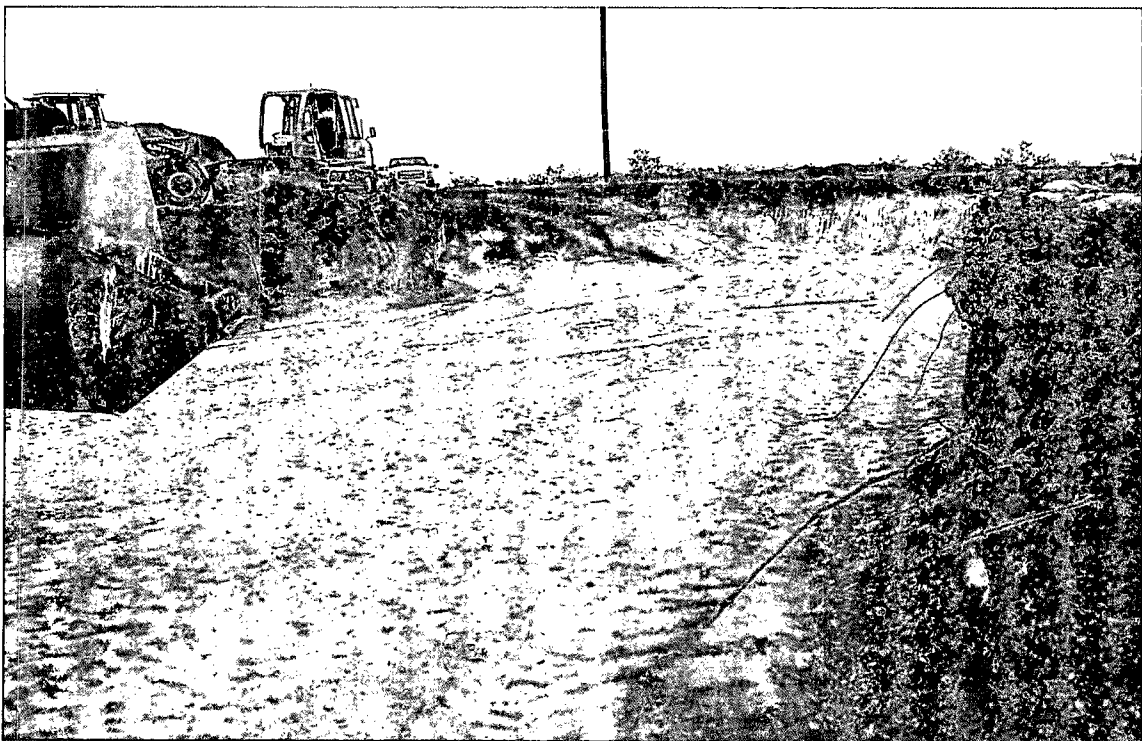
Bass 3 Federal Well #4 8-16-11 - Excavation (sample location marked in orange)

On January 5, 2012, four (4) soil samples (North Wall, South Wall, East Wall and West Wall) were collected from the sidewalls of the excavation. The soil samples were submitted to the laboratory for analysis of TPH and chloride concentrations. Laboratory analytical results indicated TPH concentrations were less than the appropriate laboratory MDL in all submitted soil samples. Chloride concentrations ranged from less than the laboratory MDL in soil sample West Wall to 752 mg/Kg in soil sample East Wall. Review of laboratory analytical results indicated TPH and chloride concentrations in all submitted soil samples were less than the regulatory remediation action levels (RRAL's) established for the site.

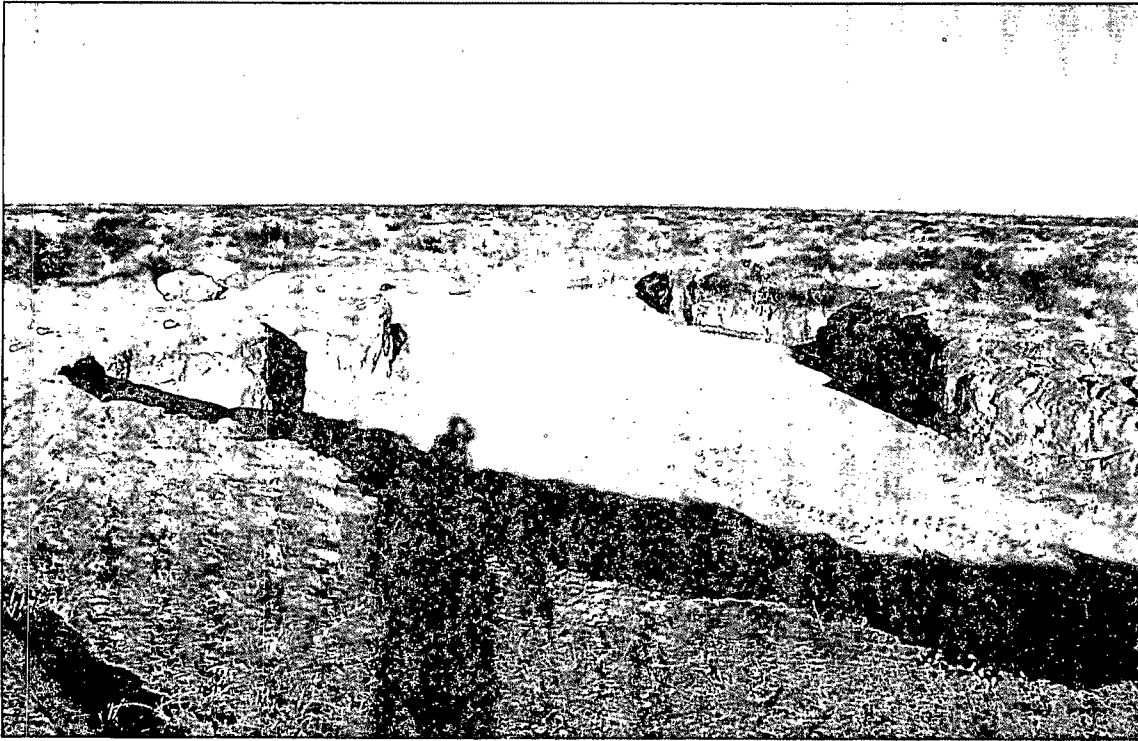
Bass 3 Federal Well #4 8-16-11 - Excavation (looking northwest)

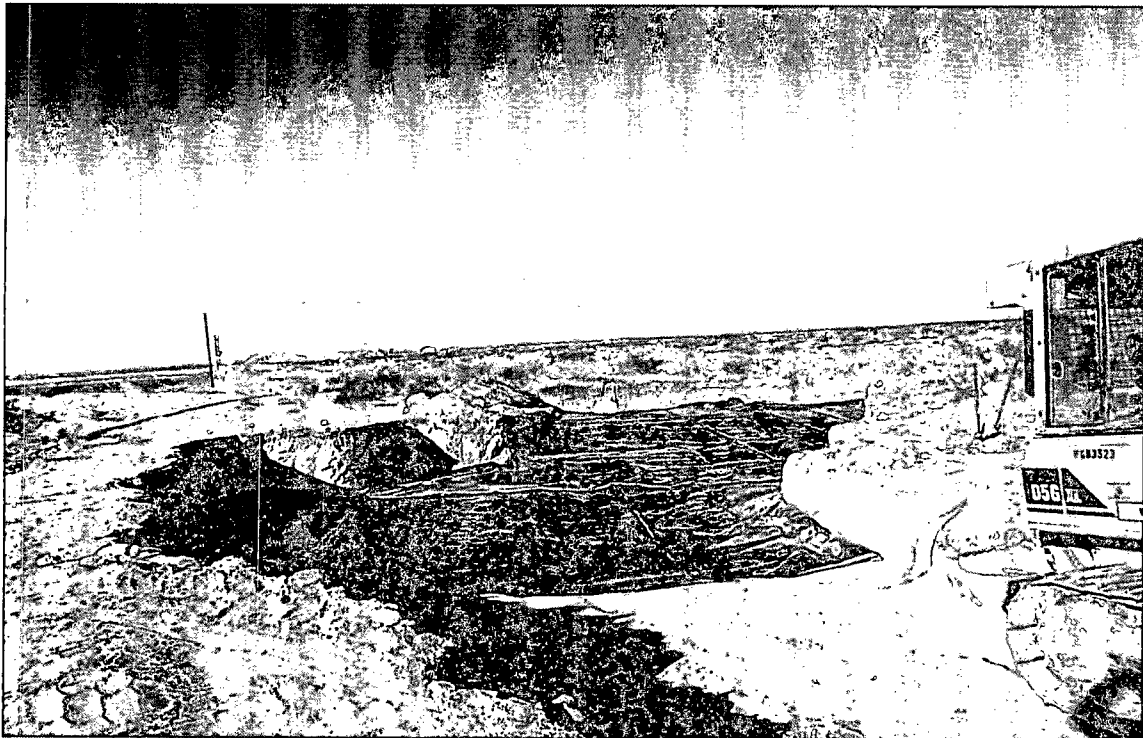
Bass 3 Federal Well #4 8-16-11 - Liner Installation

On January 18, 2012, a twenty (20) mil polyurethane liner was installed in the floor of the excavation at approximately five feet (5') bgs. Approximately six inches (6") of non-impacted pad sand was installed both above and below the liner to protect the liner from damage during installation and backfilling activities.

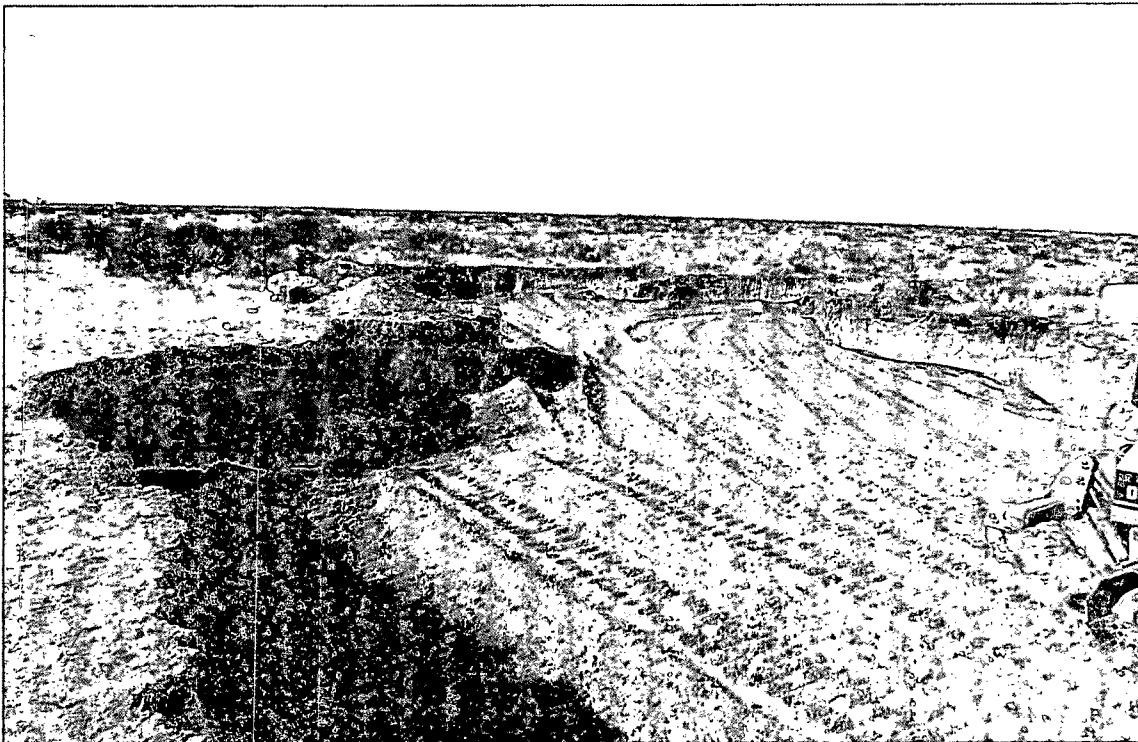
Bass 3 Federal Well #4 8-16-11 - Excavation (during backfilling)

From January 18 through January 27, 2012, based on based on results of laboratory analyses and field screens, the excavation was backfilled in eighteen-inch (18") lifts, compacted, and contoured to fit the surrounding topography. Final dimensions of the excavation were approximately one hundred and thirty feet (130') in length, ranging in width from approximately thirty-five feet (35') to approximately forty-eight feet (48'), and approximately five feet (5') in depth. The stockpiled material on-site was transported to Lea Land, Inc. (NMOCDD Permit # WM-01-035), for disposal.
