LINN ENERGY

Skelly Unit #2 (2RP-1293)

CAP Report and Termination Request

Rice Environmental Consulting & Safety

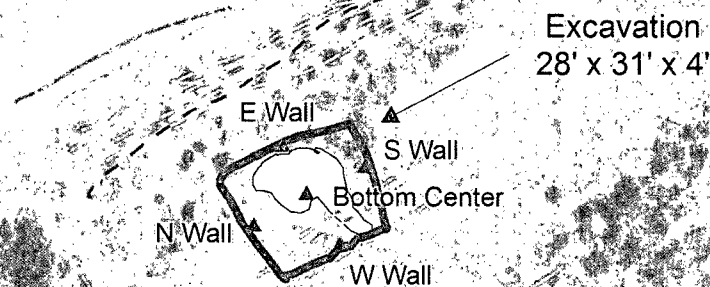
Figure 1

The site was excavated to 28 ft x 31 ft x 4 ft deep beginning on May 15th, 2013 (Figure 1). A total of 156 yards of excavated soil was taken to a NMOCD approved facility for disposal. Confirmatory samples from the excavation walls and bottom were taken to a commercial laboratory for analysis. All the wall samples returned laboratory chloride results below 1,000 mg/kg. The bottom sample at 4 ft bgs returned a laboratory chloride

result of 17,200 mg/kg, a GRO reading of 778 mg/kg, a DRO reading of 15,200 mg/kg and a Total BTEX reading of 40.5 mg/kg (Appendix B). This data was sent to BLM and NMOCD. BLM and NMOCD responded on June 3rd, 2013, that the bottom of the excavation needed to be further delineated. NMOCD requested that a vertical be completed at the base of the excavation.

Excavation Lab Sampling

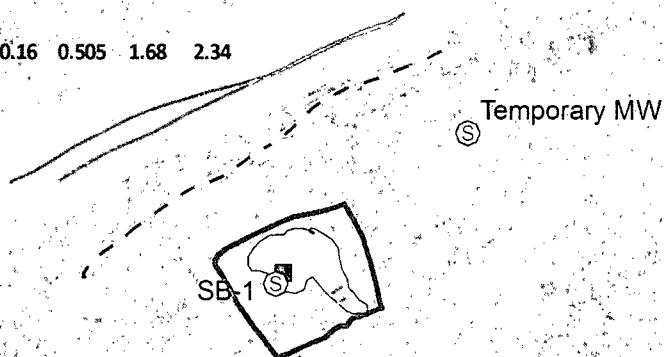
Figure 2

On June 4th, 2013, a vertical was installed at the base of the 4 ft bgs excavation (Figure 2). The vertical was installed to a depth of 17 ft bgs, and samples were taken at regular intervals as it was being advanced. The field samples were field tested for chlorides and hydrocarbons and representative samples were taken to a commercial laboratory for analysis. The 17 ft bgs sample returned a laboratory chloride reading of 7,440 mg/kg, a GRO reading of 72.5 mg/kg, a DRO reading of 2,040 mg/kg and a BTEX reading of 2.34 mg/kg (Appendix C).

Based on the vertical data, a soil bore was installed through the excavation to determine the depth of contamination. Per BLM's approval on June 27th, 2013, a caliche road was installed from the well pad to the site to facilitate the soil bore installation. On July 24th, 2013, a soil bore was installed through the center of the excavation (Figure 2). The soil bore was advanced to a depth of 39 ft bgs and field samples were taken at regular intervals and field tested for chlorides and hydrocarbons. The 39 ft bgs sample was taken to a commercial laboratory for analysis and returned a chloride result of 64 mg/kg, a DRO result of 11.3 mg/kg and GRO and BTEX results of non-detect (Appendix D). A temporary monitor well was installed at the site to determine whether groundwater existed in the area. The temporary monitor well was drilled to 45 ft bgs. Red bed clay was encountered at 43 ft bgs, which indicates the base of the aquifer. The bore was gauged and no groundwater was discovered in the bore.

Vertical and SB Installation Data

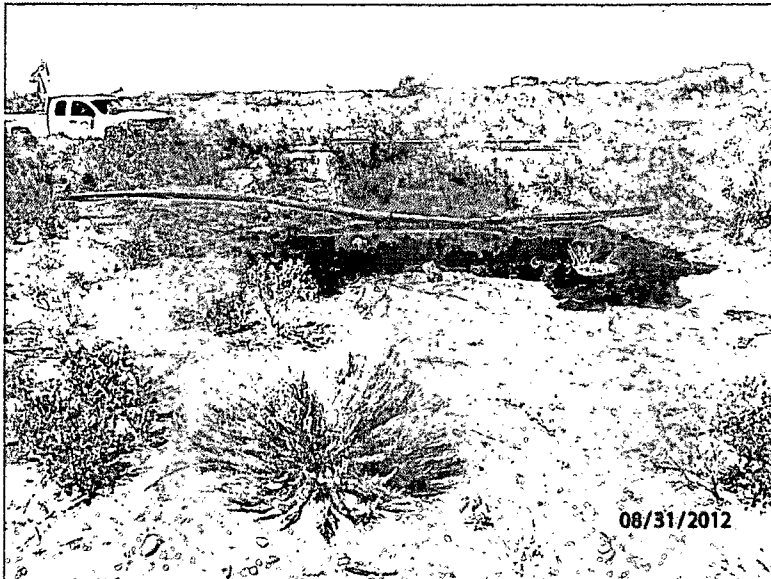
Initial release, facing east

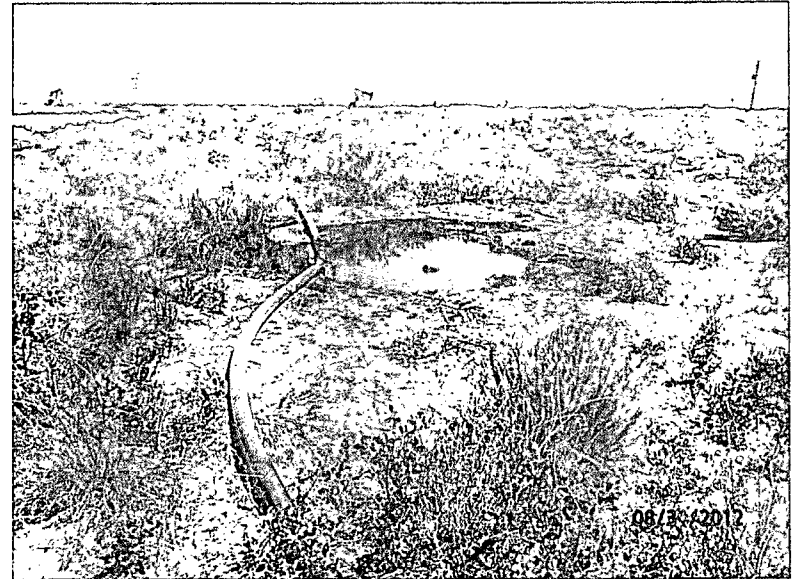
Initial release, facing south

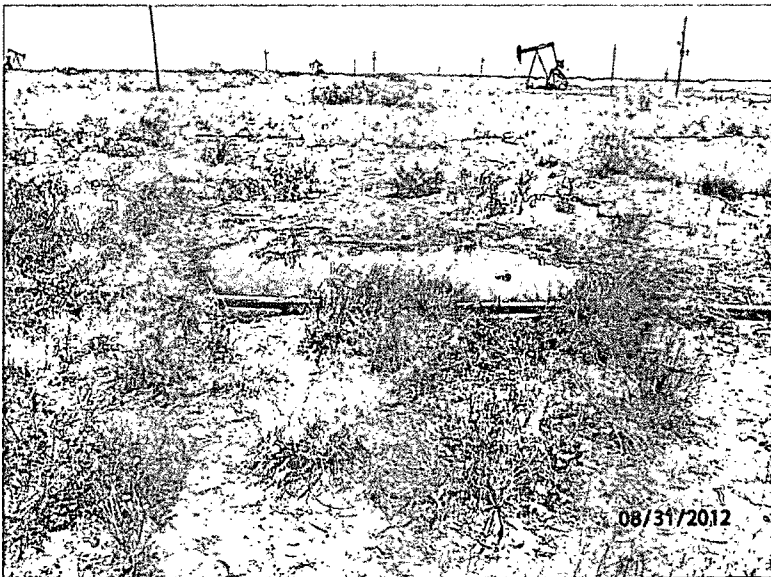
Initial release, facing west

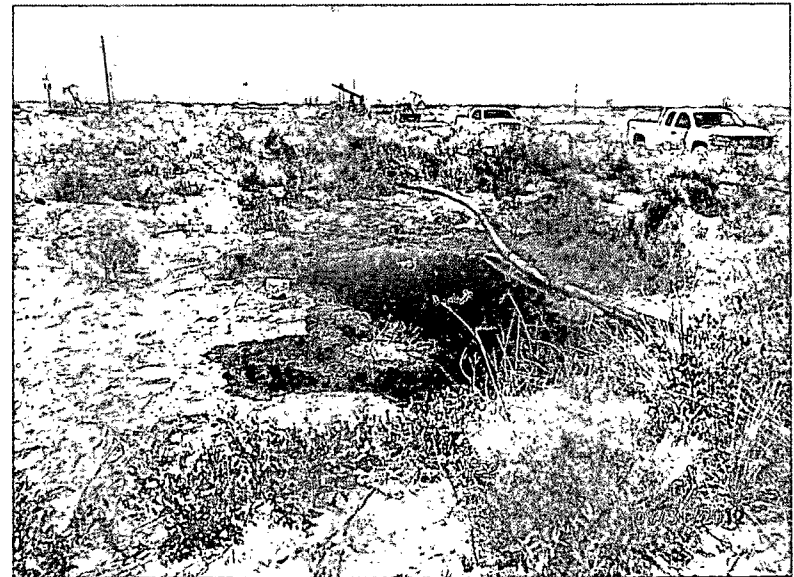
Initial release, facing north

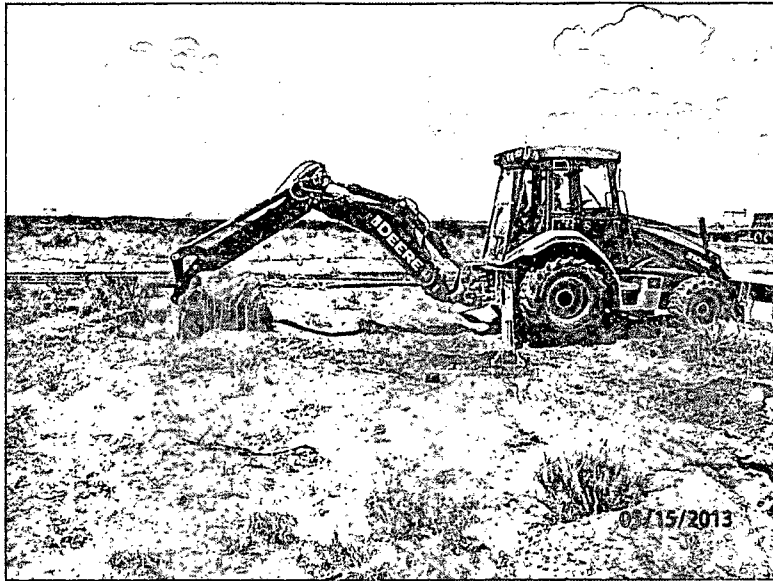
Excavating release area, facing east 5/15/13

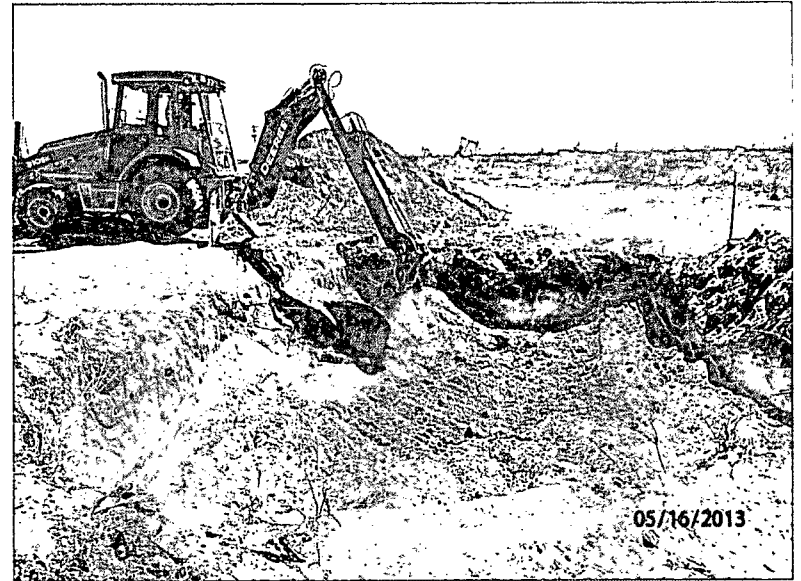
Excavating release area, facing south 5/16/13

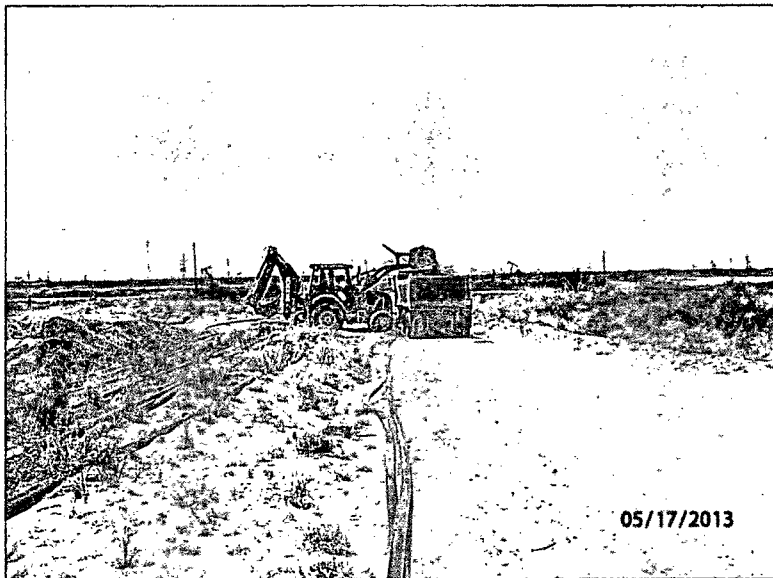
Exporting soil, facing north 5/17/13

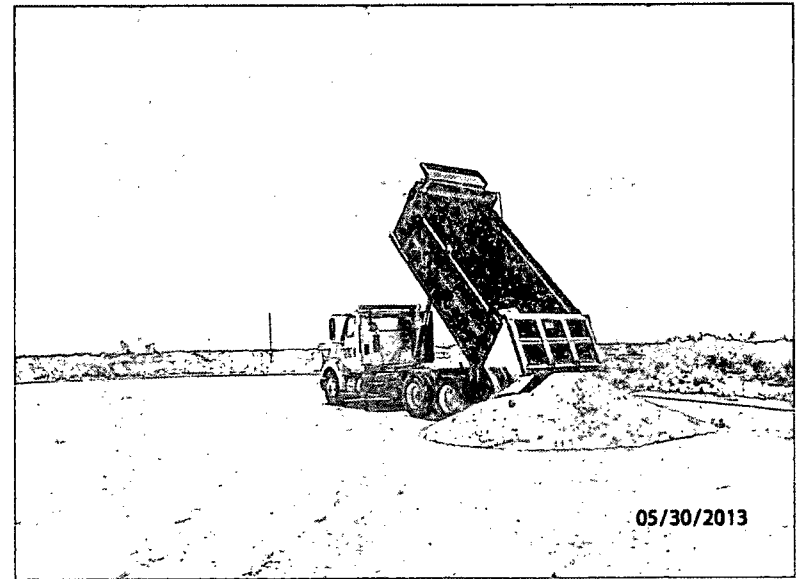
Importing soil, facing southwest 5/30/13

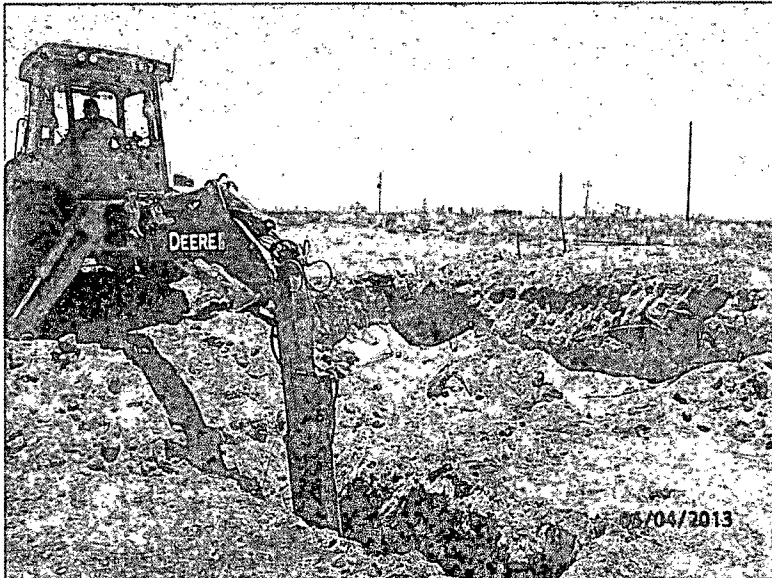
Installing vertical, facing southeast

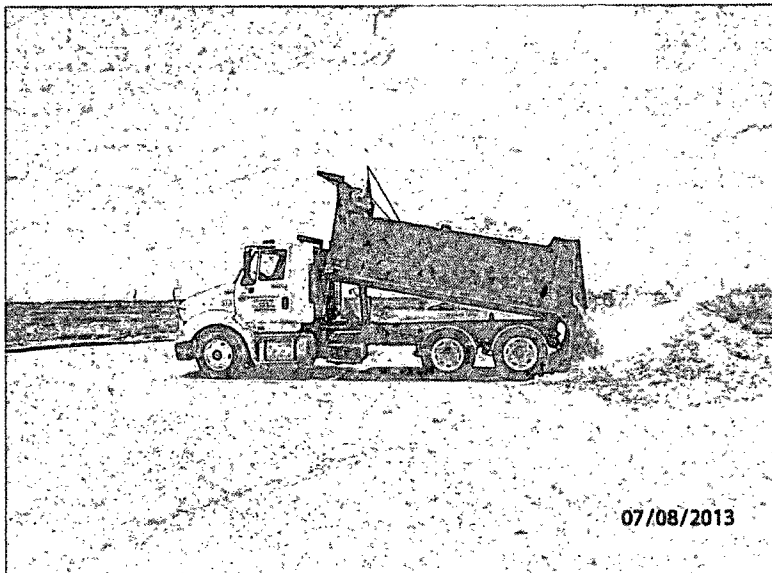
Importing caliche, facing southwest

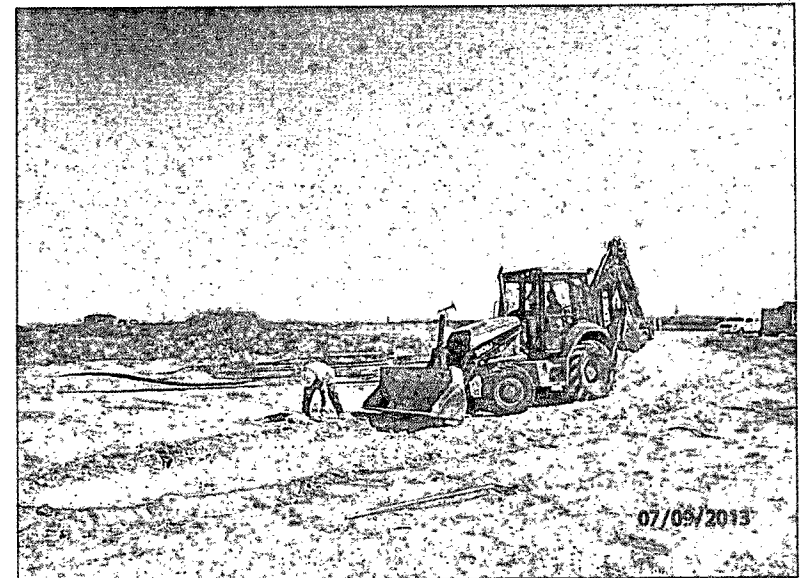
Creating road for SB installation, facing northwest 7/9/13

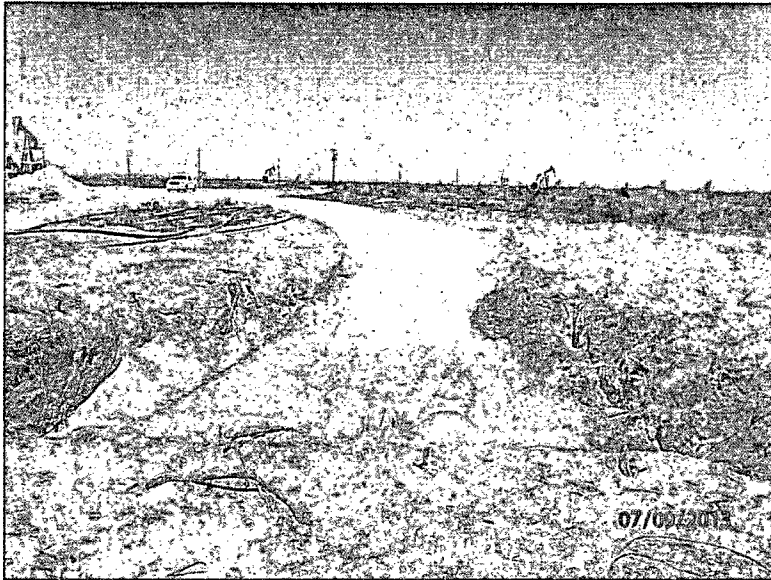
Road completed, facing northeast

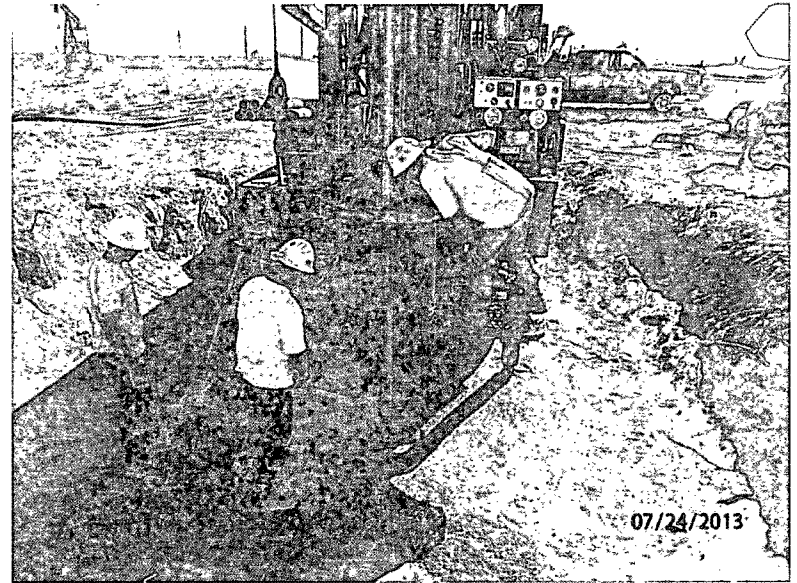
Installing SB-1, facing northeast

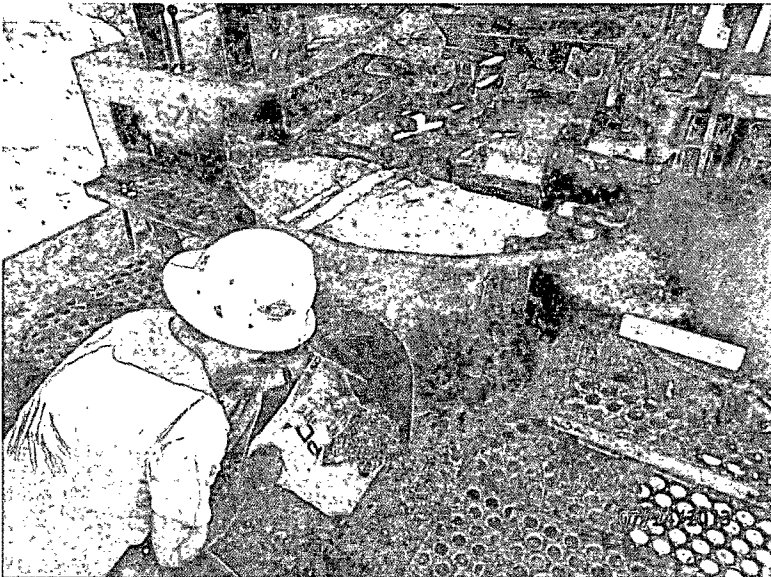
Plugging SB-1 in total with bentonite

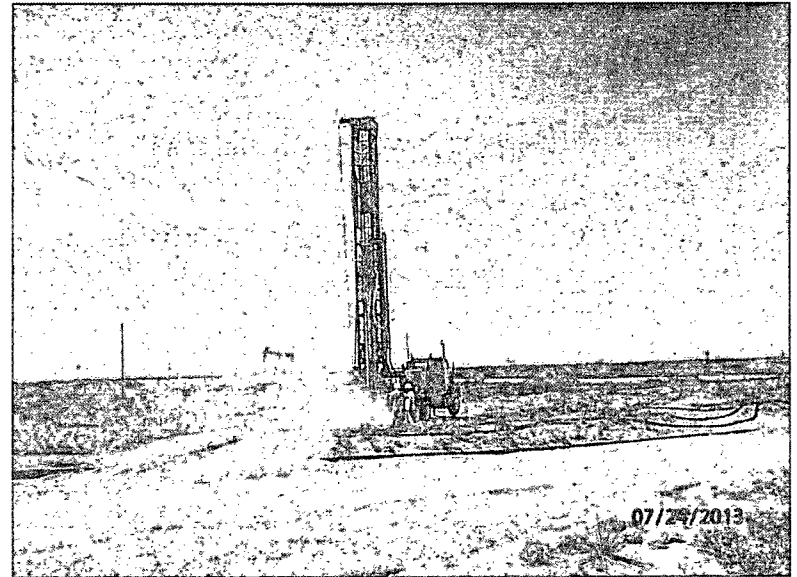
Installing temporary monitor well, facing SW

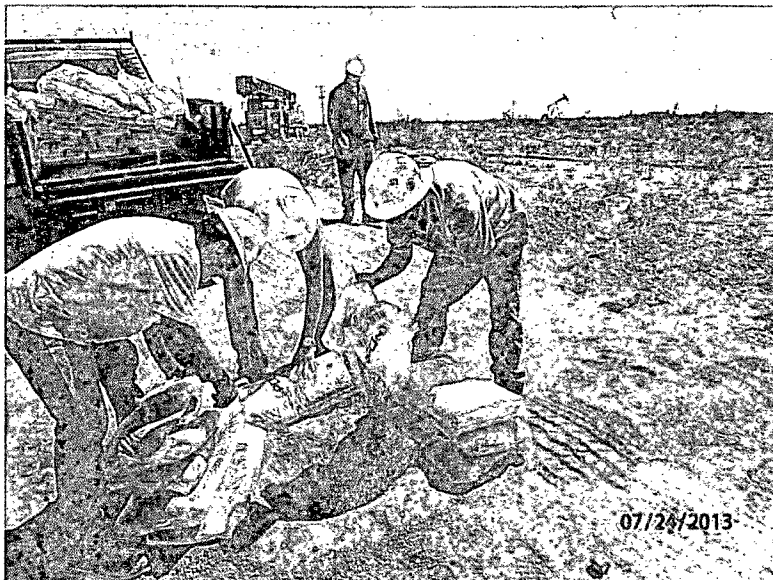
Plugging temporary monitor well in total with bentonite
Facing northeast
7/24/13

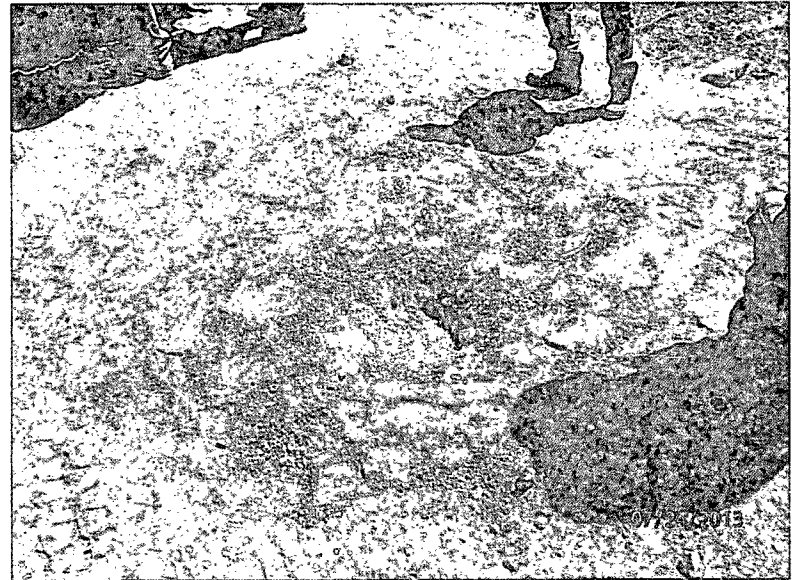
Completed temporary monitor well, facing NE 7/24/13

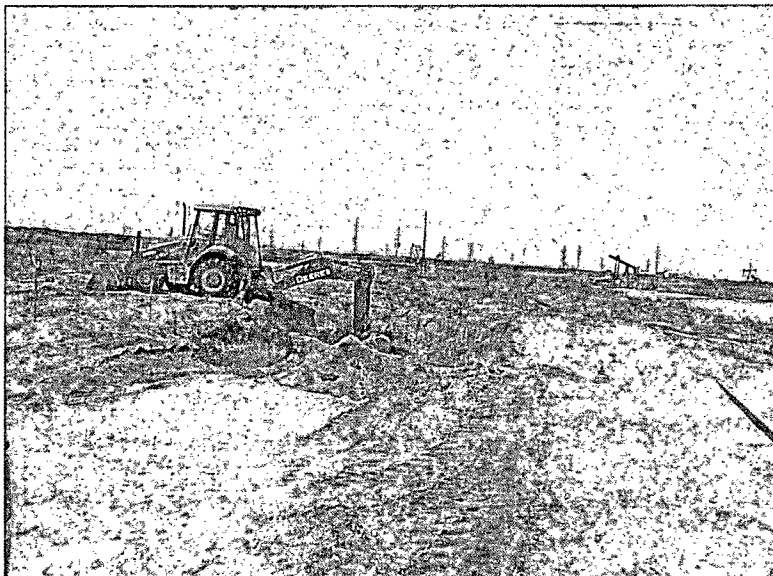
Digging trench to key set liner, facing SW 8/21/13

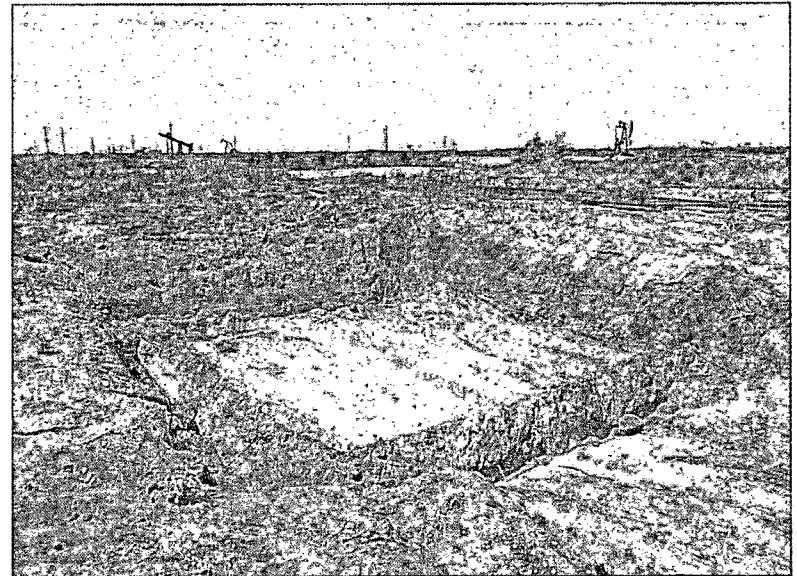
Trench completed, facing northwest 8/21/13

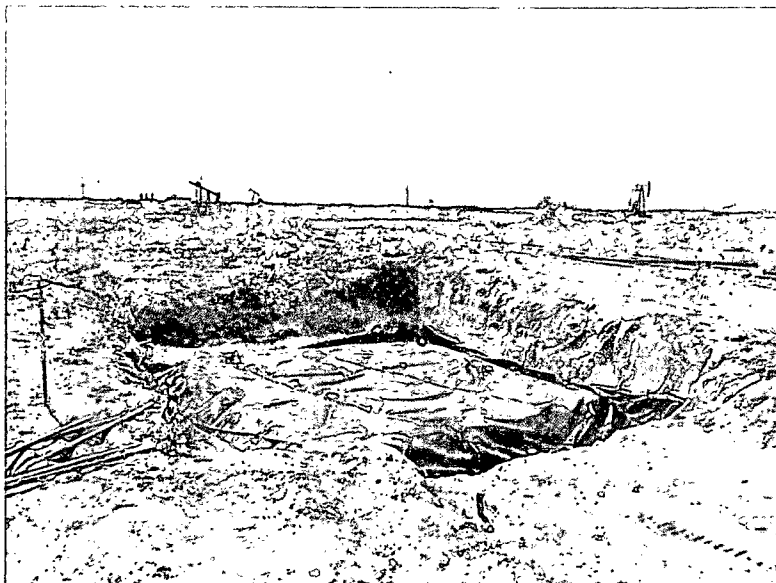
20-mil reinforced poly liner installed, facing NW
8/21/13

On August 21st, 2013, RECS personnel were on site to install the liner. A trench was excavated along the base of the 4 ft bgs excavation to key set the liner. A 20-mil reinforced poly liner was then installed and properly seated into the base of the excavation. 120 yards of clean topsoil and 72 yards of clean caliche were imported to the site to serve as backfill. A 2 ft layer of topsoil was placed over the liner to prevent it from punctures. A 1.5 ft layer of caliche was placed over the topsoil and then additional topsoil was used to backfill the site to the surface. On August 23rd, 2013, amendments were added to the soil and the site was seeded with LPC seed mix.

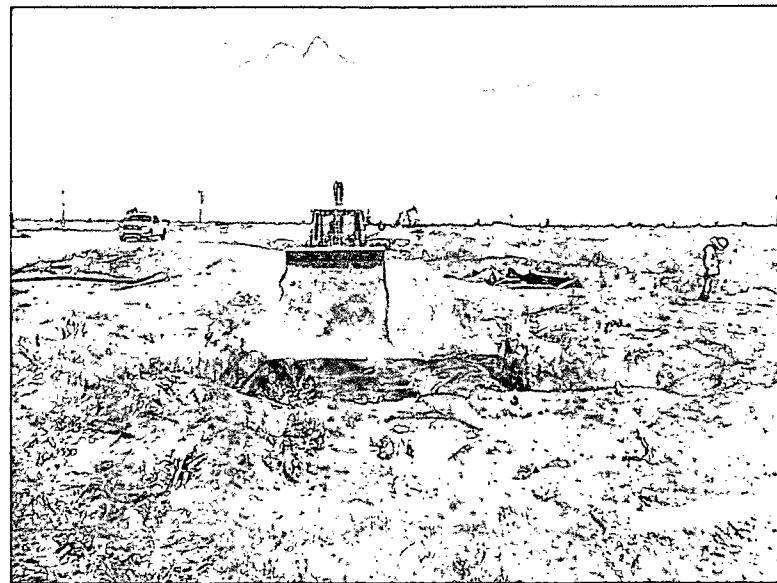
Padding above liner, facing east
8/21/13

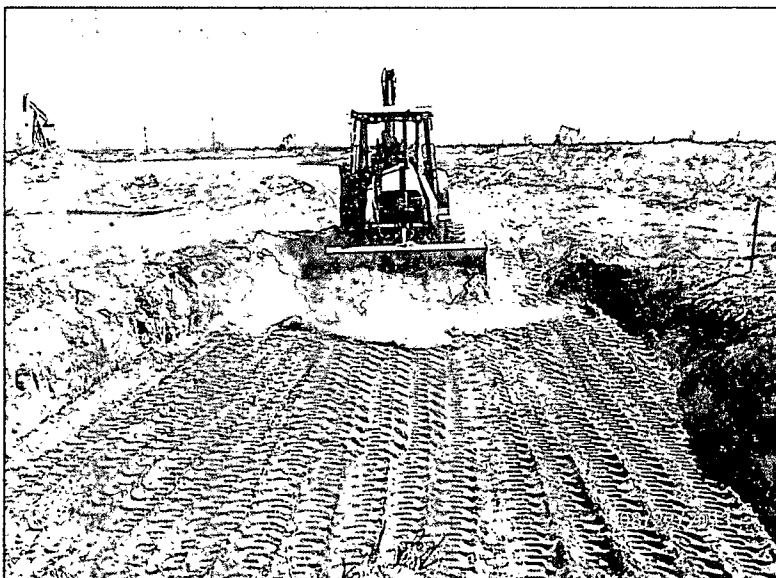
Padding over liner completed; backfilling with caliche
facing east
8/22/13

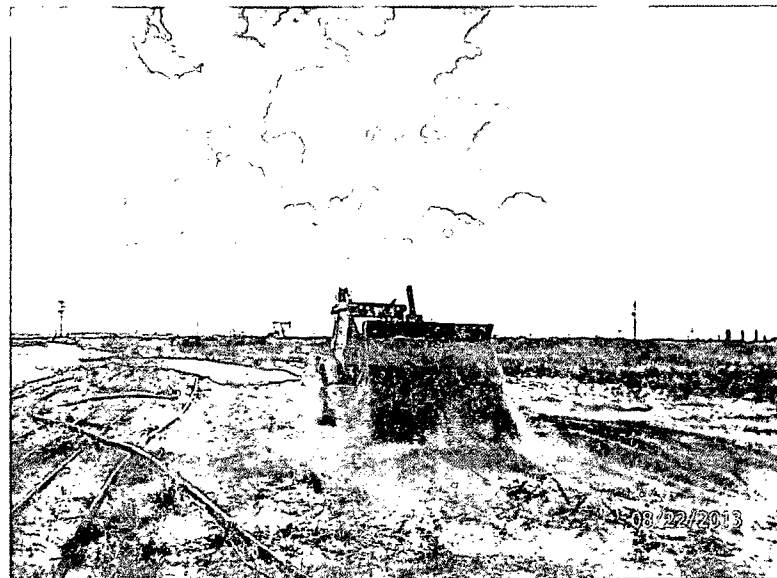
Backfilling with topsoil, facing northeast
8/22/13

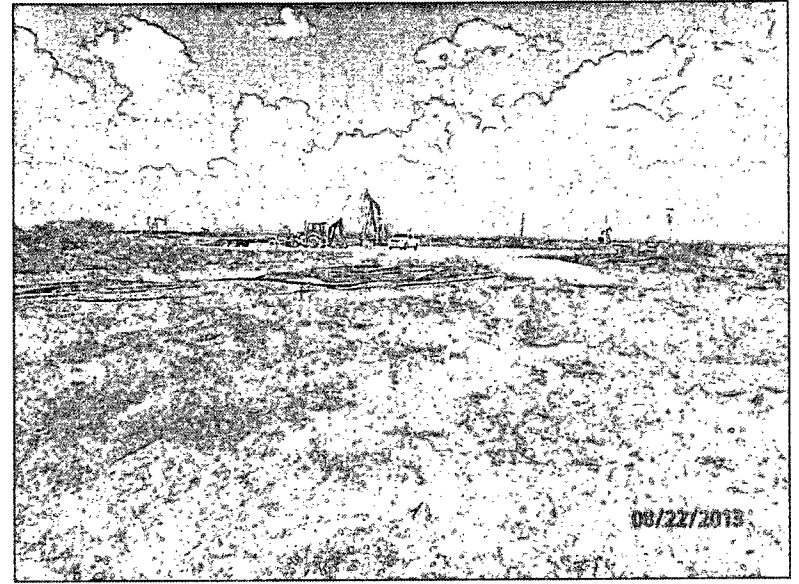
Backfilling completed, facing northeast 8/22/13

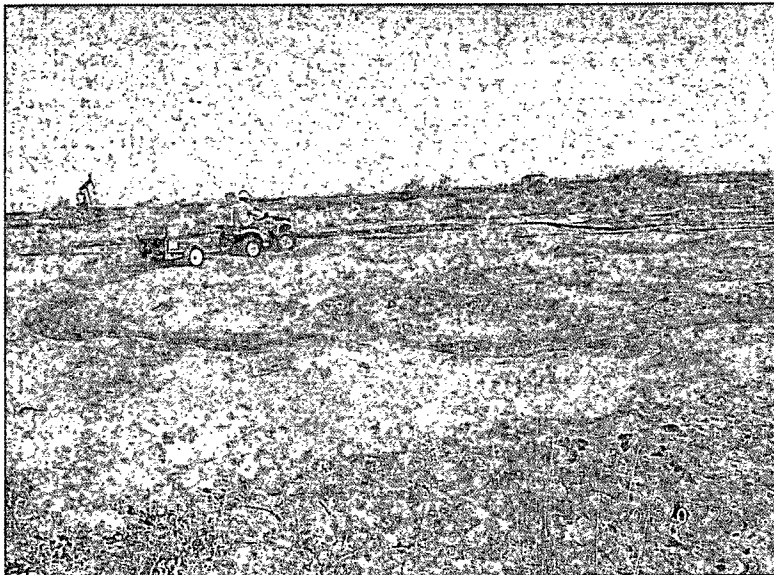
Adding soil amendments, facing northeast 8/23/13

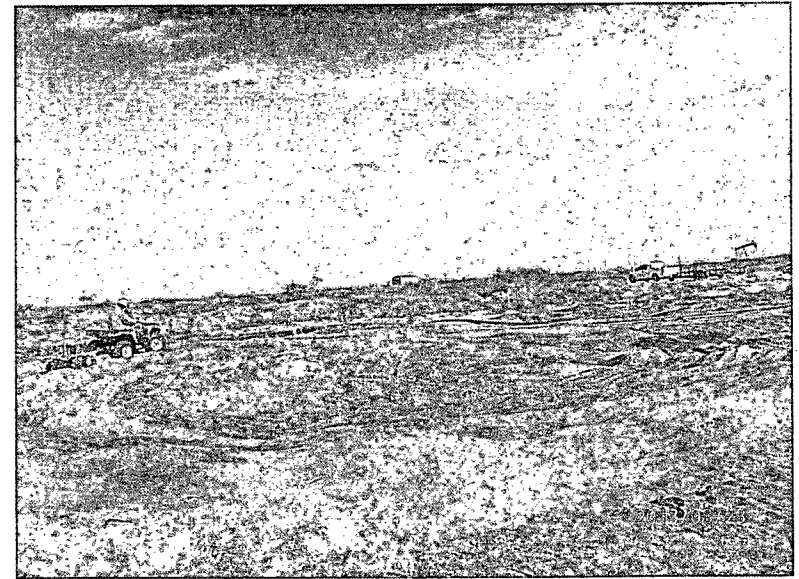
Tilling in soil amendments, facing northeast 8/23/13

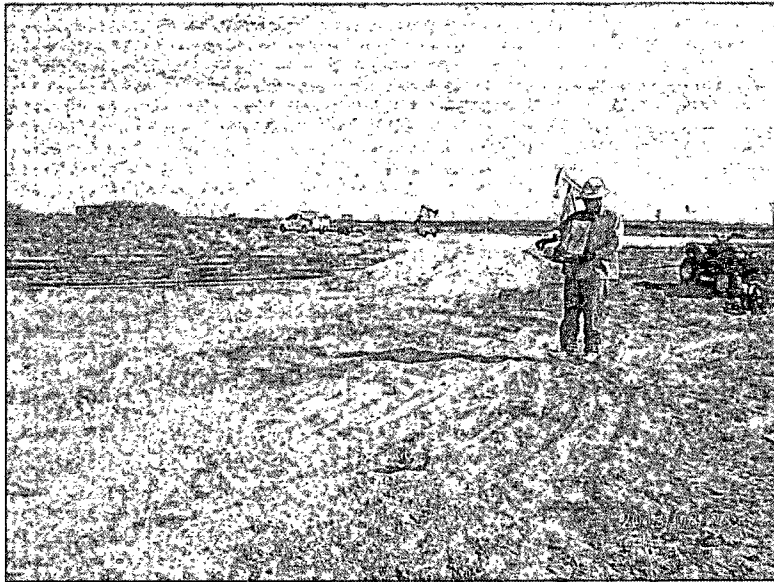
Seeding site with LPC mix, facing east

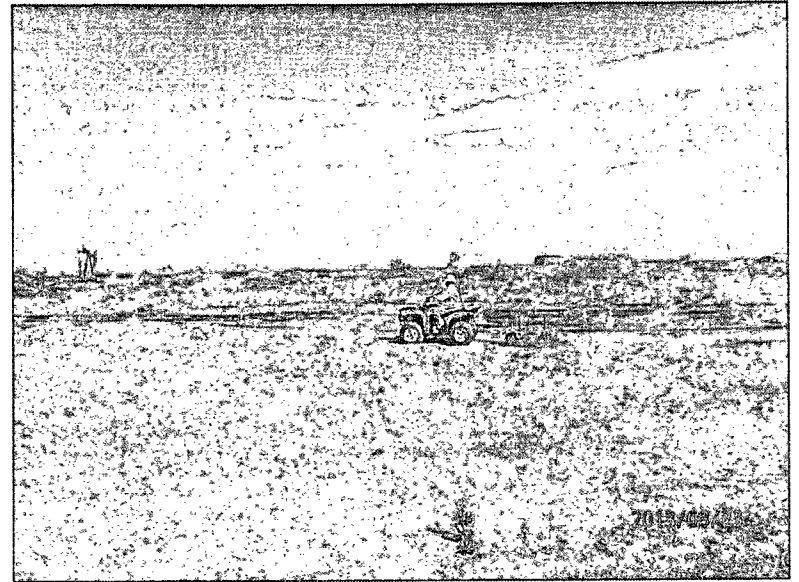
Tilling in seed, facing northeast

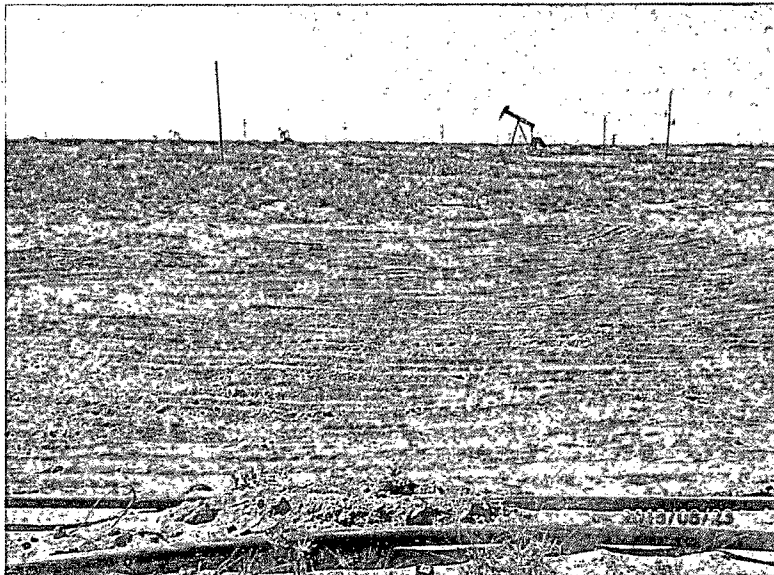
Site completed, facing west

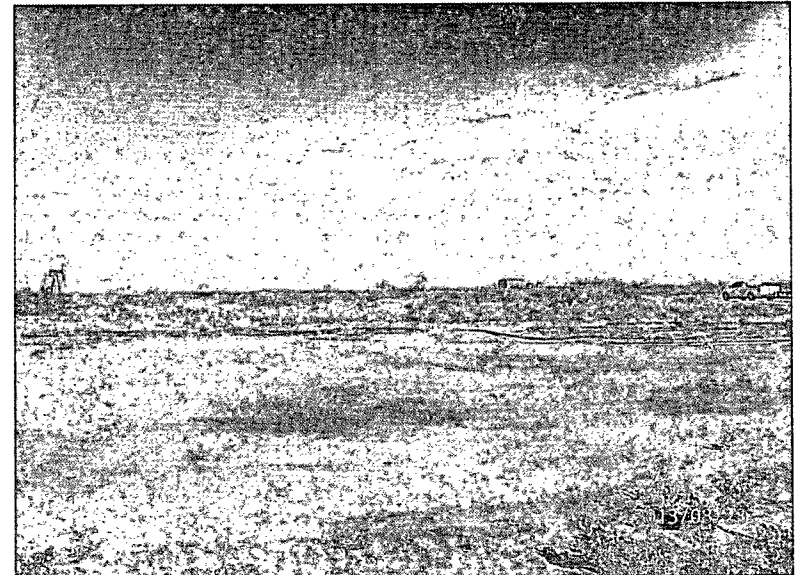
Site completed, facing northeast
