REMEDIATION SUMMARY AND RISKED-BASED SITE CLOSURE REQUEST

**BOPCO, LP
POKER LAKE UNIT WELL #205 AT PLU #158 BATTERY
Eddy County, New Mexico
Unit Letter "A" (NE/NE), Section 7, Township 24 South, Range 30 East
Latitude 32.237400° North, Longitude 103.914150° West
NMOCD Reference #s 2RP-_____**

September 2012

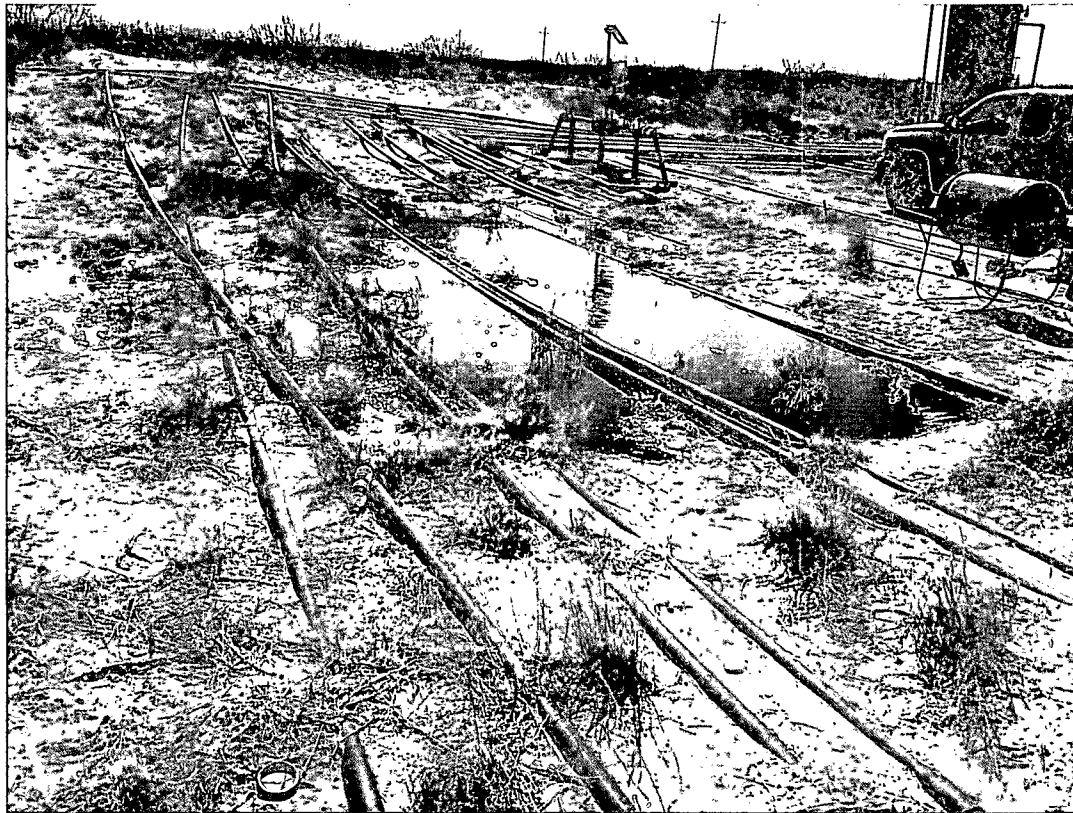
Photograph of the initial release at the Poker Lake Unit Well #205 at PLU #158 Battery.

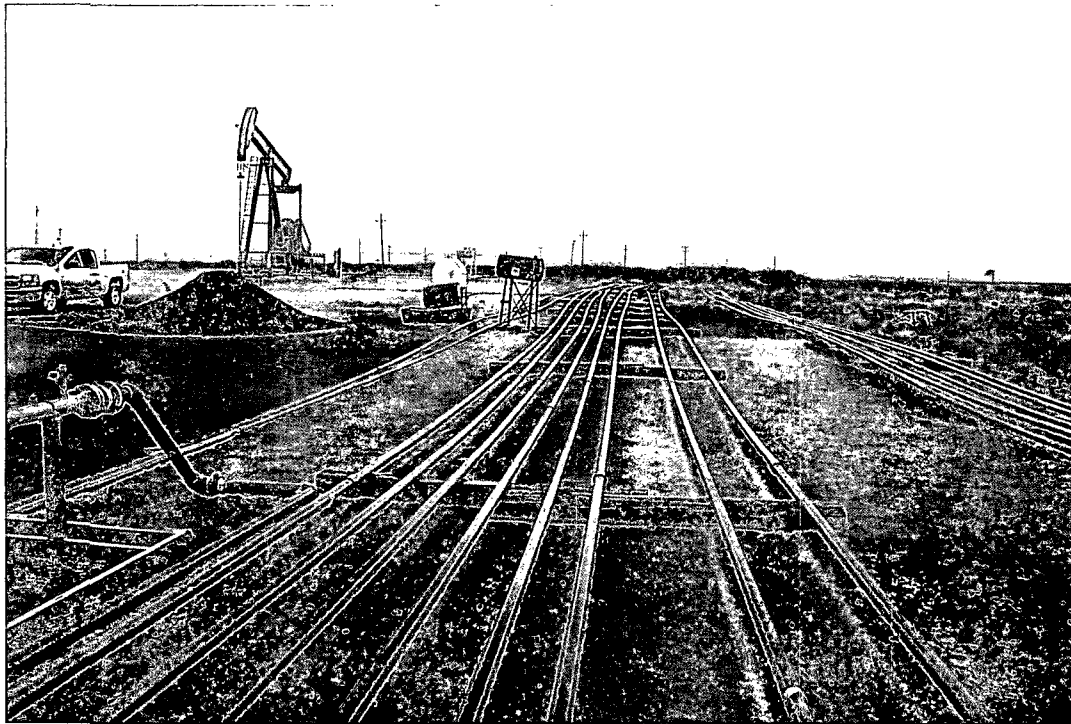
Photograph of the Poker Lake Unit Well #205 at PLU #158 Battery Remediation Site after being backfilled.
