**Release Report/ General
Correspondence**

Enterprise SJ

Release Notification and Corrective Action

Enterprise Products
Gallegos Canyon Unit #89E Pipeline Release
Latitude North 36.60454°, Longitude West -108.157400°
SE/NW (Unit F) Section 6, T27N R12W
San Juan County, New Mexico
September 29, 2014

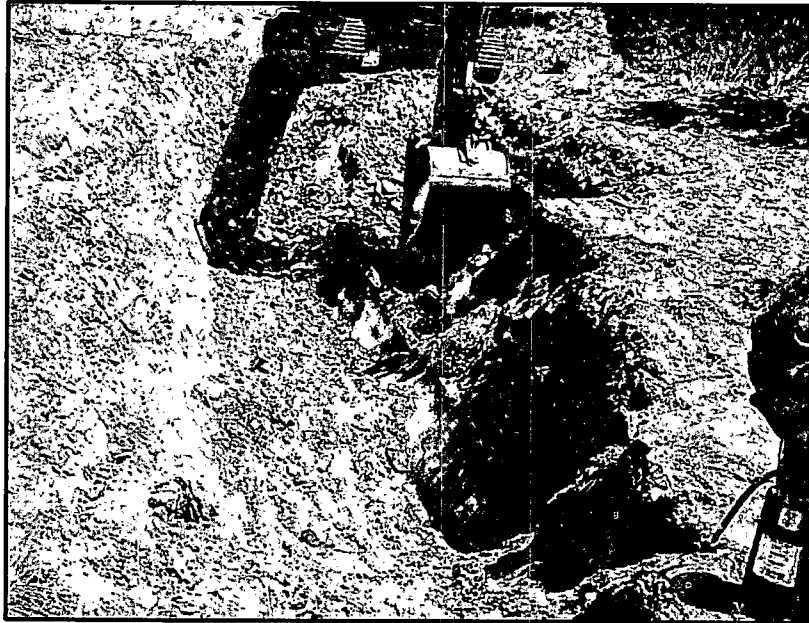
Photo 1: Beginning of excavation at the GCU #89E pipeline release.

On July 23, August 20 and 21, 2014 Souder, Miller & Associates (SMA) responded to a hydrocarbon release associated with the GCU #89E pipeline release. Excavation of the pipeline began on August 20, 2014 for pipeline repairs. Under the supervision and direction of SMA, West States Energy Contractors (WSEC) excavated soil for repair activities. SMA field screened the excavated soil, stockpiles, and the walls and base of the excavation to determine the extent of the release.
