**Release Report/ General
Correspondence**

Enterprise RA

Release Notification and Corrective Action

Enterprise Products
Lateral K-39 Pipeline Release
Latitude North 36.04130, Longitude West -107.521890
Unit A Section 13 T25N R7W
Rio Arriba County, New Mexico
March 13, 2014

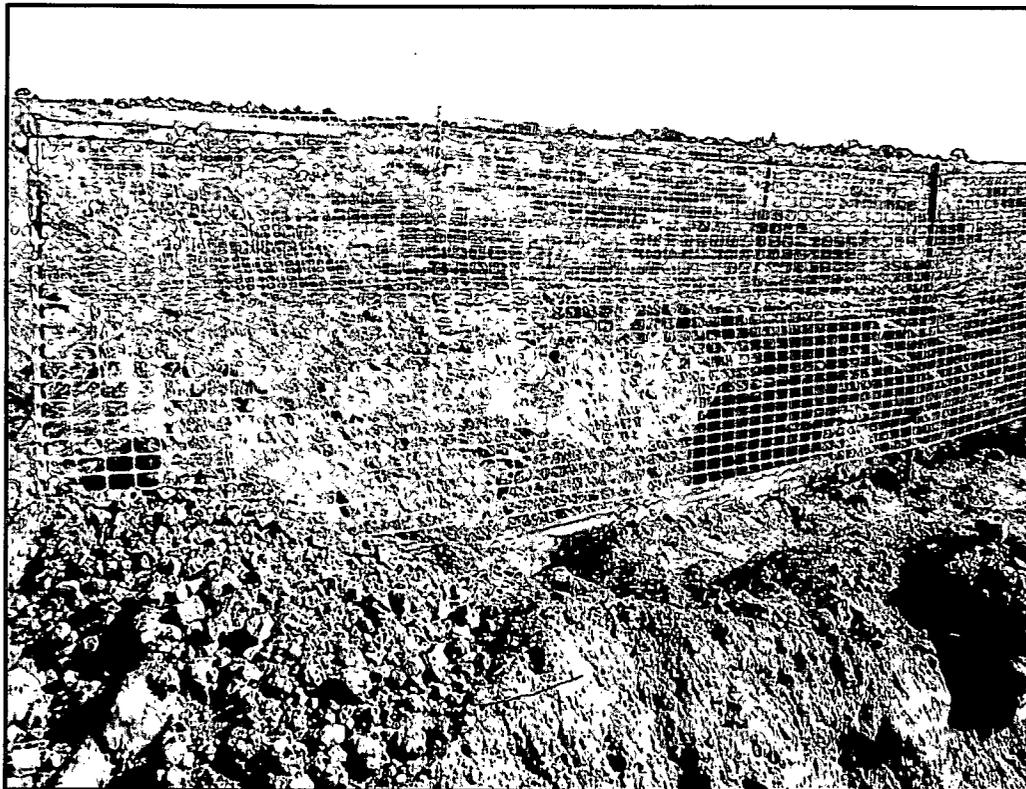
Photo 1: Photo of the Lateral K-39 Pipeline release point during the beginning of excavation activities.

Notes: Spiral weld pipe could not be repaired by West States Energy Contractors. Ems is to be scheduled to I-wrap pipe. High Benzene in excavation, no entry (2/13/14)

- Excavate around pipeline release. EMS Repaired pipeline using Trenching

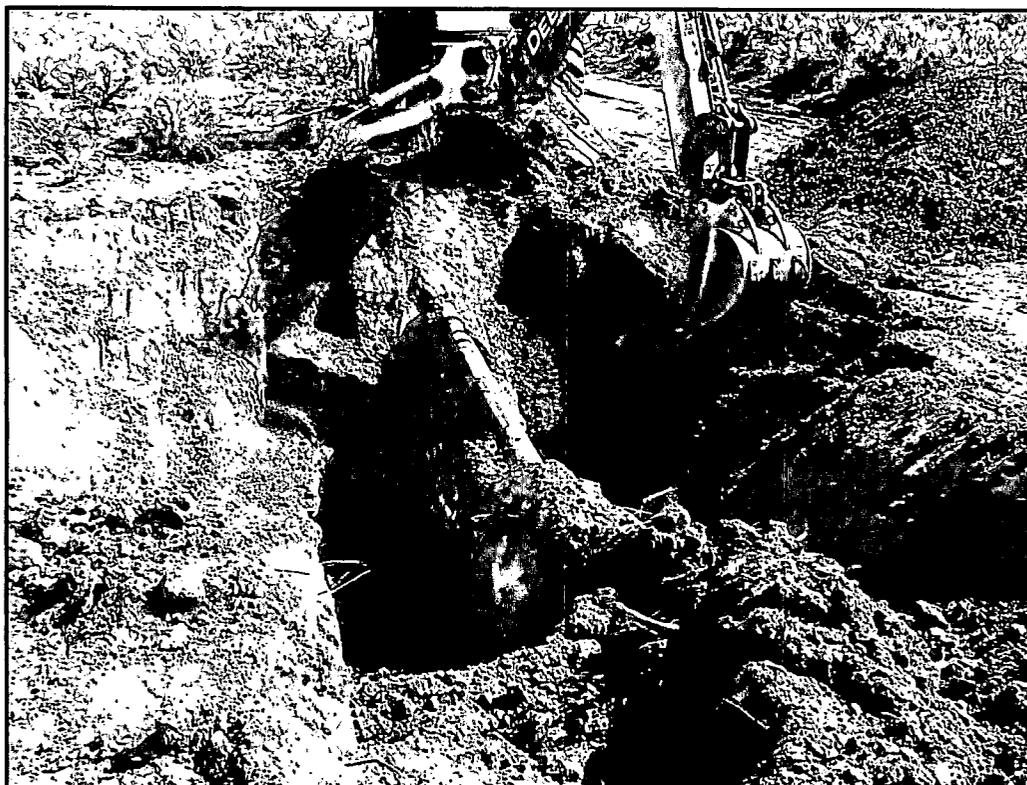
Photo 2: View during the beginning of the Lateral K-39 Pipeline excavation, facing west.

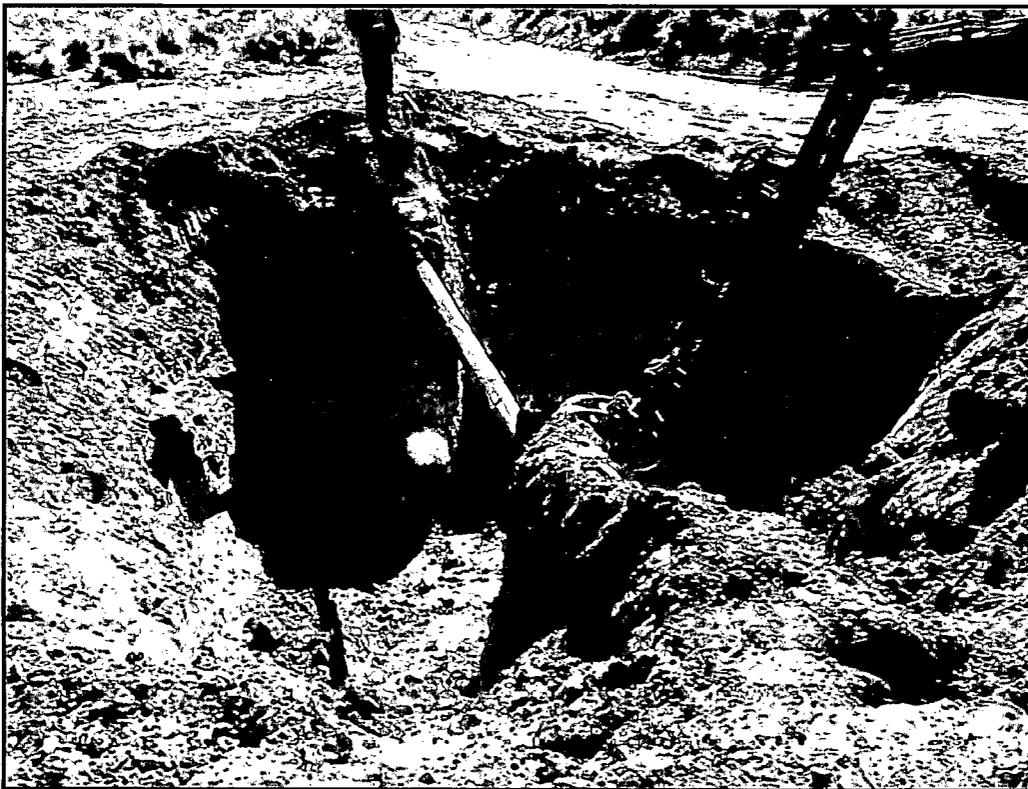
Photo 3: Continued excavation of the Lateral K-39 Pipeline, facing east.

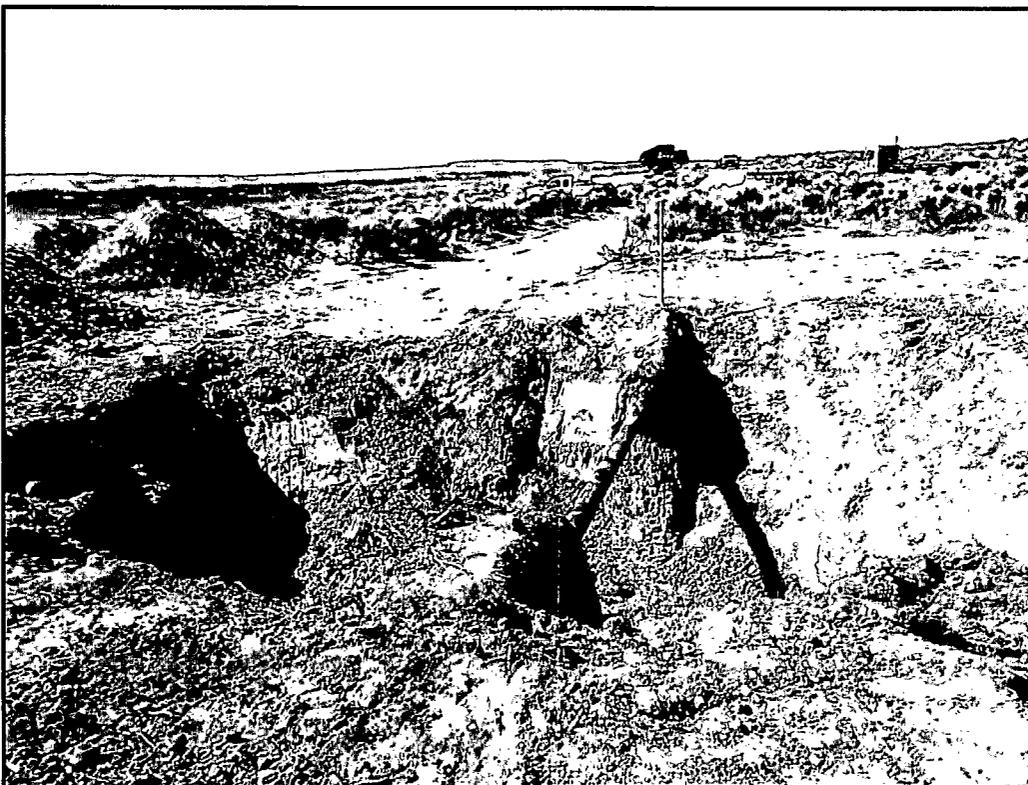
Photo 4: View of the total extent of the Lateral K-39 Pipeline excavation, facing west.

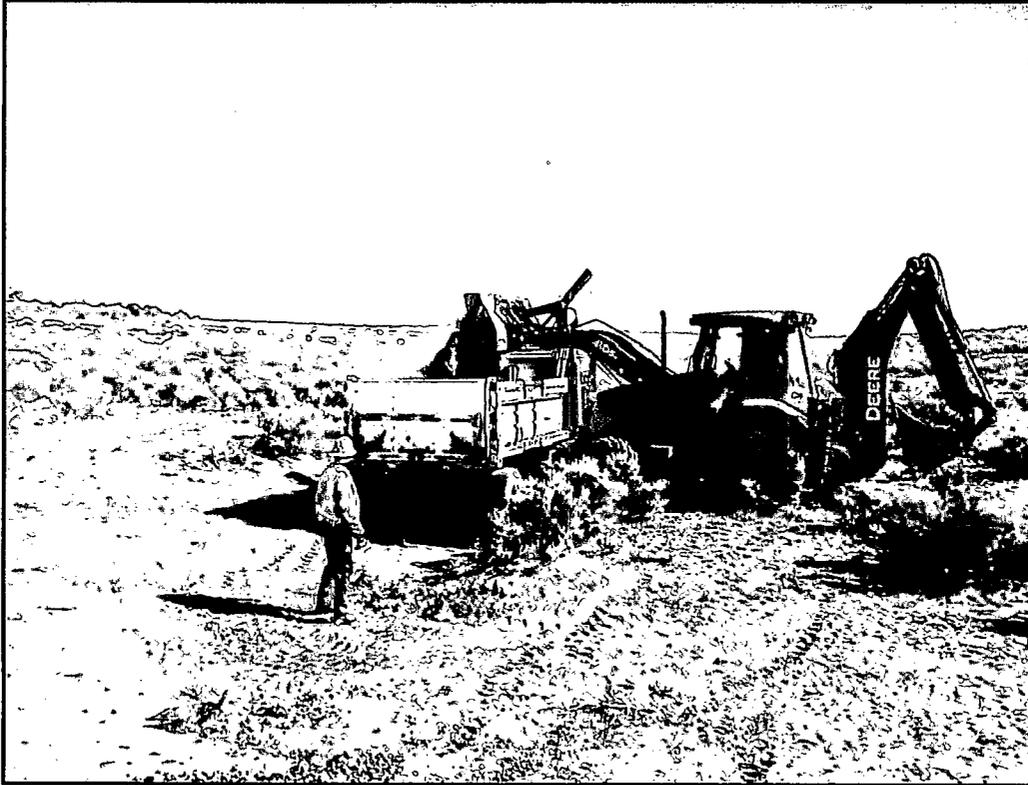
Photo 5: Photo documentation of contaminated soils being loaded for offsite disposal.

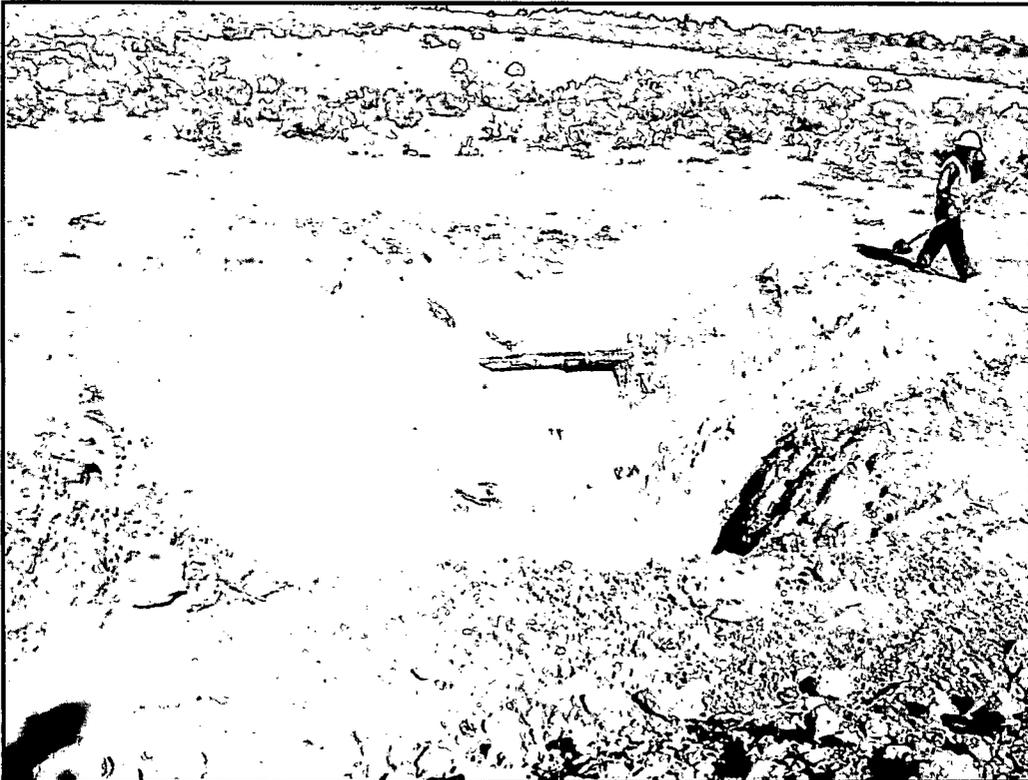
Photo 6: Backfilling of the Lateral K-39 Pipeline excavation, facing north.

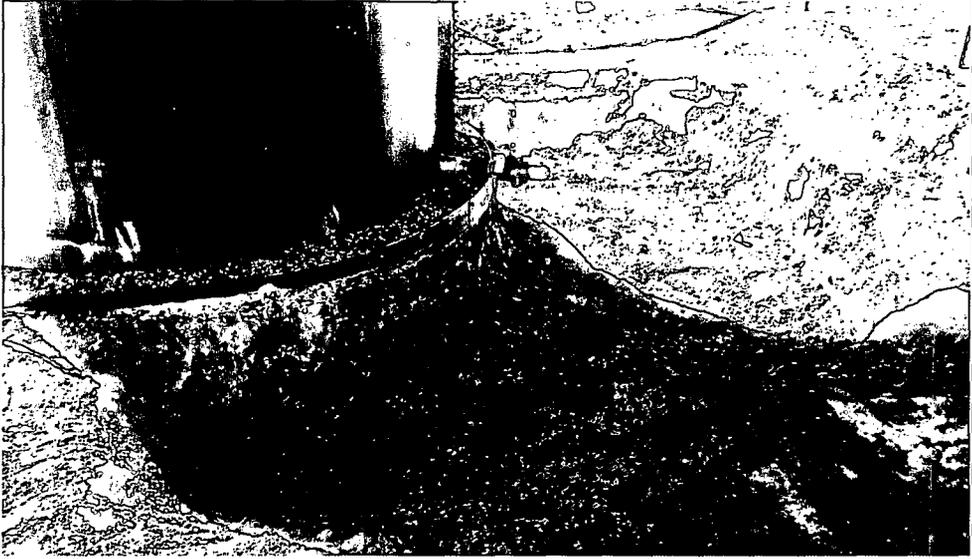
Photo #1

Client: Enterprise Field Services, LLC	
Project: Trunk A-LP San Juan 30-6 #18A Drip Tank	
Taken by: Heather Woods	
Date: January 24, 2014	
AES Project No. 140121	Description: View of final excavation looking south.

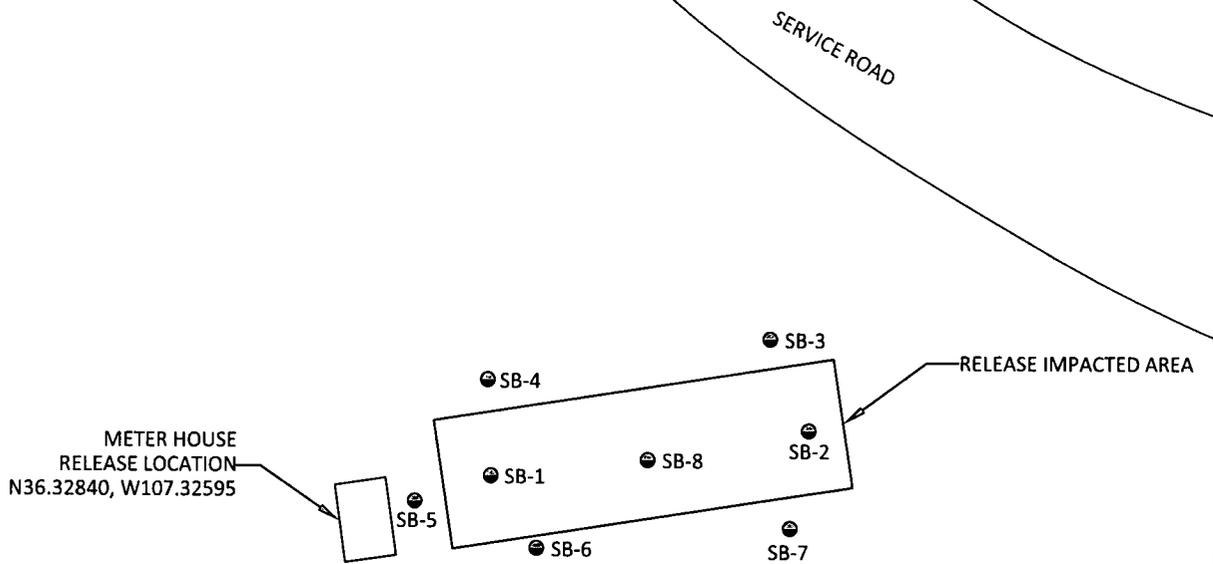
FIGURE 3

Field Screening Results			
Sample ID	Date	Depth (ft)	OVM-PID (ppm)
JANOGA ACTION LEVEL			100
SB-1	3/11/14	0.75	3.7
		1.5	8.7
		2.25	18.4
SB-2	3/11/14	0.5	57.9
		0.75	4.3
SB-3	3/11/14	0.5	0.9
SB-4	3/11/14	0.5	1.5
SB-5	3/11/14	0.25	1.6
		1.25	0.8
SB-6	3/11/14	0.25	0.3
		1.25	0.6
SB-7	3/11/14	0.25	1.1
		1.25	0.4
SB-8	3/11/14	0.5	12.8
		1.0	1.6
		1.25	3.2

INITIAL ASSESSMENT SAMPLE LOCATIONS AND RESULTS MARCH 2014
 ENTERPRISE FIELD SERVICES LLC
 JICARILLA 35B GAS COM #1
 SE¼ NE¼, SECTION 11, T24N, R5W
 RIO ARRIBA COUNTY, NEW MEXICO
 N36.32785, W107.32590

On March 11, 2014, AES completed the initial release assessment field work. The assessment included collection and field screening of 16 soil samples from 8 soil borings in the area impacted by the release. Soil borings were terminated between 0.5 and 2.25 feet below ground surface (bgs). Based on field screening results, AES recommended excavation of the release area. Sample locations are shown on Figure 3.

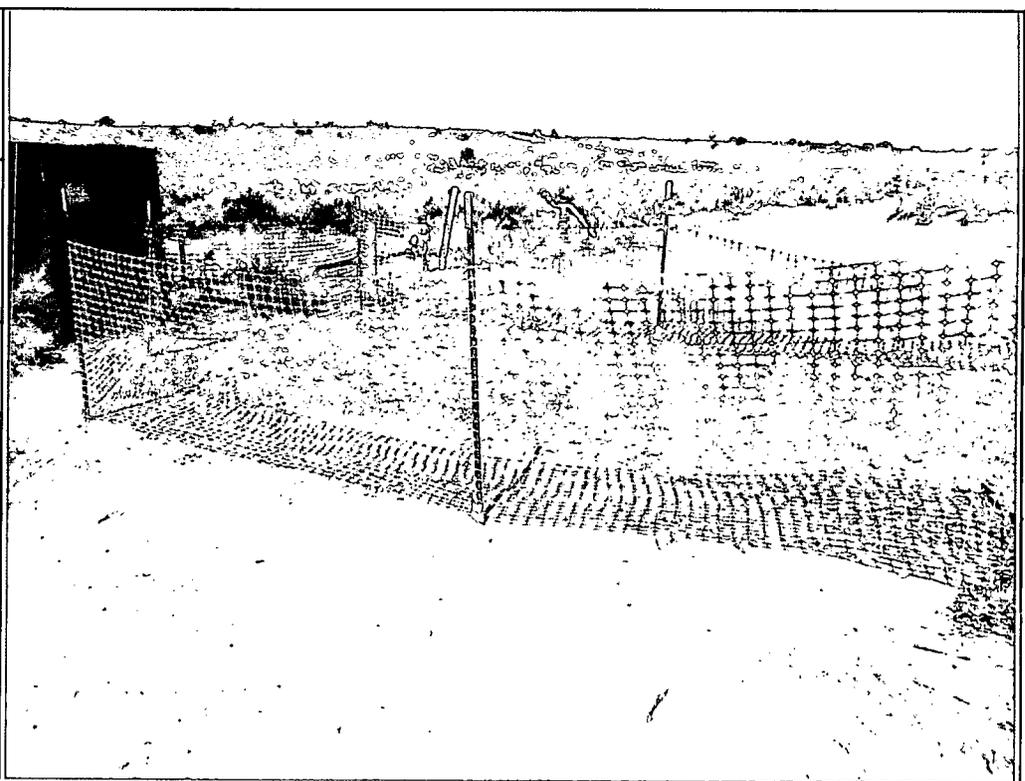
Photo #1

Client: Enterprise Field Services, LLC	
Project: Jicarilla 35B Gas Com #1	
Taken by: Heather Woods	
Date: March 11, 2014	
AES Project No. 140304	Description: View of impacted area prior to excavation looking north.

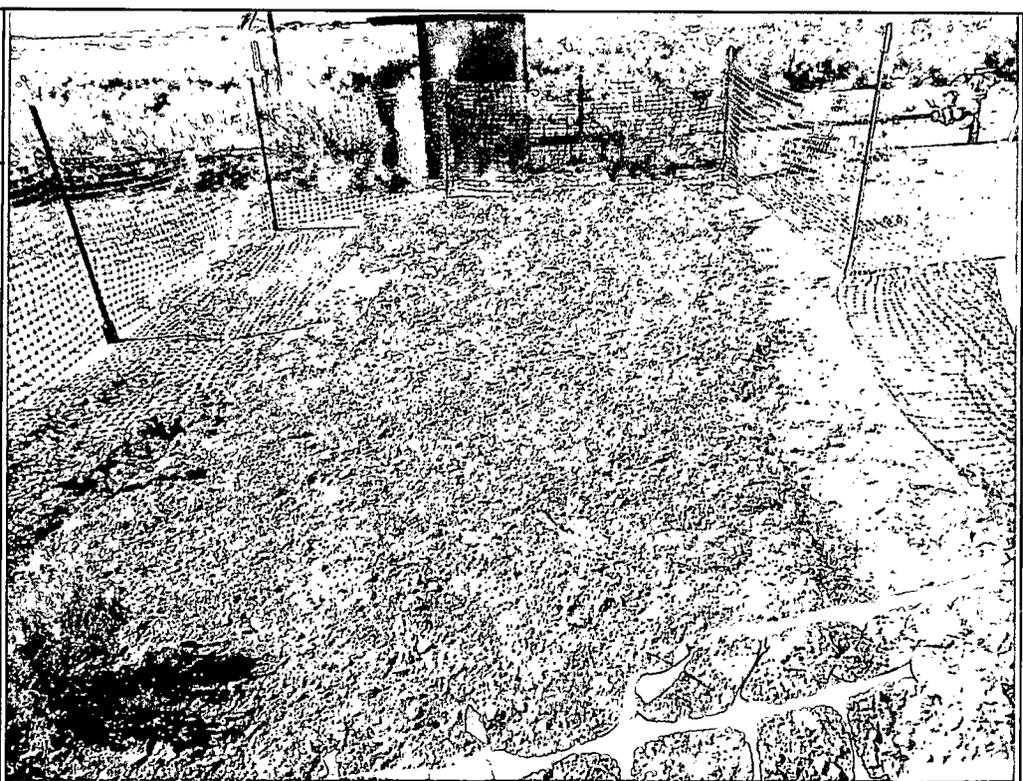
Photo #2

Client: Enterprise Field Services, LLC	
Project: Jicarilla 35B Gas Com #1	
Taken by: Heather Woods	
Date: March 11, 2014	
AES Project No. 140304	Description: View of impacted area prior to excavation looking west.

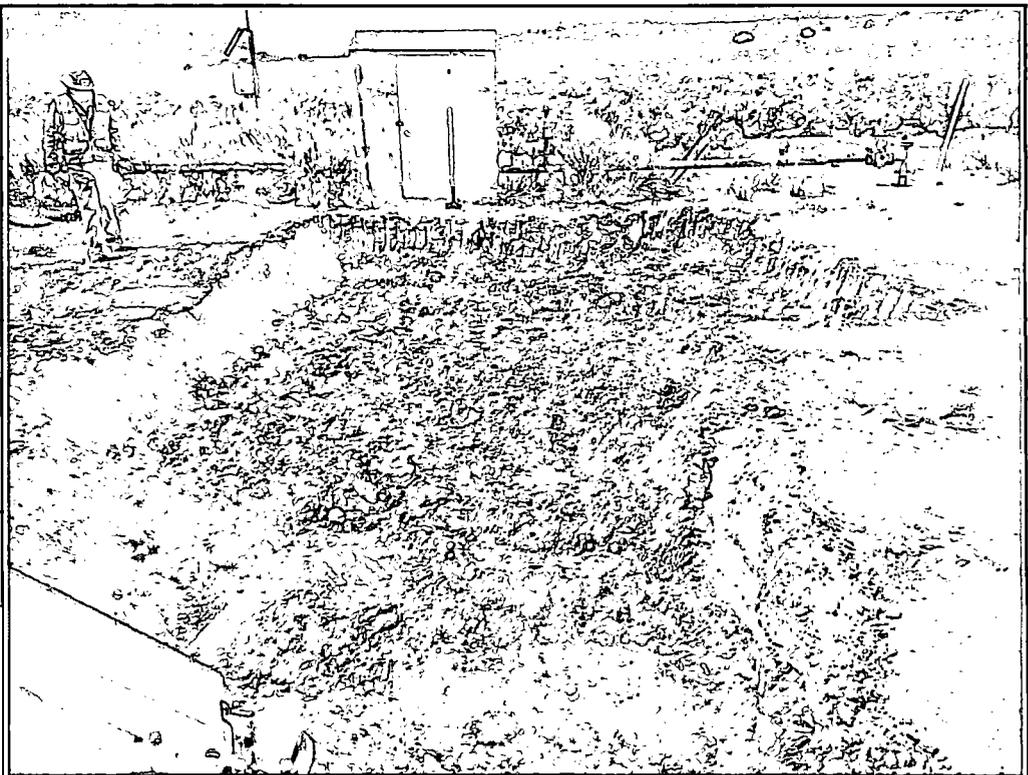
Photo #3

Client: Enterprise Field Services, LLC	
Project: Jicarilla 35B Gas Com #1	
Taken by: Heather Woods	
Date: March 27, 2014	
AES Project No. 140304	Description: View of final excavation looking west.

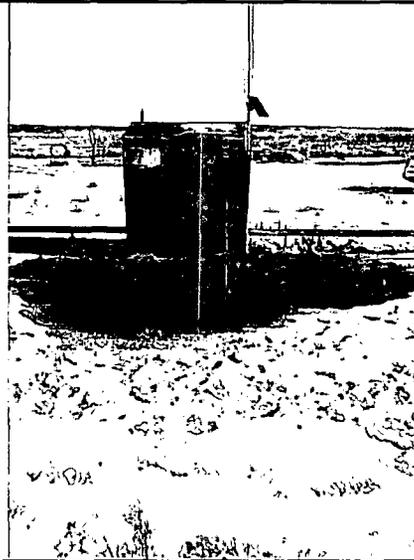
Photograph 1

Condensate and water pooled outside of meter house, looking towards the east.

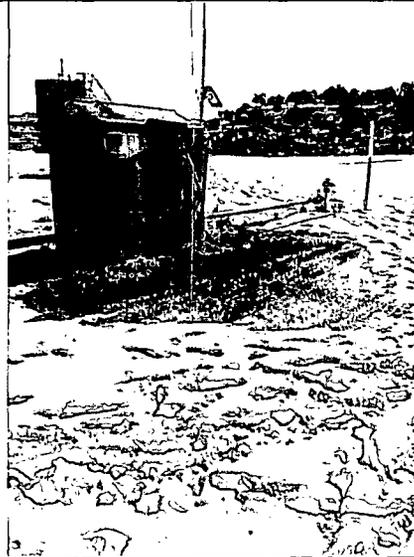
Photograph 2

Condensate and water pooled outside meter house, looking towards the southeast.

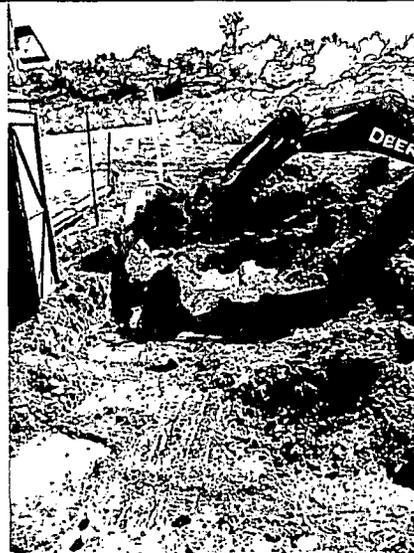
Photograph 3

Excavation activities removing hydrocarbon affected soil near A New Dawn meter house.

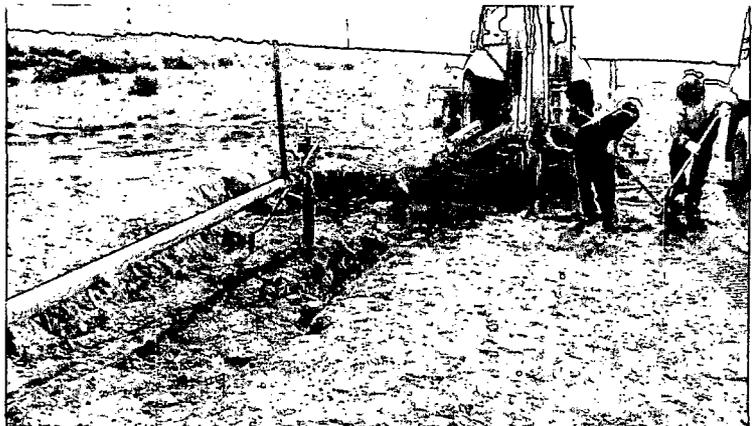
Photograph 2

General view of excavation area facing east.

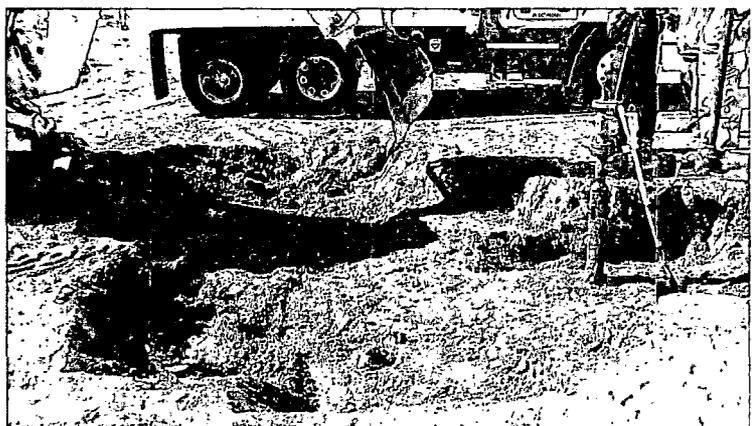
Photograph 3

General view of excavation area facing south.
