**Release Report/ General
Correspondence**

Enterprise RA

Enterprise Products
SJ 27-5 # 133 Meter Run Release
Latitude North 36.556226°, Longitude West -107.405558°
Unit M (SW ¼, SW ¼) Section 19 T27N R5W
Rio Arriba County, New Mexico
February 3, 2014

Site Photographs
Enterprise Products for the San Juan 27-5 #133 Meter Run Release

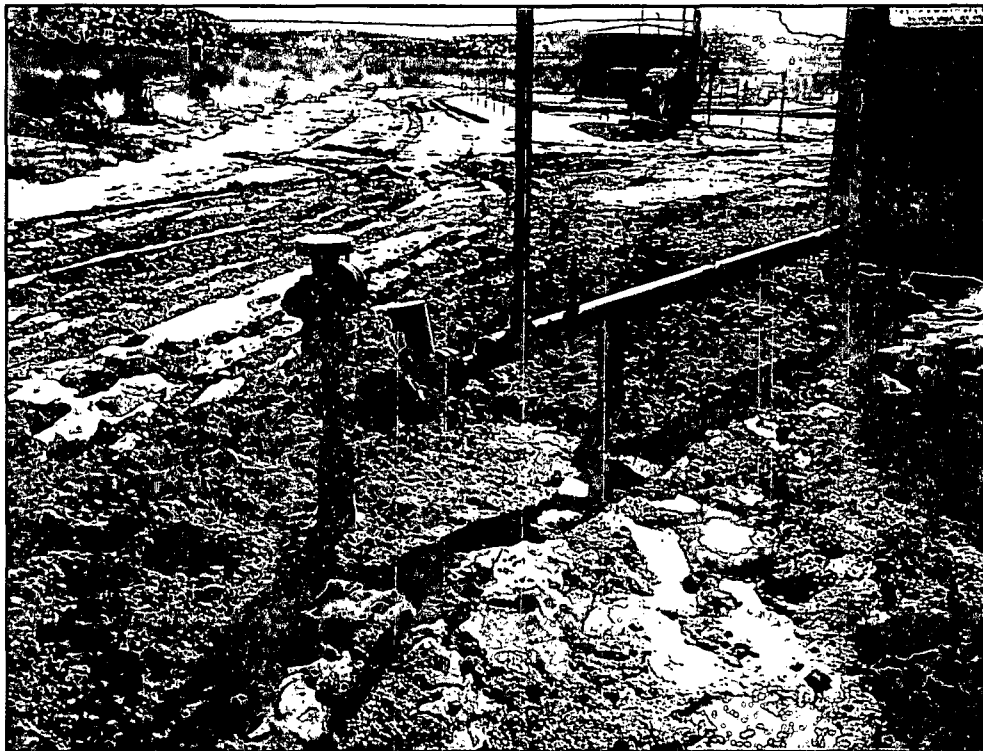
Photo 1: View of the SJ 27-5 #133 Meter Run release point.

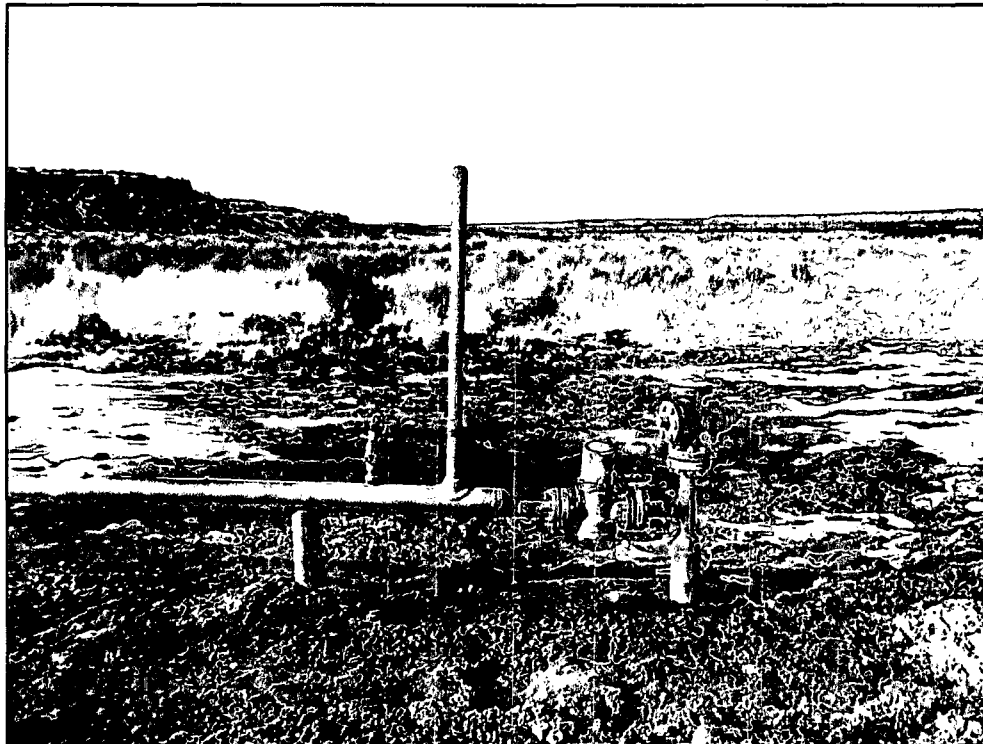
Photo 2: View of the SJ 27-5 #133 release looking west.

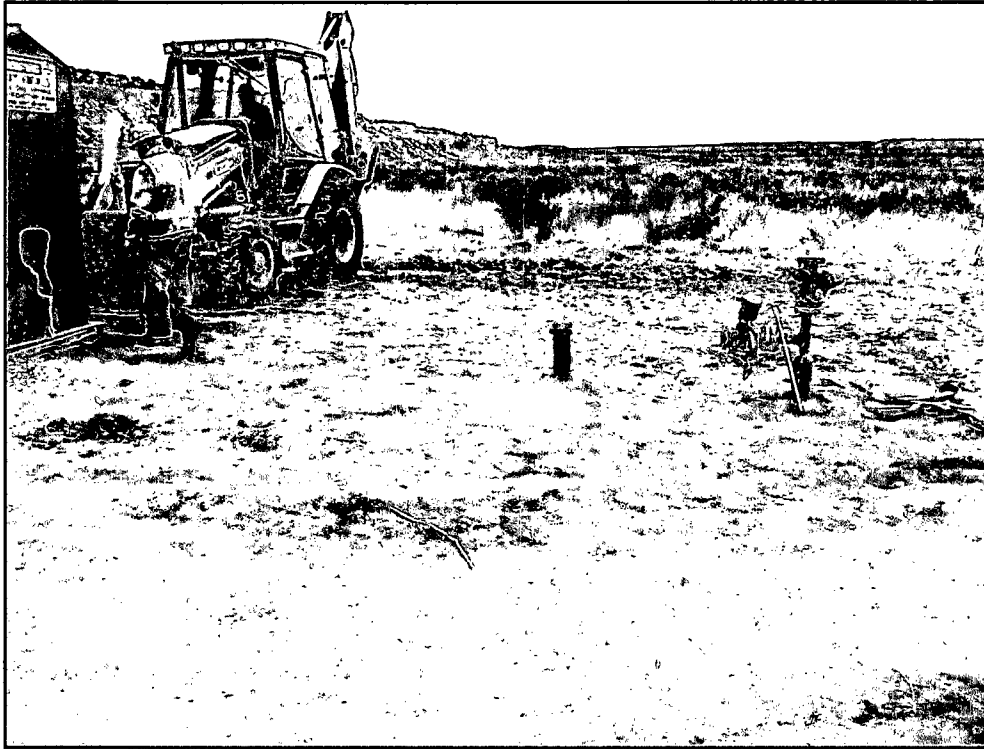
Photo 3: View of the Meter run repair activities. The area of impact was scraped just beyond the underground tie-in in the photo.

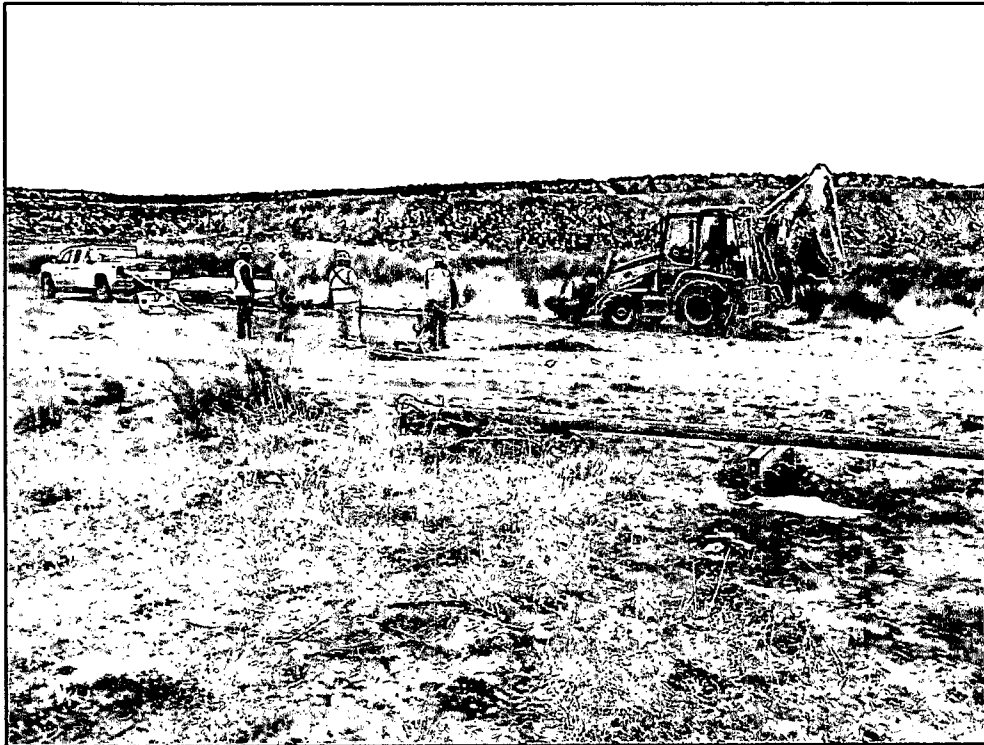
Photo 4: View of the impacted area being scraped with a backhoe.

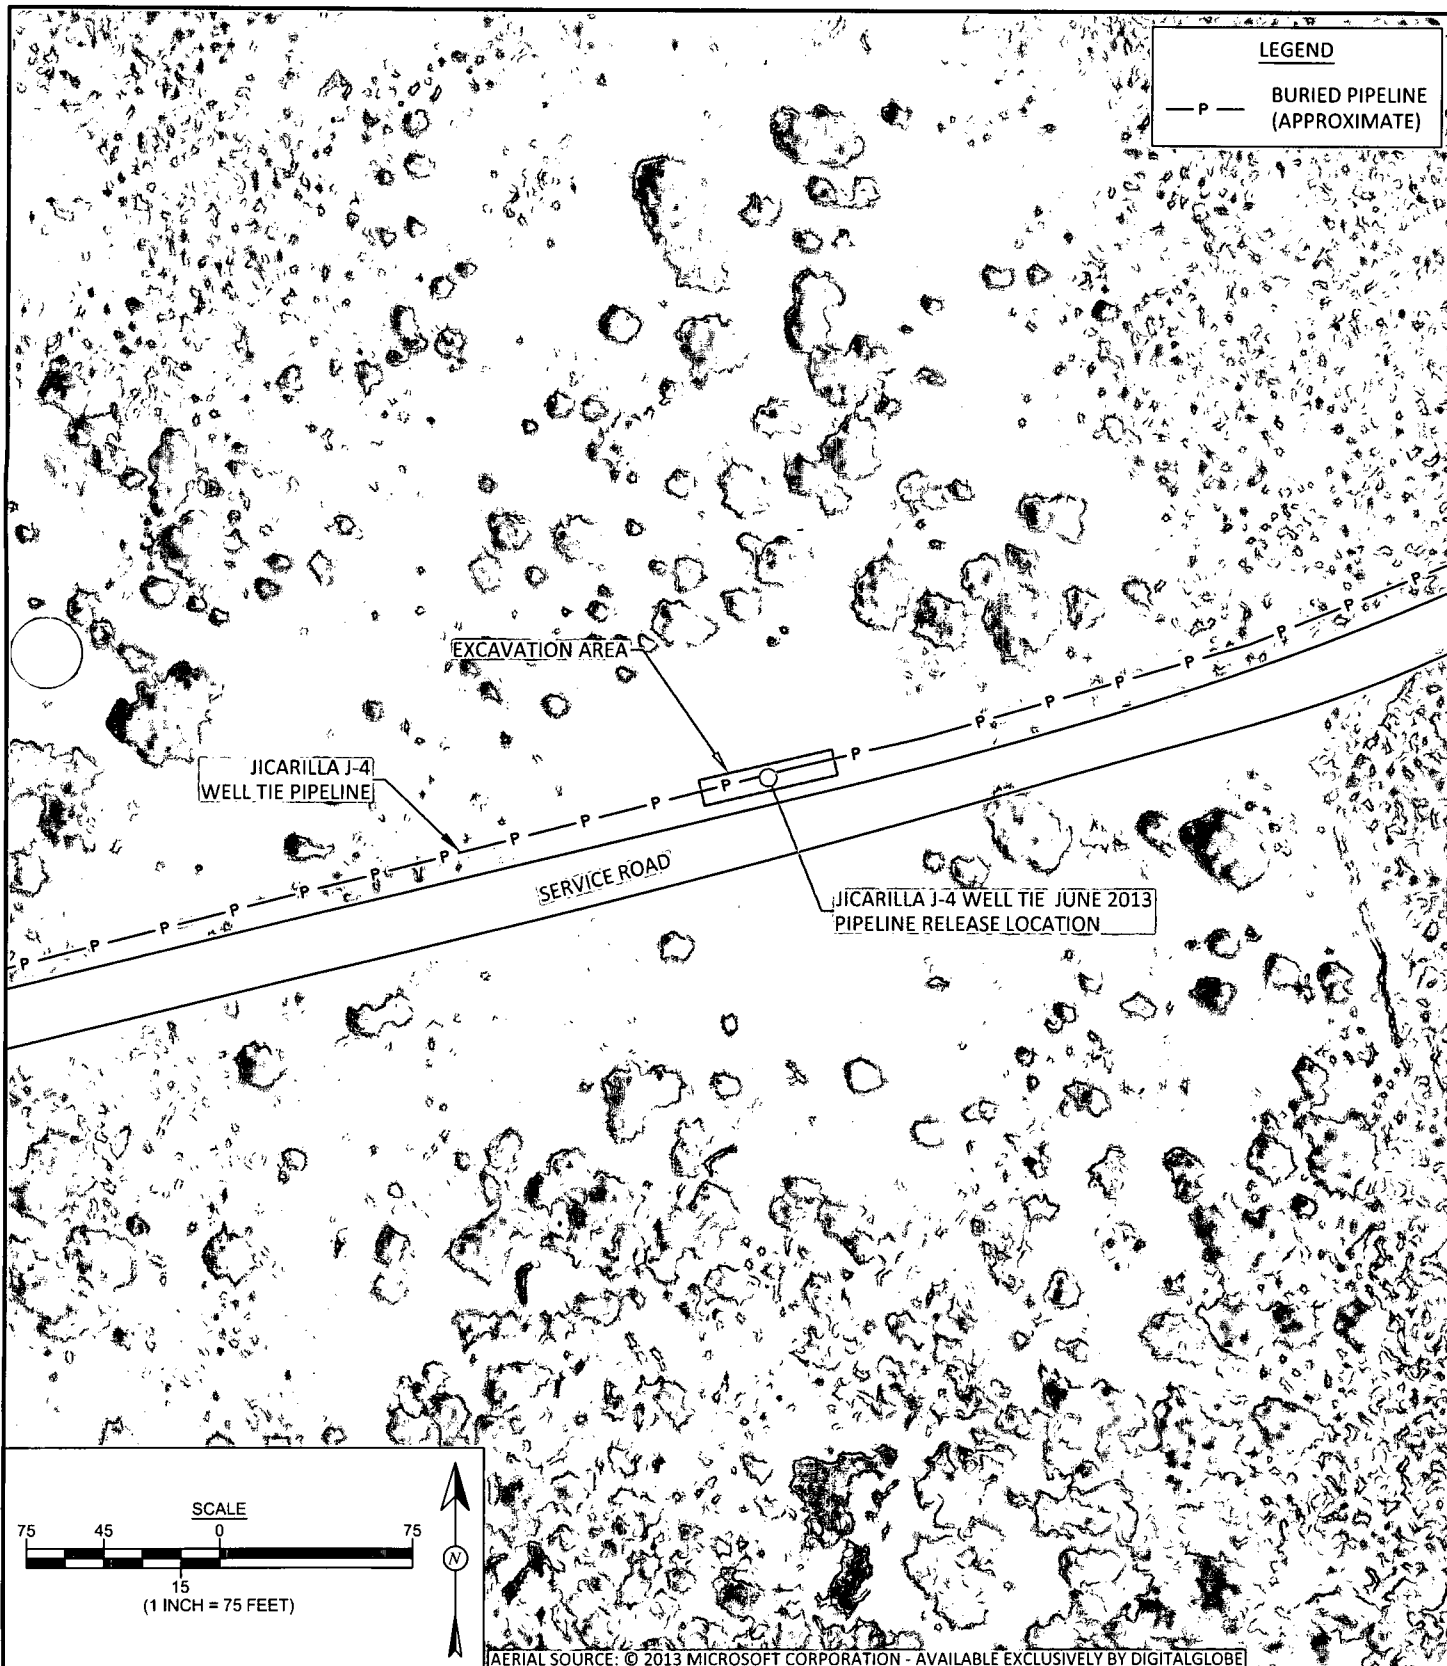
FIGURE 2

INITIAL ASSESSMENT SAMPLE
LOCATIONS AND RESULTS

- SAMPLE LOCATIONS
- P — BURIED PIPELINE (APPROXIMATE)

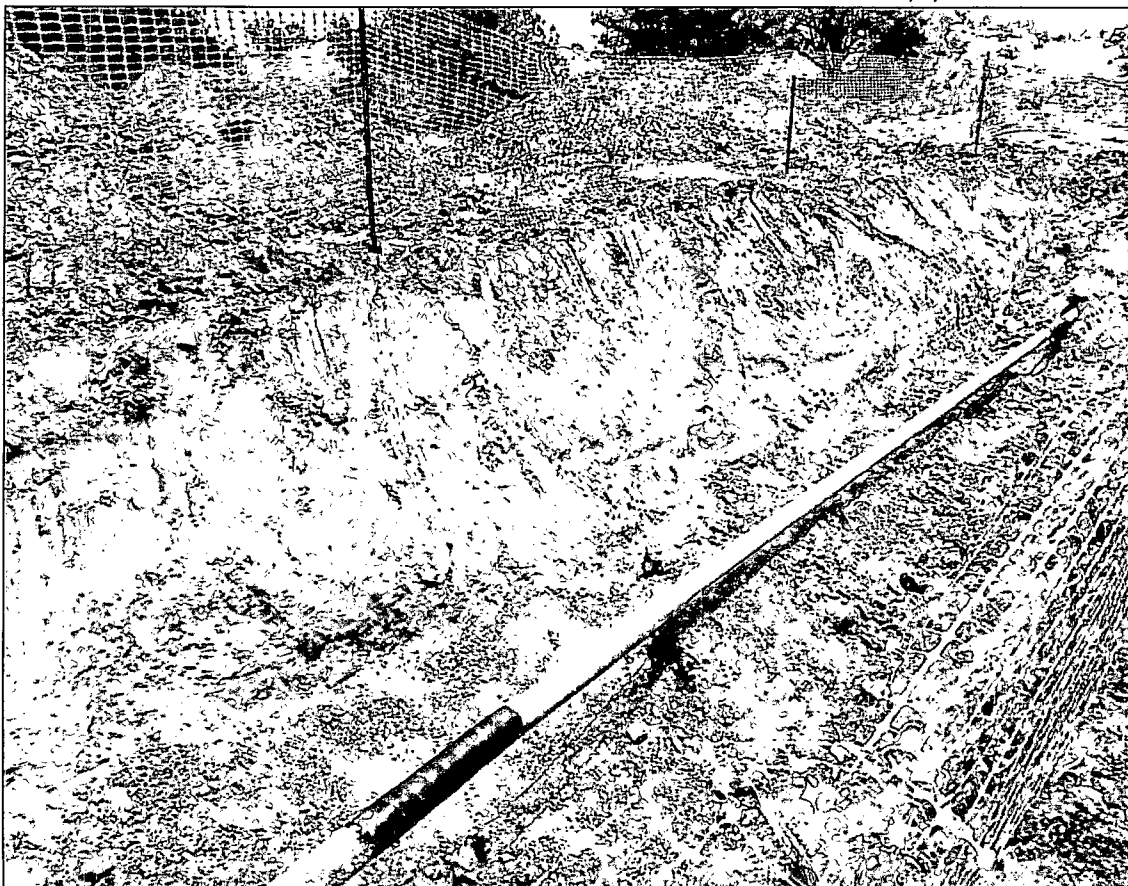
Description: View of the final excavation and repaired pipeline looking to the northeast.
