REMEDIATION SUMMARY AND RISK-BASED SITE CLOSURE REQUEST

**BOPCO, LP
JAMES RANCH UNIT #41
Eddy County, New Mexico
Unit Letter "N" (SE/SW), Section 36, Township 22 South, Range 30 East
Latitude 32.343149° North, Longitude 103.835467° West
NMOCD Reference #s 2RP- 70 λ**

June 2012

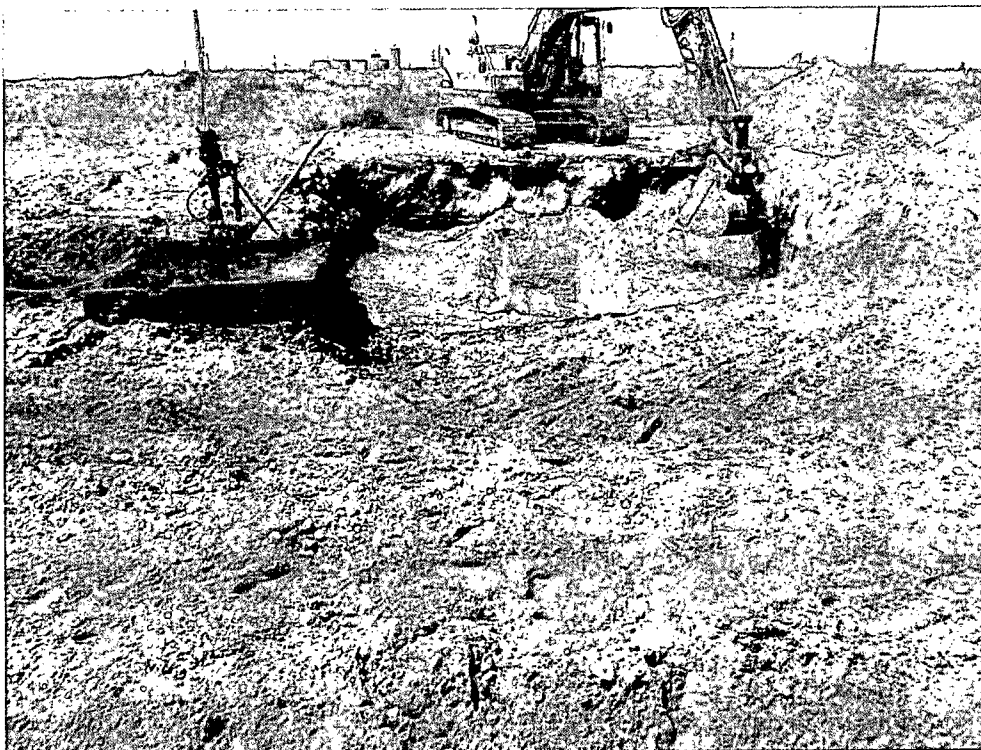
JRU #41 Release Site-Photograph of Excavation Activities

On May 22, 2012, excavation activities commenced at the release site. A Photo-Ionization Detector (PID) and chloride field kit were used to field screen the horizontal and vertical extent of impacted soil and to help guide the excavation. The floor of Section 1 of the excavation was advanced to approximately five feet (5') bgs pending the installation of an approved twenty (20) mil polyurethane liner. The excavation sidewalls were advanced until field tests suggested TPH and chloride concentrations were below the NMOCD regulatory remediation action levels established for the site.

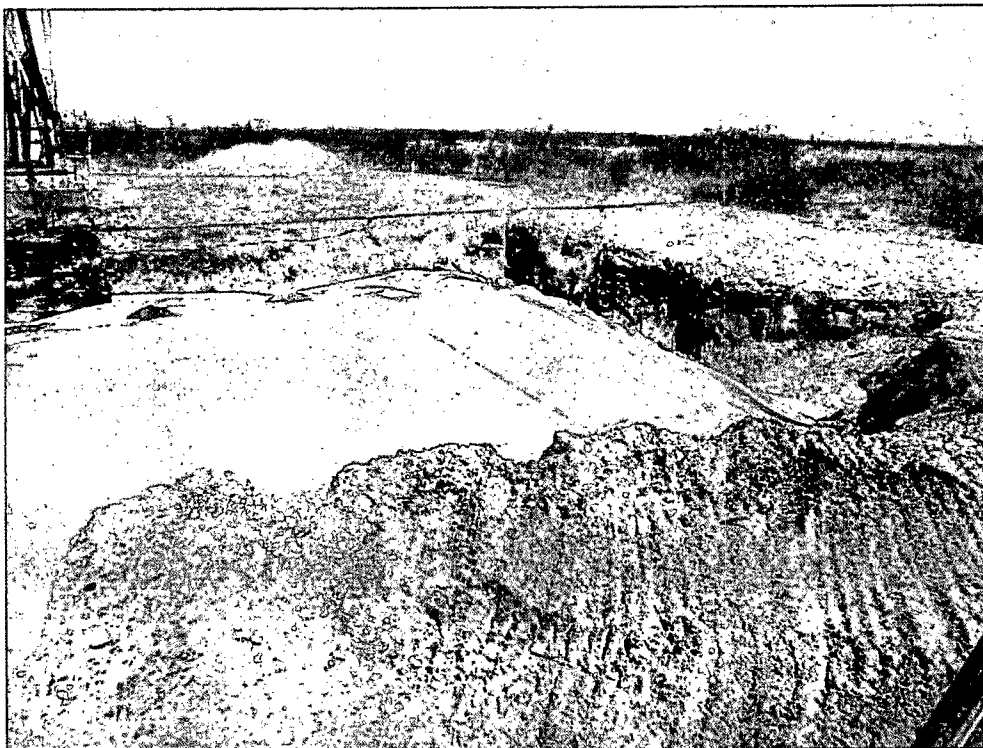
JRU #41 Release Site-Photograph of Backfilling Activities

On May 25 through May 29, 2012, upon receiving verbal approval from the NMOCD, the excavated area was backfilled. Approximately three hundred sixty cubic yards (360 yd³) of excess well pad material, along with two hundred forty (240 yd³) of locally purchased, non-impacted material, was used to backfill the excavation. Excavation backfill was compacted in eighteen inch (18") lifts and contoured to fit the needs of the pad. Areas affected by the "well pad reduction" were contoured to fit the surrounding topography and will be seeded with a BLM approved seed mixture prior to the end of the 2012 calendar year.

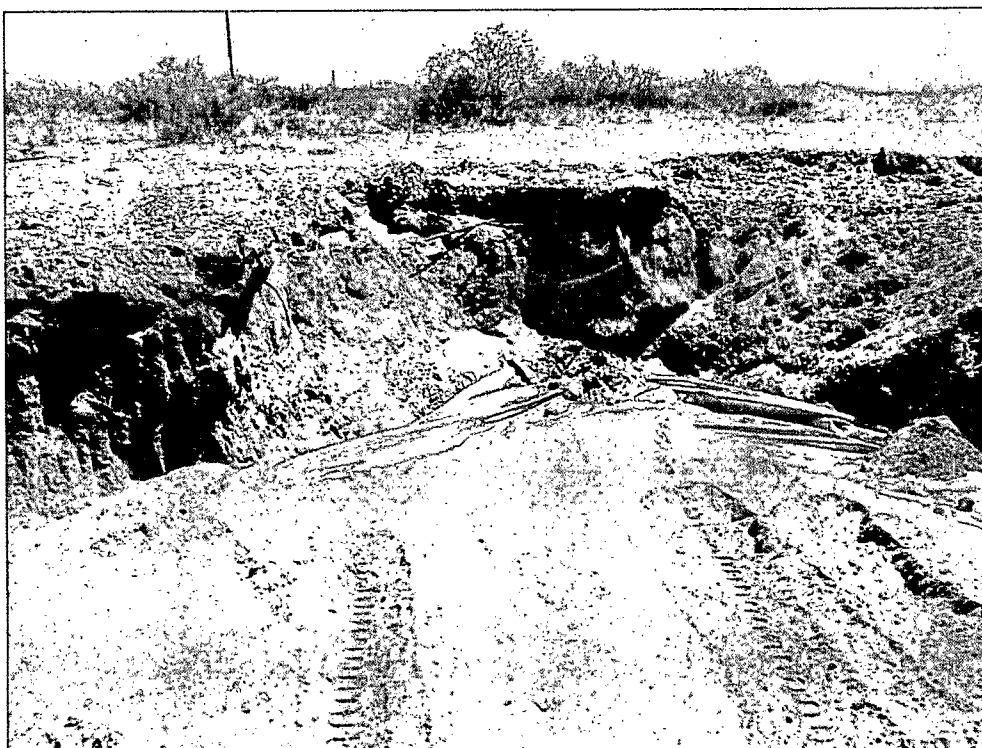
JRU #41 Release Site-Photograph of Backfilling Activities
