REMEDIATION SUMMARY & SITE CLOSURE REQUEST

**BOPCO, LP
POKER LAKE UNIT #236
Eddy County, New Mexico
UNIT LTR "H" (SE/NE), Section 19, Township 24 South, Range 30 East
Latitude 32.206120° North, Longitude 103.912591° West**

June 2011

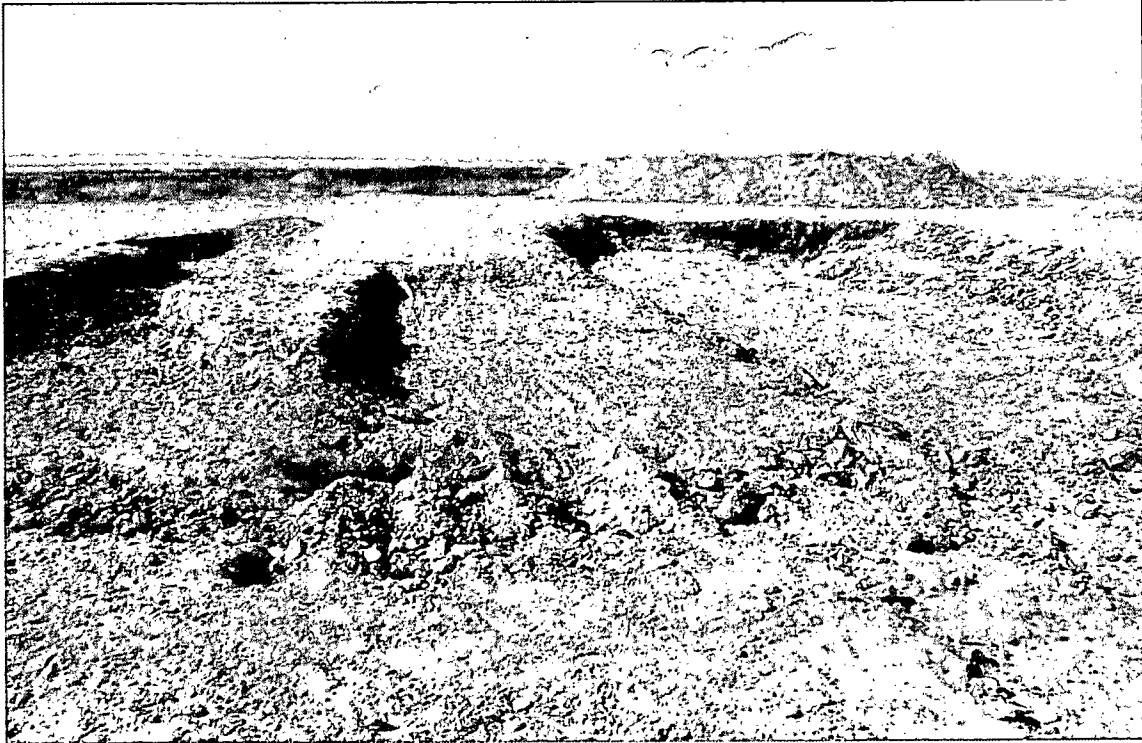
Poker Lake Unit #236 - Excavation (looking West)
