Remediation Final Report Form

Client: LINN Energy

Site Name: Skelly Unit 18

Release Notification and Corrective Action

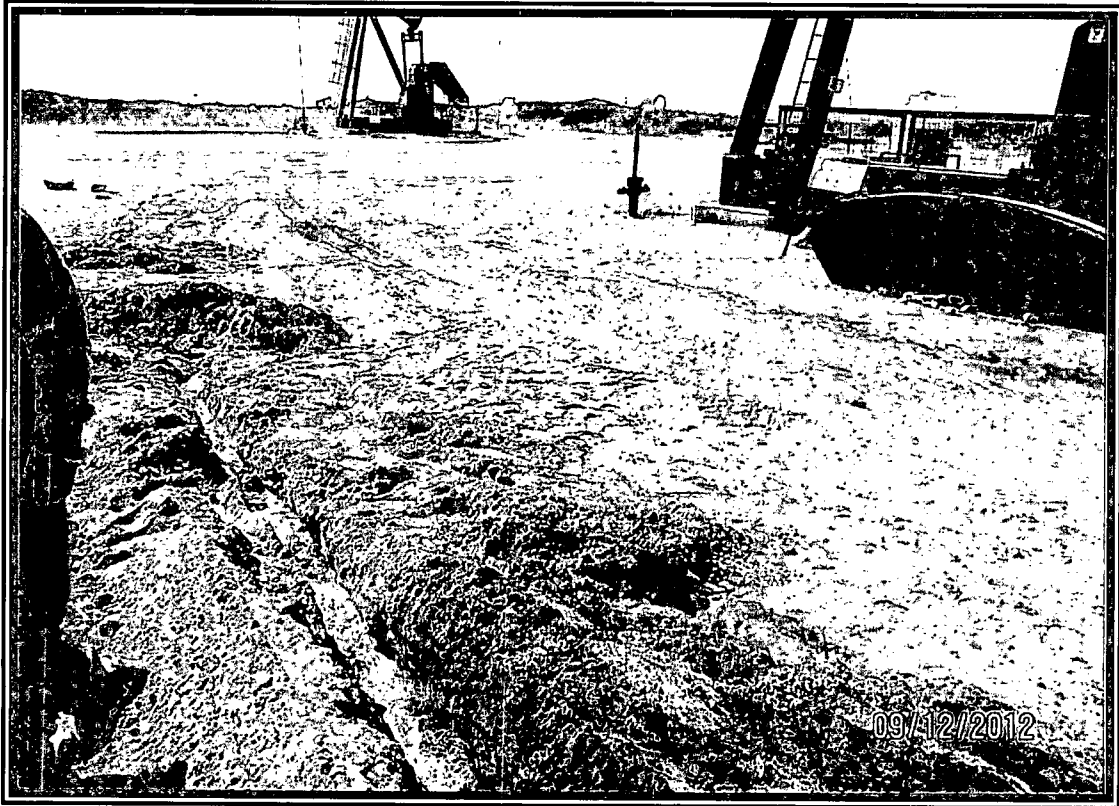
Spill area before excavation.

Impacted soils above regulatory threshold levels were manually and mechanically excavated from the spill area.

Impacted soils were transported off-site to Lea Land Landfill. Once the impacted soils were removed to acceptable levels, the production pad was backfilled with like materials and smoothed to grade.

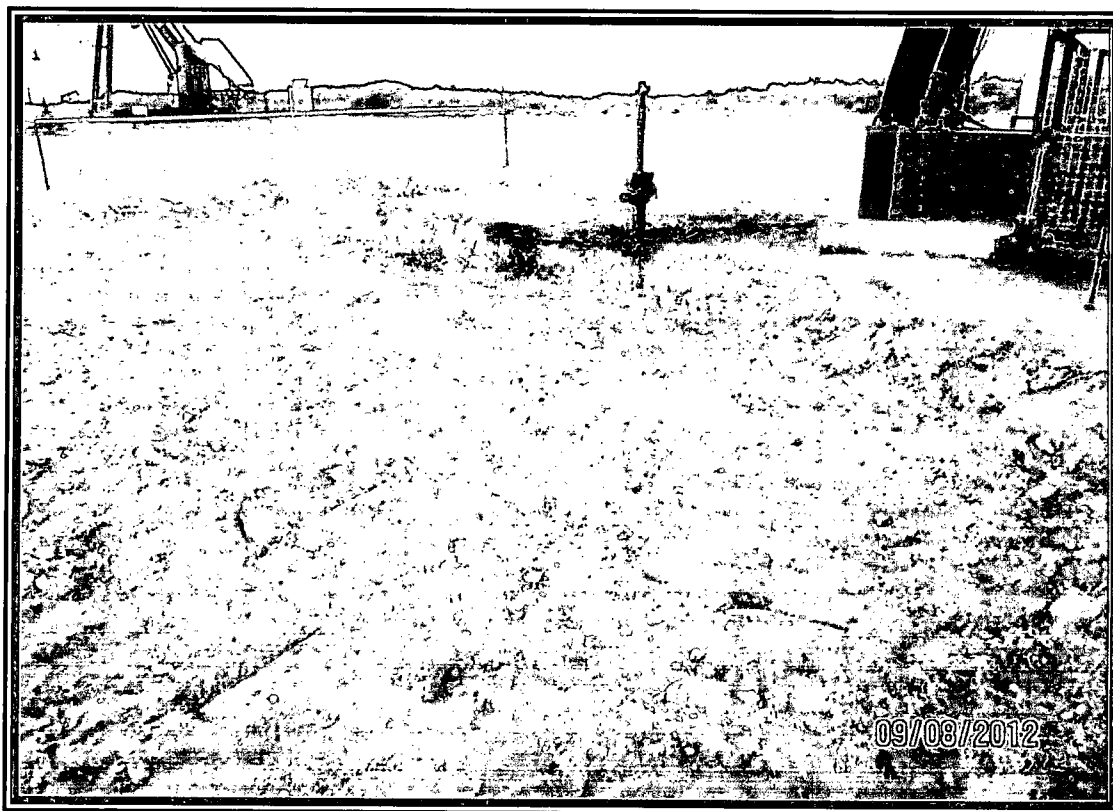
Spill area during backfill.

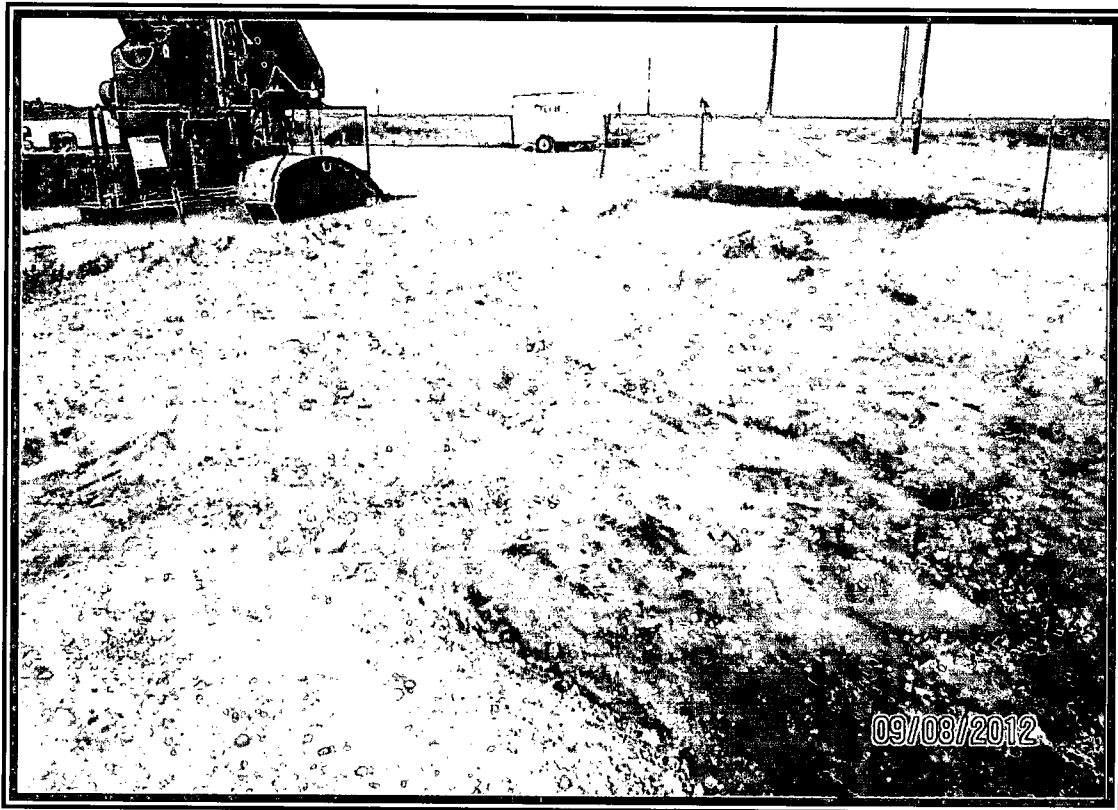
Spill area during backfill.

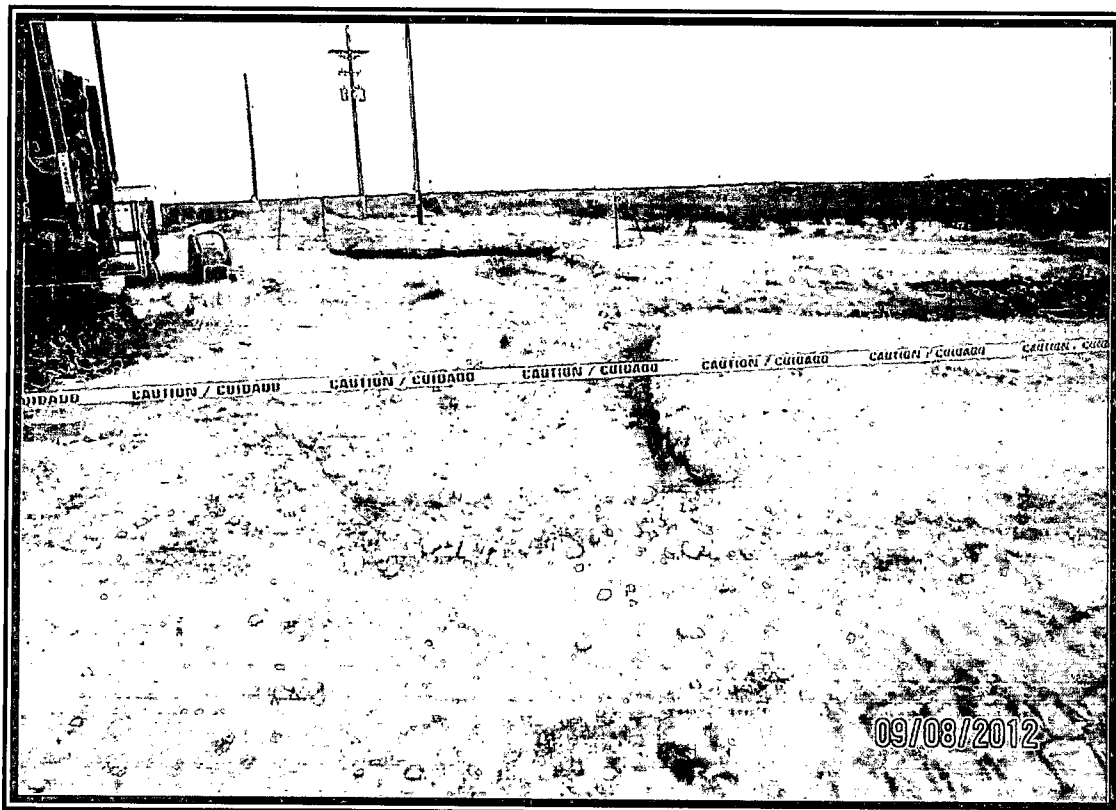
Spill area during backfill.
