Lee Federal Tank Battery

Closure Report

2RP-1132

**RE: TERMINATION REQUEST
Apache – Lee Federal Tank Battery AD
UL/G sec. 20 T17S R31E
API No. 30-015-30243
2RP-1132**

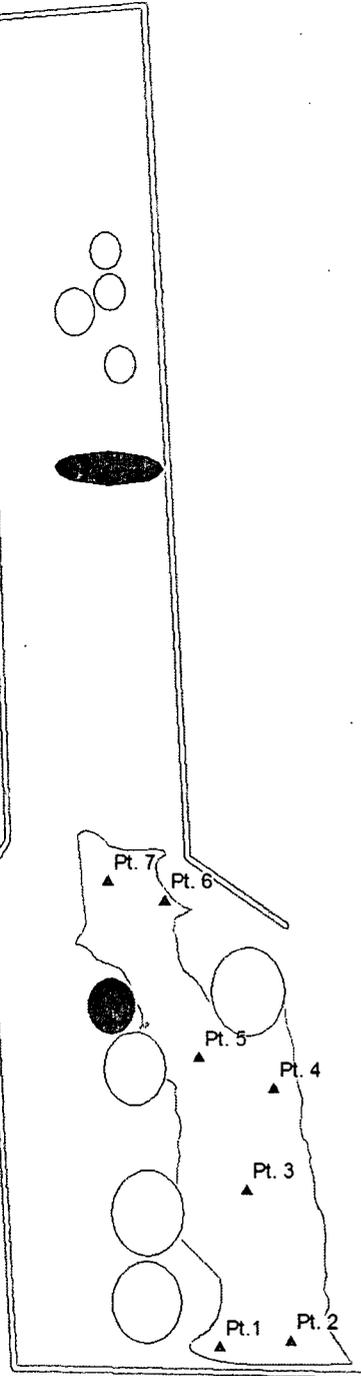
Figure 1

Site Plat

Initial Lab Sampling Data

Sample Description	Cl-	GRO	DRO
Pt. 1	3,520	22,900	56,600
Pt. 2	11,800	22,100	53,700
Pt. 3	1,840	25,700	47,100
Pt. 4	10,200	986	9,930
Pt. 5	9,100	17,000	41,600
Pt. 6	17,400	5,940	47,800
Pt. 7	18,000	8,620	20,600

- ▲ SAMPLE POINTS
- BERM
- OIL TANK
- TANK
- TREATER
- WATER TANK
- STAIN (1,903 sq ft)

On October 4, 2011, RECS personnel initiated work at the Lee Federal Tank Battery (Figure 1). Surface soil samples were collected from the site field tested for chloride. Headspace measurements were also taken in the field using a Photo Ionization Detector (PID). The samples were submitted to a commercial laboratory for chloride and TPH (GRO/DRO) analyses (Appendix C). Chloride ranged from 1,840 ppm (parts per million or mg/kg) to 18,000 ppm. GRO ranged from 986 ppm to 25,700 ppm and DRO ranged from 9,930 ppm to 56,600 ppm.

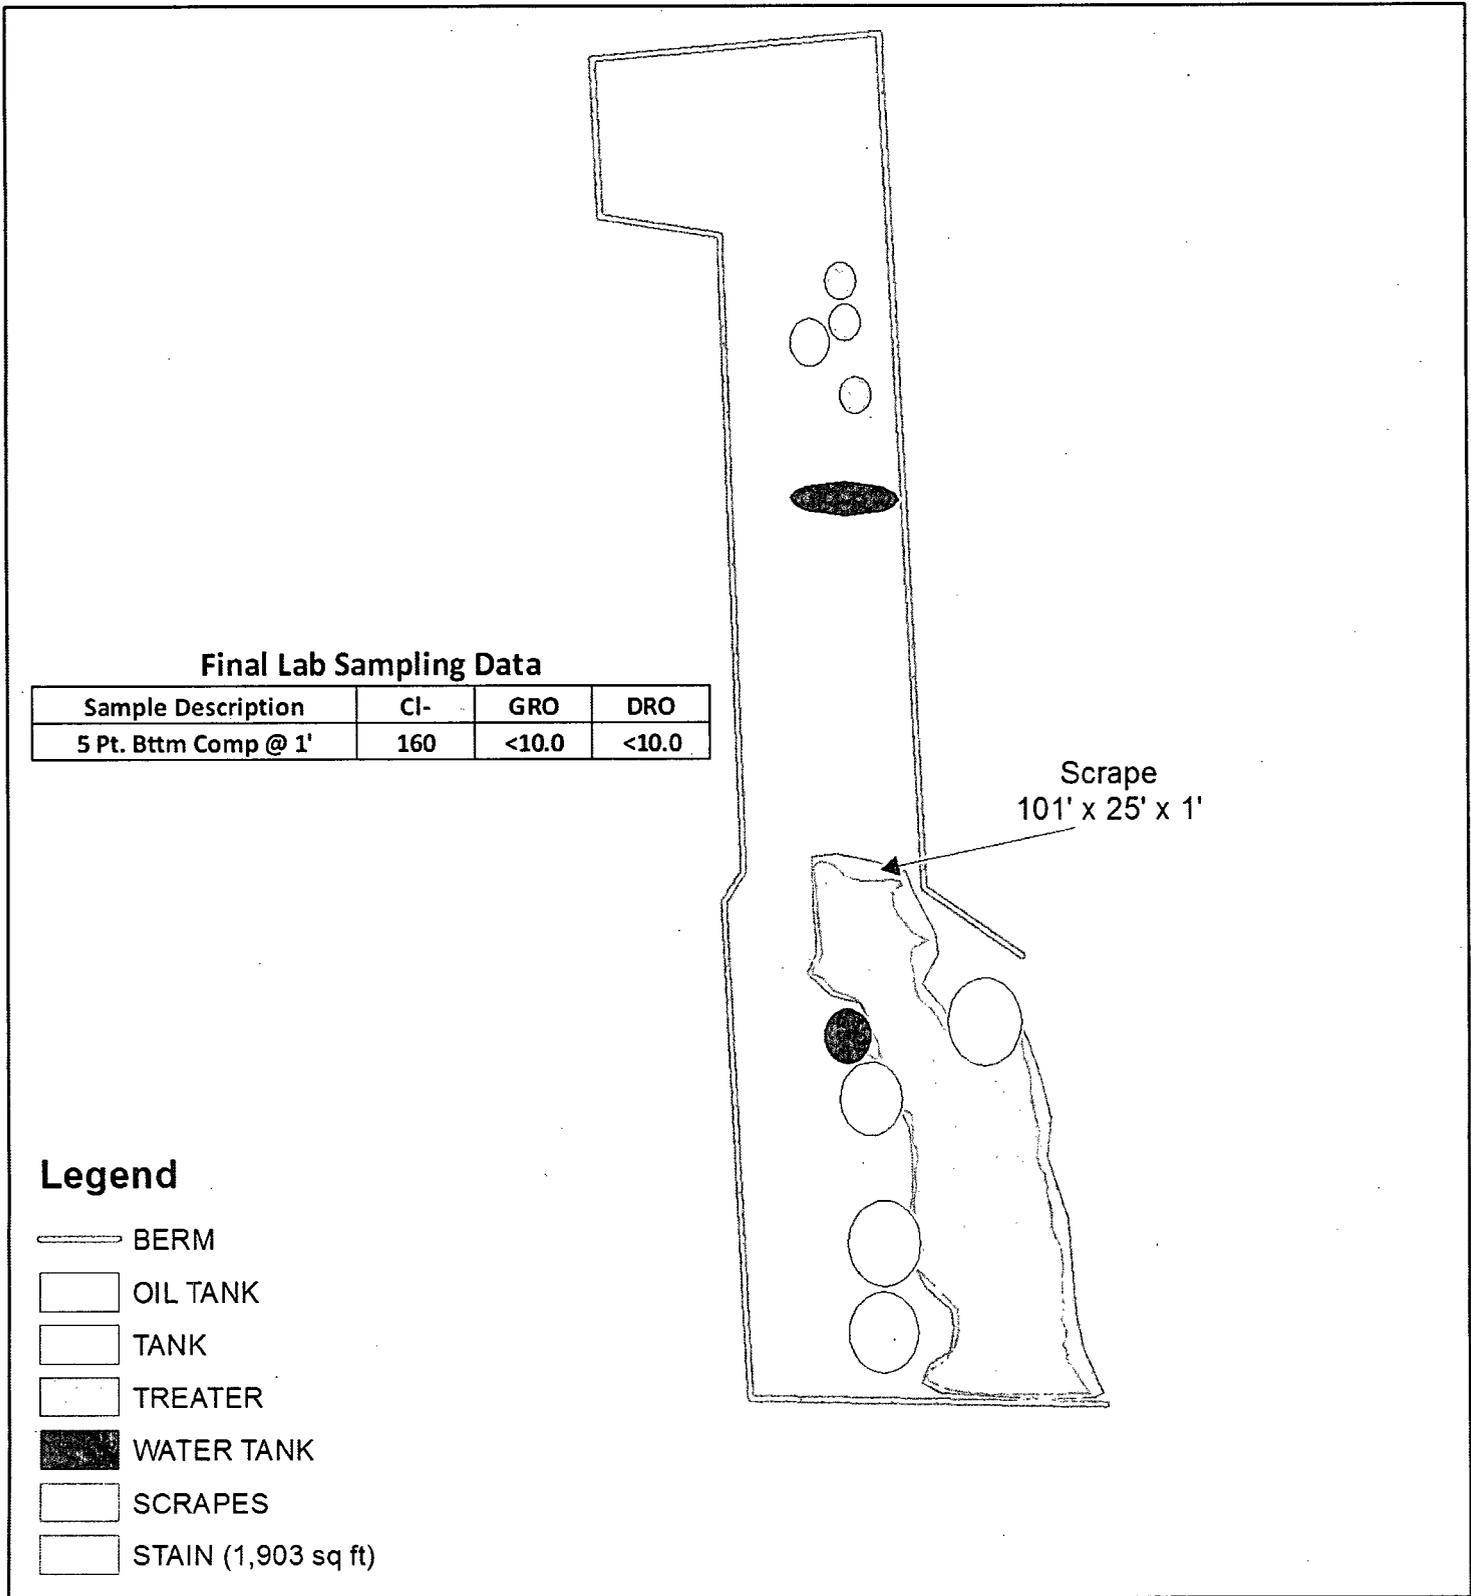
Figure 2

Site Plat

**APACHE LEE
FEDERAL TANK
BATTERY AD**

The leak area was excavated to 1 ft. below ground surface (Figure 2). On October 10, 2011, RECS personnel collected and field tested a representative composite soil sample from the bottom of the excavation. The sample was submitted to a laboratory for chloride and TPH analyses (Appendix C), and contained 160 ppm chloride and <10.0 ppm TPH.

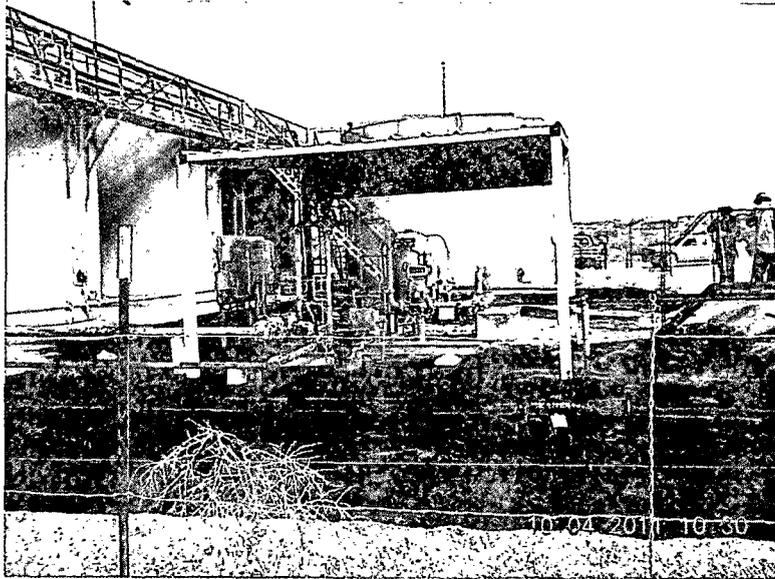
Initial release, facing north

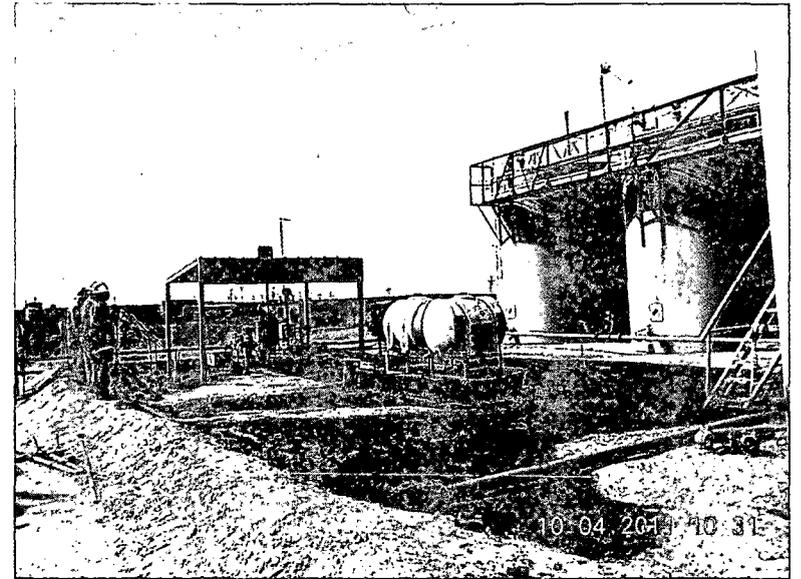
Initial release, facing southwest

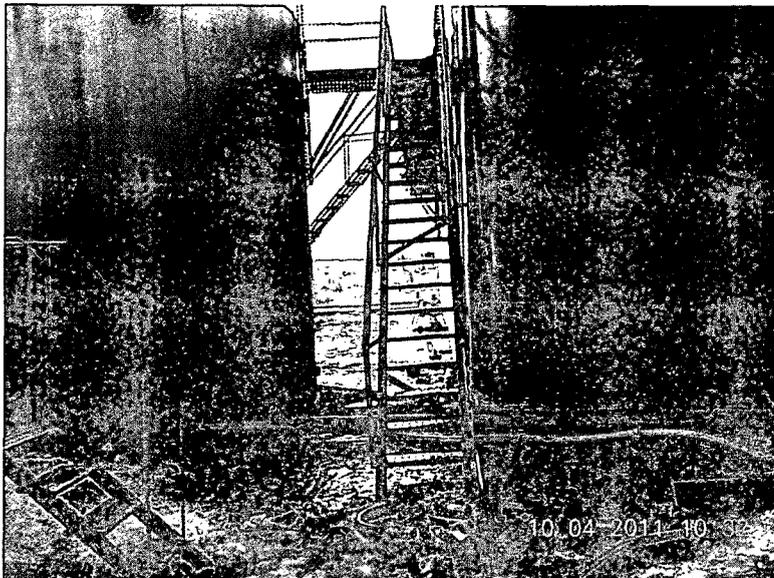
Initial release, facing west

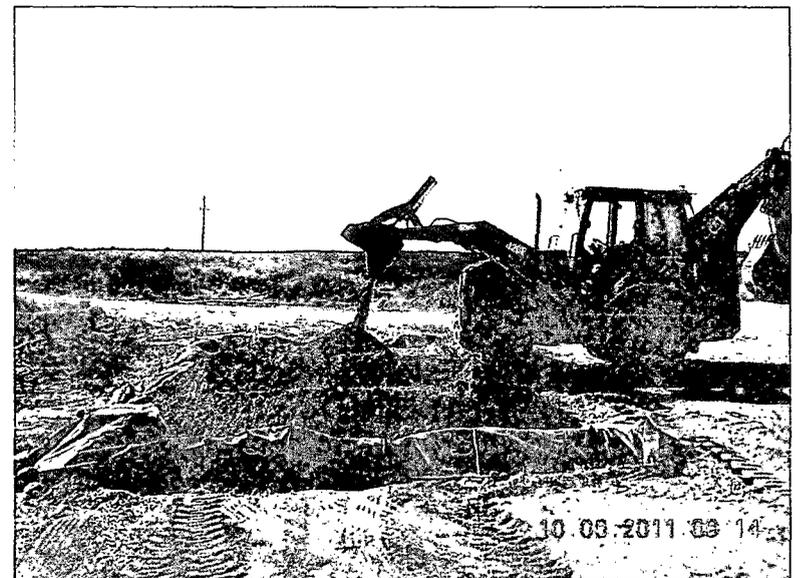
Stockpiling on plastic, facing south

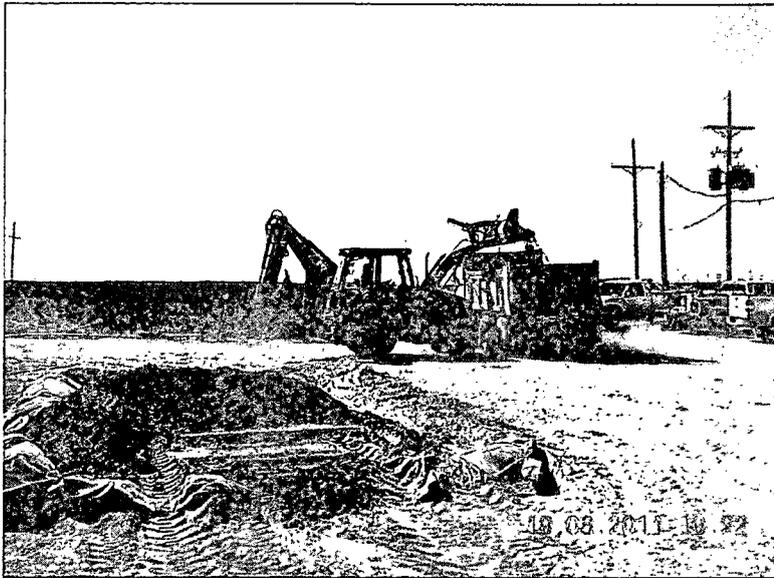
Exporting soil, facing south

Impacted soils were removed from the excavation and transported to a NMOCD approved disposal facility. The excavation was backfilled with clean caliche and leveled. See Appendix B for photographs of field activities.

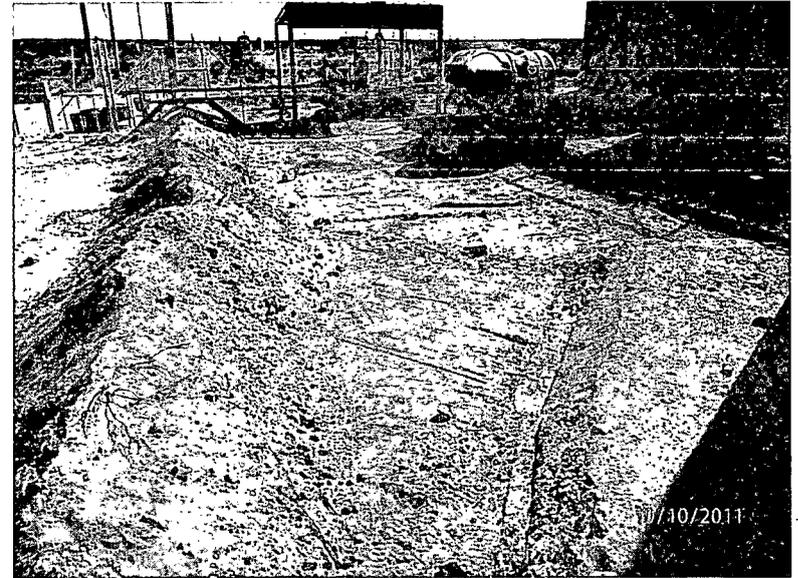
Excavation complete, facing south

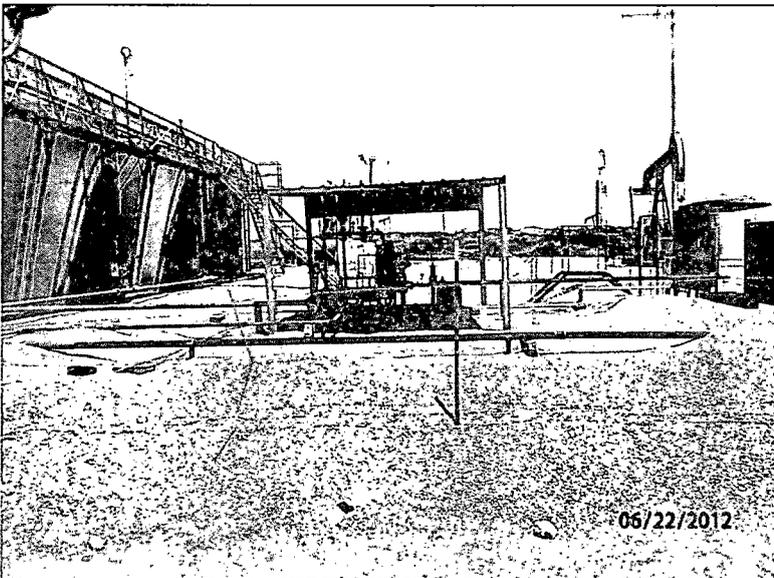
Backfill complete, facing north

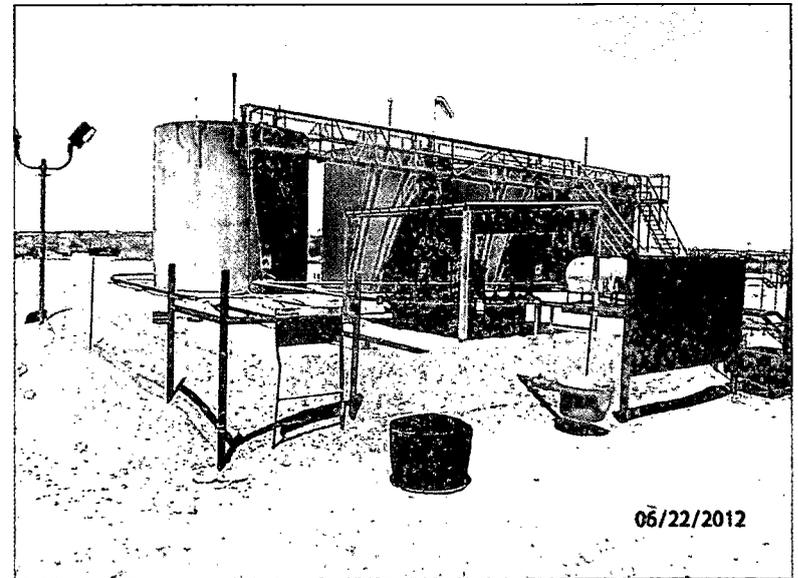
Backfill complete, facing northwest
