**RE: Corrective Action Plan (CAP)**

**Linn Energy – Max Friess MA Battery (2RP-1898)**

**UL/G sec. 30 T17S R31E**

### **Corrective Action Plan**

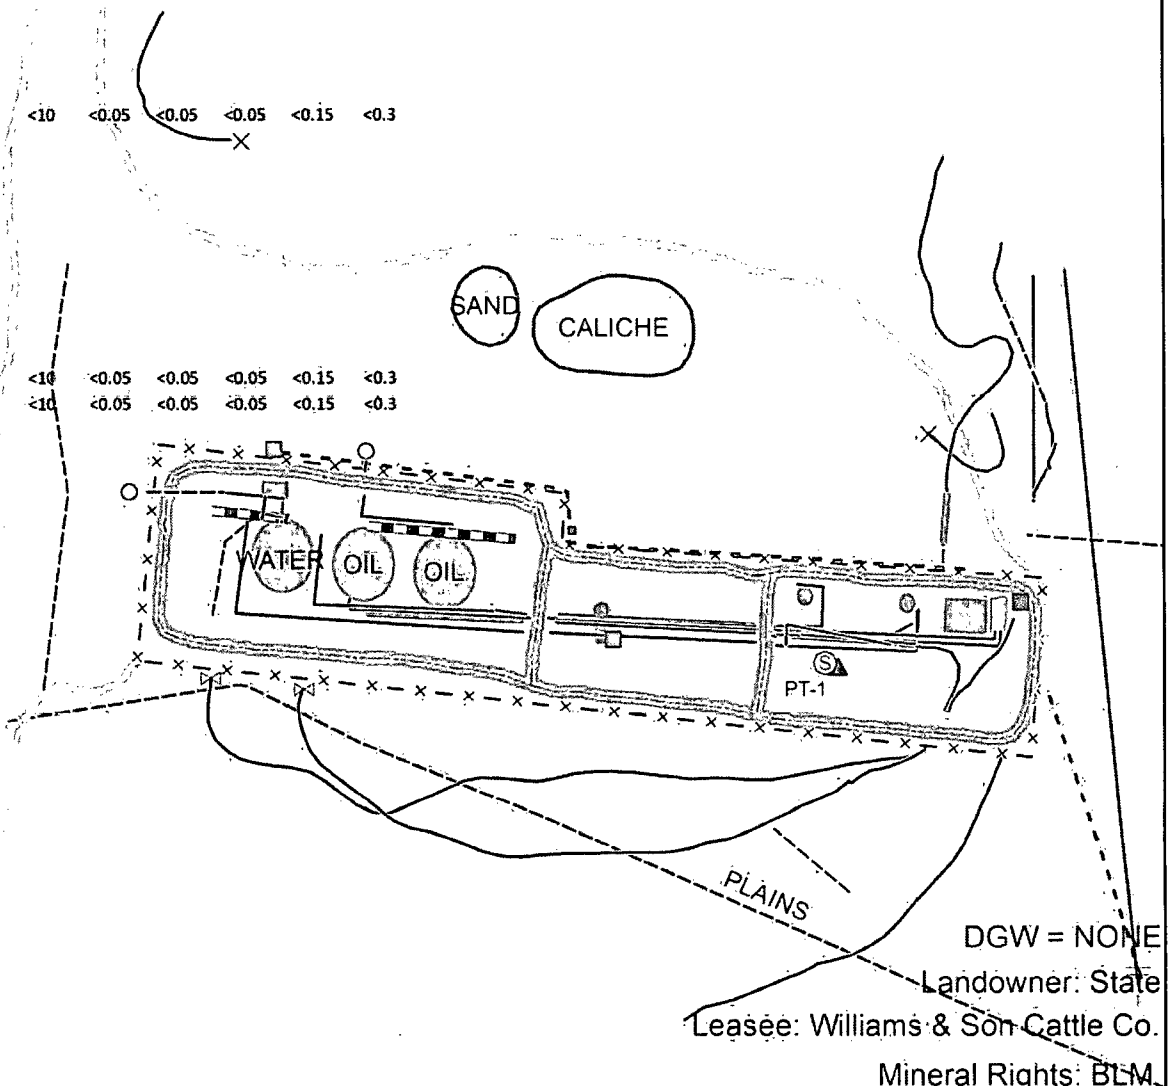
**Figure 1**

# Vertical and SB Installation Data

Vertical Pt. 1									
Depth	CI-	PID	GRO	DRO	B	T	E	X	BTEX
SS	6400	391.4	<50	4100	<0.2	<0.2	<0.2	<0.6	<1.2
6"	1840	15000							
1'	1695	332							
1.5'	1466	2301							
2'	1356	1155							
2.5'	1013	1792							
3'	909	457.5							
3.5'	649	348.2							
4'	713	376.5							
4.5'	2884	83.6							
5'	1889	80.9							
5.5'	1556	148.6							
6'	2320	54.8	<10	<10	<0.05	<0.05	<0.05	<0.15	<0.3
6.5'	1457	82.6							
7'	1903	1345							
7.5'	2181	1067							
8'	1671	693.1							
8.5'	1857	28.9							
9'	562	32.8							
9.5'	2840	24.4	<10	<10	<0.05	<0.05	<0.05	<0.15	<0.3
10'	1007	26.2							
10.5'	762	2.7							
11'	457	95.5							
11.5'	807	18.5							
12'	492	16.7							
12.5'	423	44.7							
13'	193	49.5							
13.5'	428	12.7							
14'	627	547							
14.5'	560	400	<10	<10	<0.05	<0.05	<0.05	<0.15	<0.3
15'	608	76.8	<10	<10	<0.05	<0.05	<0.05	<0.15	<0.3

Soil Bore									
Depth	CI-	PID	GRO	DRO	B	T	E	X	BTEX
18'	1660	2.3	<10	<10	<0.05	<0.05	<0.05	<0.15	<0.3
21'	815	1							
24'	837	4.4							
30'	112	2.5	<10	<10	<0.05	<0.05	<0.05	<0.15	<0.3
35'	112	3.7	<10	<10	<0.05	<0.05	<0.05	<0.15	<0.3

On August 6<sup>th</sup>, 2013 BLM approved soil bore installation activities at the site that occurred on August 20<sup>th</sup>, 2013. One soil bores was installed at the site to a depth of 35 ft bgs (Figure 1). Field samples were taken at regular intervals as the bore was advanced and representative samples from the bore were taken to a commercial laboratory for analysis (Appendix C). The laboratory chloride readings dropped from 1,660 mg/kg at

18 ft bgs to 112 mg/kg at 30 and 35 ft bgs. GRO, DRO and BTEX readings in all samples were non-detect.

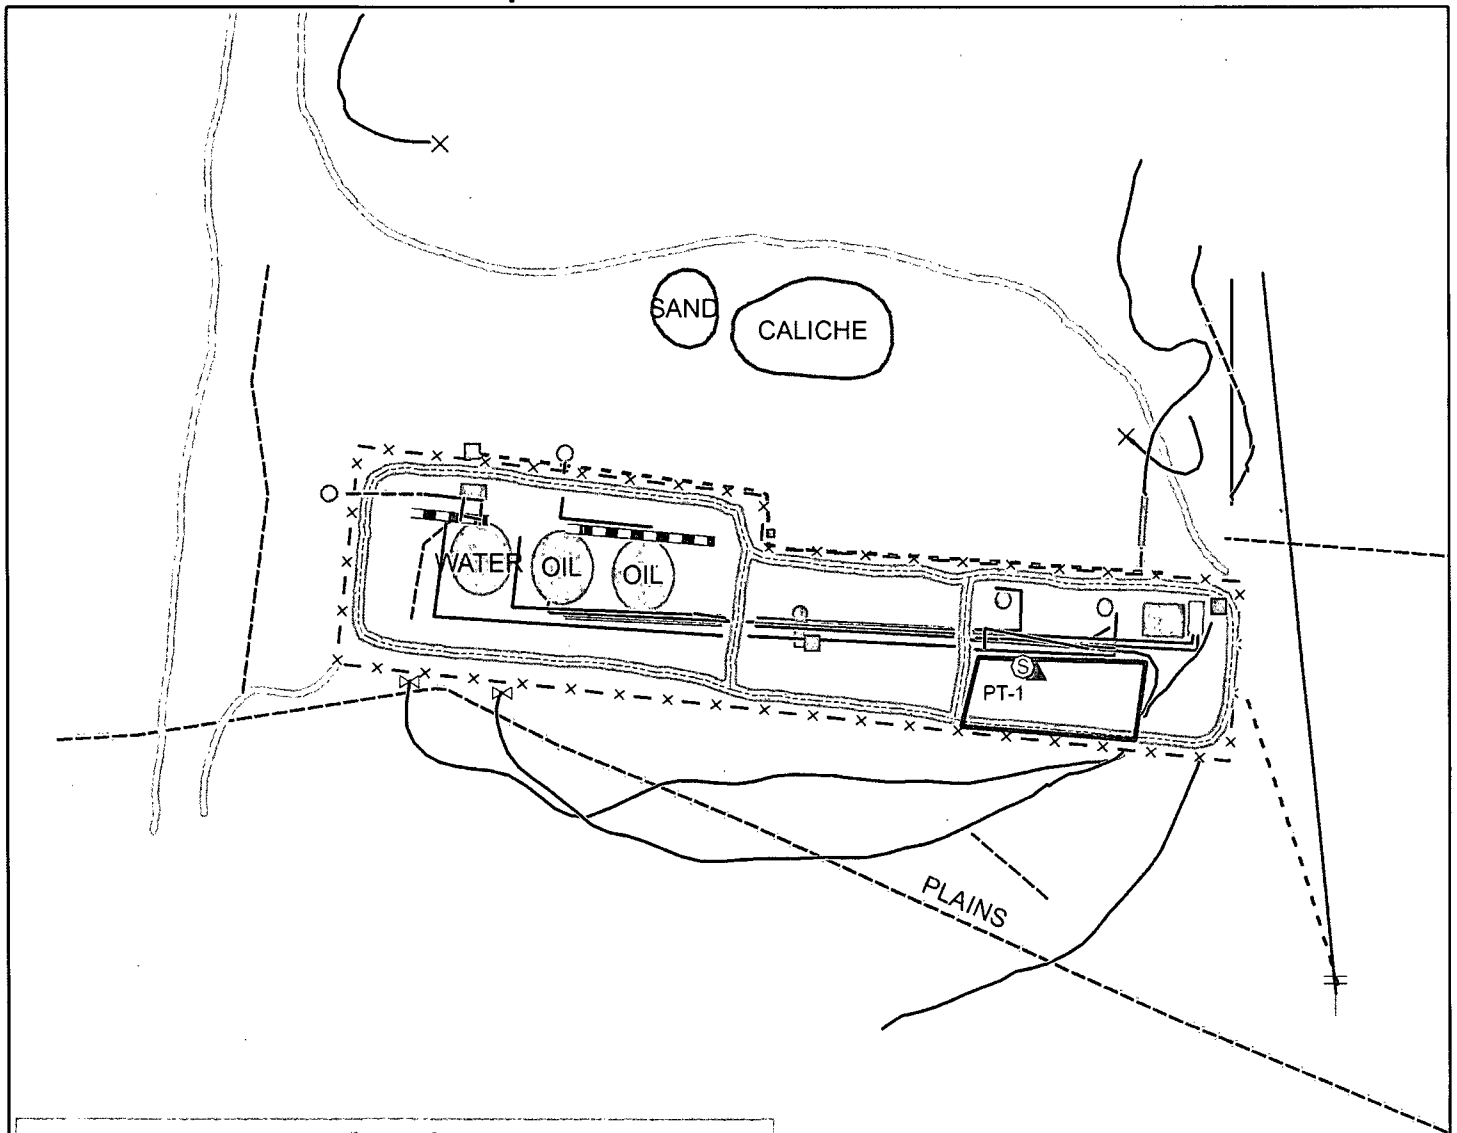
**Figure 2**

# Proposed Liner Installation

⊙ SOIL BORE	BERM	OVERHEAD ELECTRIC LINE
▲ VERTICAL POINT	--- BURIED ELECTRIC	PAD/ROAD EDGE
PROPOSED 18' x 38' 20-mil POLY LINER @ 3 FT	--- BURIED PIPELINE	--- RISER
○ CONTAINMENT	x - x FENCE	--- STAIRS/CATWALK
■ CONTROL BOX	--- HEADER	--- SURFACE PIPELINE
⊕ ELECTRIC POLE	--- LINEFINDER HIT	□ PUMP
⊕ ELECTRICAL BOX		□ SPOIL PILE
⊕ SUMP		□ STORAGE TANK
⊕ VALVE		□ TREATER
⊕ PIPE END

Since there is no groundwater at the site, the residual chlorides in the vadose zone will not in any way affect groundwater beneath the site. However, to mitigate any chance that the residual chlorides could affect groundwater in the future, RECS recommends that Linn excavate the site to 18 ft x 38 ft to a depth of 3 ft bgs (Figure 2). The excavation will avoid the tanks and other facilities in the battery that could cause safety hazards. At 3 ft bgs, a 20-mil reinforced poly liner will be installed throughout the excavation. The excavated soil will be transported to a NMOCD approved facility. Once the liner is installed, the excavation will be backfilled with clean, imported soil. The site will not need to be seeded since the release occurred in an active battery.

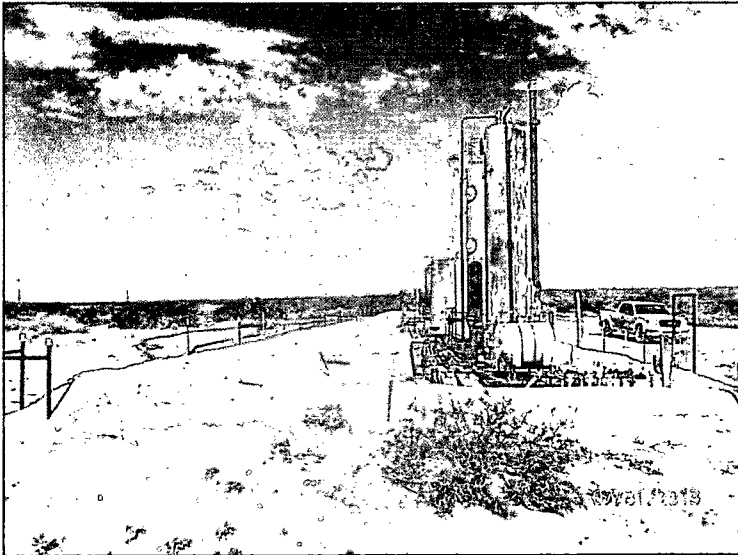
Initial site photo, facing west

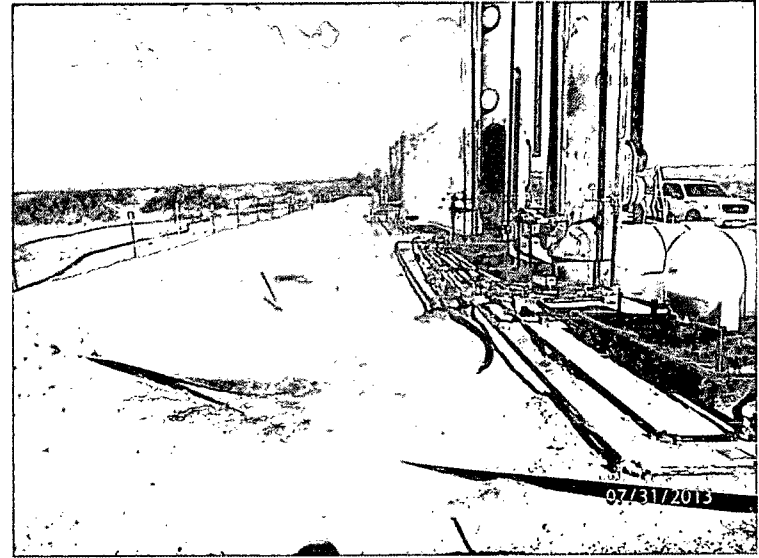
Initial site photo, facing west

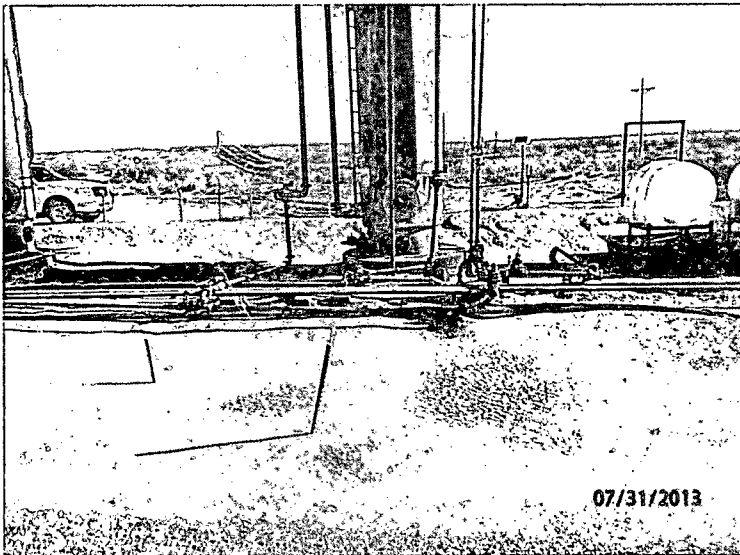
Initial site photo, facing north

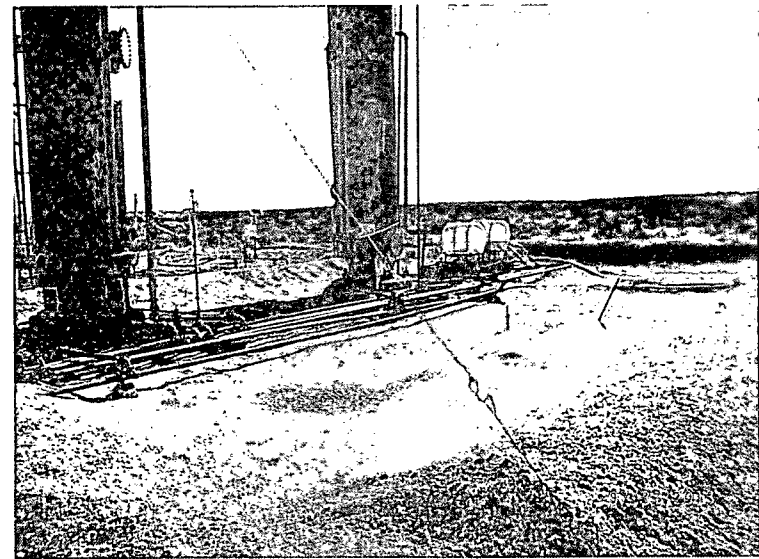
Initial site photo, facing northeast

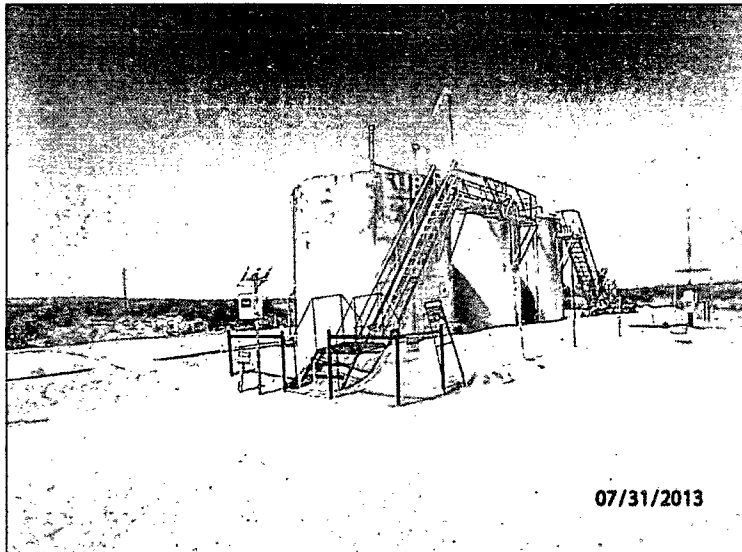
Initial site photo, facing southwest

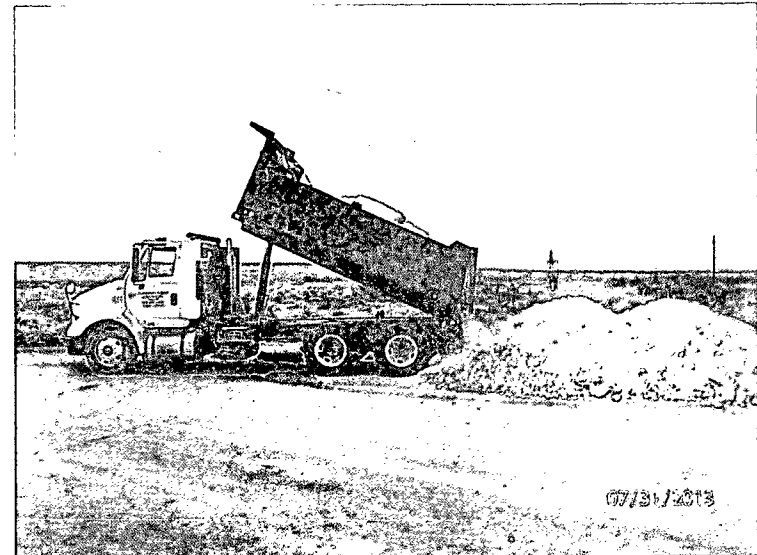
Import caliche, facing northwest

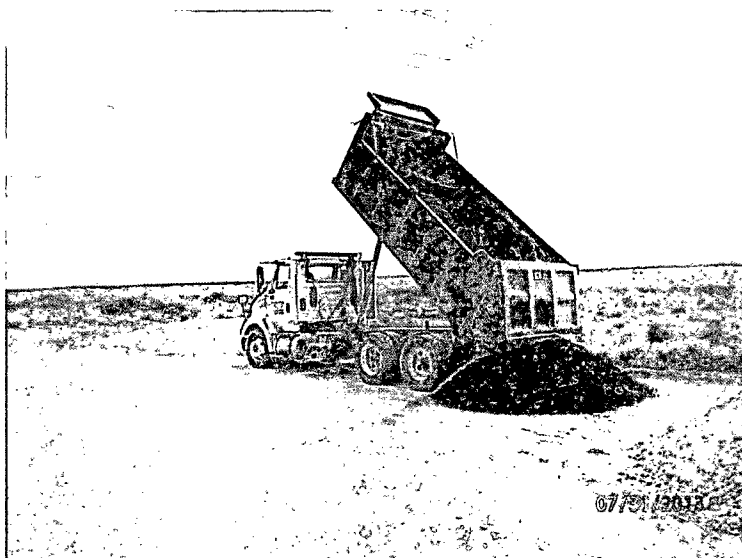
Import top soil, facing northwest

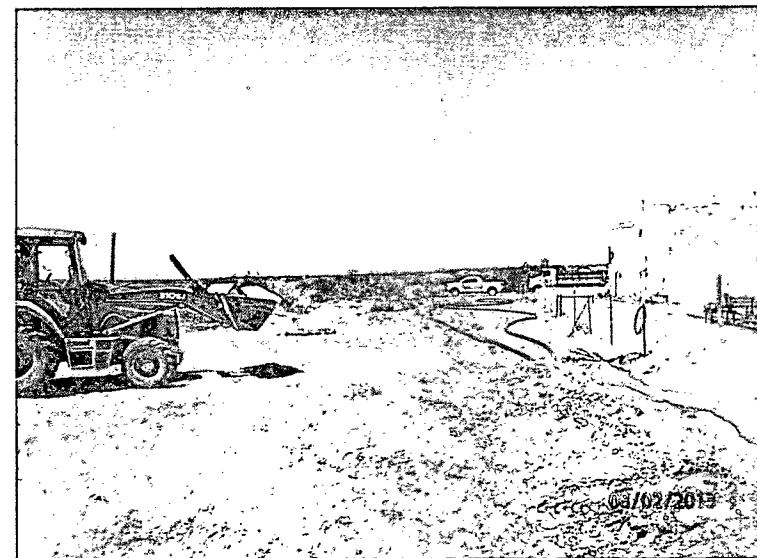
Removing berm on southeast corner, facing west 8/2/13

RECS met with BLM on July 29<sup>th</sup>, 2013. BLM stated that a vertical needed to be conducted at the site. To prepare for the vertical, the berm in the southeast corner was removed and disposed of at a NMOCD approved facility. On August 5<sup>th</sup>, 2013 a vertical was installed to a depth of 15 ft bgs (Figure 1). Samples were taken at regular intervals and field tested for chlorides and hydrocarbons. Representative samples were taken to a commercial laboratory for analysis (Appendix B). As the vertical was advanced, laboratory chloride readings dropped until they reached 608 mg/kg at 15 ft bgs. GRO, DRO and BTEX laboratory readings were non-detect, except for at the surface where the DRO reading was 4,100 mg/kg.

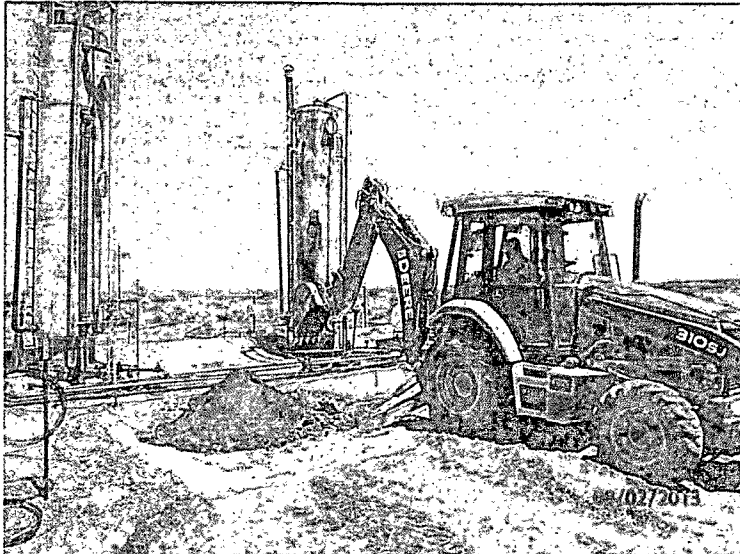
Install vertical, facing northeast

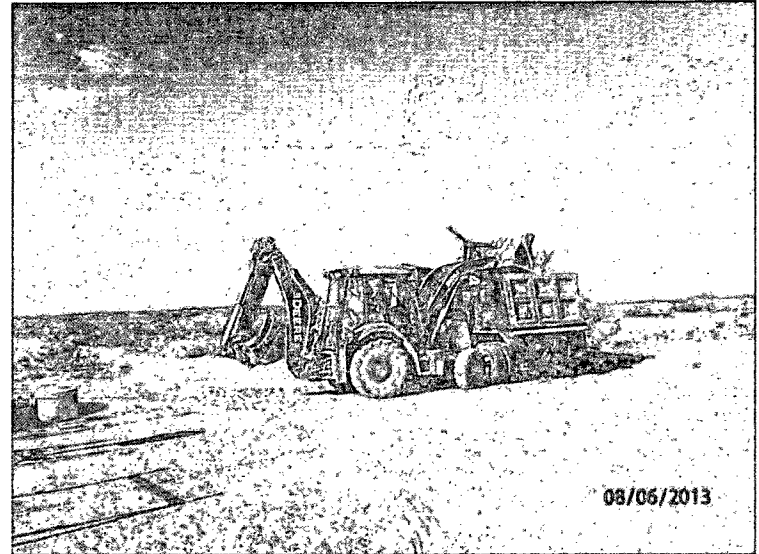
Exporting soil, facing southwest

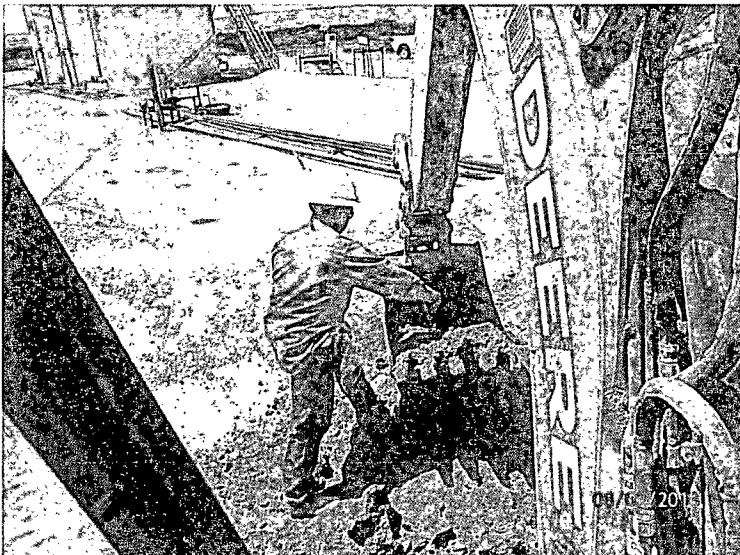
Taking vertical sample, facing northwest

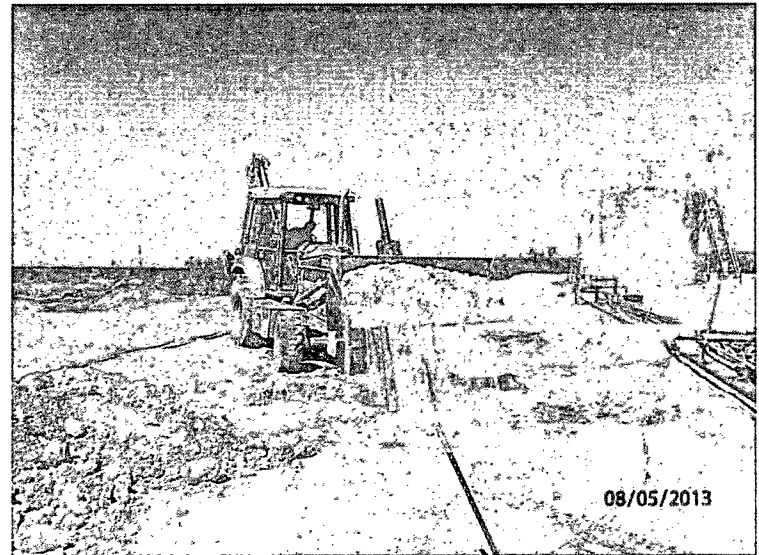
Backfilling vertical, facing west

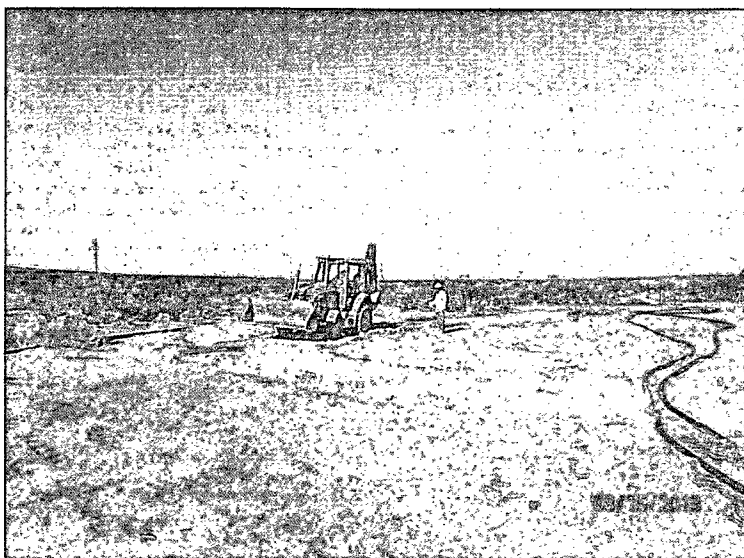
Building caliche road for SB installation, facing SW 8/15/13

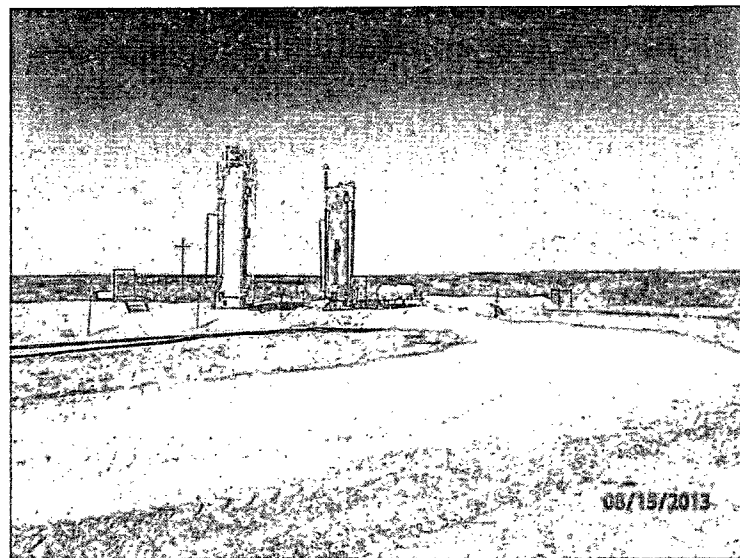
Caliche road completed, facing northeast 8/15/13

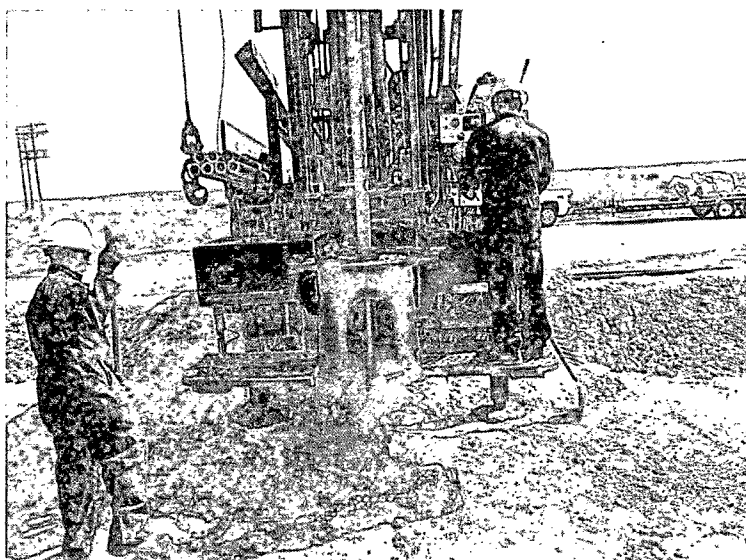
Installing soil bore, facing south 8/20/13

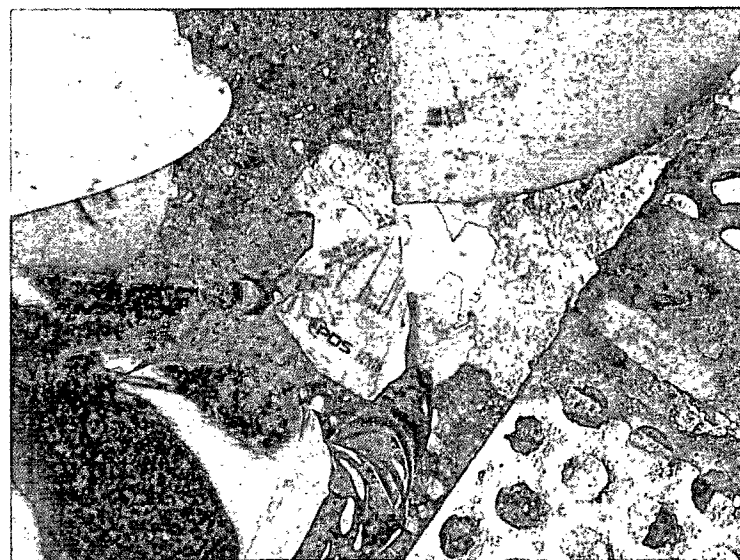
Plugging the soil bore in total with bentonite 8/20/13

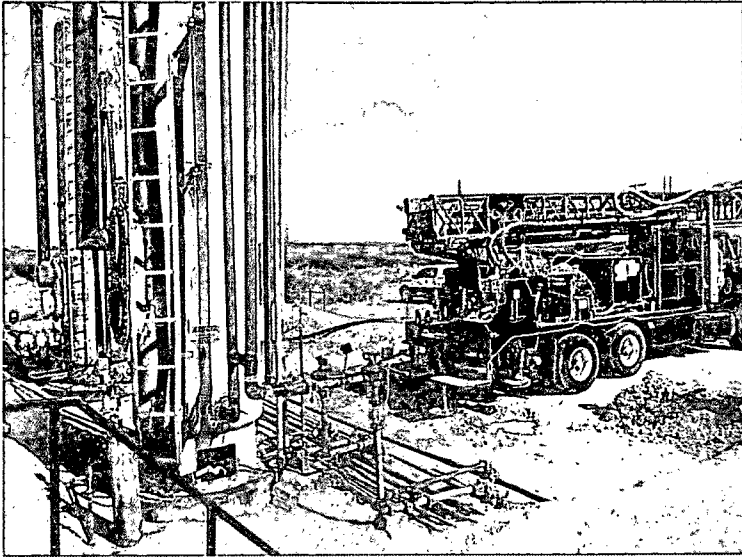
Completed soil bore, facing southeast
