LINN ENERGY

Max Friess 'MA' Battery

2RP-1898

Termination Request

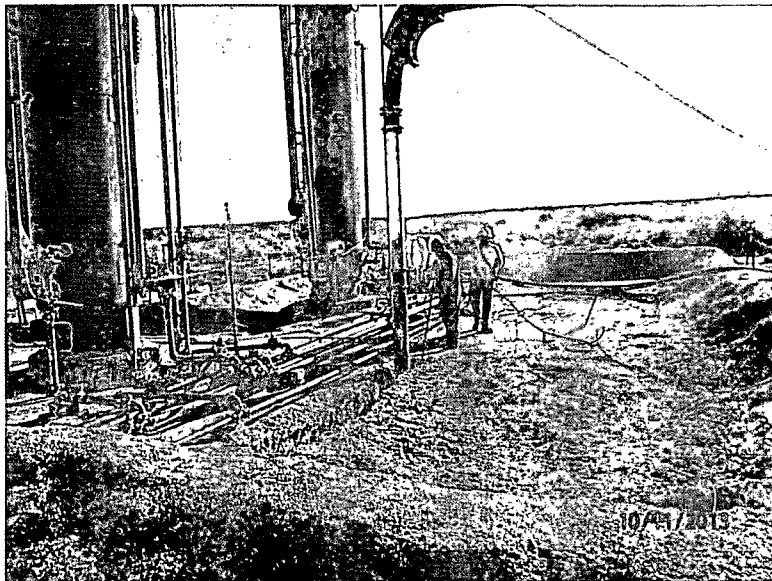
Line spot using a hydrovac, facing northeast 10/11/13

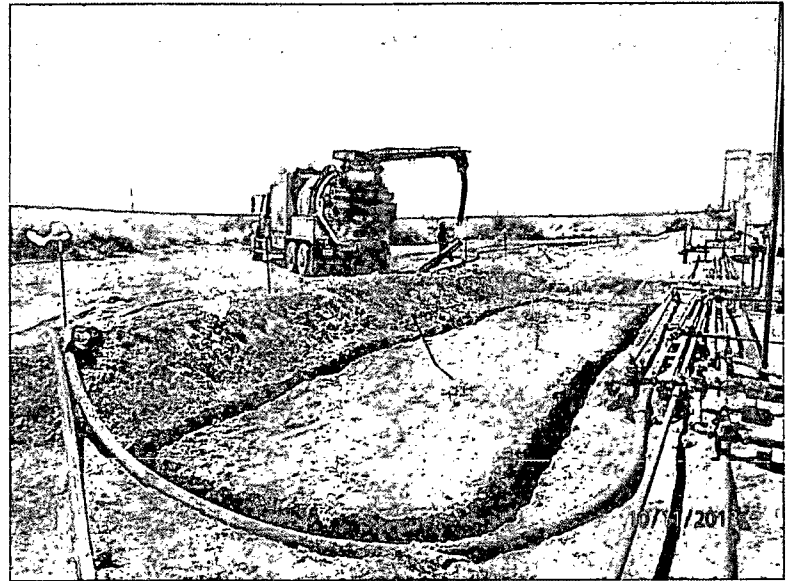
Hydrovac of site completed, facing southwest 10/11/13

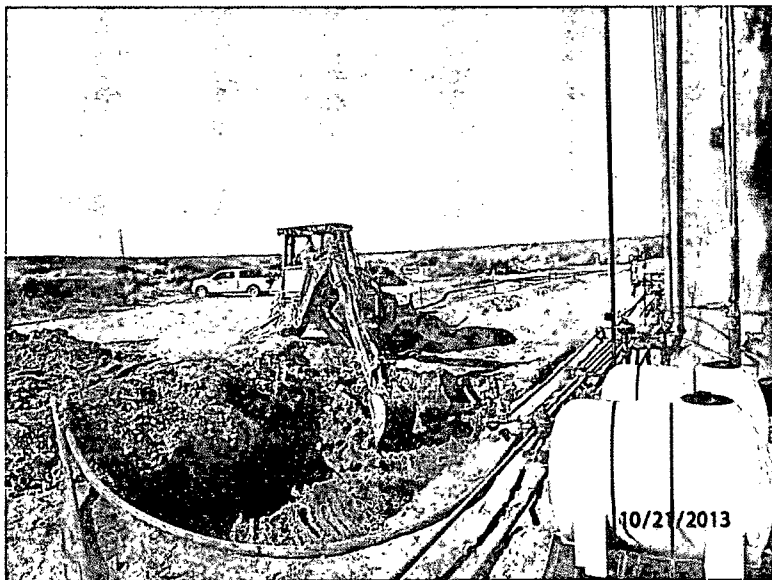
Excavating for liner installation, facing southwest
10/21/13

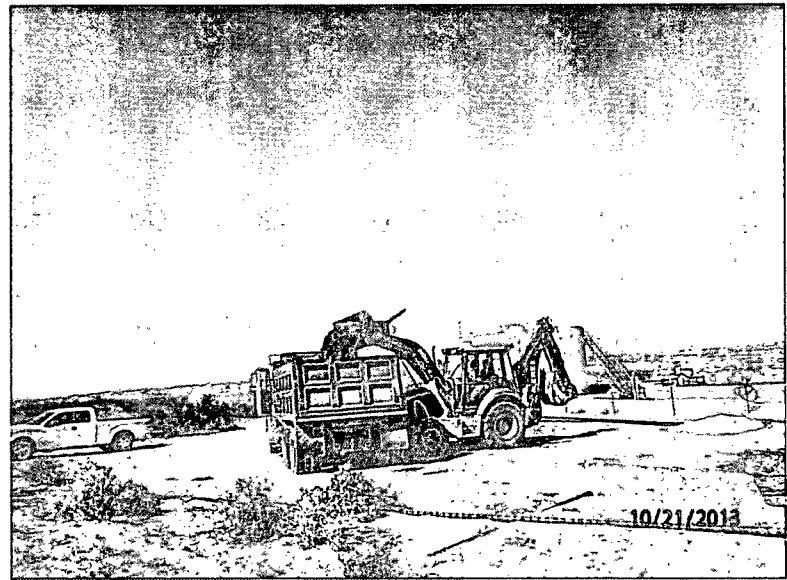
Exporting soil, facing northwest
10/21/13

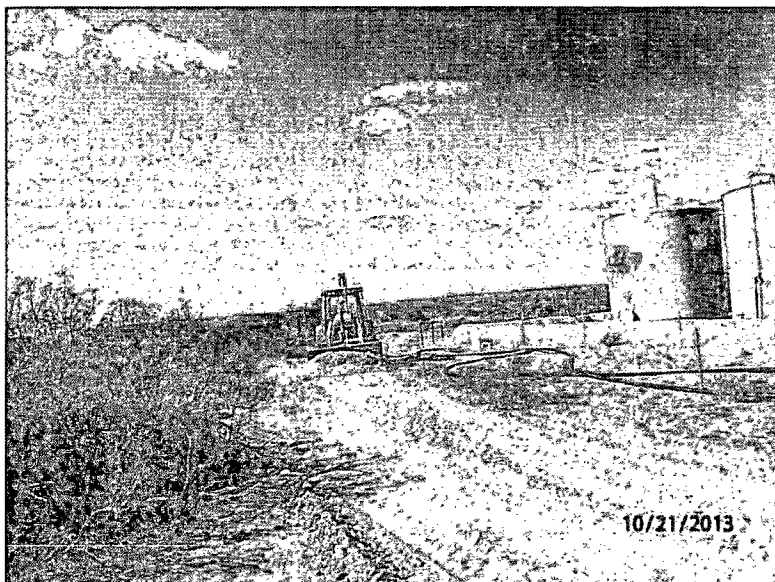
Scraping up road used to conduct soil bores, facing west
10/21/13

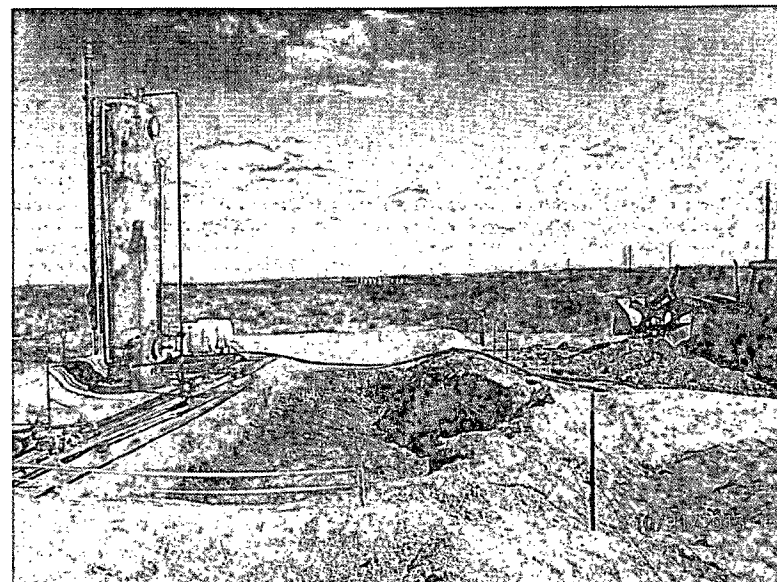
Excavation completed, facing east
10/21/13

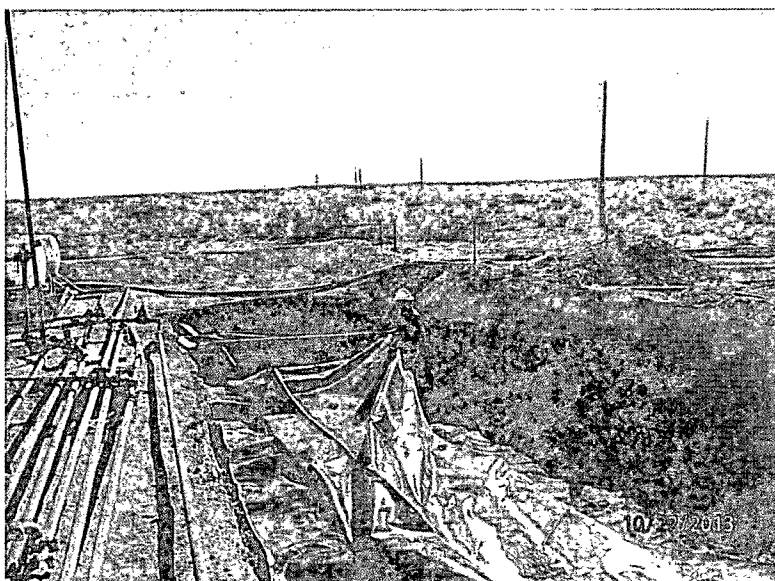
Installing 20-mil reinforced poly liner, facing southeast
10/22/13

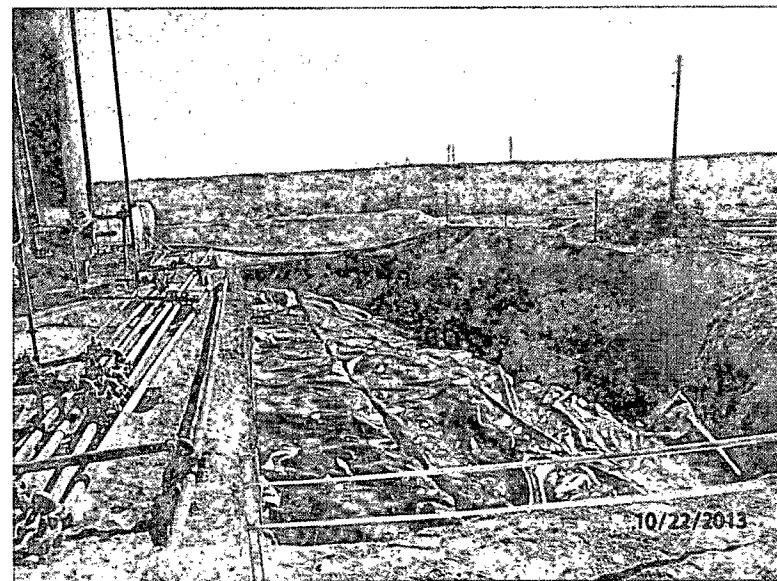
Liner installation completed, facing southeast
10/22/13

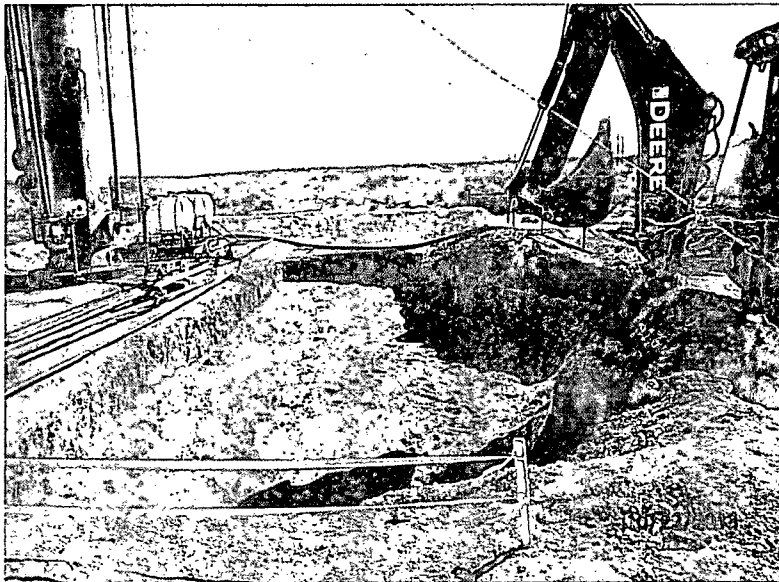
Padding of liner completed, facing east 10/22/13

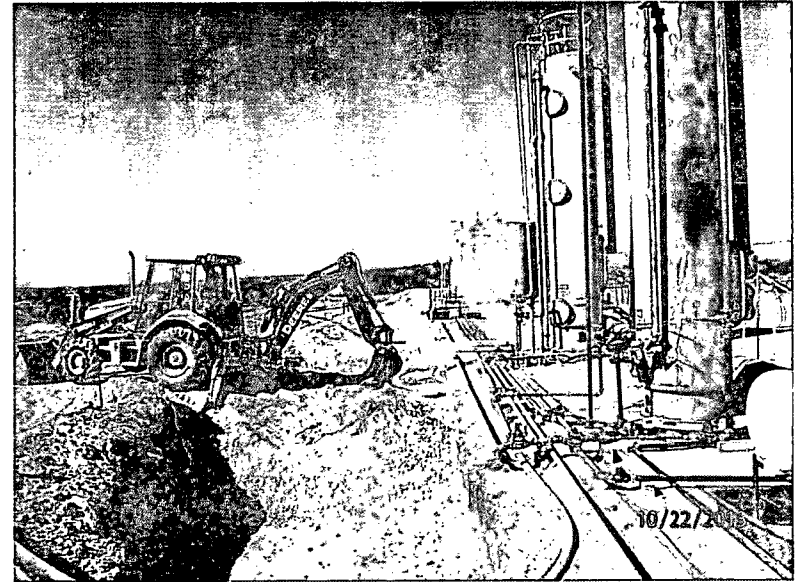
Backfilling site with caliche, facing west 10/22/13

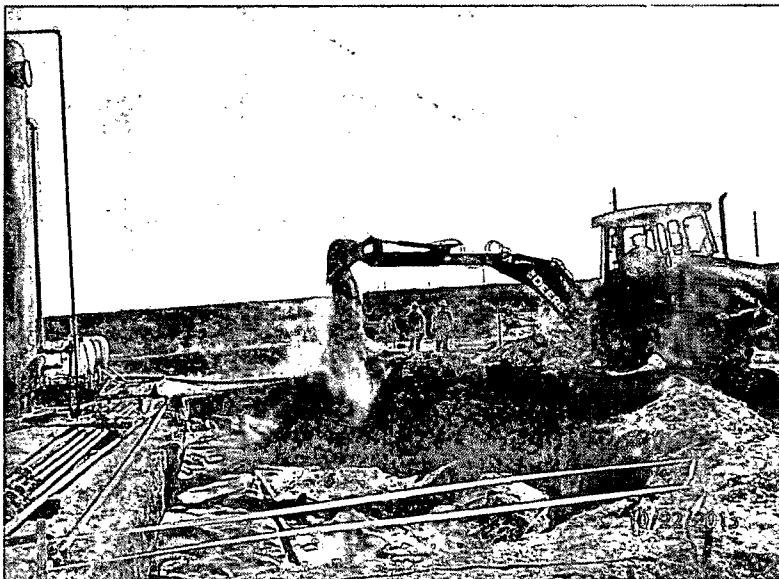
Padding liner with 6 in of sand, facing east 10/22/13

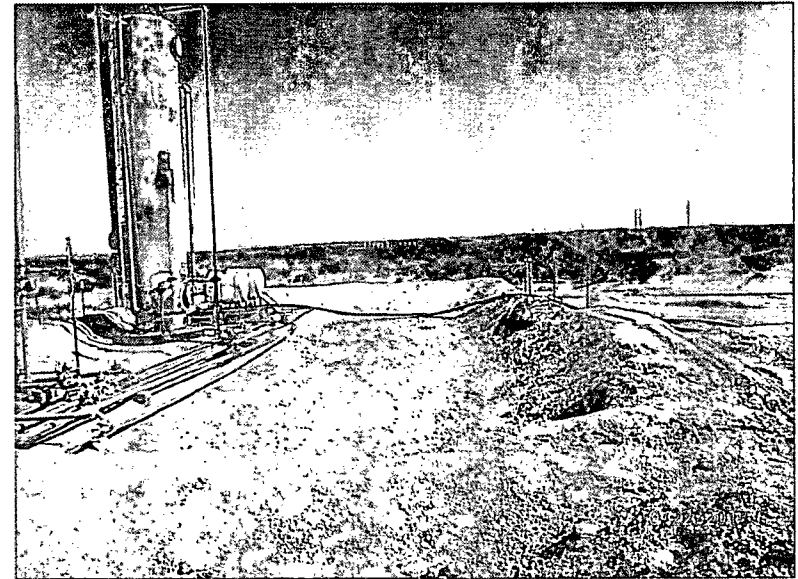
Site completed, facing east 10/22/13
