Choctaw 3" Water Line

**Unit O, Section 16, Township 17 South, Range 31 East
Eddy County, New Mexico**

ENVIRONMENTAL SITE INVESTIGATION

CLOSURE REPORT

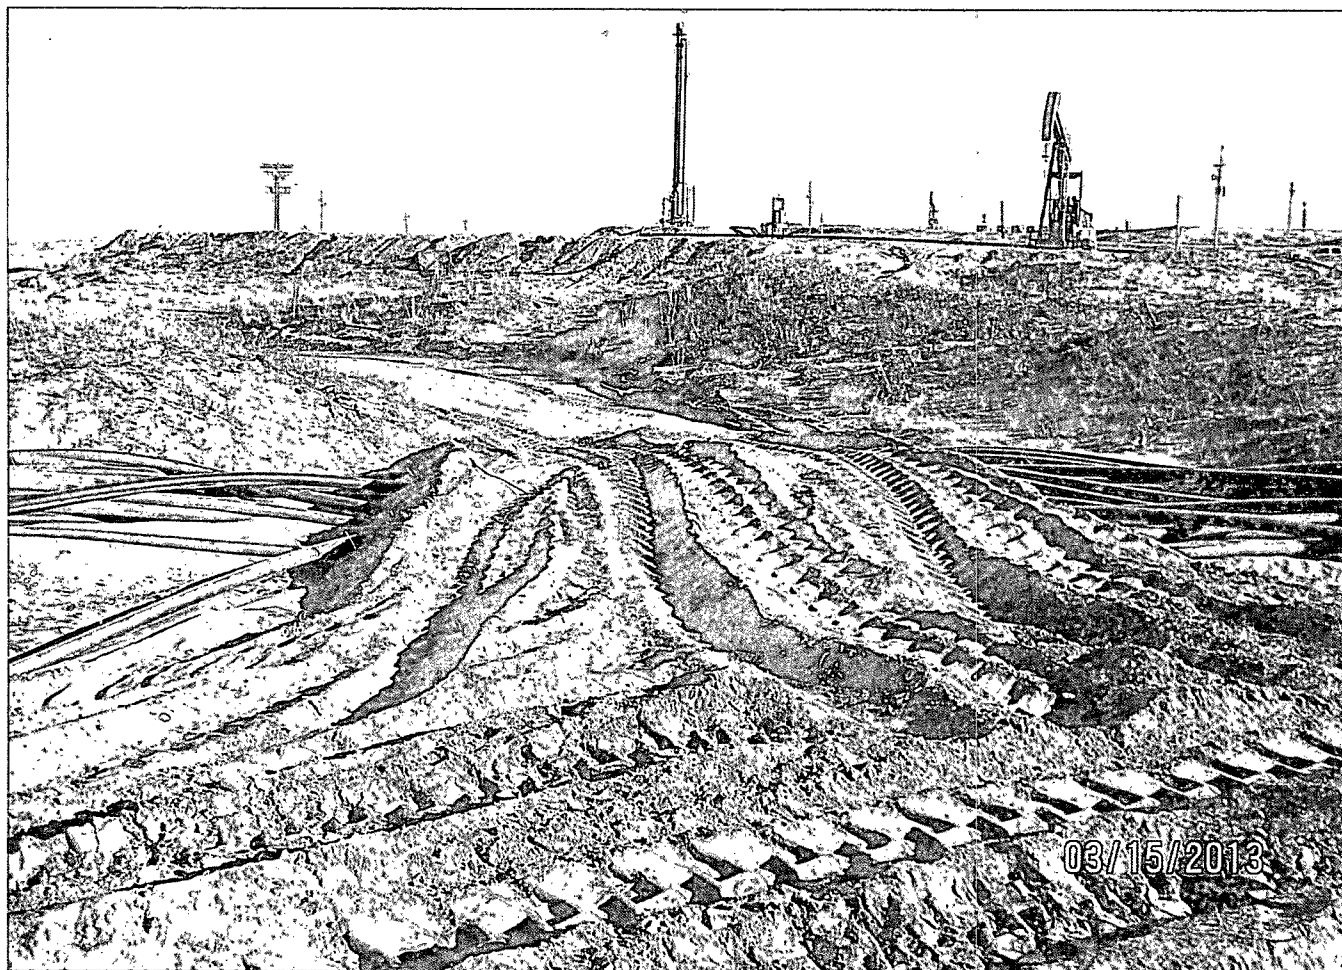
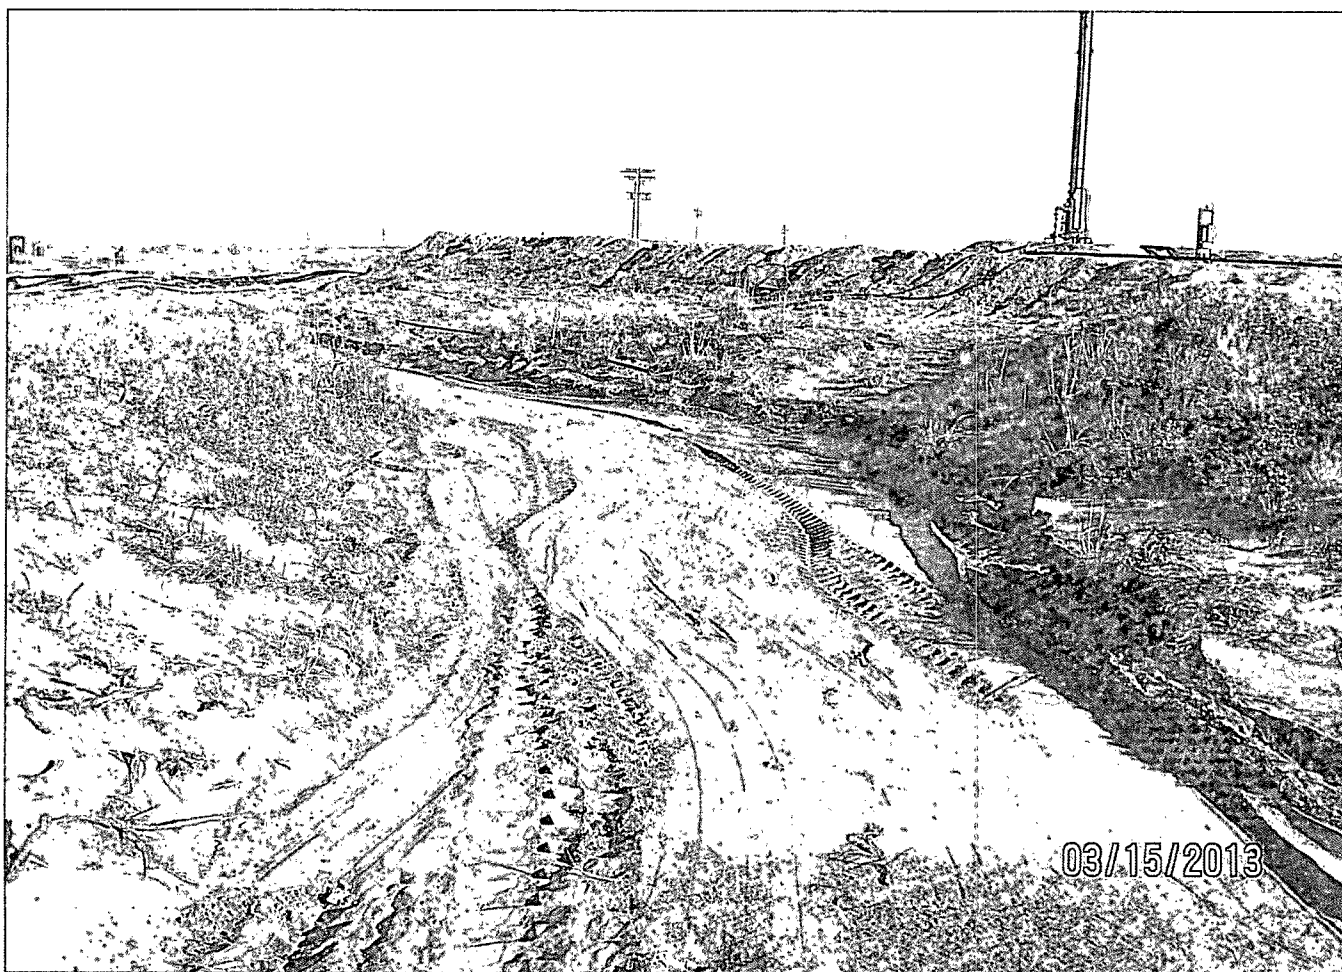
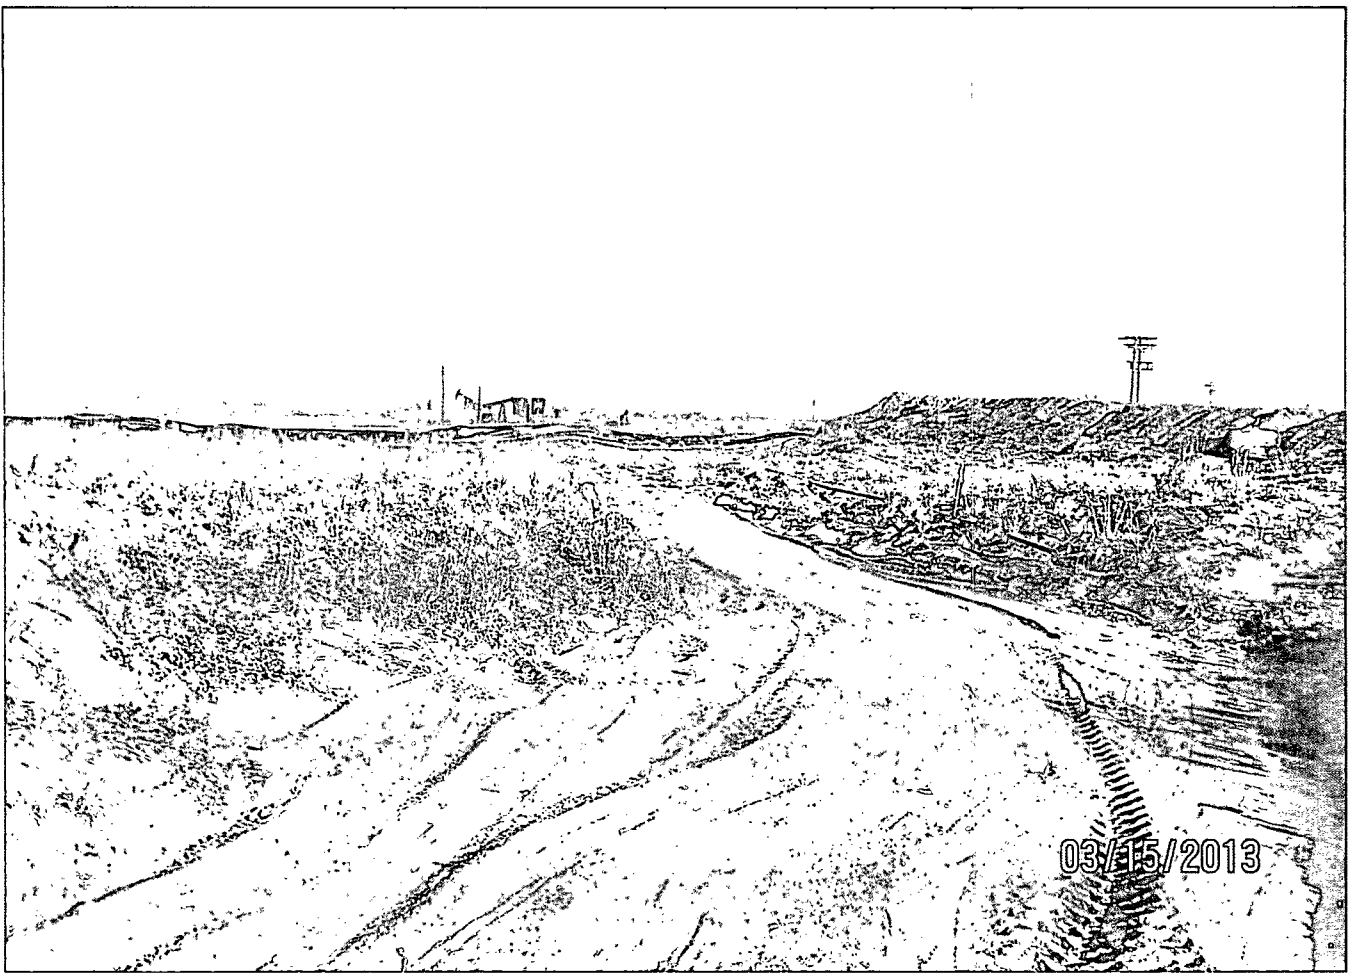
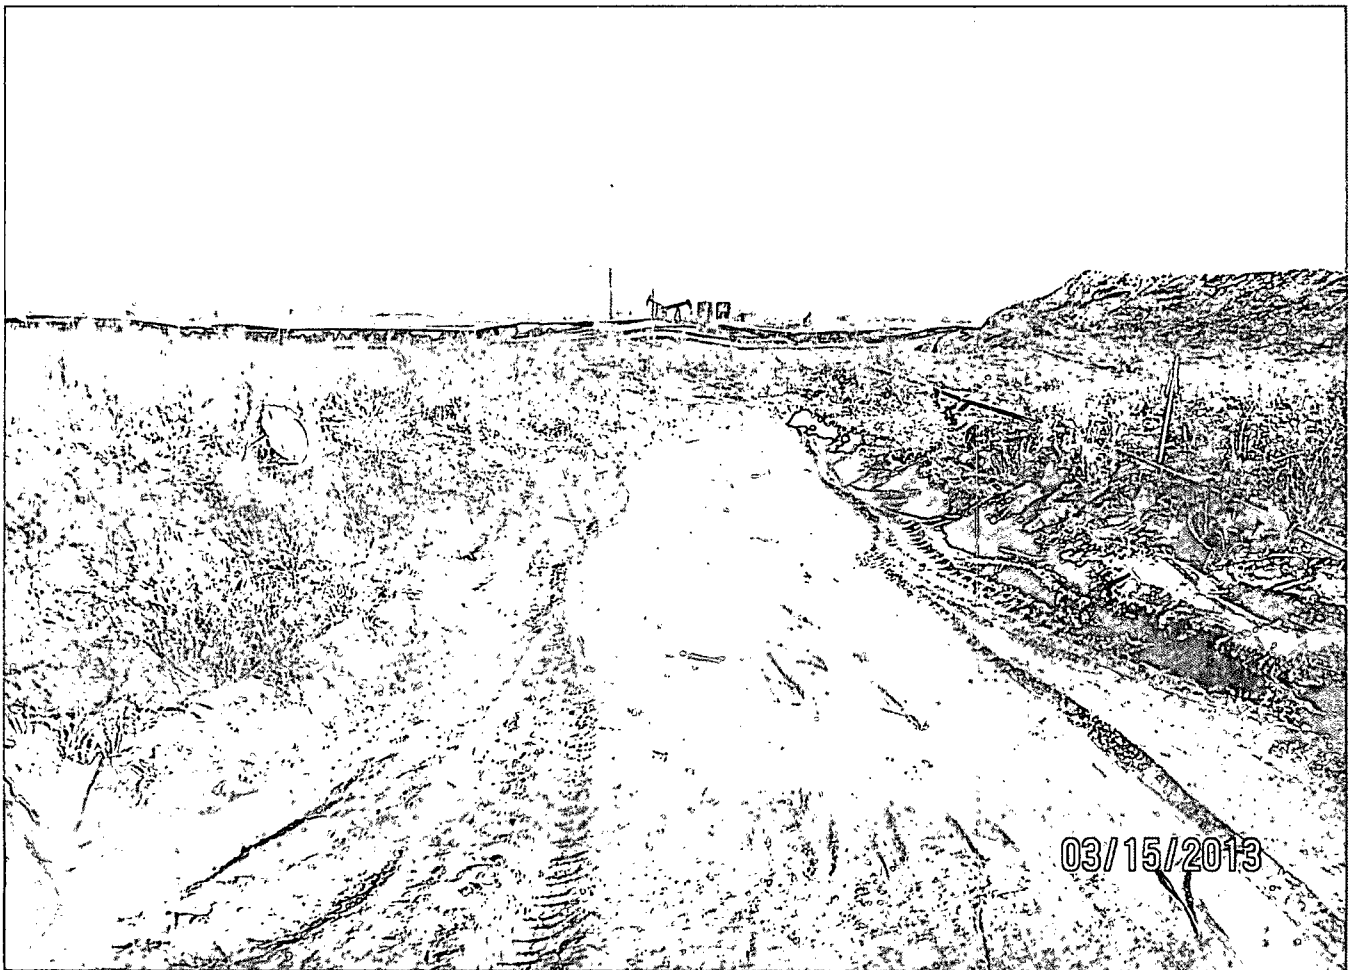
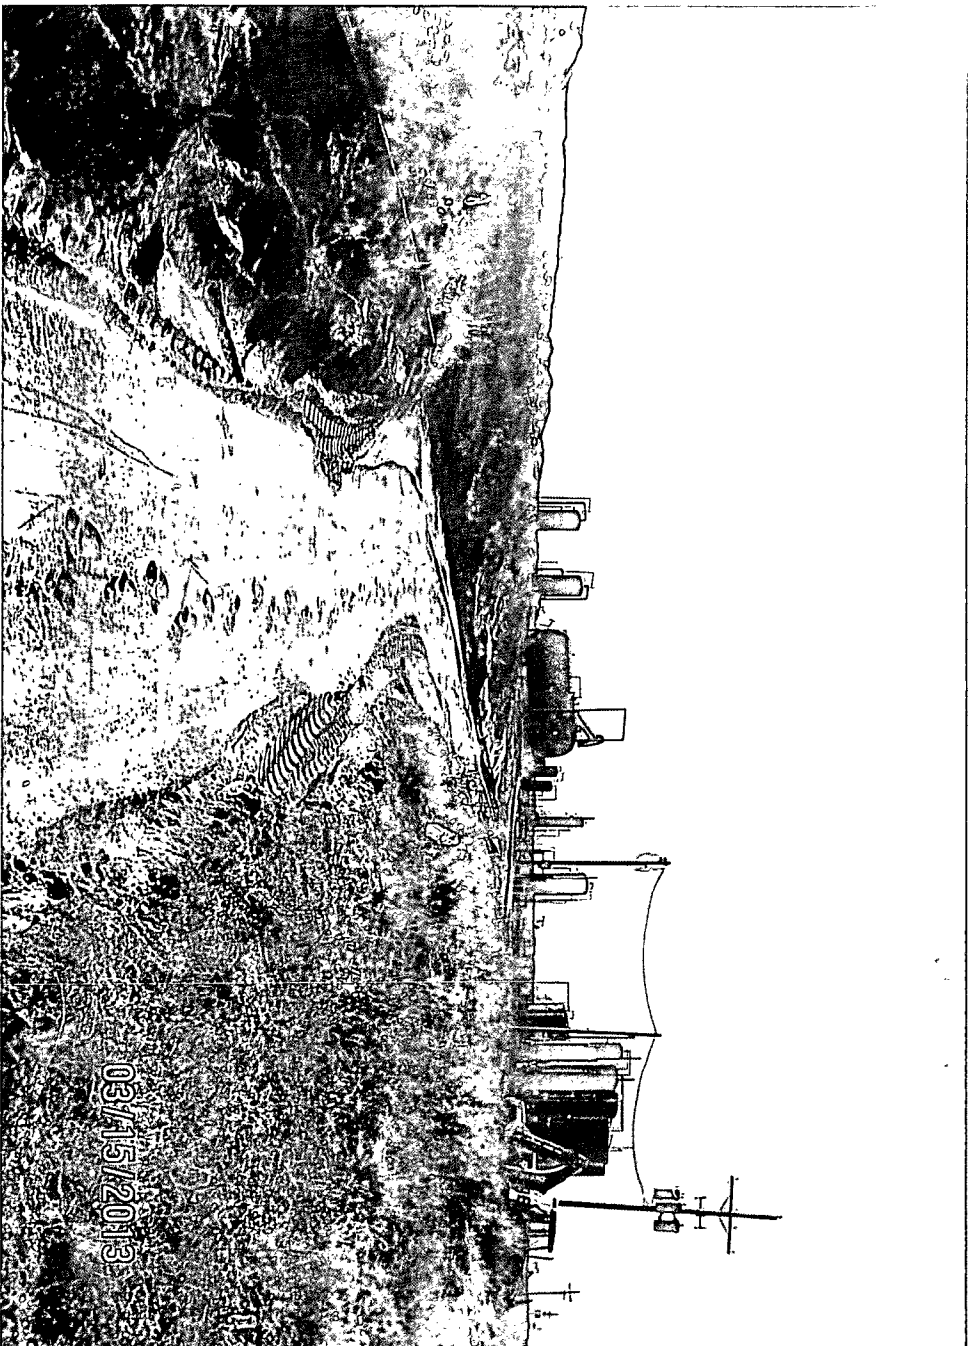
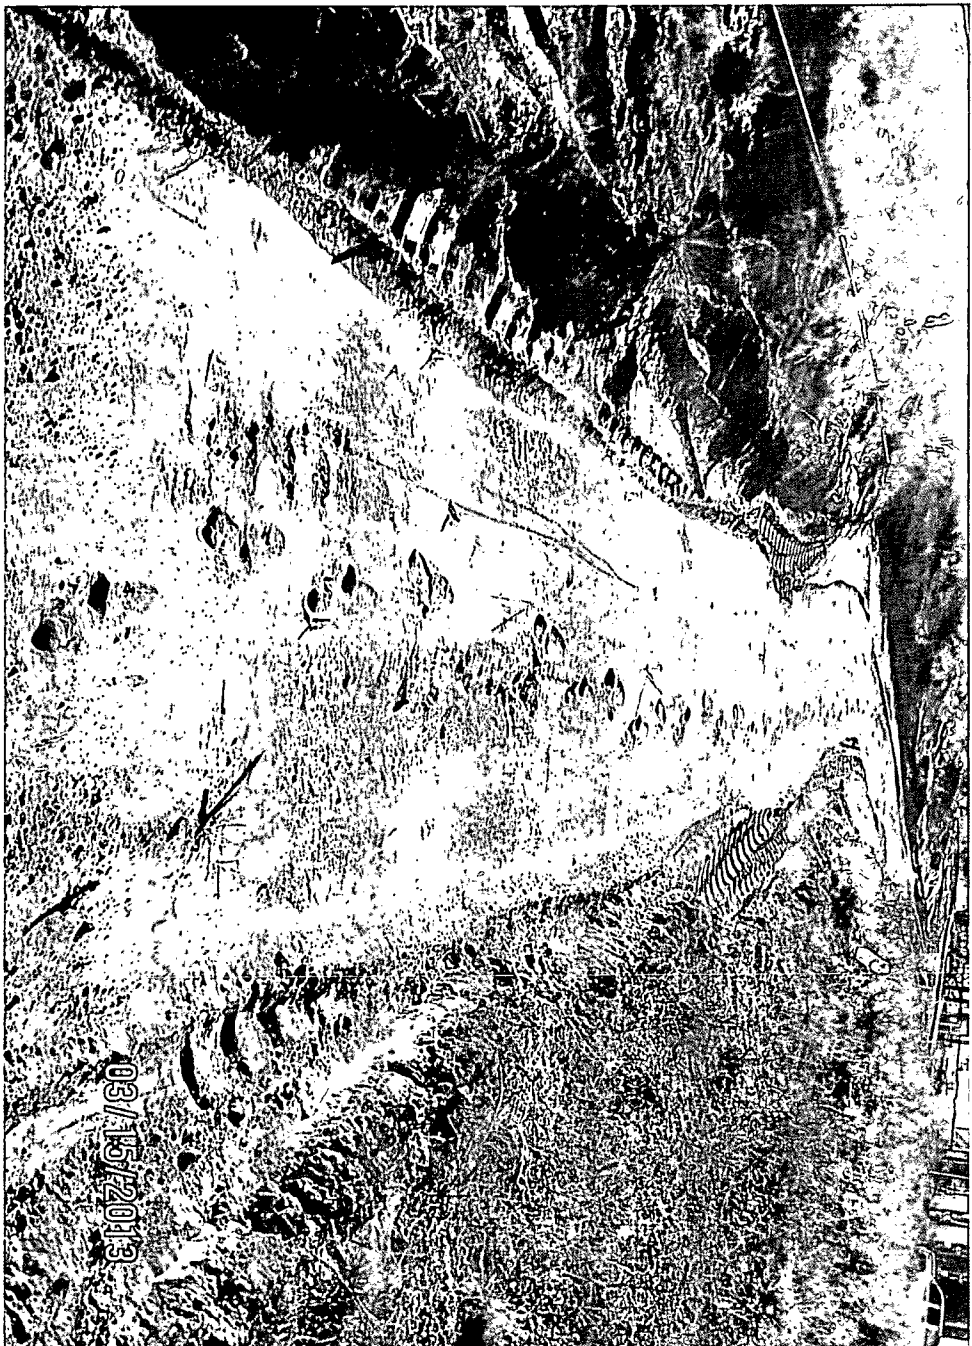
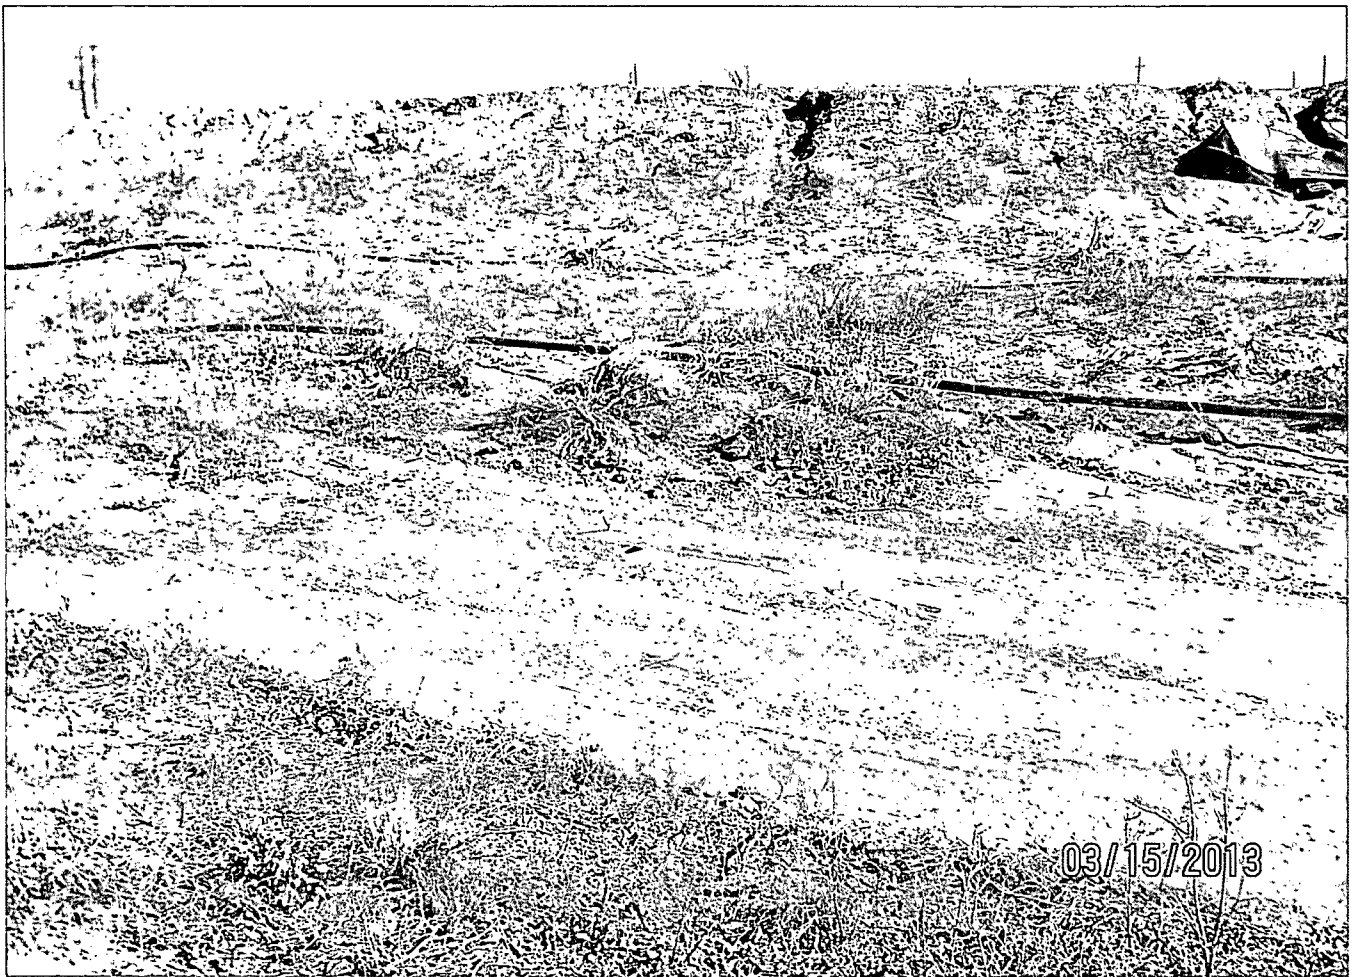
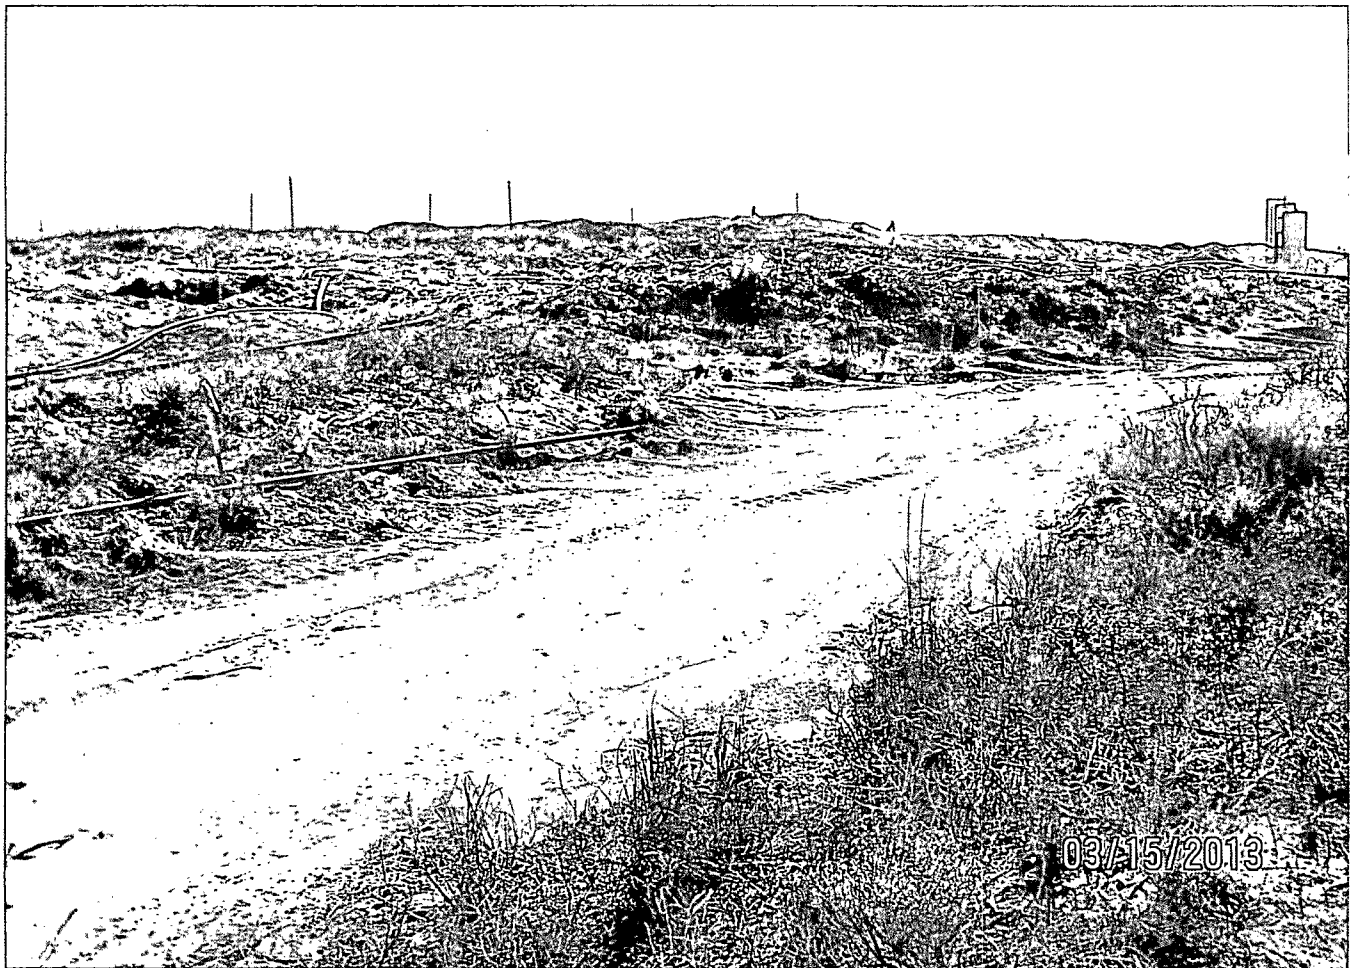
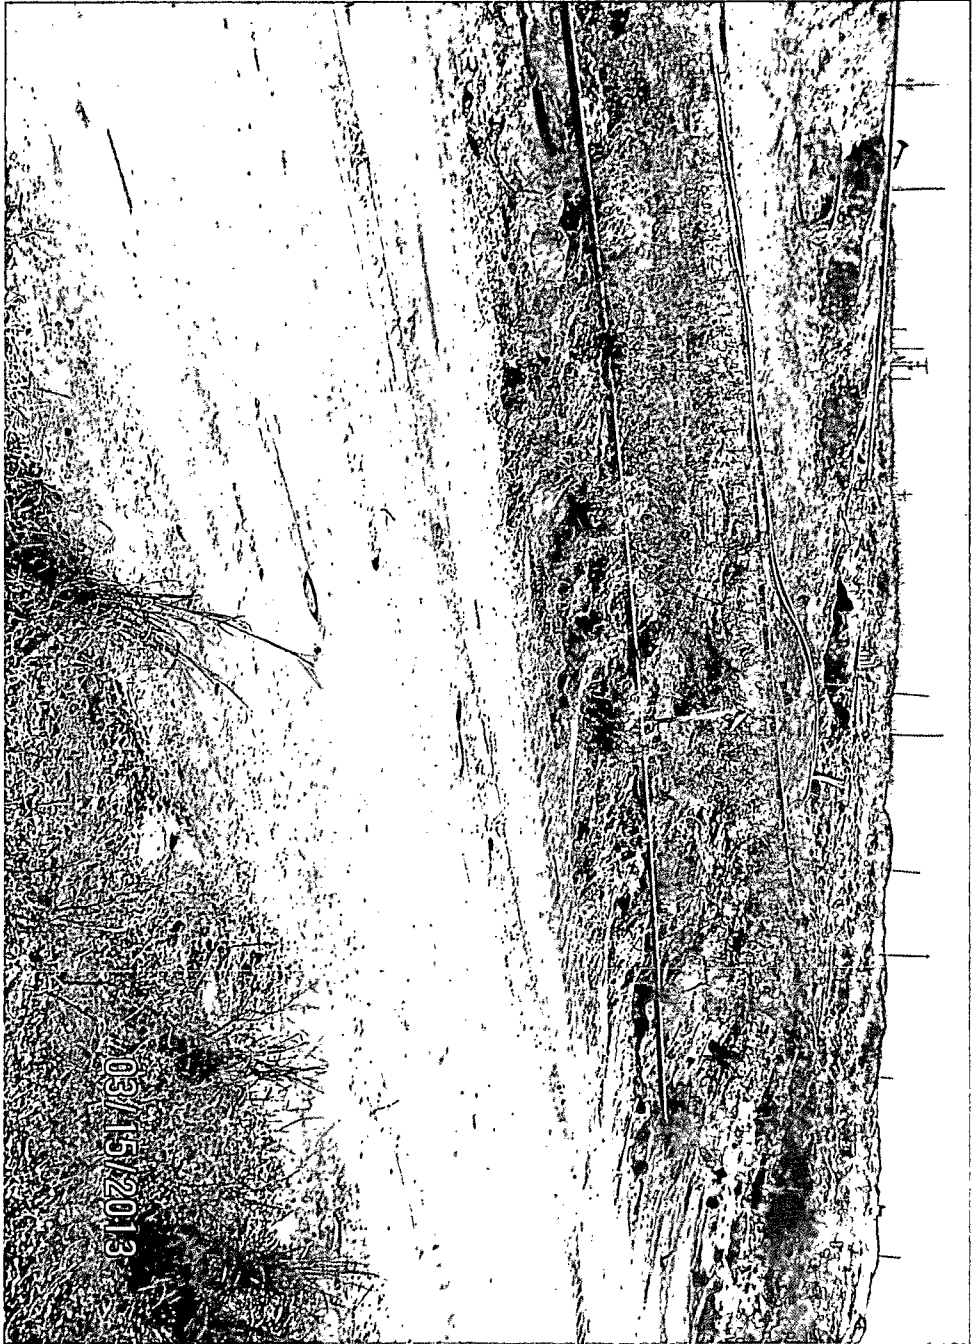
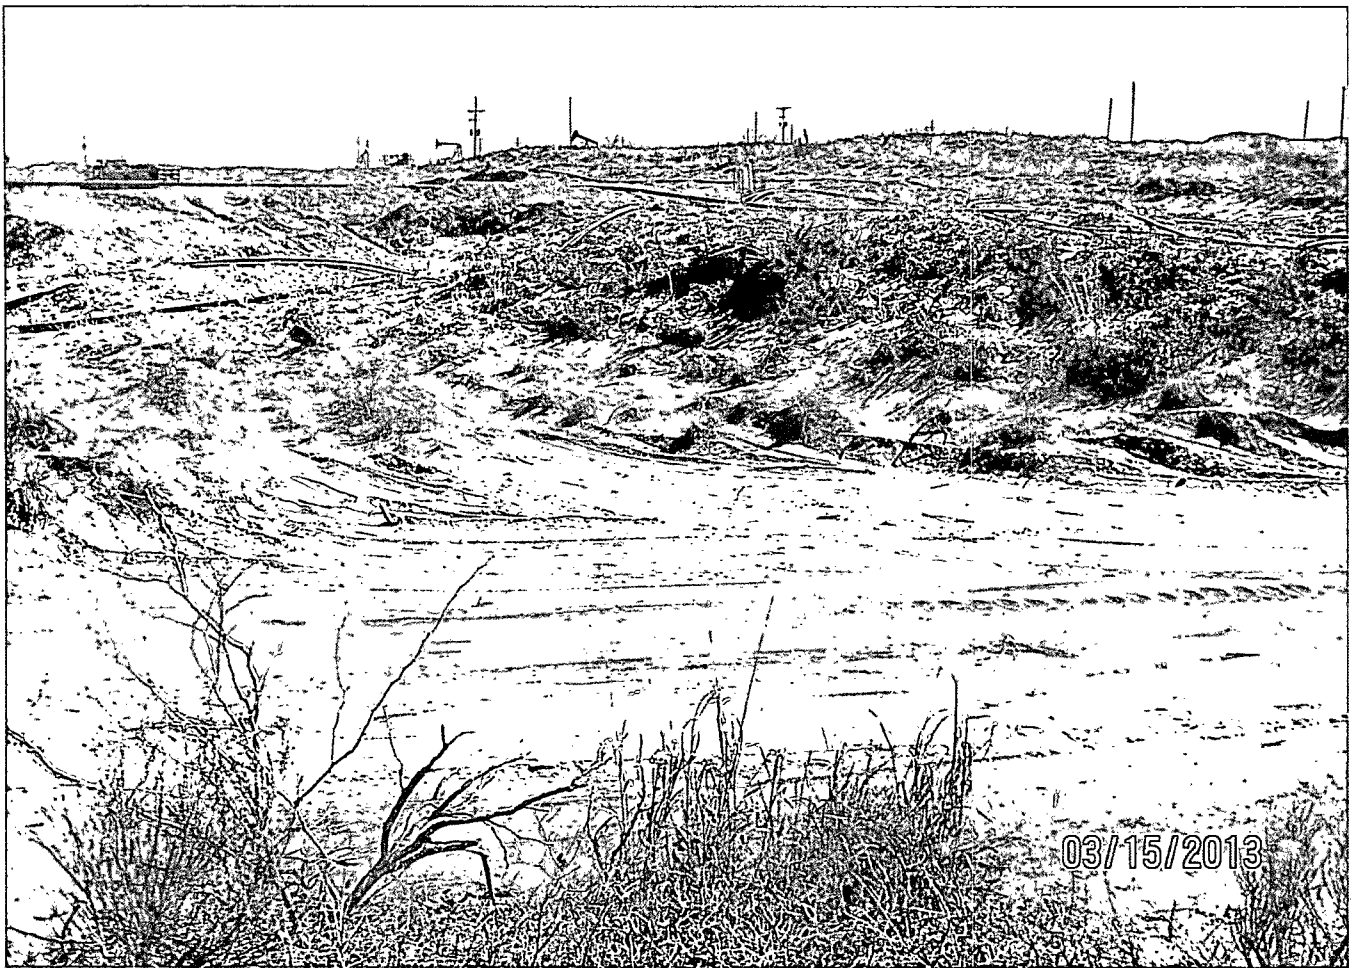
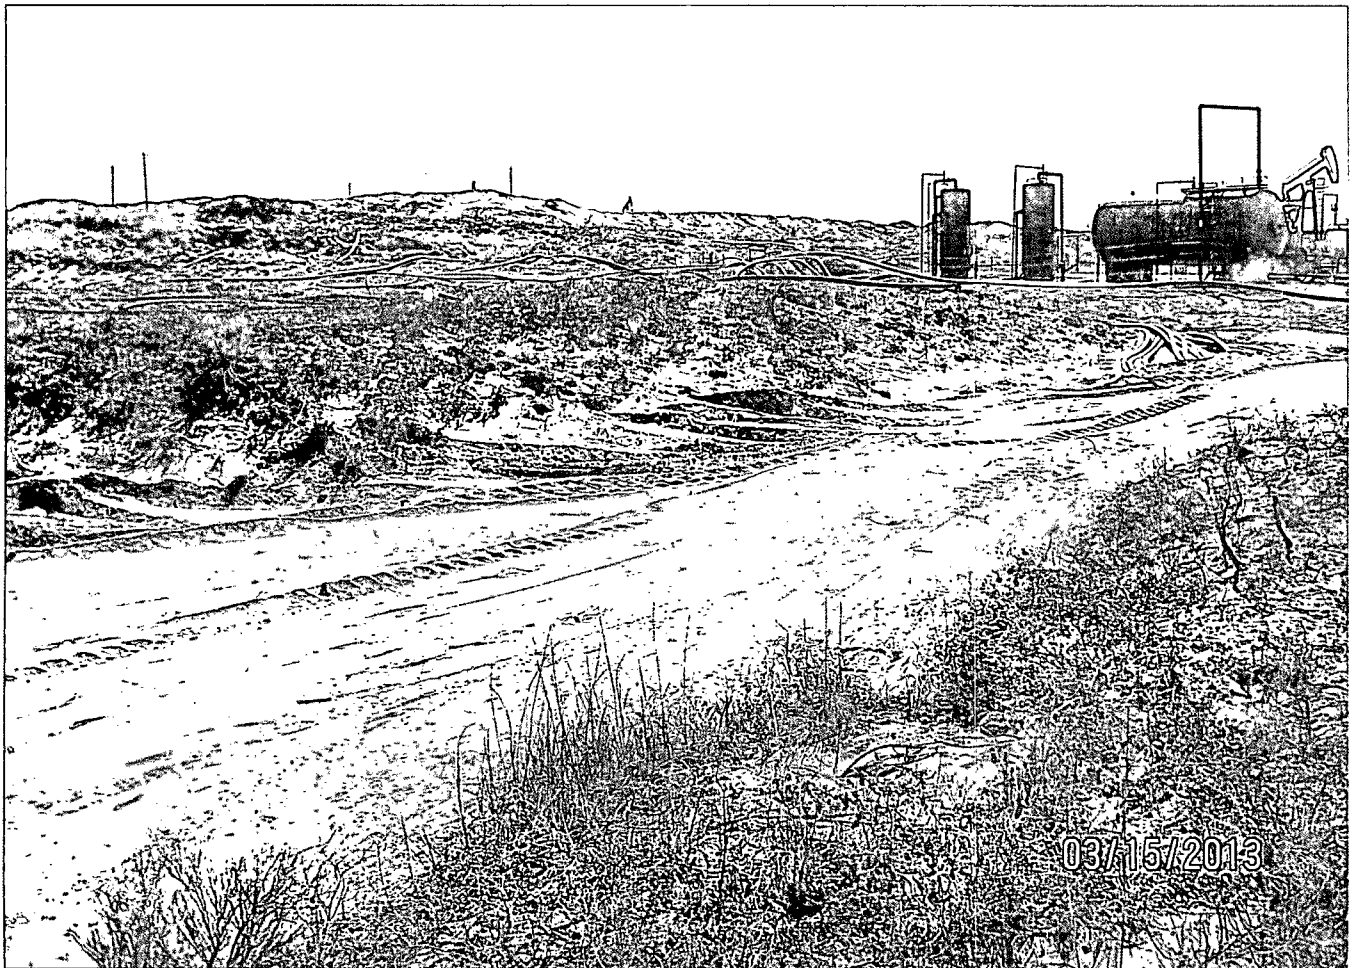
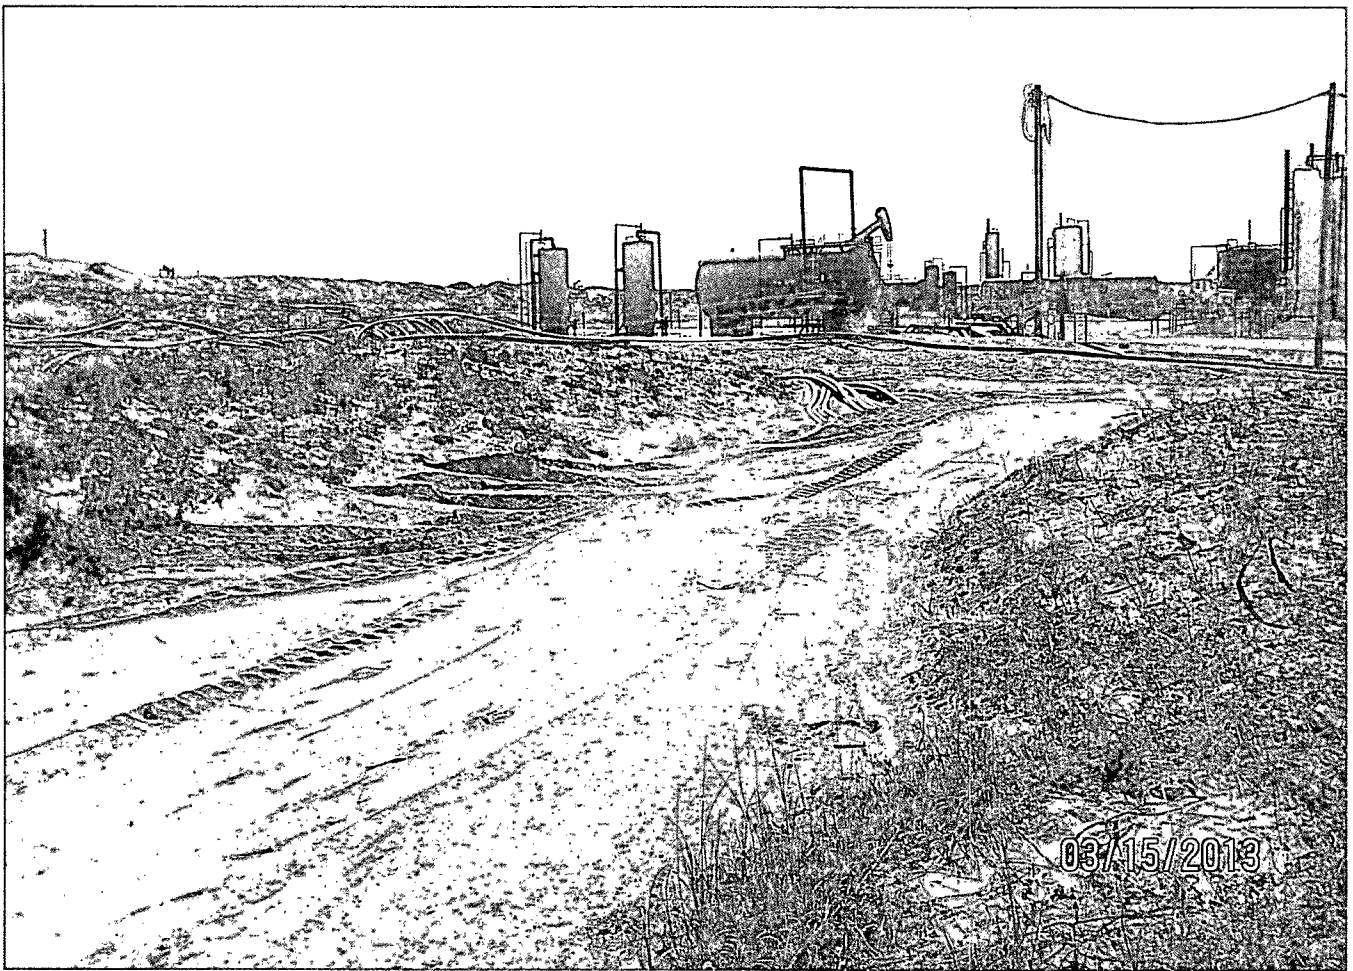
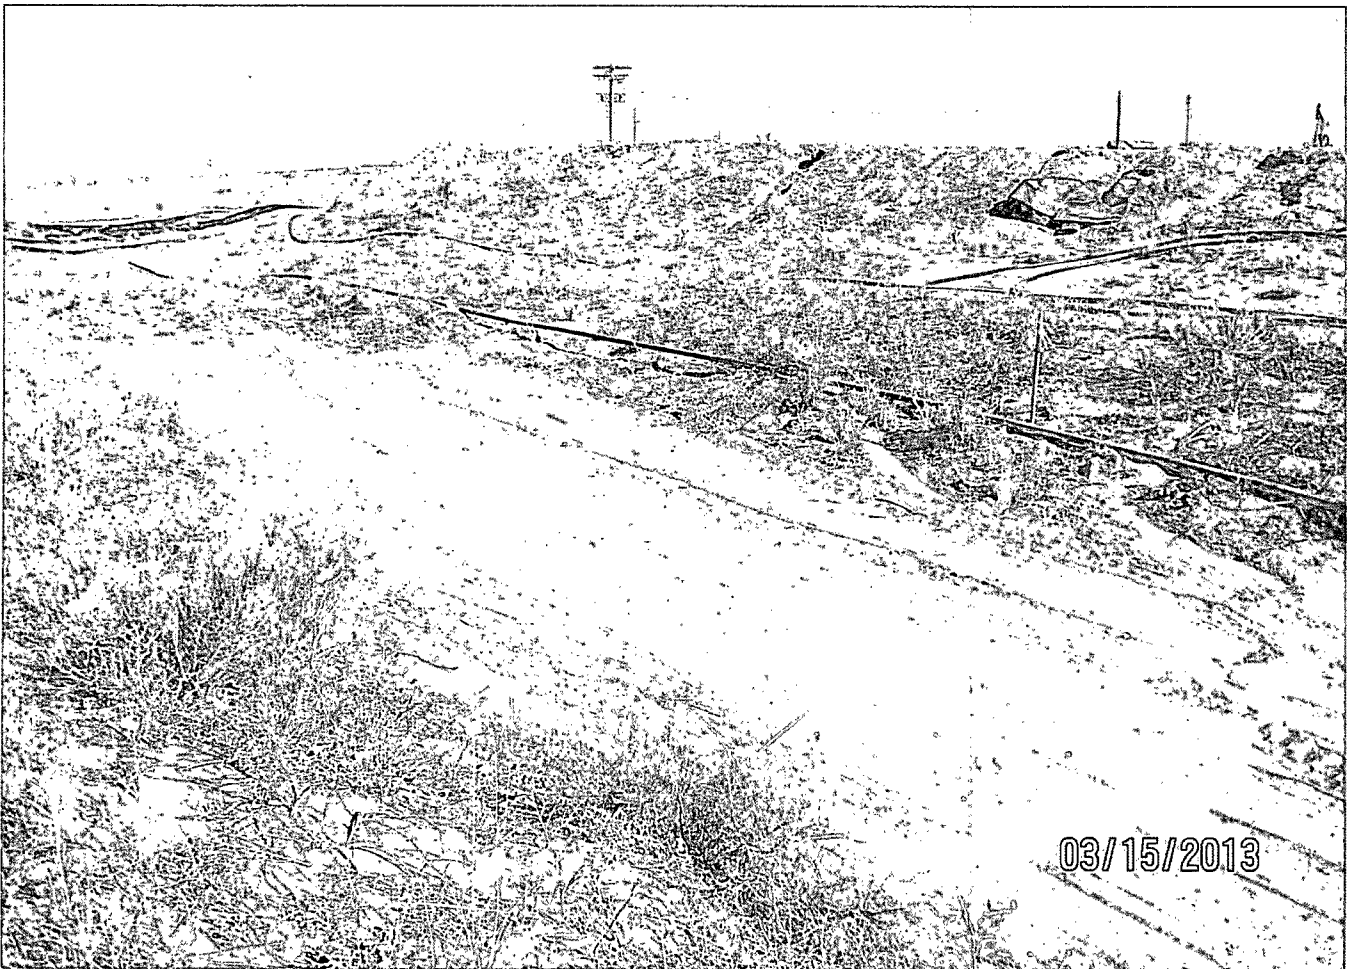
Upon completion of the approved remediation plan, BBC requested closure of the site and submitted a final C-141 to NMOCD. Photos of the remediation activities are located in Appendix IV of this report.

In accordance with the approved remediation plan, excavation of approximately 1 foot across the entire leak site was completed. Then, the site was backfilled with clean soil.
