3R-1012

**Release Report/ General
Correspondence**

Enterprise RA

CORRECTIVE ACTION REPORT

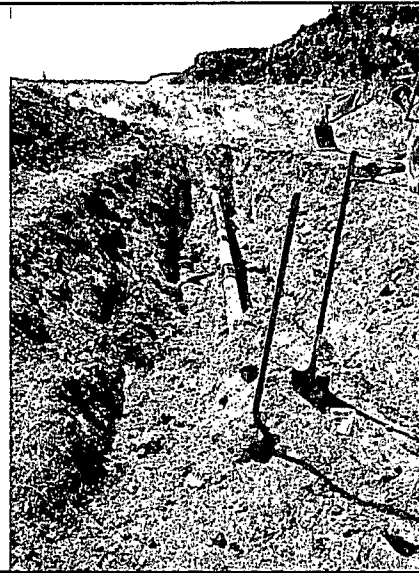
Photograph 1

View of final excavation at the North release location, facing north.

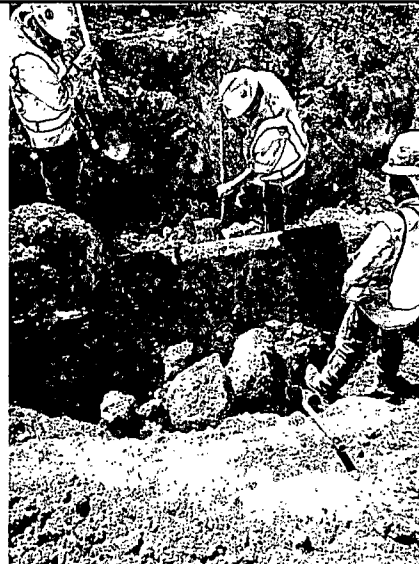
Photograph 2

View of excavation at the south release location during repair activities, facing east.

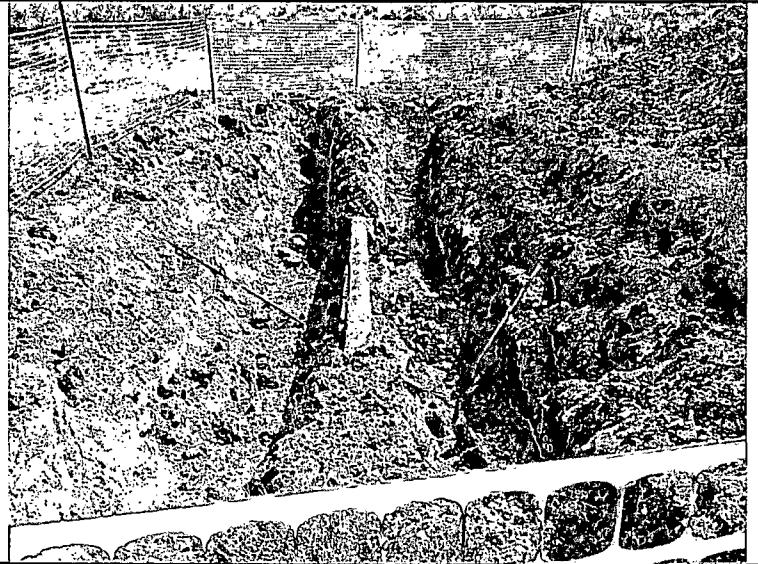
Photograph 1

View of the final North Release excavation, facing northwest.

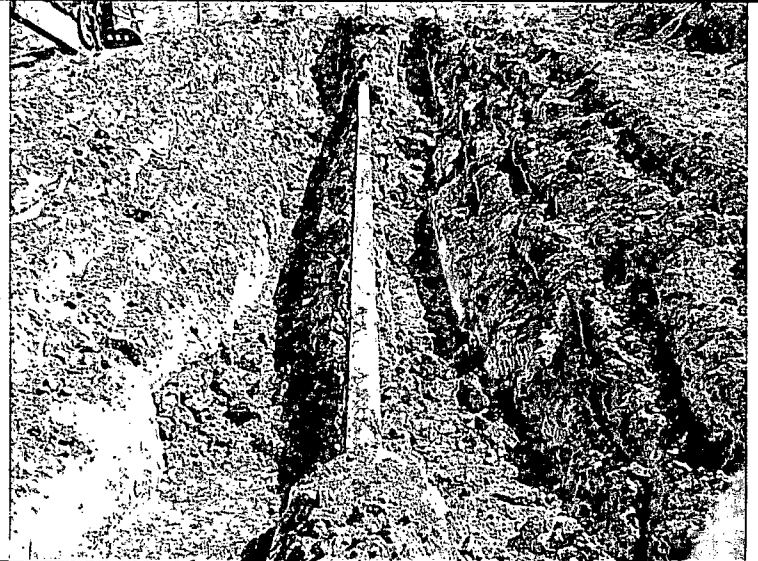
Photograph 2

View of the final Mid-North Release excavation, facing northwest.

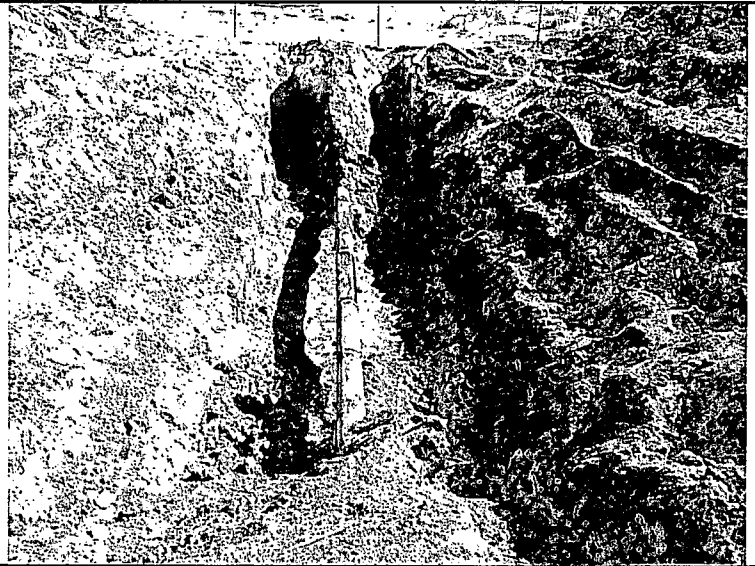
Photograph 4

View of the partially completed South Release excavation following pipeline repair activities, facing northwest.

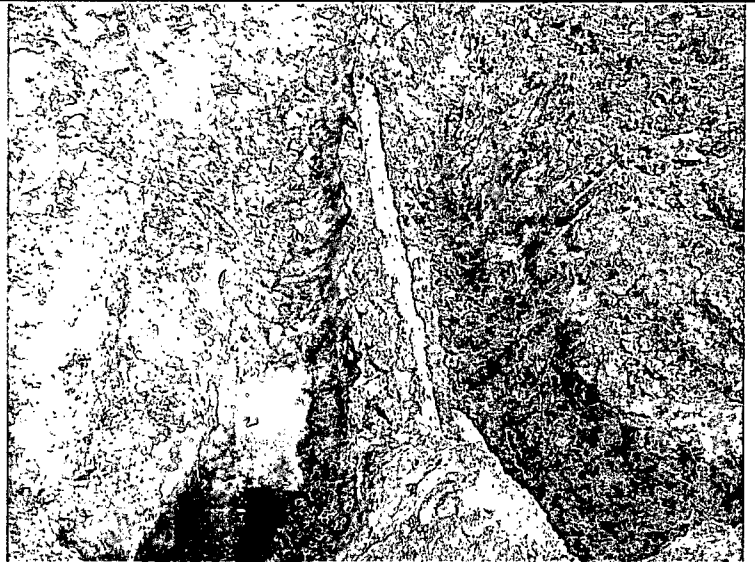
Photograph 5

View of the final South Release excavation following corrective action activities, facing northwest.

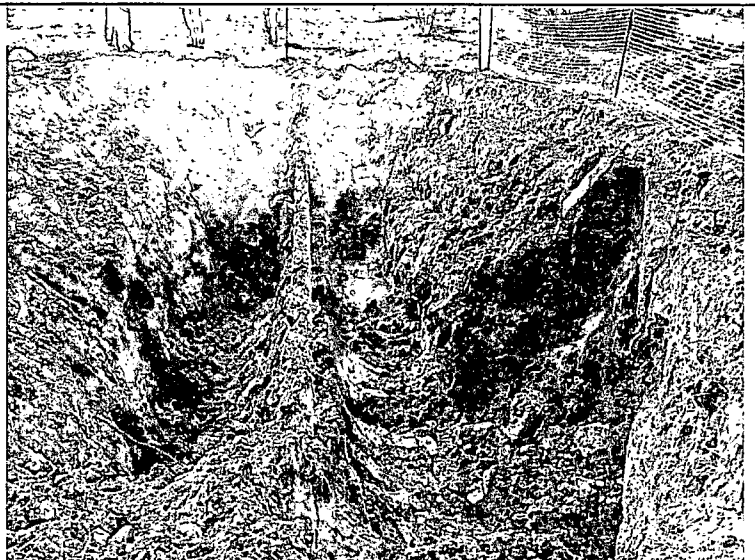
Photograph 6

View of the final South Release excavation following corrective action activities, facing southeast.

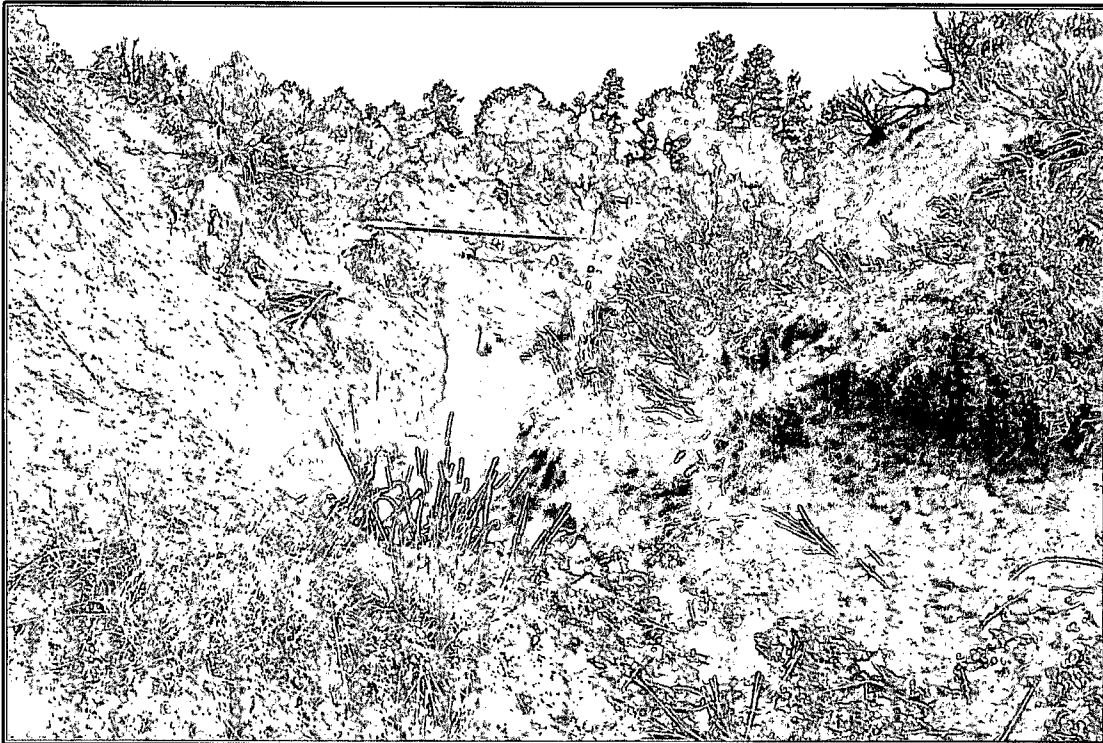
Photo 2: South end of excavation increased to ~2ft bgs , odor and PID screening above NMOCD standards.

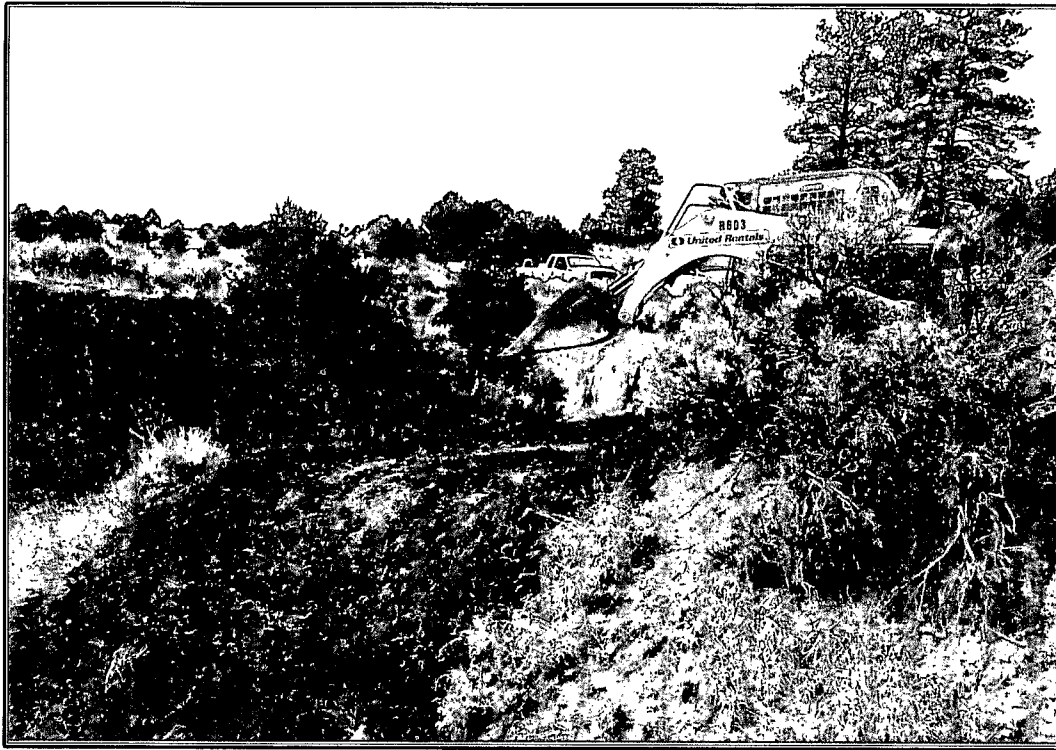
Photo 3: Skidsteer making access ramp for mini-excavator.

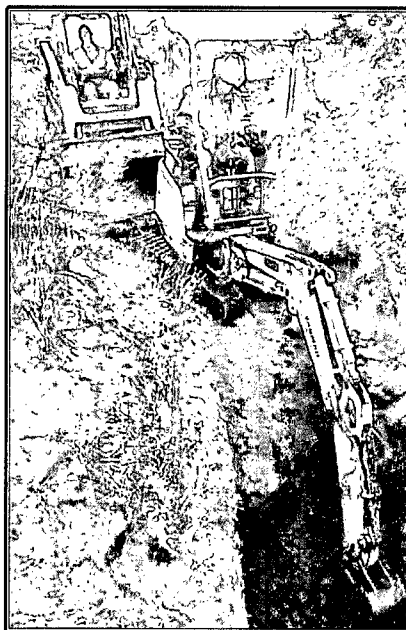
Photo 4: Mini-excavator loading contaminated soil by the bucket into the skidsteer bucket. Skidsteer then hauls each bucket to dump truck for removal.

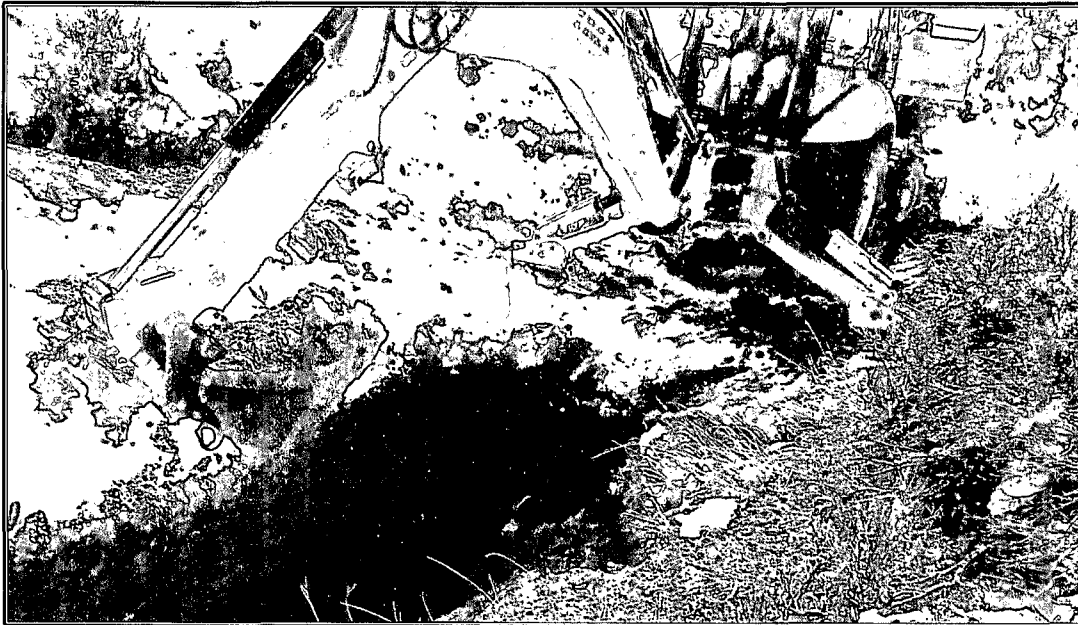
Photo 5: Rubber-tire backhoe excavating the southern portion of excavation on 12/30/2015.

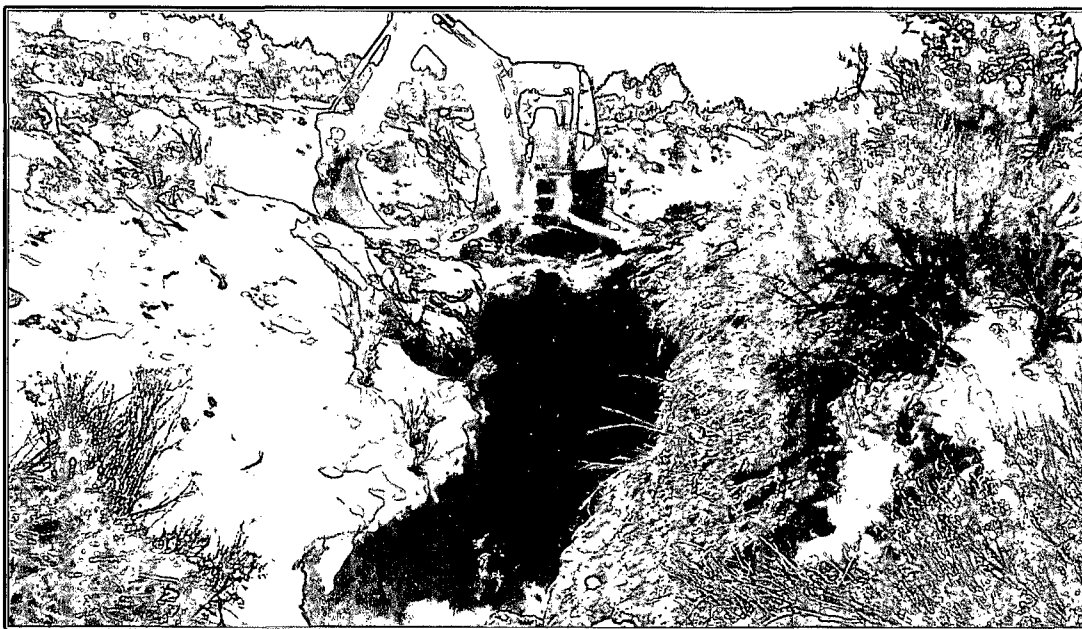
Photo 6: Completed excavation extent. 12/30/2014. Southern section dimension are now 8' wide, 6.5' below grade, and 14.5' in length.

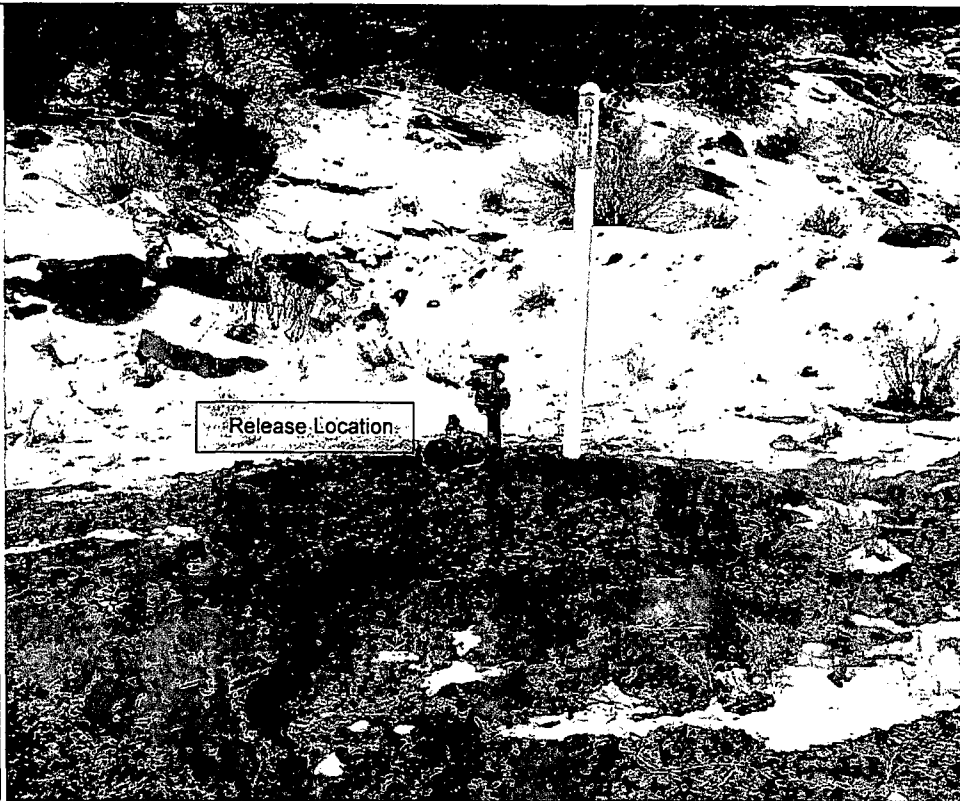
Photograph #1

Client: Enterprise Products	
Site Name: Lateral K-36/ San Juan 28-7 Unit #3 P/A	
Date Photo Taken: December 16, 2014	
Release Location: N36.59906, W107.61945 N-06-27N-07W Rio Arriba County, New Mexico	
Photo Taken by: Deborah Watson	Description: Facing S, looking at the San Juan 28-7 Unit #3 P/A abandoned meter stem, along Lateral K-36 pipeline. Photo shows surface extent of release reported on December 15, 2014.

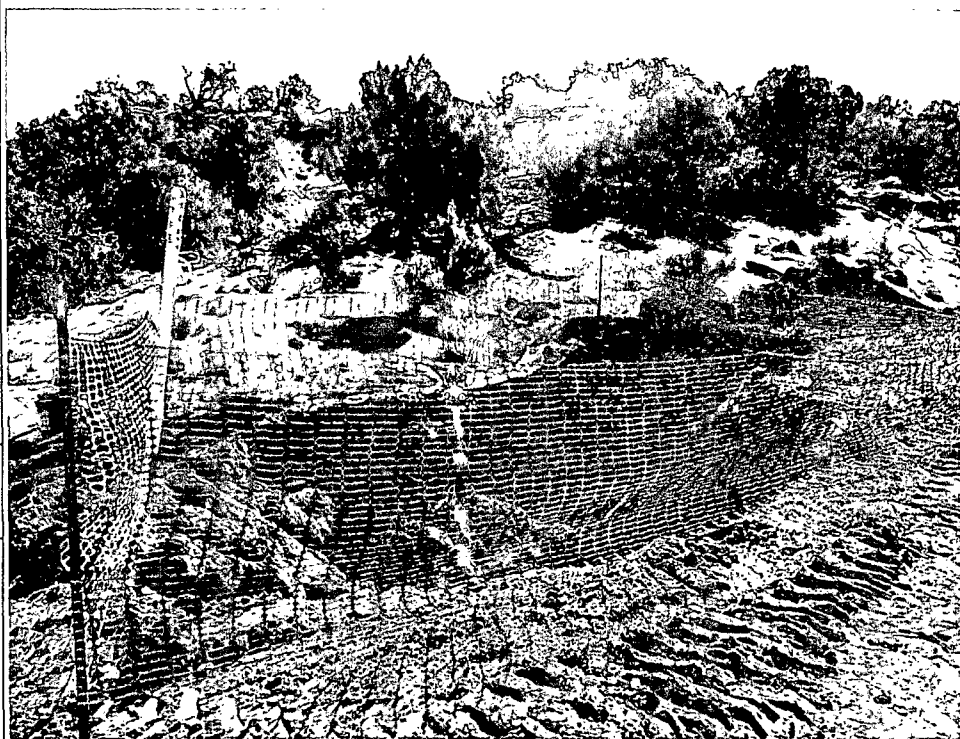
Photograph #2

Client: Enterprise Products	
Site Name: Lateral K-36/ San Juan 28-7 Unit #3 P/A	
Date Photo Taken: January 9, 2015	
Release Location: N36.59906, W107.61945 N-06-27N-07W Rio Arriba County, New Mexico	
Photo Taken by: Deborah Watson	Description: Facing SE, looking at excavation following remediation on January 7, 2015. Excavation measured approximately 19 feet x 16 feet x 6 (to 7) feet in depth.

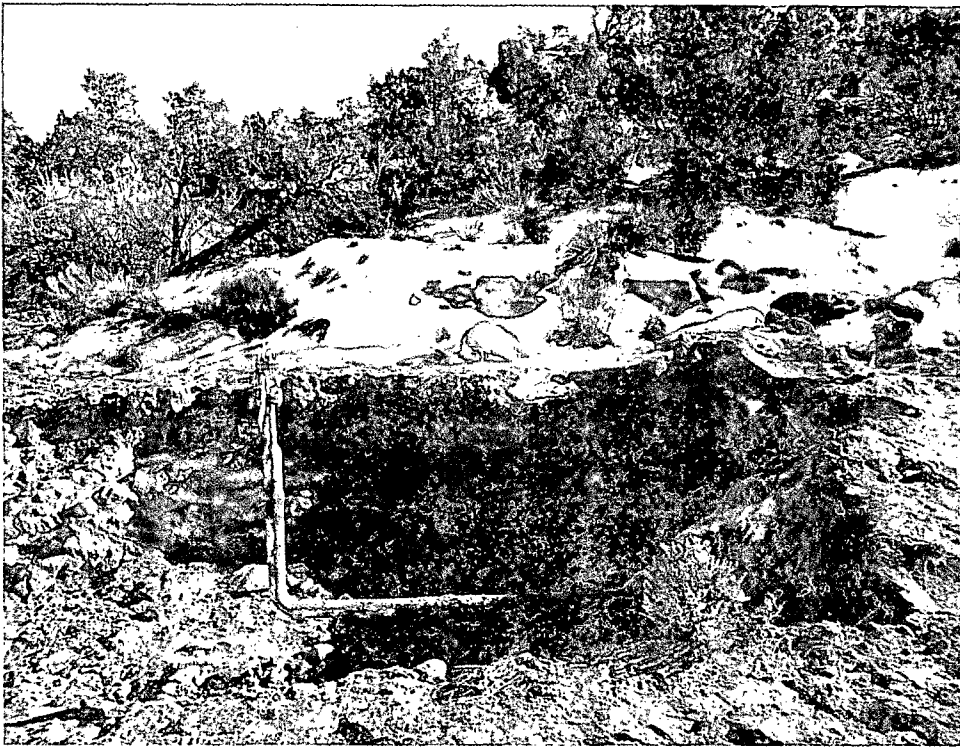
Photograph #3

Client: Enterprise Products	
Site Name: Lateral K-36/ San Juan 28-7 Unit #3 P/A	
Date Photo Taken: January 23, 2015	
Release Location: N36.59906, W107.61945 N-06-27N-07W Rio Arriba County, New Mexico	
Photo Taken by: Deborah Watson	Description: Facing SE, looking at exposed Lateral K-36 pipeline and San Juan 28-7 Unit #3 P/A abandoned meter stem. Final area of excavation measured 30.5 feet x 13 (to 16) feet x 3 (to 7) feet in depth

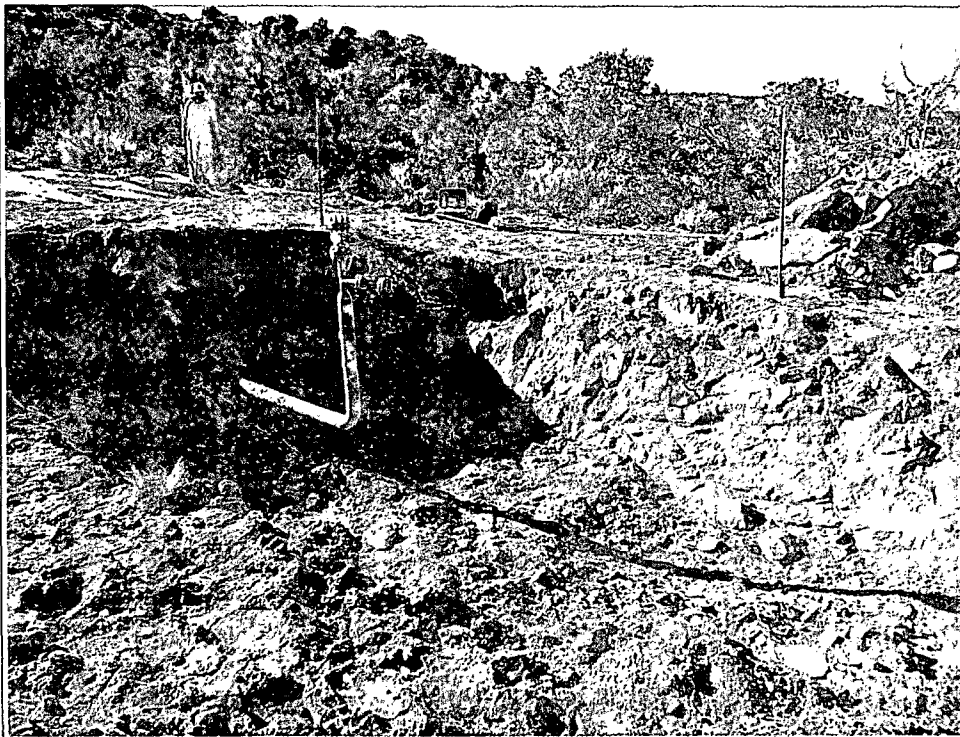
Photograph #4

Client: Enterprise Products	
Site Name: Lateral K-36/ San Juan 28-7 Unit #3 P/A	
Date Photo Taken: January 23, 2015	
Release Location: N36.59906, W107.61945 N-06-27N-07W Rio Arriba County, New Mexico	
Photo Taken by: Deborah Watson	Description: Facing SW, looking at exposed Lateral K-36 pipeline and San Juan 28-7 Unit #3 P/A abandoned meter stem.

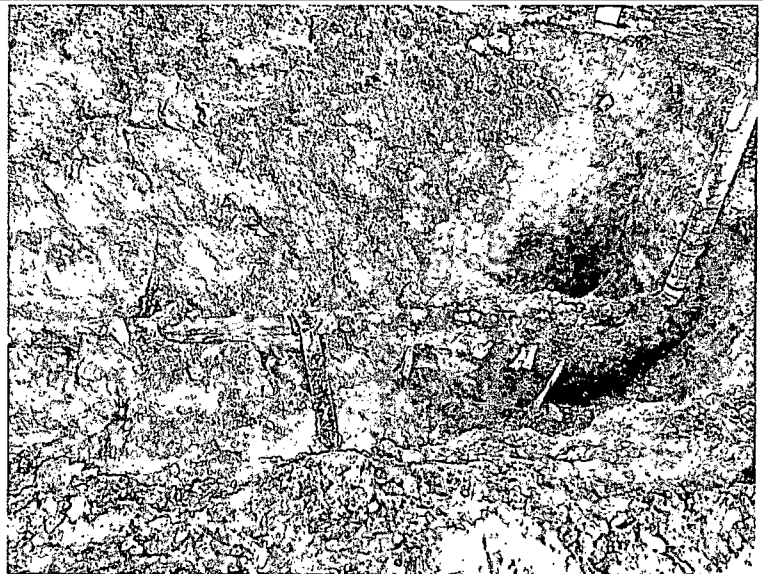
Photograph 2

View of partially completed excavation, facing east.

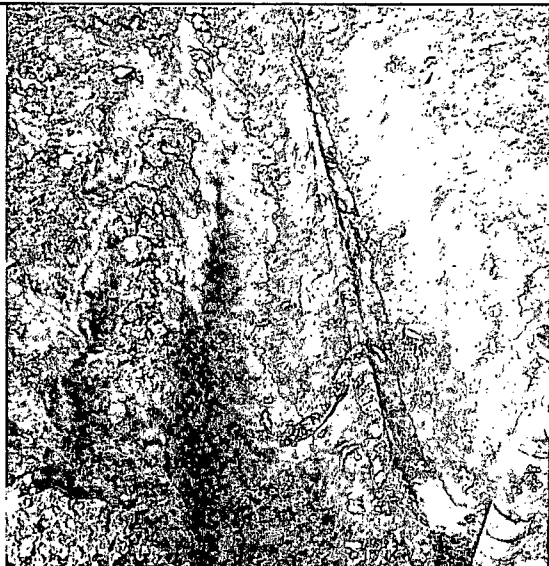
Photograph 3

View of partially completed excavation, facing northwest.

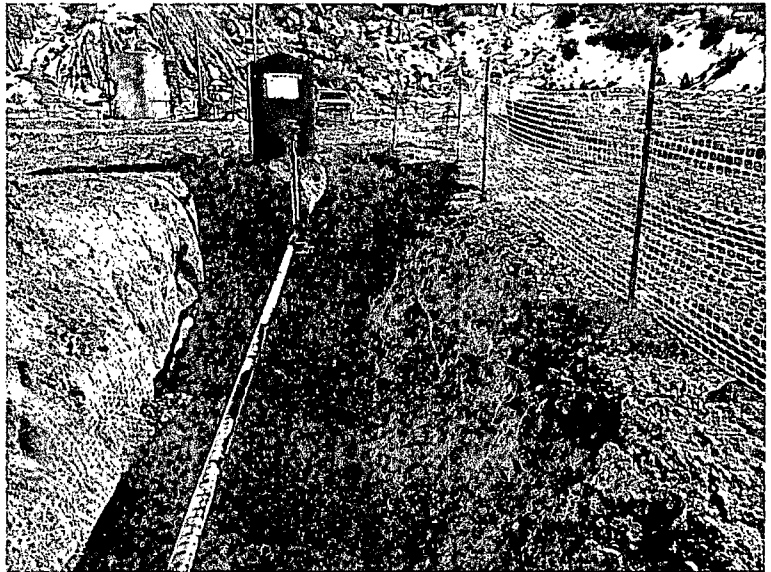
Photograph 5

View of the final excavation at the completion of corrective action activities, facing southeast.
