**Soil C-141 & Work plan  
Gallegos #2**

**CORRECTIVE ACTION REPORT AND SITE INVESTIGATION WORK PLAN**

**Gallegos #2 Well Tie Pipeline Release (9/18/2014)  
NE 1/4, S29 T26N R11W  
San Juan County, New Mexico**

December 2, 2014  
Apex Project No. 7030414G035

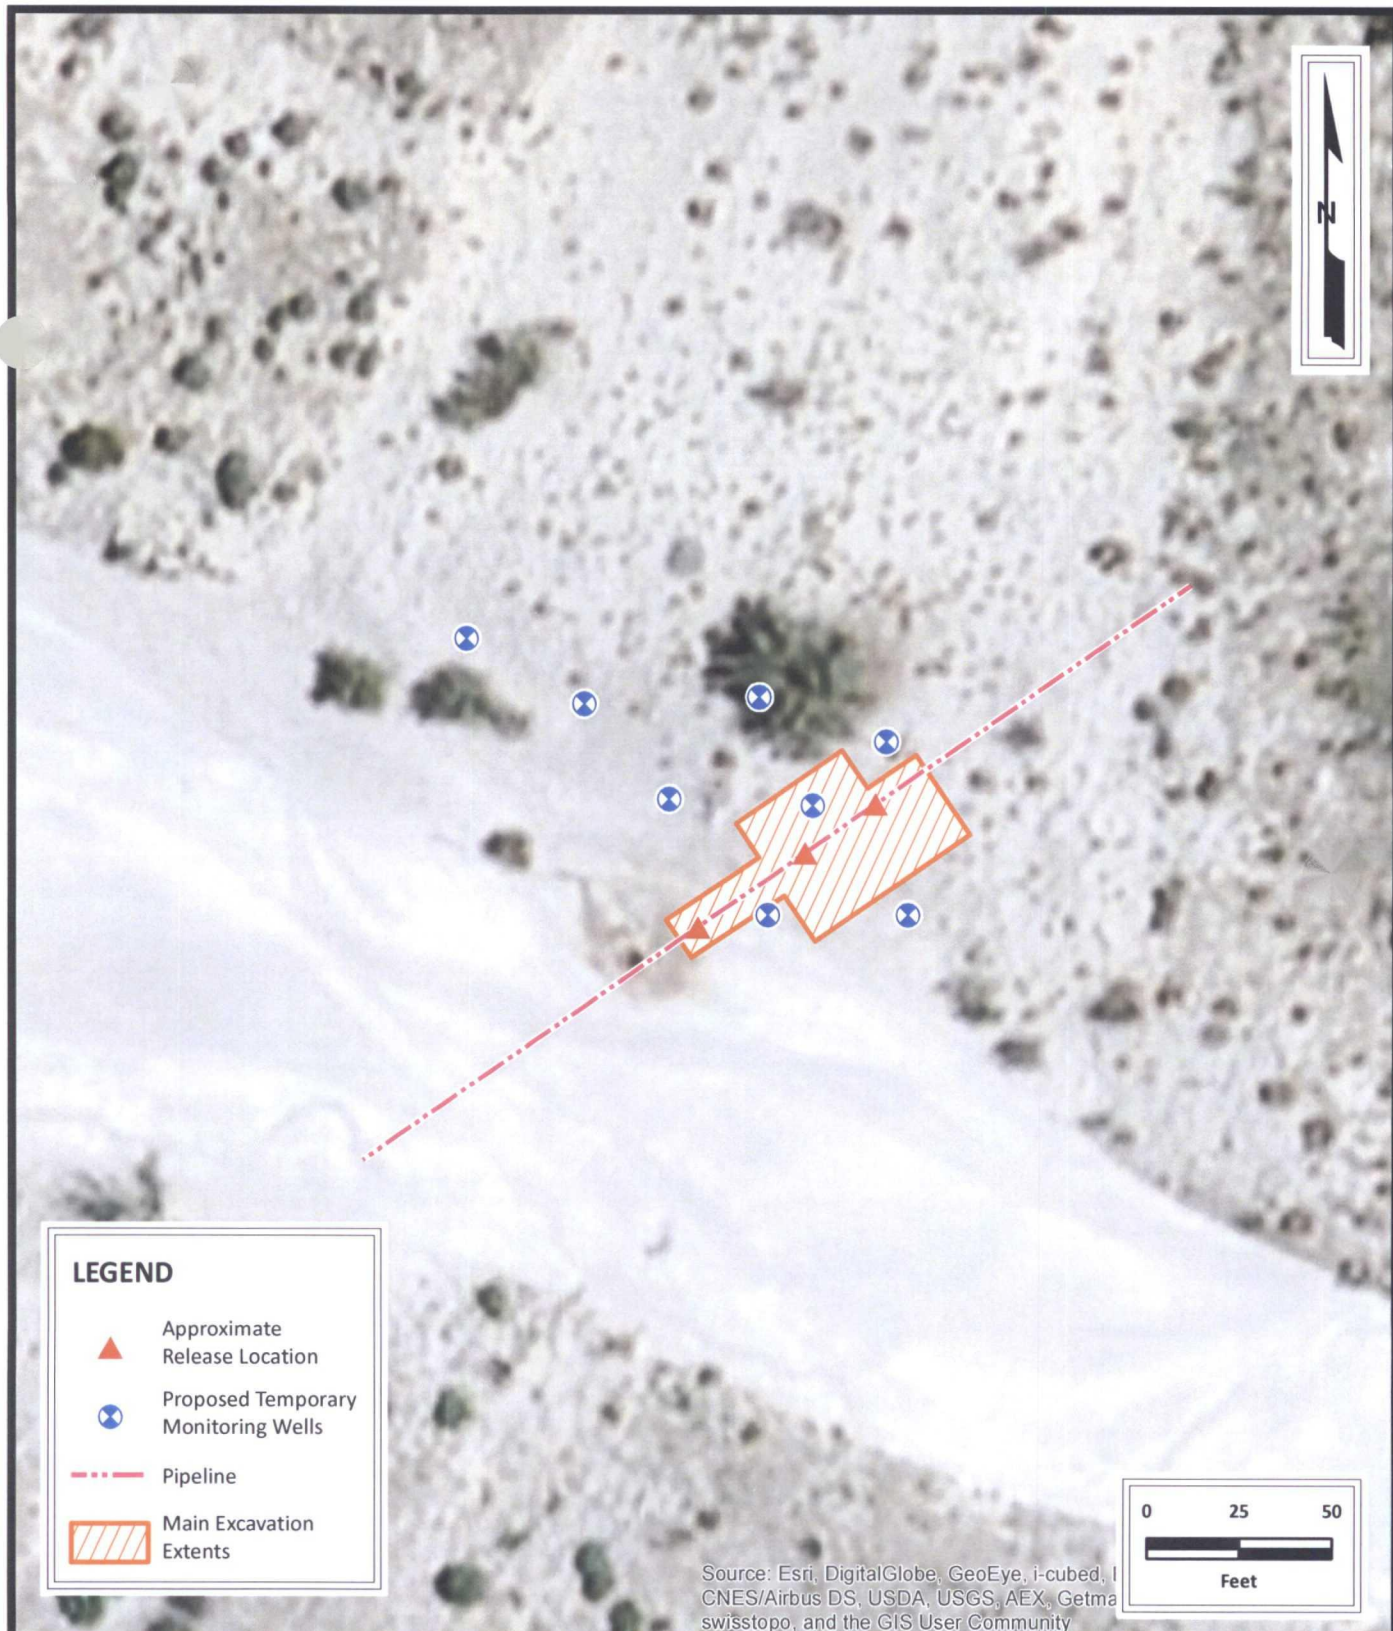
Figure 3.dwg

Figure 3 is a site map that indicates the approximate location of the final excavated area in relation to pertinent land features (Appendix A). Photographic documentation of the field activities is included in Appendix C.

Apex's soil sampling program included the collection of sixteen (16) confirmation samples (C-1 through C-16) from the resulting excavation for laboratory analysis. Additionally, twelve (12) composite samples (SP-1 through SP-12) were collected from the remaining unaffected stockpiled soils to determine the potential to reuse these soils as excavation backfill. Figure 3 depicts the approximate location of the excavated areas and shows the final confirmation sample locations in relation to the final excavation dimensions (Appendix A).

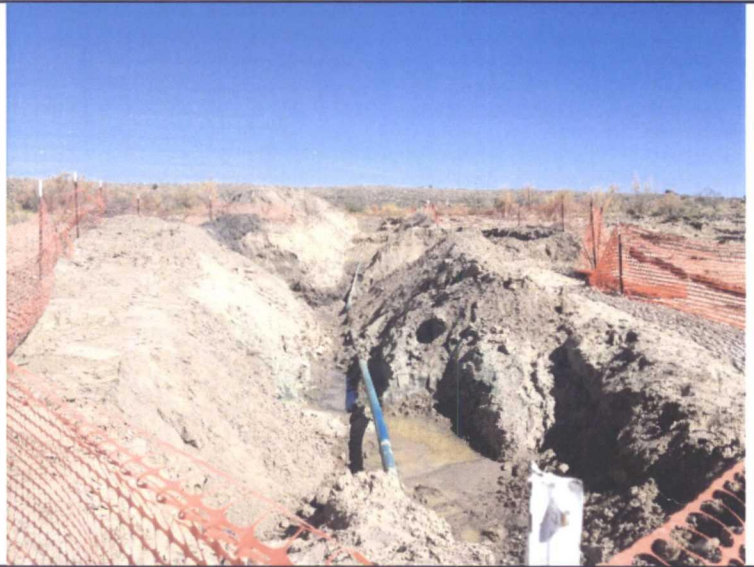
### Photograph 1

View of the excavation facing north-east.

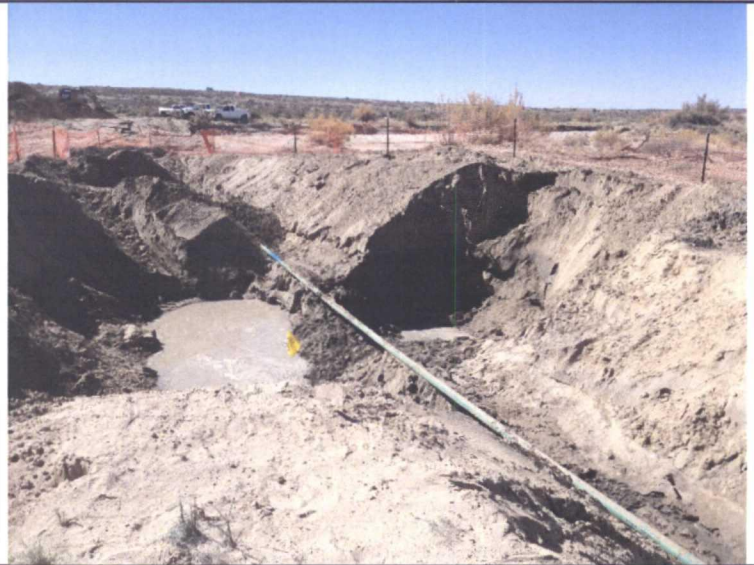
### Photograph 2

View of the hydrocarbon affected release excavation facing southwest.

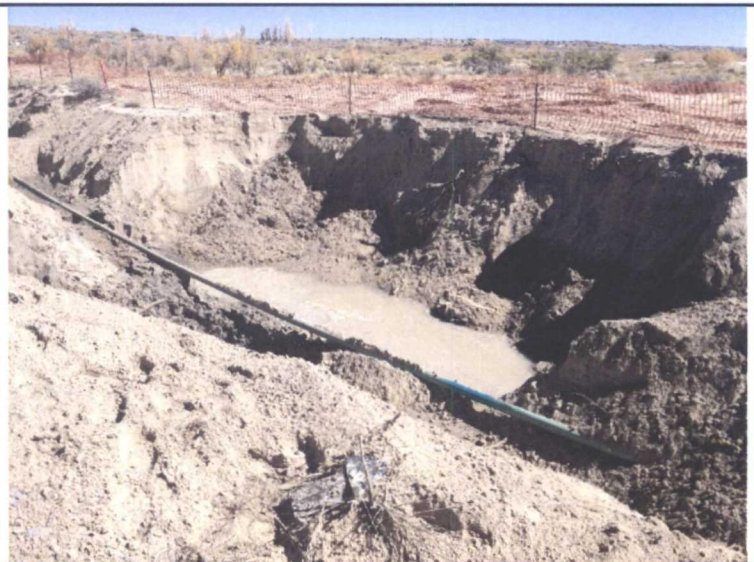
### Photograph 3

View of the hydrocarbon affected release excavation facing east.

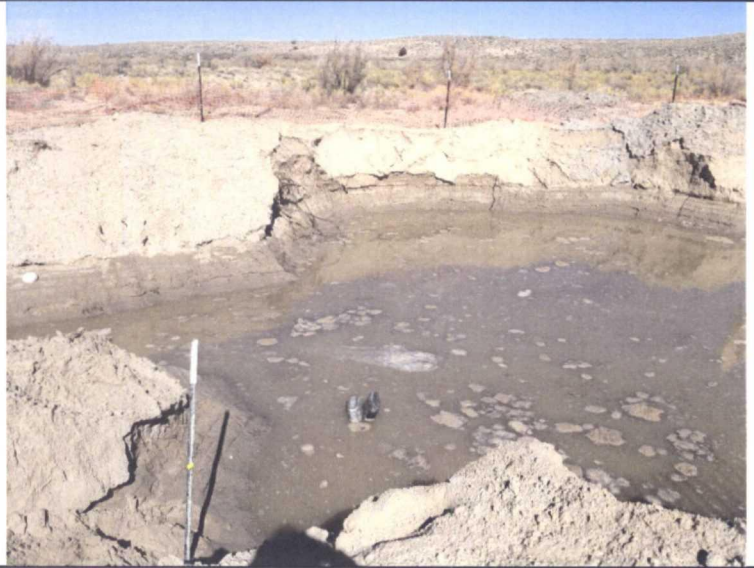
**Photograph 4**

View of the hydrocarbon affected release excavation facing northwest.
