**Release Report/ General
Correspondence**

Enterprise RA

Release Notification and Corrective Action

Lateral K-31 (Jan 2015)
Pipeline Release
 NW1/4 Sec16 T25N R6W
 Rural Rio Arriba County, New Mexico
 36.4035806N, 107.4775972W

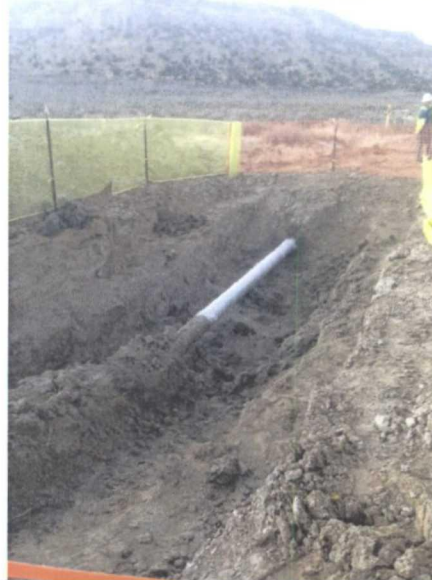
Photograph 1

View of the final excavation, facing northwest

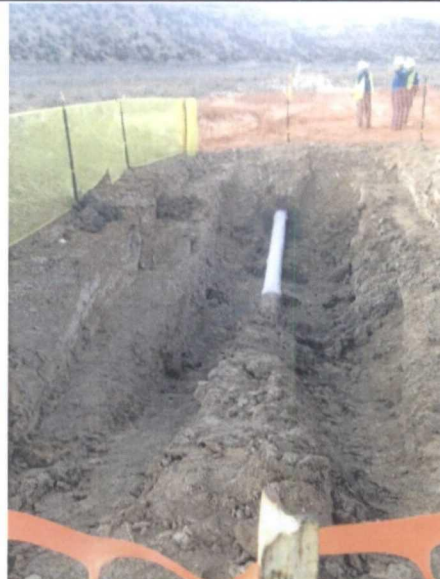
Photograph 2

View of the final excavation, facing northwest.

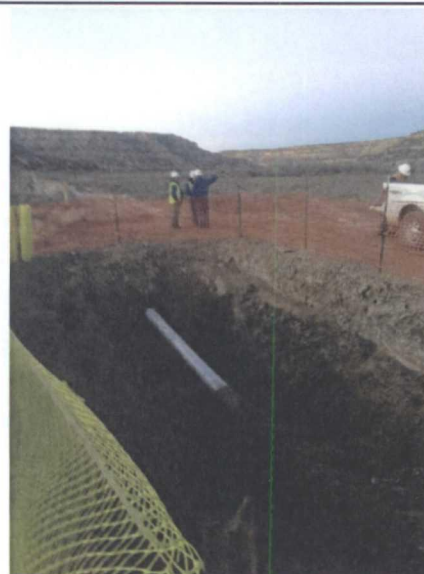
Photograph 3

View of the final excavation, facing north.

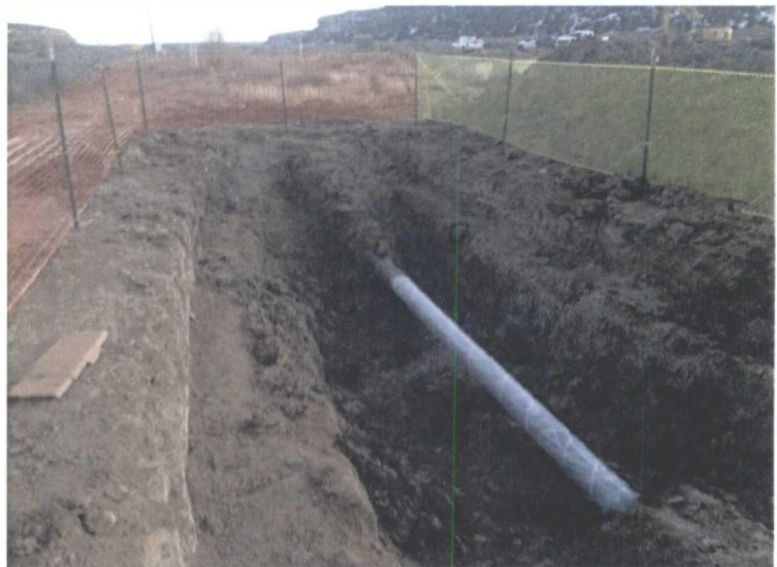
Photograph 5

View of the final excavation, facing southwest.

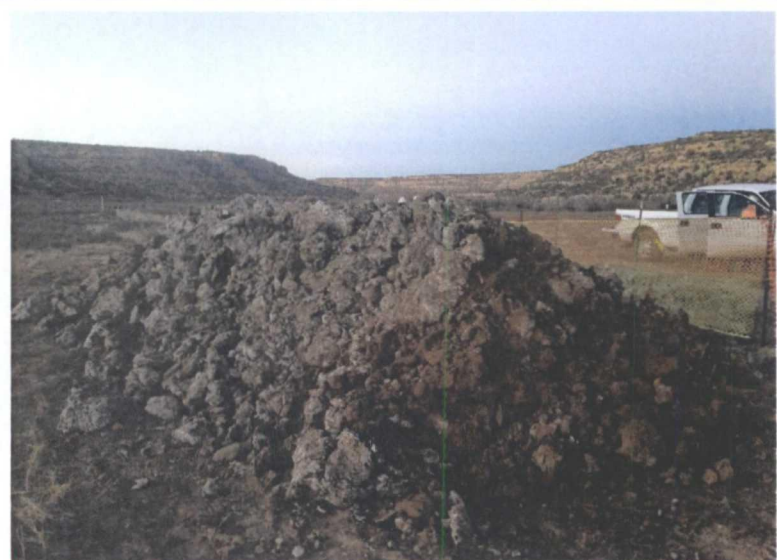
Photograph 6

View of stockpile, facing north.

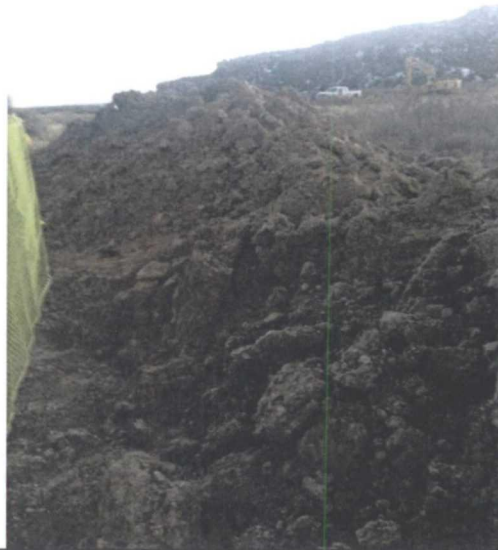
Photograph 7

View of stockpile, facing southwest.

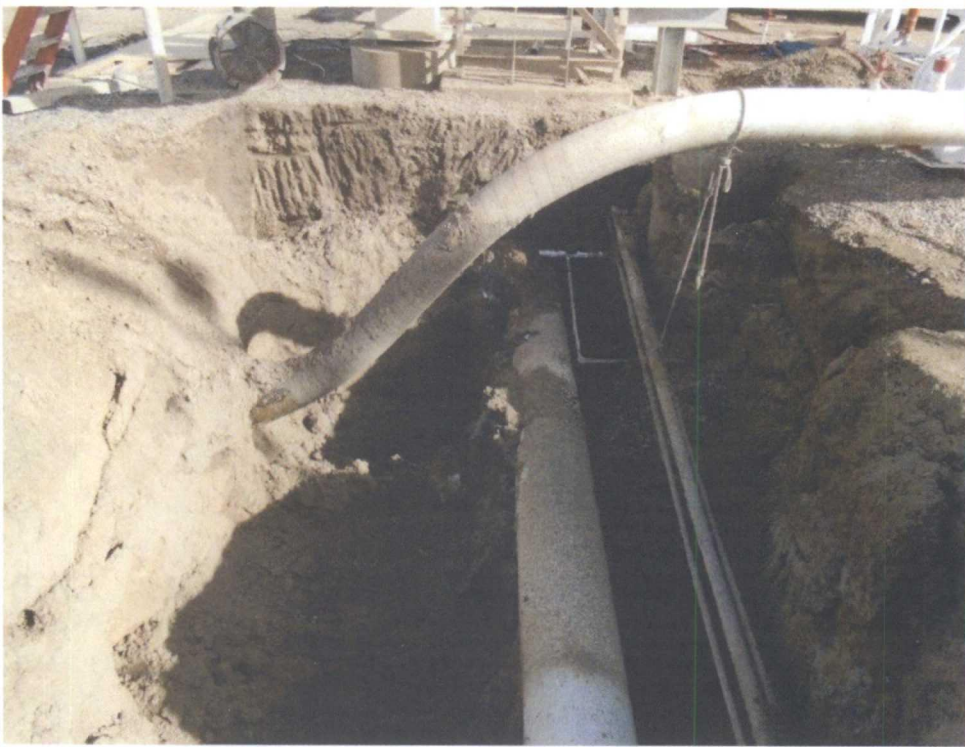
Photograph #1

Client: Enterprise Products	
Site Name: Lybrook Pump Station	
Date Photo Taken: January 28, 2015	
Location: N36.23255, W107.54605 C-14-23N-07W Rio Arriba County, New Mexico	
Photo Taken by: Deborah Watson	Description: Excavation A, facing E, looking at excavation following removal of petroleum impacted soils discovered while searching for the release location. Excavation measured approximately 19 feet x 12.5 feet x 6 (to 8) feet in depth.

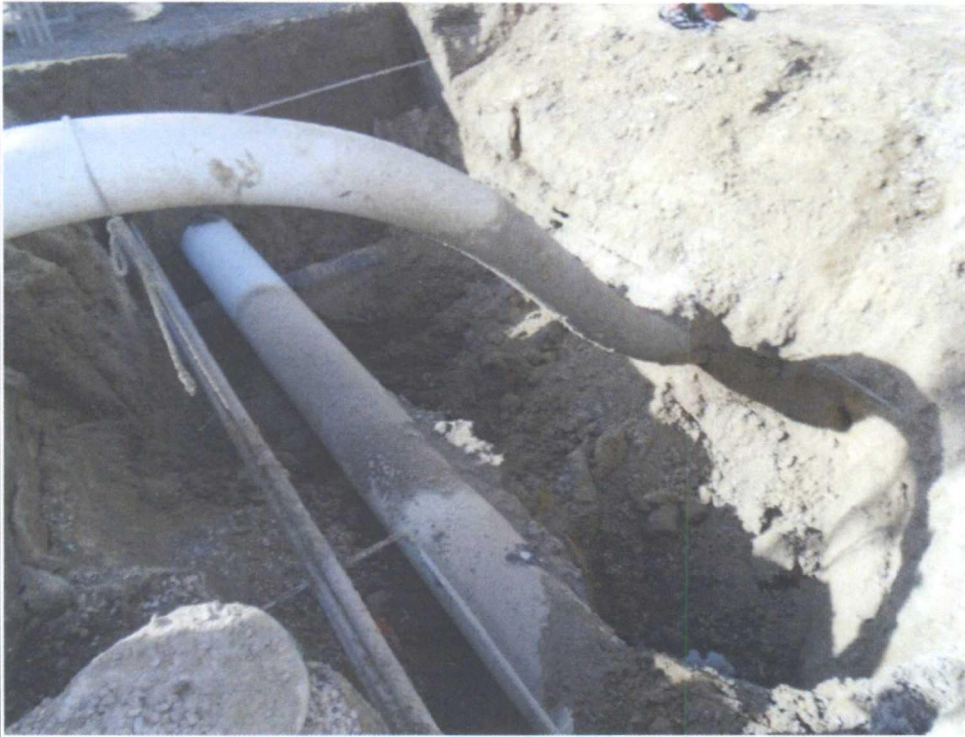
Photograph #2

Client: Enterprise Products	
Site Name: Lybrook Pump Station	
Date Photo Taken: January 28, 2015	
Location: N36.23255, W107.54605 C-14-23N-07W Rio Arriba County, New Mexico	
Photo Taken by: Deborah Watson	Description: Excavation A, facing WNW, looking at excavation following remediation on January 28, 2015.

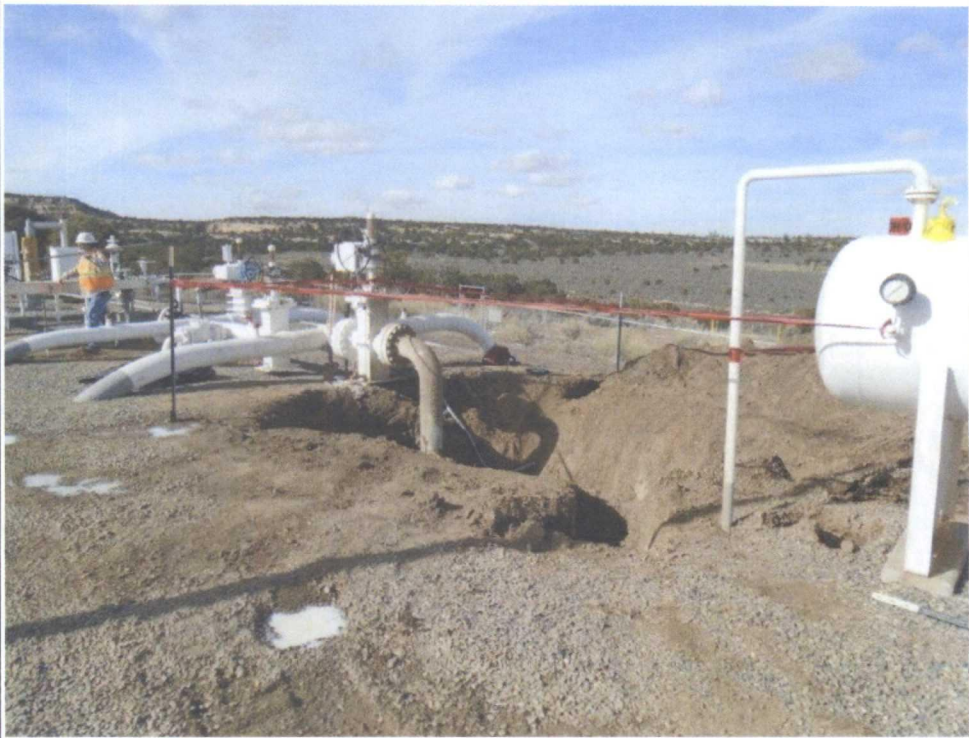
Photograph #4

Client: Enterprise Products	
Site Name: Lybrook Pump Station	
Date Photo Taken: January 28, 2015	
Location: N36.23255, W107.54605 C-14-23N-07W Rio Arriba County, New Mexico	
Photo Taken by: Deborah Watson	Description: Excavation B, facing NW, looking at excavation following remediation on January 28, 2015.

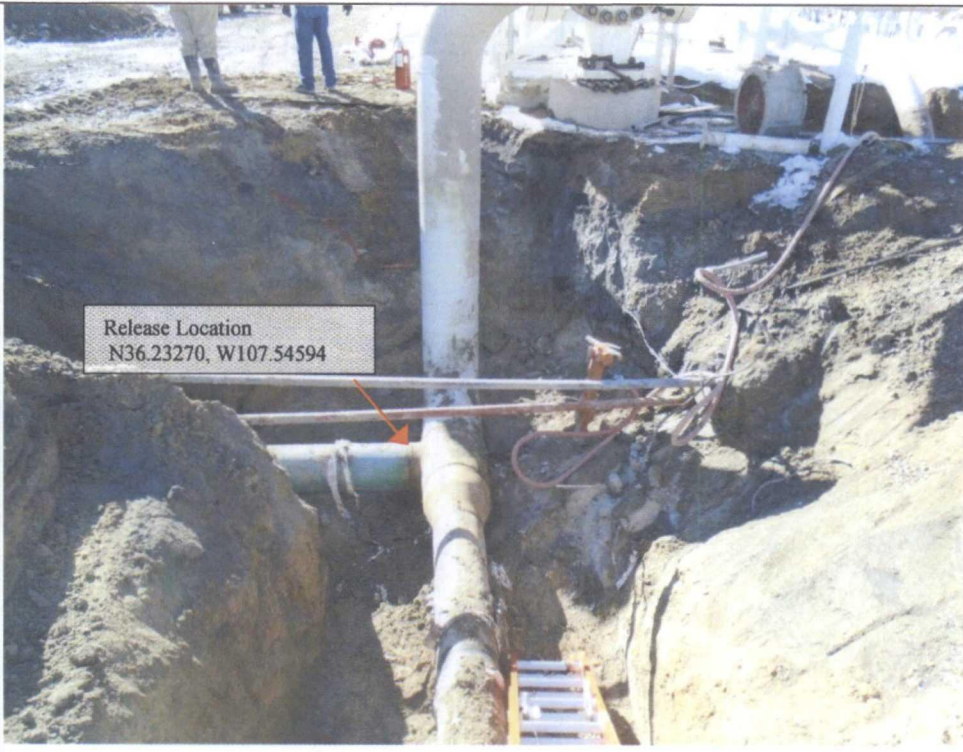
Photograph #5

Client: Enterprise Products	
Site Name: Lybrook Pump Station	
Date Photo Taken: February 4, 2015	
Location: N36.23255, W107.54605 C-14-23N-07W Rio Arriba County, New Mexico	
Photo Taken by: Deborah Watson	Description: Excavation C, facing S, looking at release point along a T-connection between the 18-inch and 12-inch pipeline. Final area of excavation measured 21 feet x 14 feet x 8 feet in depth.

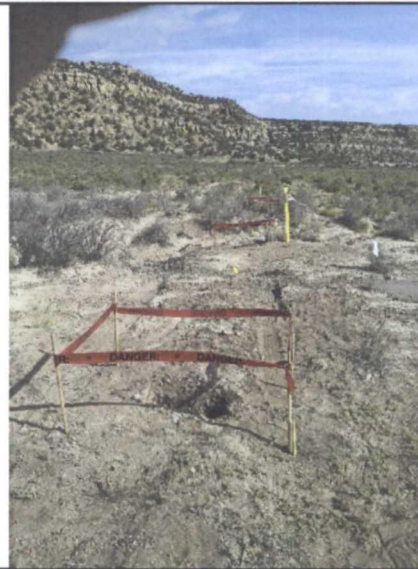
Photograph 1

View of site prior to excavation activities, facing northwest.

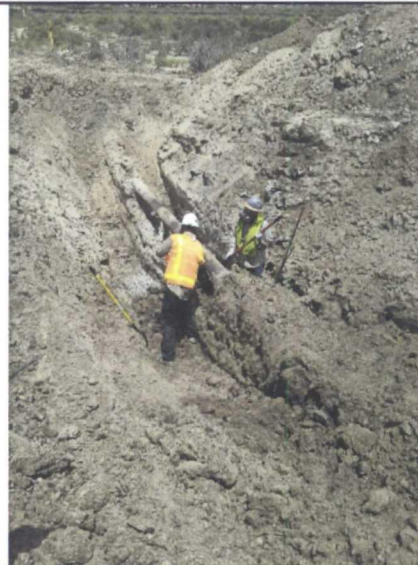
Photograph 2

View of partially completed excavation during corrective action activities, facing northeast.

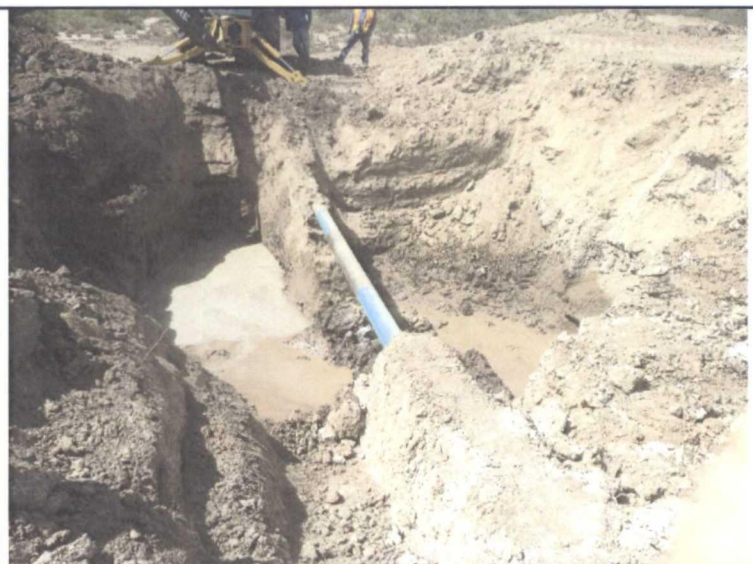
Photograph 3

View of partially completed excavation during corrective action activities, facing north.

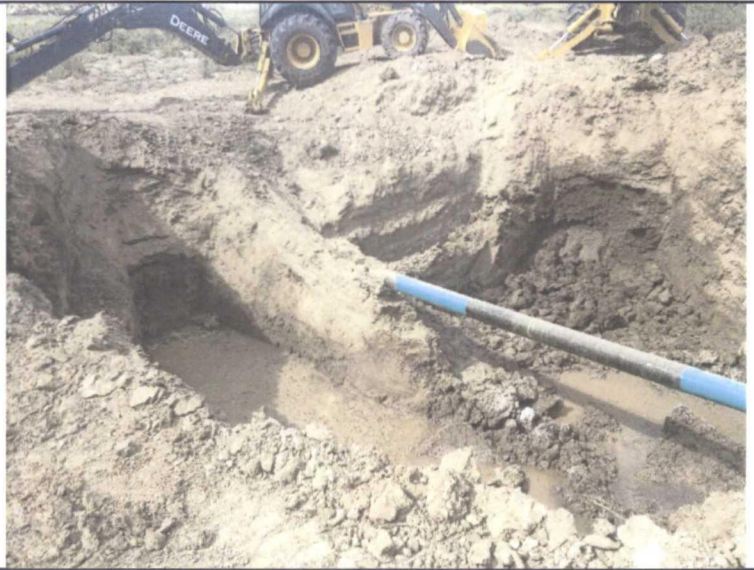
Photograph 4

View of partially completed excavation during corrective action activities following extension of east wall, facing northeast.

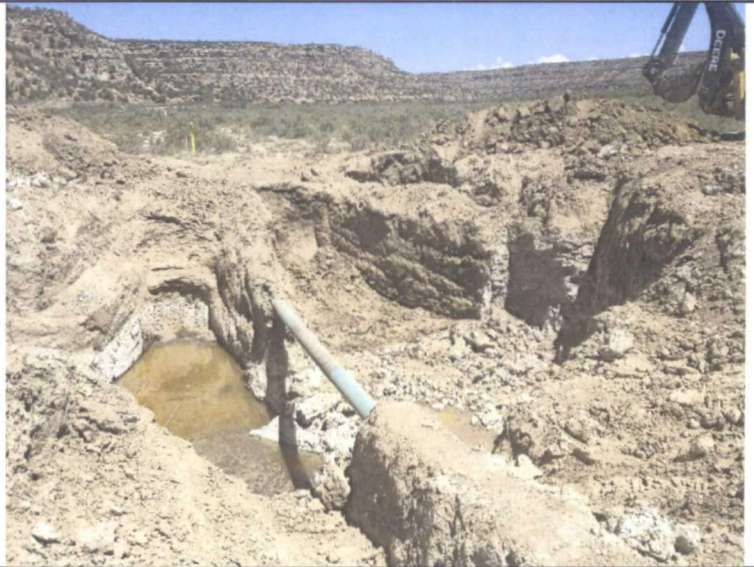
Photograph 5

View of the final excavation at the completion of corrective action activities, facing north.

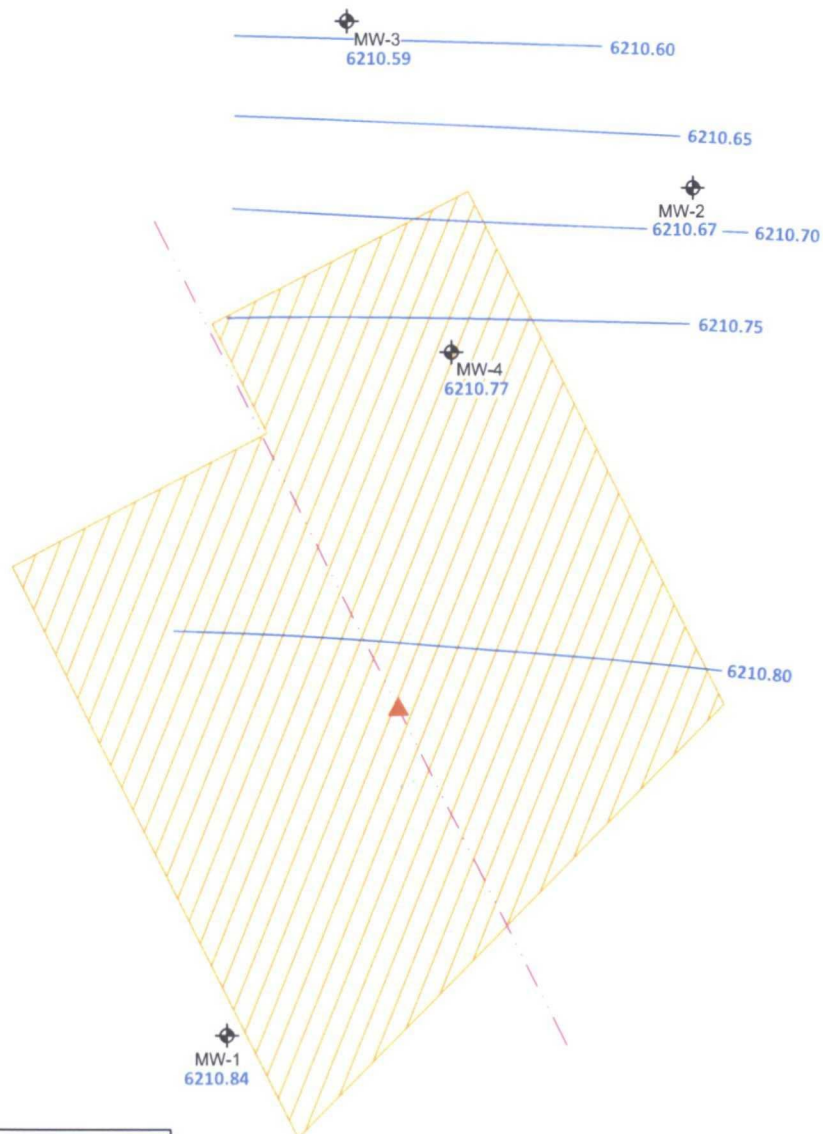
FIGURE 4
Groundwater Gradient Map
March 3, 2015

- PIPELINE
- ⊕ MONITORING WELL LOCATION
- ▲ RELEASE POINT
- ▨ EXTENT OF FORMER EXCAVATION
- 6210.84 GROUNDWATER ELEVATION (FEET AMSL)
- 6210.80 GROUNDWATER ELEVATION CONTOUR (FEET AMSL)
