Quantum Resources

Artesia Unit #007

CLOSURE REPORT

API No. 30-015-10080

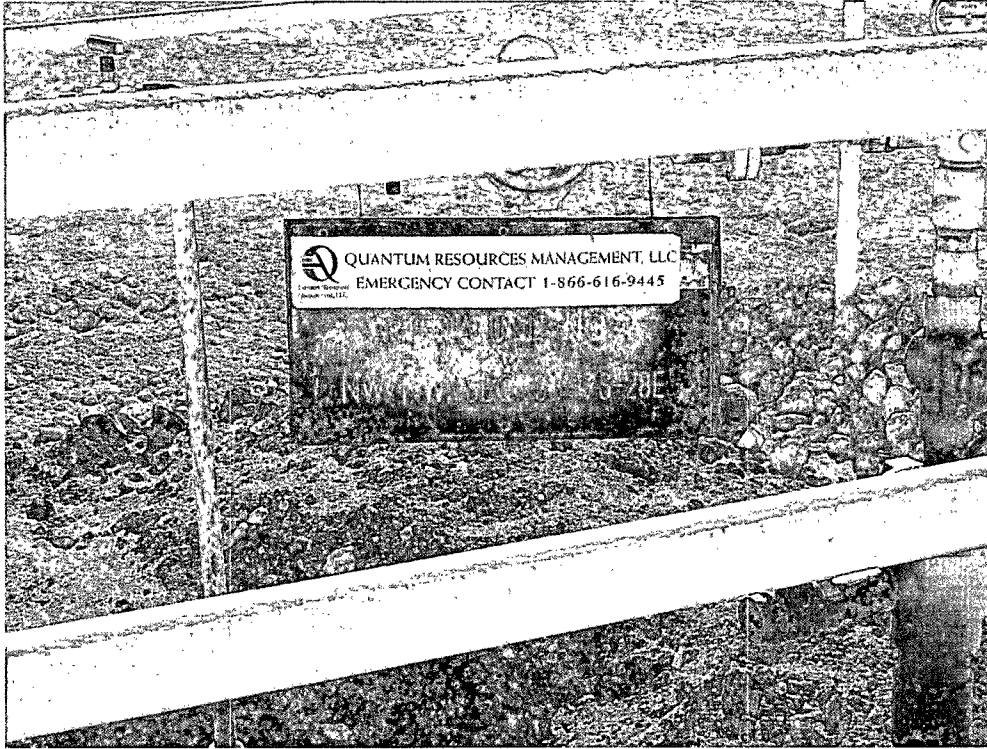
Sign marking location

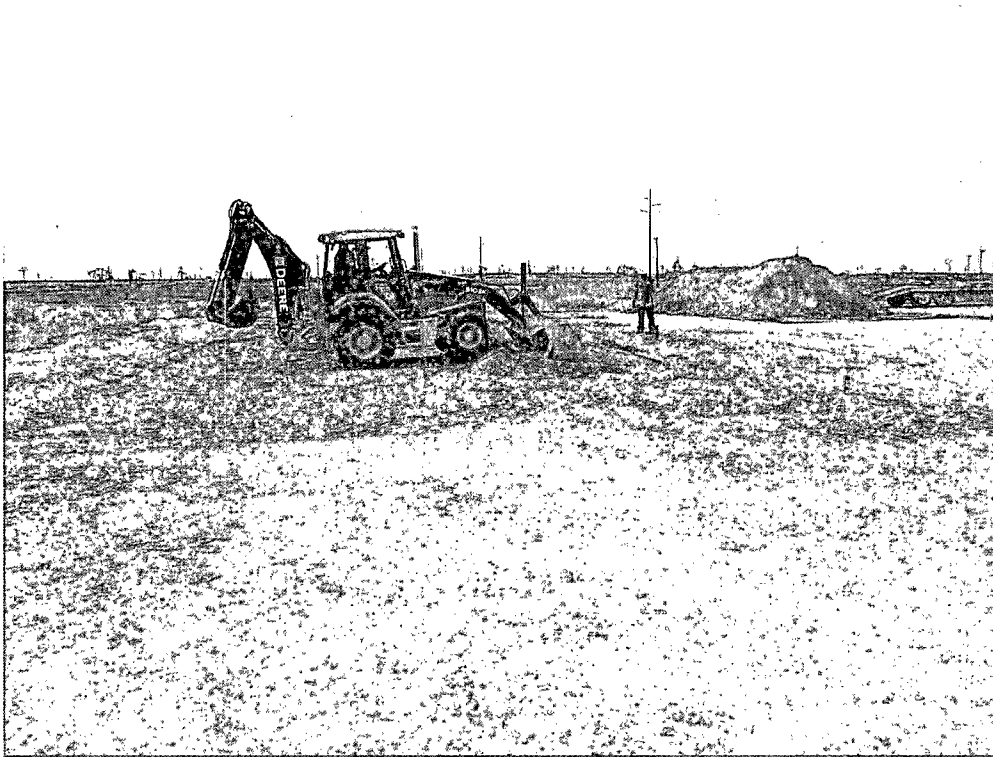
Excavation of spill area 3/04/14

Simultaneous soil field testing to 1ft. bgs revealed low chloride and hydrocarbon levels at 1 ft. below ground surface (bgs) (Figure). Soil samples were collected from the excavation floor and submitted to a laboratory for confirmation (Appendix IV). Chlorides were significantly reduced to levels of 32mg/kg to 144 mg/kg respectively. TPH totaled less than 10.0 mg/kg GRO and less than 10.0 mg/kg DRO, and BTEX totaled less than 0.300 mg/kg in all samples. Photographs of site activities can be viewed in Appendix II.
