Reference: Occidental Permian * Eeyore 34 St 1 * 30-015-39383 * A-34-17s-28e * Eddy County, New Mexico
NMOCD Tracking Number: 2RP-1405 * Date of release: 11/11/12

OXY Permian Eeyore 34 State #1 Closure Report

**Section 24, T17S, R28E
Eddy County, New Mexico**

March 8, 2013

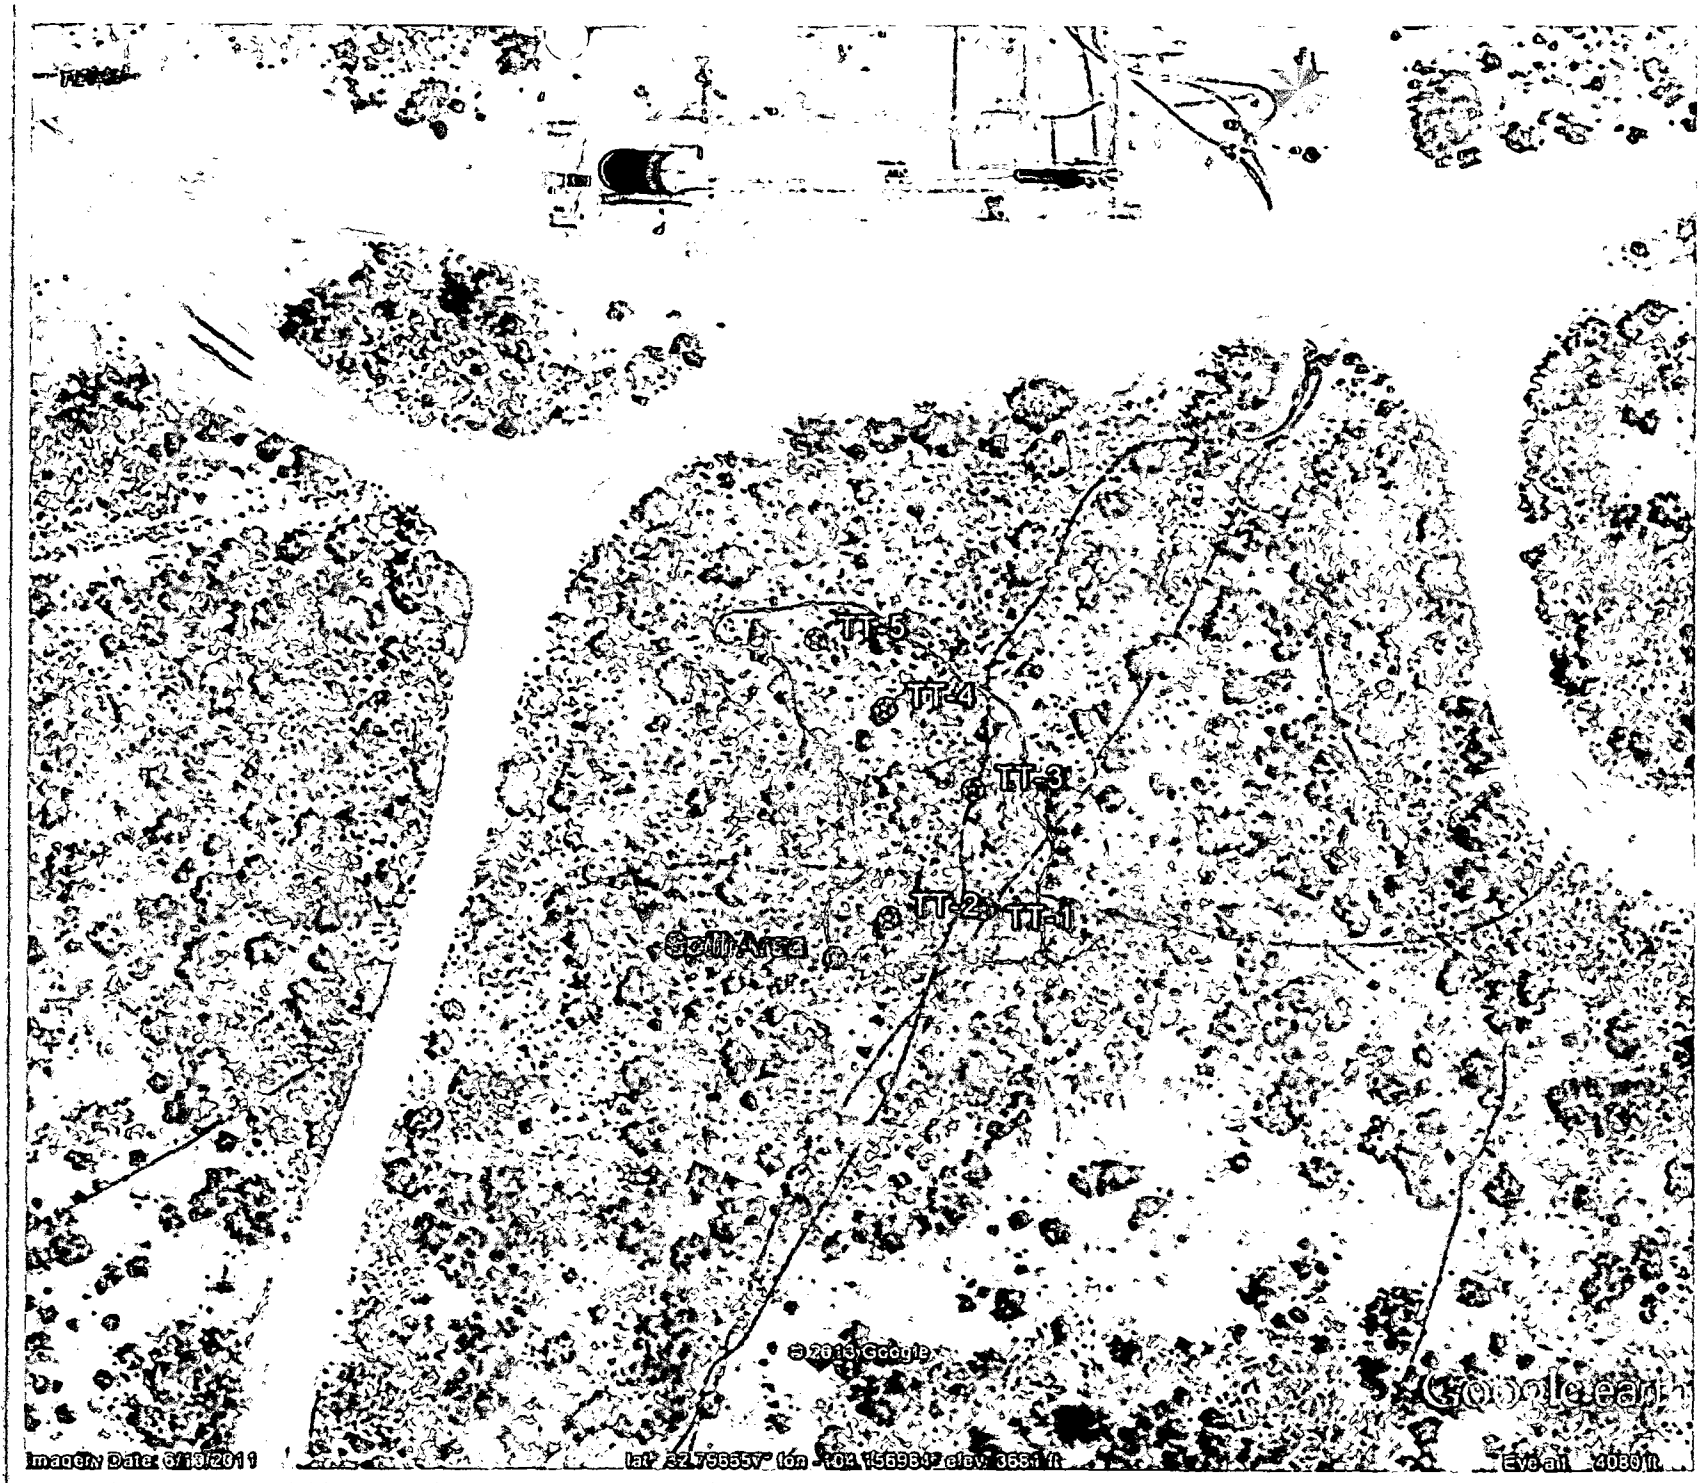
Figure 2 Site Plan

Please check the aerial map, in the proposal, with the spill outline. It is OCD's understanding that the release was confined to the well pad. The aerial map shows the release in the pasture to the south. Please advise.

The release area and test trench sample points were mapped using the Trimble Juno 3D and site photos were taken.

The most highly contaminated and/or saturated soils were excavated, which in this case, TT 1-3 area be excavated to a depth of 1.5 ft. bgs; TT 4 area to a depth of 2.5 ft. bgs; and TT-5 area to a depth of 5 ft.

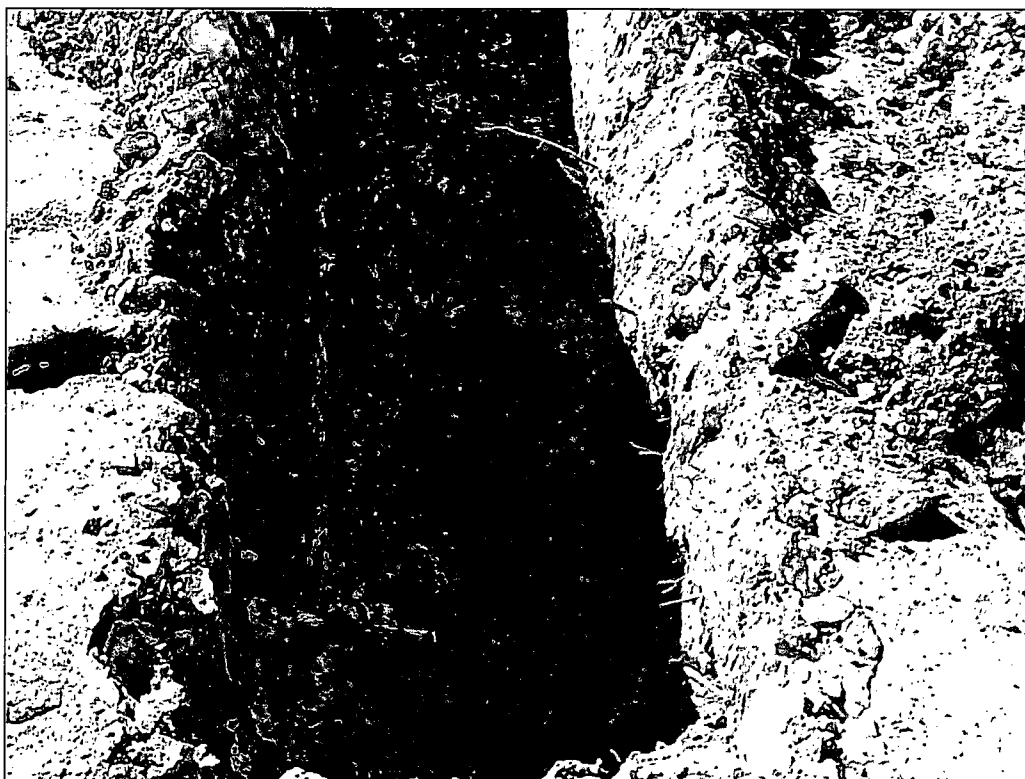
Test Trench # 2 (Facing West)

The results of the analysis indicate that the vertical extent of contamination was found in all test trenches at a depth of two (2) ft. bgs in TT 1-3, at three (3) ft. bgs in TT-4 and at six (6) ft. bgs in TT-5.

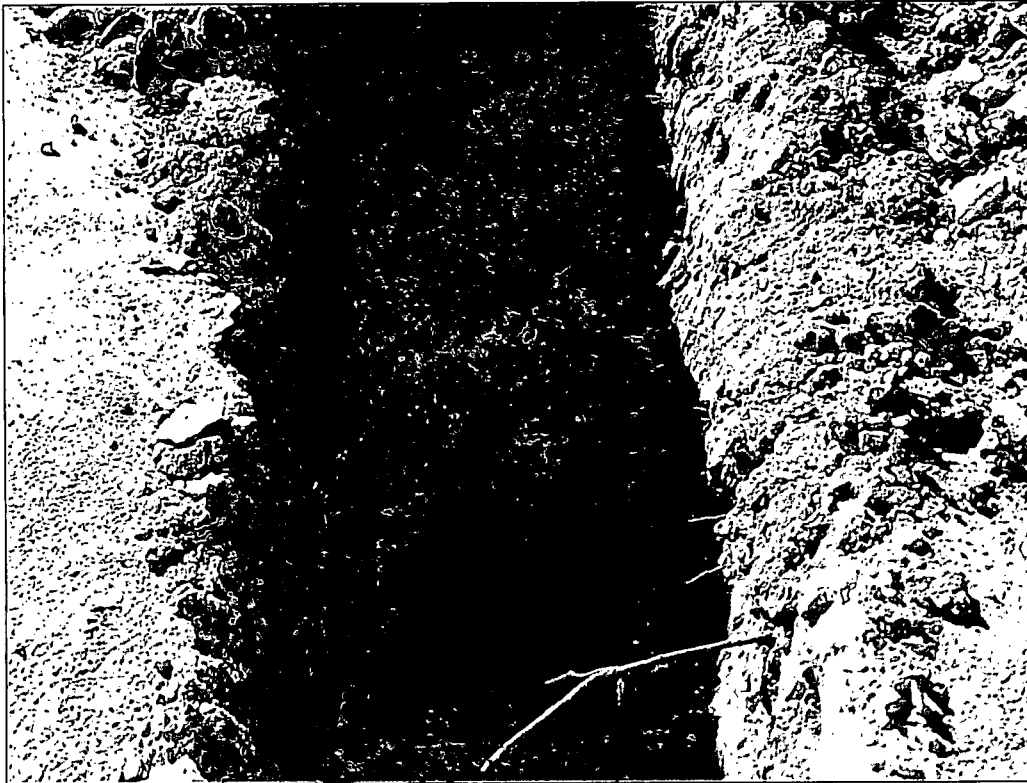
Test Trench # 3 (Facing West)

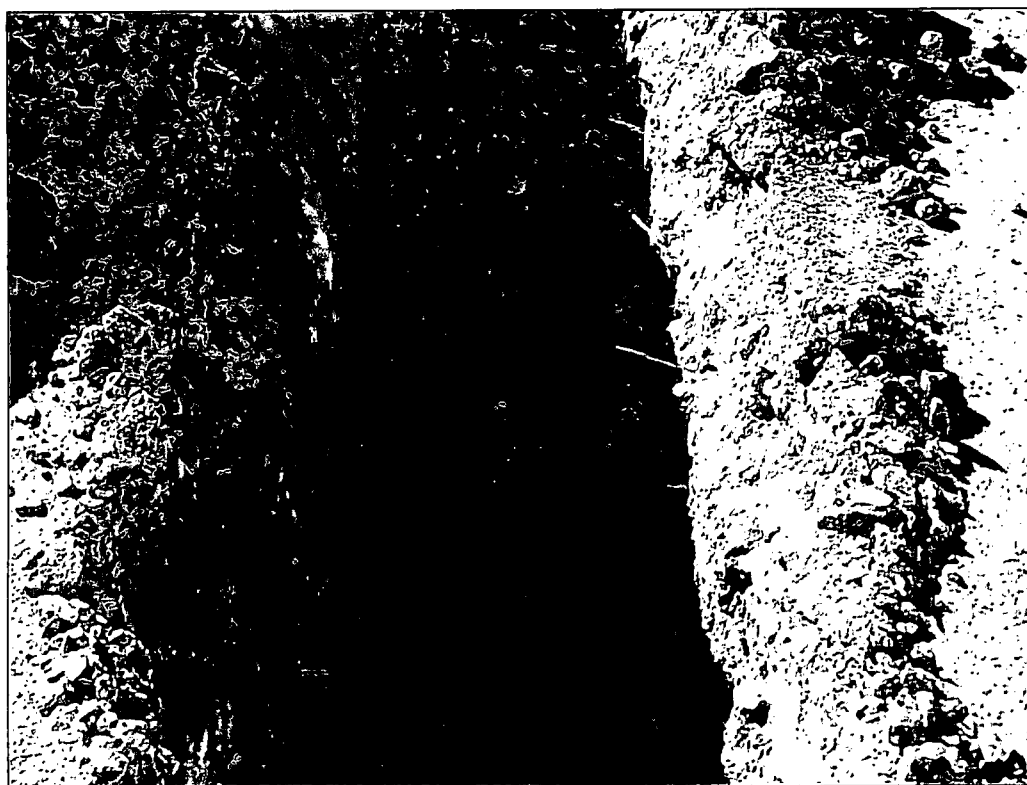
Test Trench # 4 (Facing West)

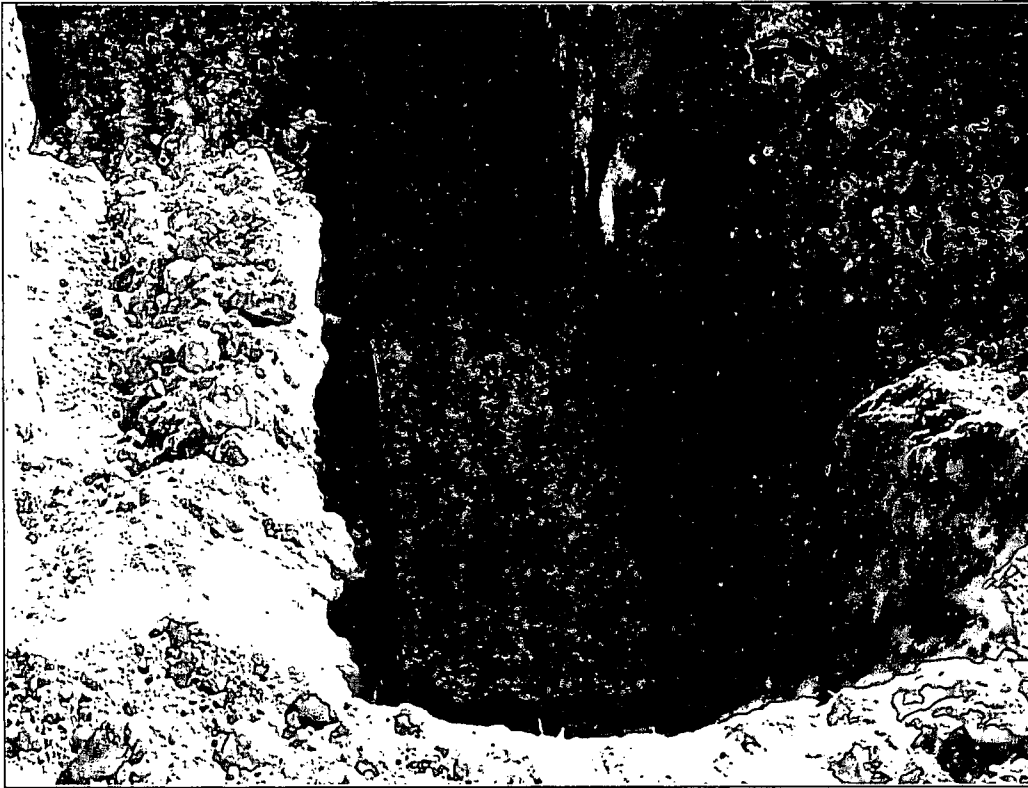
Test Trench # 5 (Facing South)

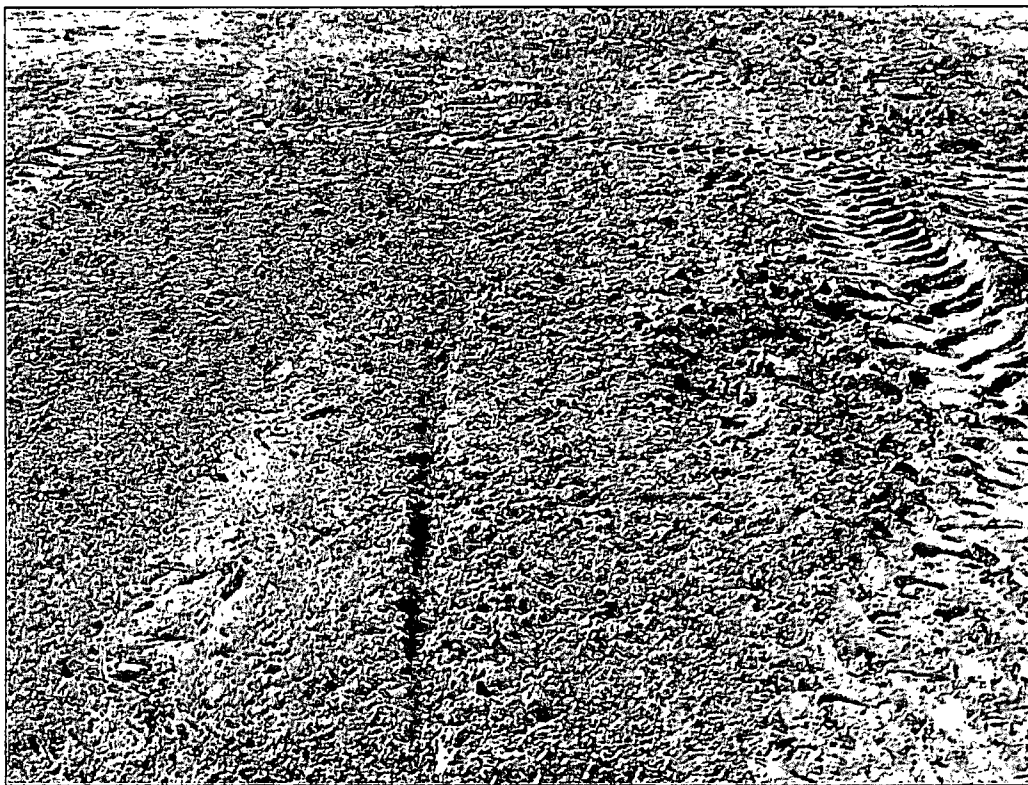
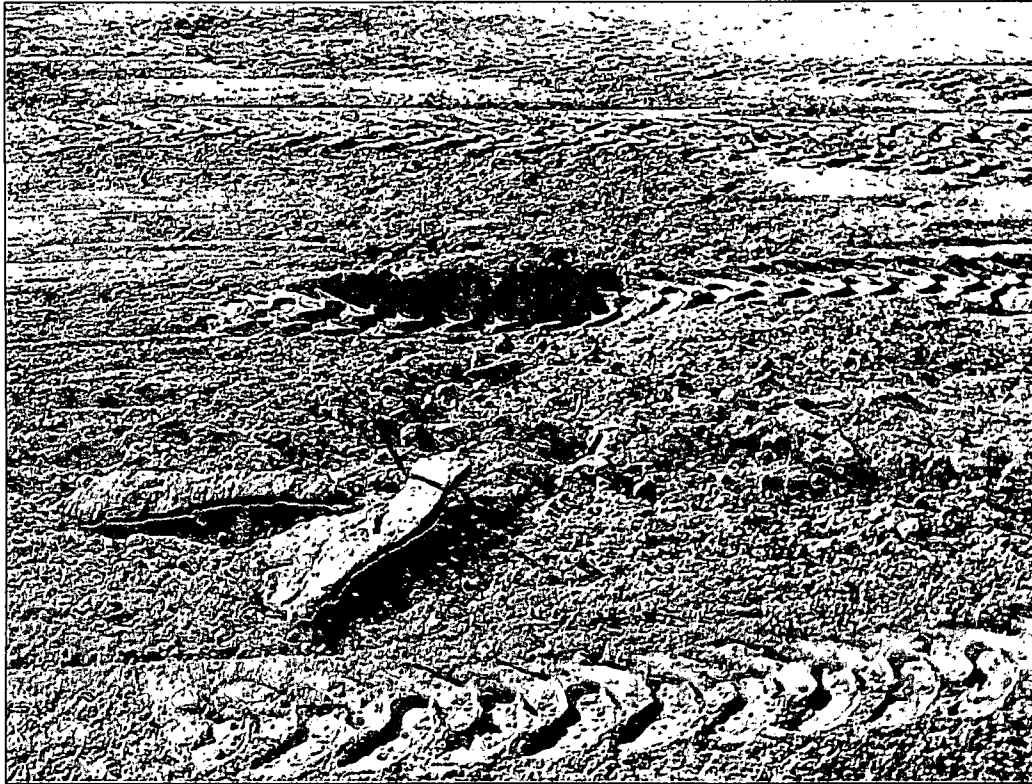
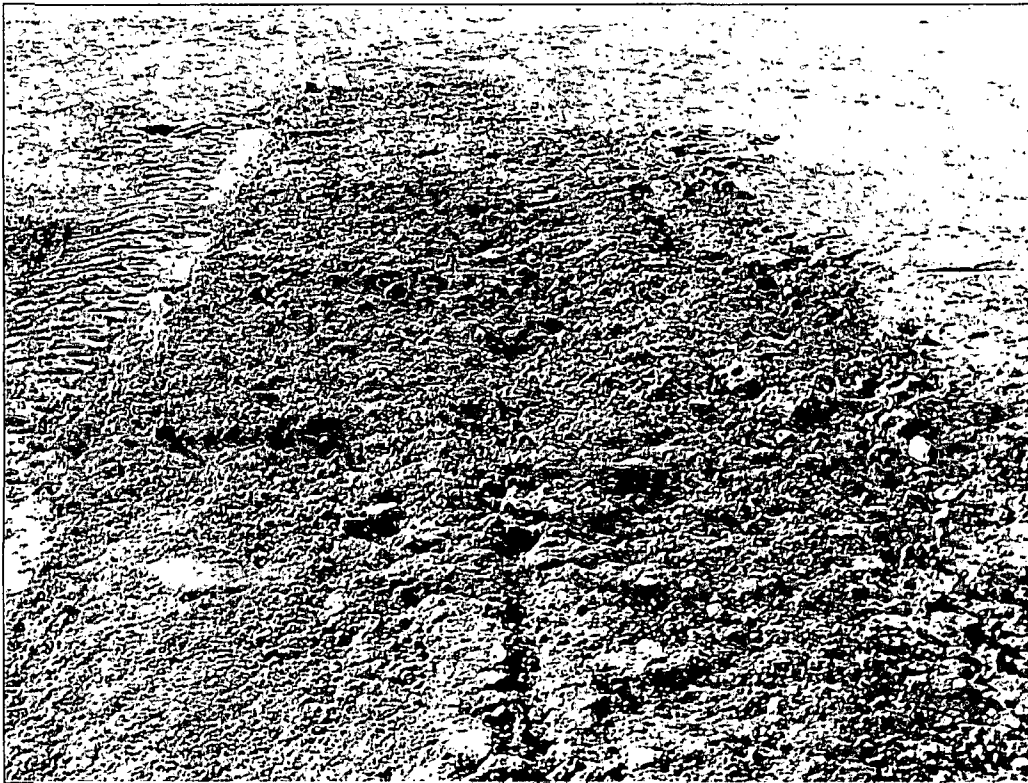
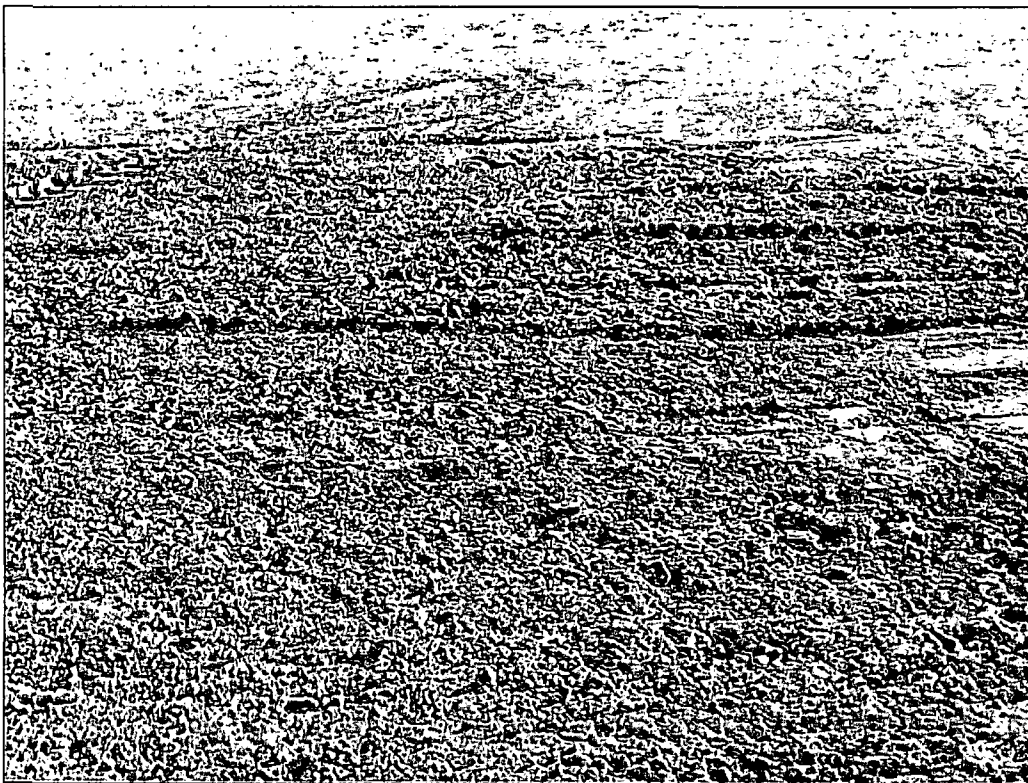
Test Trench # 1 Backfilled (Facing West)

Test Trench # 2 Backfilled (Facing West)

Test Trench # 3 Backfilled (Facing West)

Test Trench # 4 Backfilled (Facing West)

Test Trench # 5 Backfilled (Facing South)

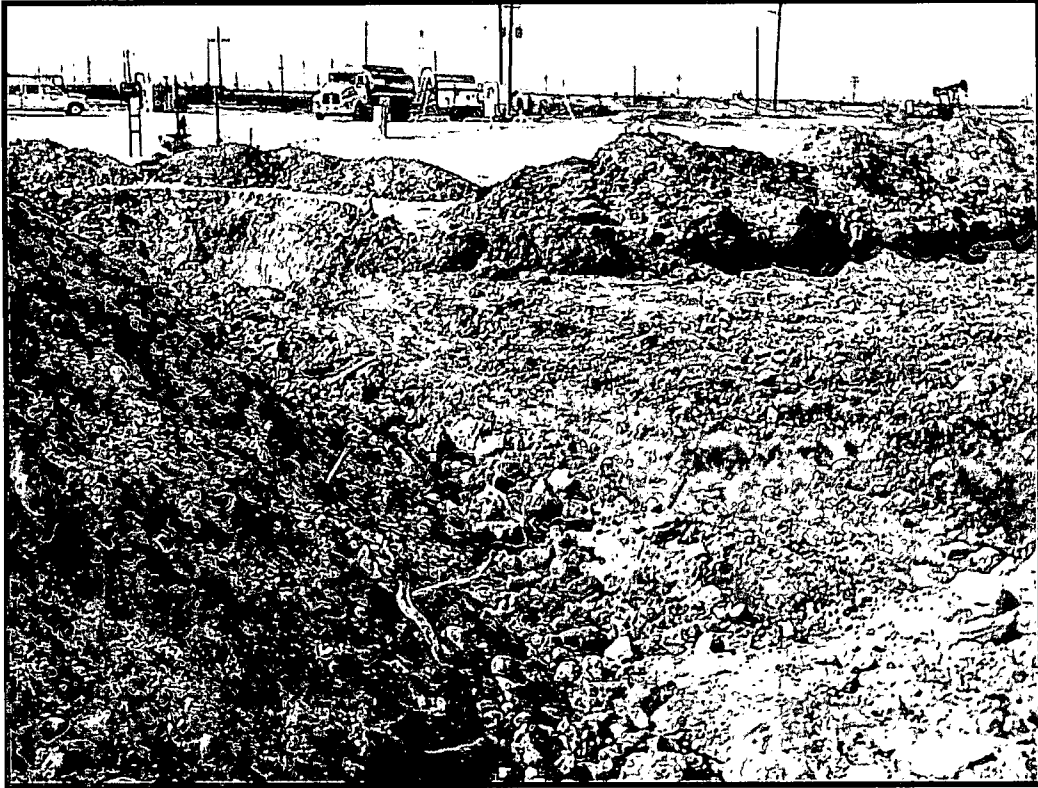
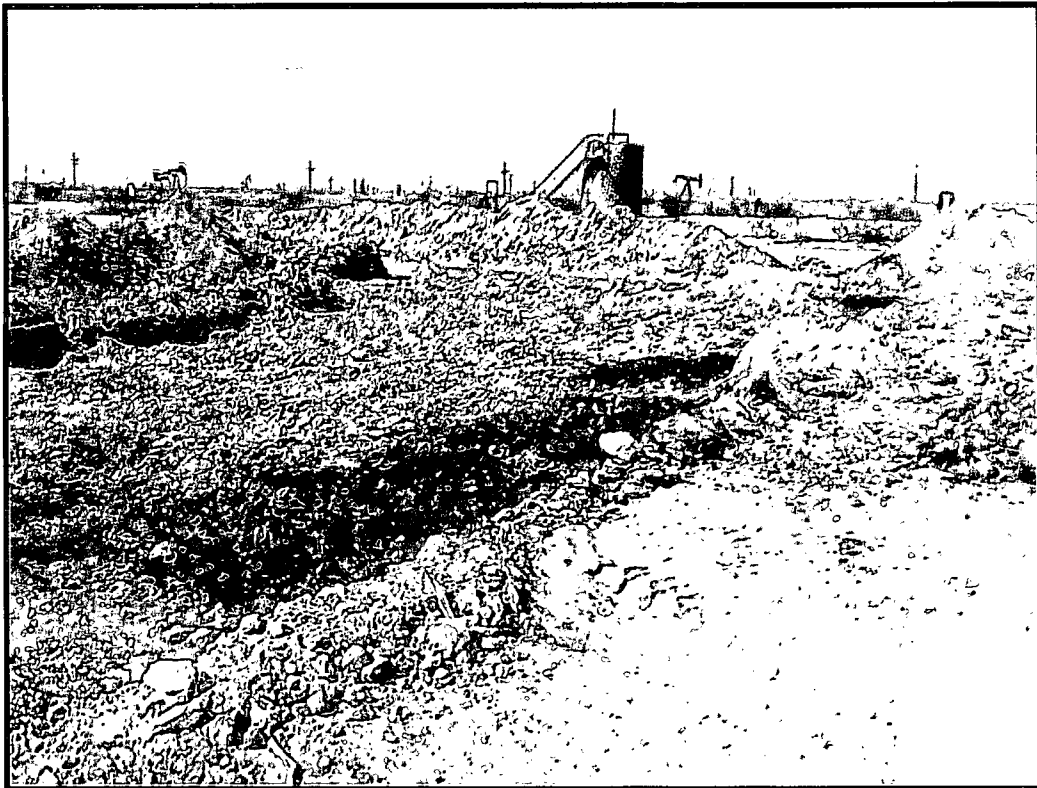
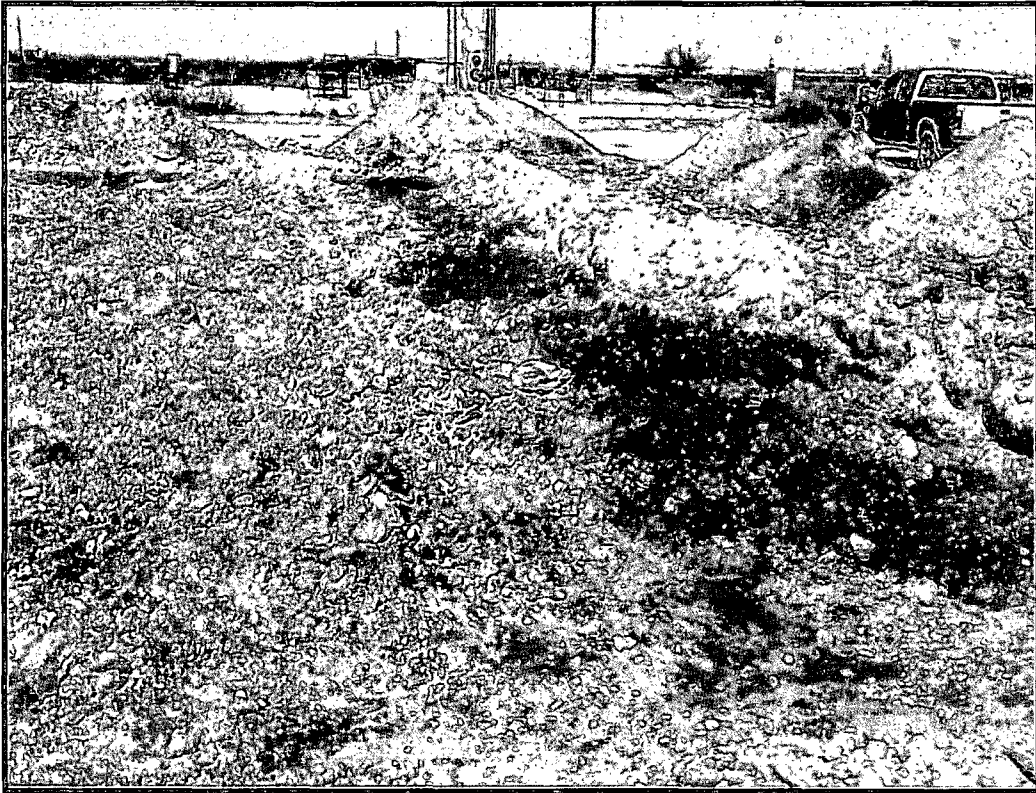
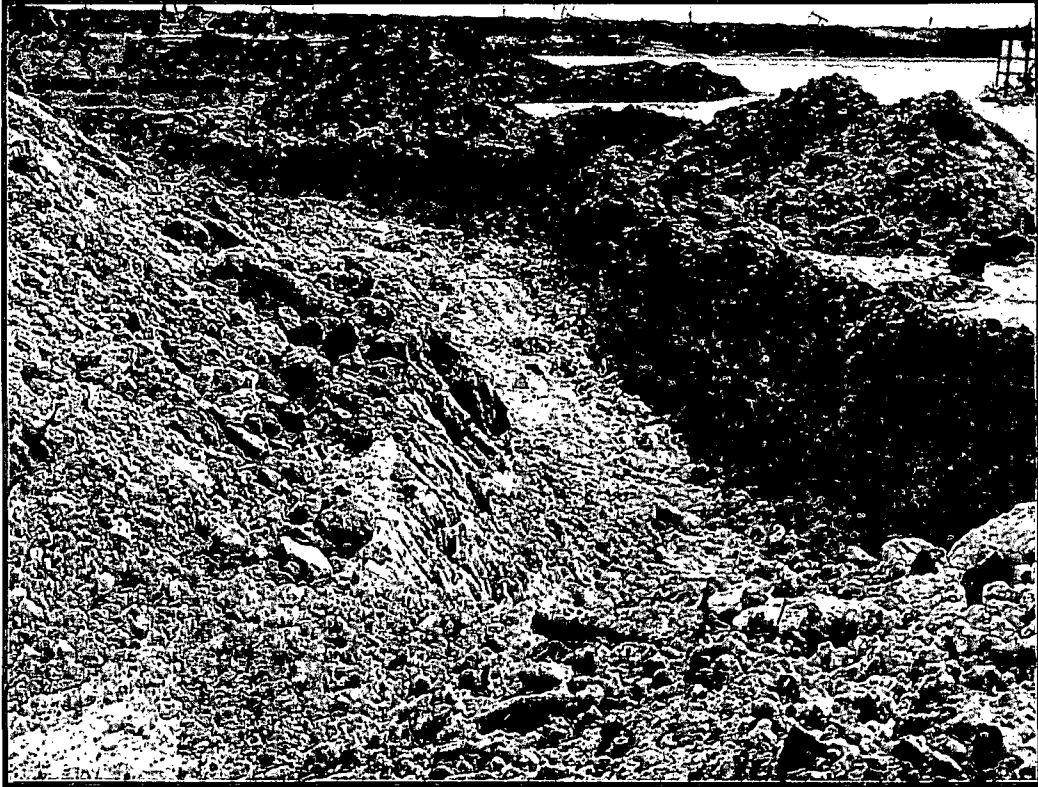
Excavation 1.5 ft. (Facing West)

Excavation 1.5 ft. (Facing Northwest)

Excavation 1.5 ft. (Facing North)

Excavation 1.5 ft. (Facing South)

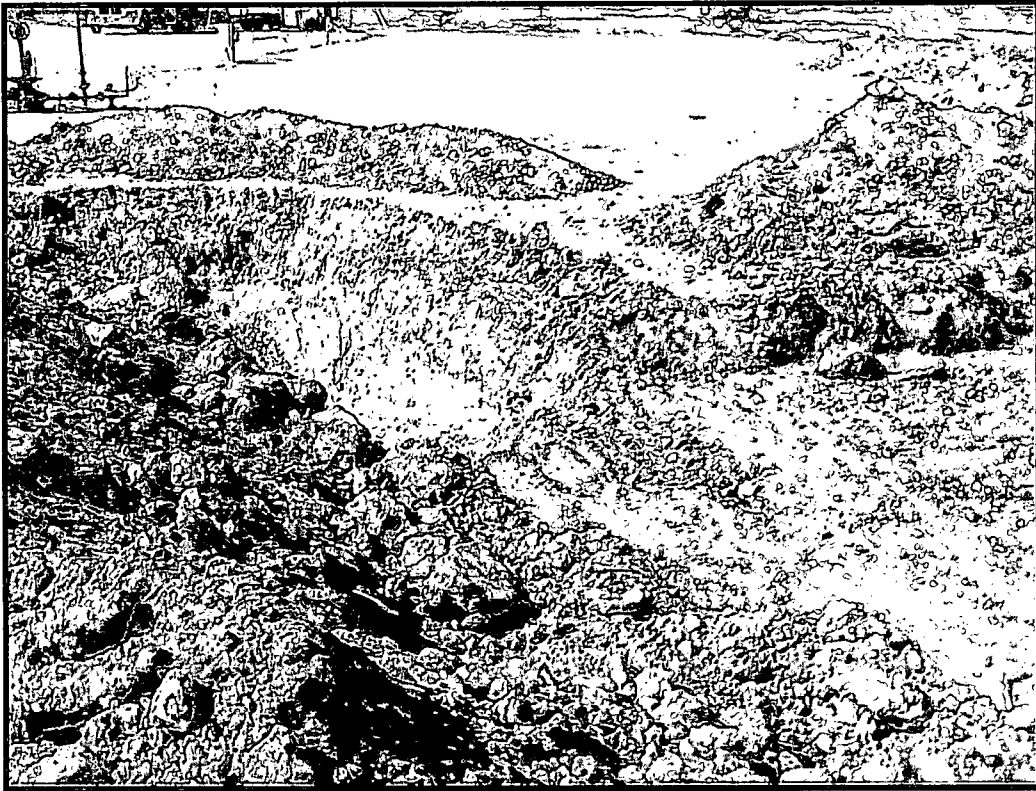
Excavation 5 ft. (Facing West)

Excavation 5 ft. (Facing East)

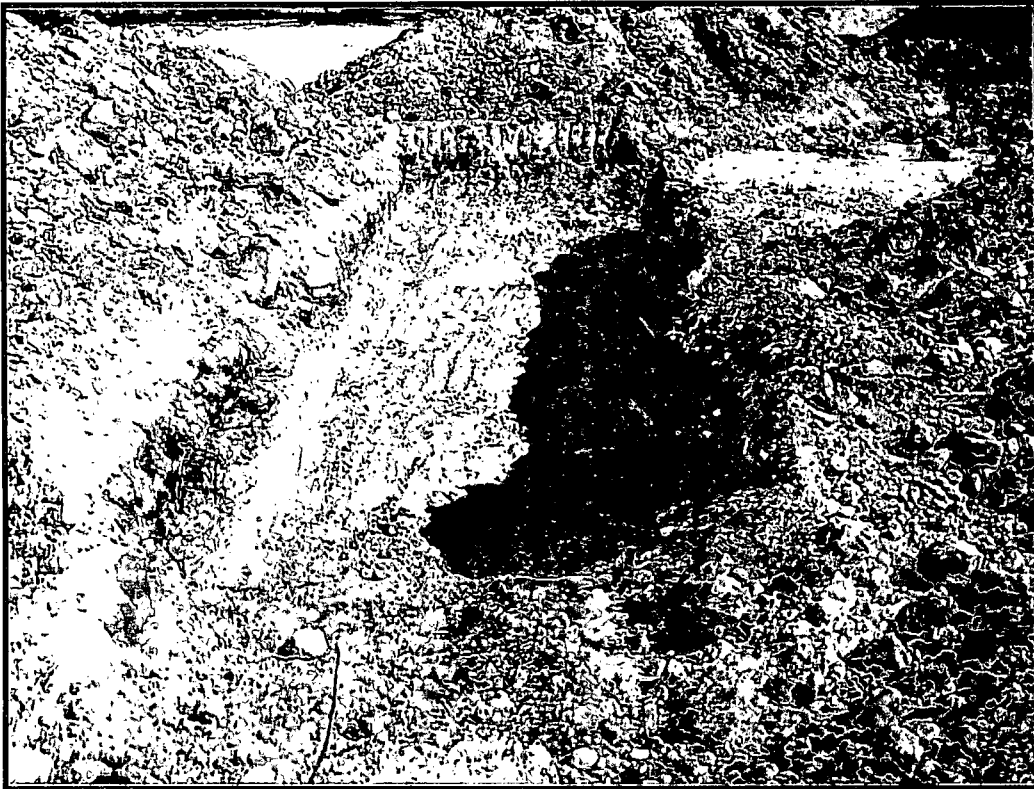
Excavation 2.5 ft. (Facing East)

Excavation 2.5 ft. (Facing Southeast)

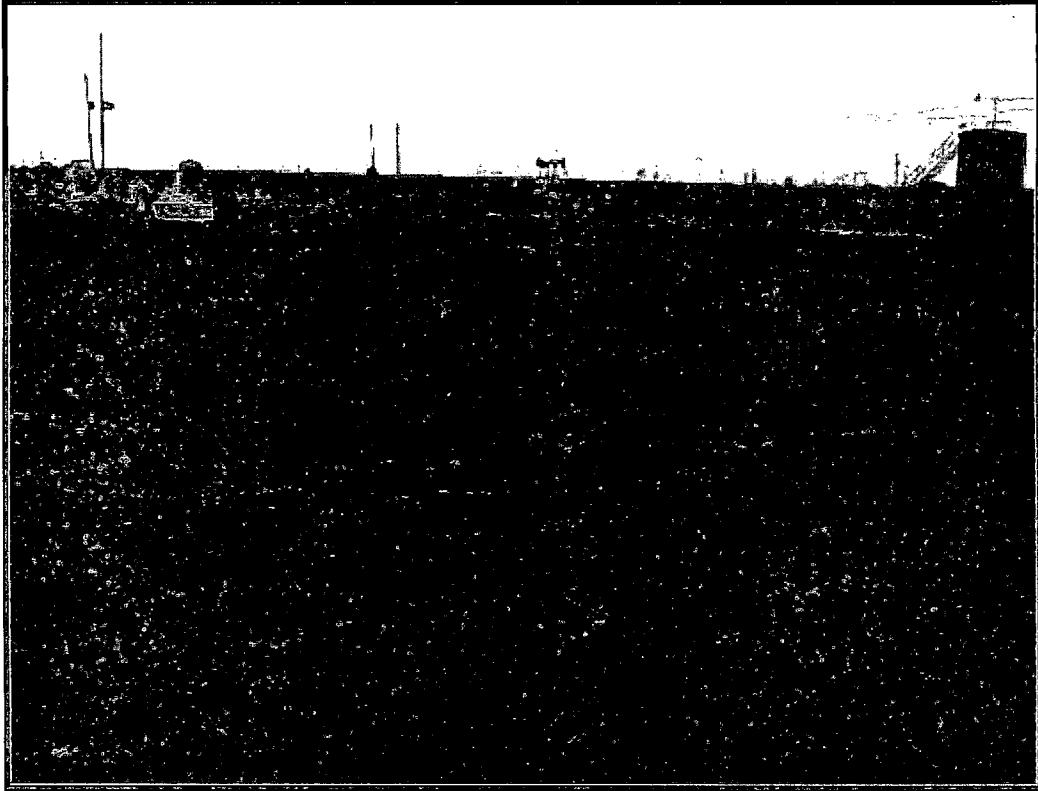
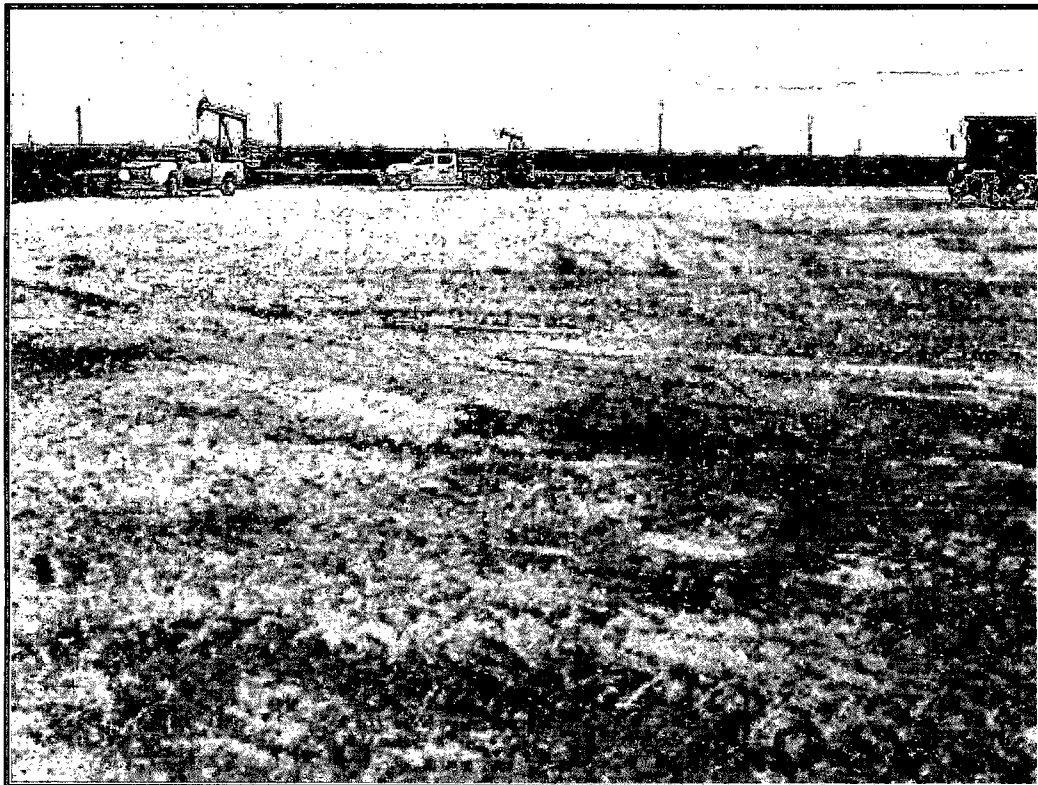
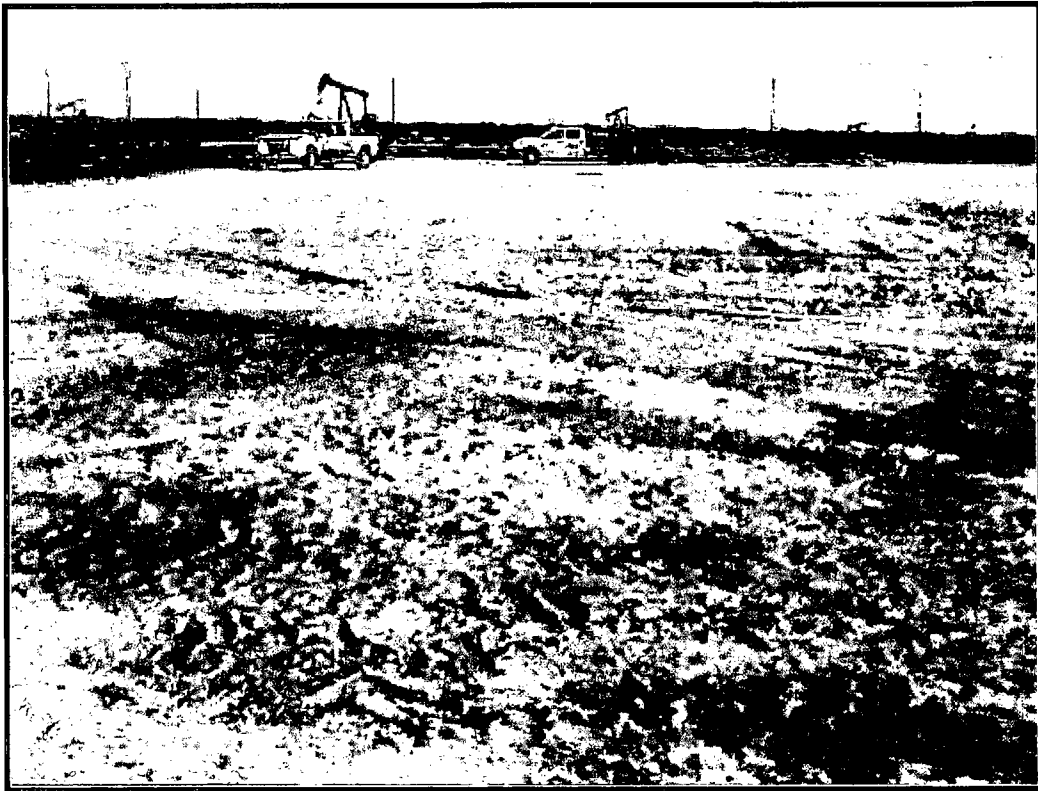
Excavation Backfilled (Facing West)

Excavation Backfilled (Facing South)

Excavation Backfilled (Facing North)

A total of 252 yards of excavated soils were transported to Lea Land, a New Mexico Oil Conservation Division (NMOCD) approved facility for disposal. The excavation was backfilled with 268 yards of clean caliche and compacted to the original pad elevation.
