Re: Removal of Hydrocarbon-Impacted Soils from the C-23-2 (Site #1) site
Township 20 South, Range 36 East, Section 25, Unit C

Re: Remediation Closure Approval for Removal of Hydrocarbon-Impacted Soils

SITE MAP

C-23-2 (Site #1)

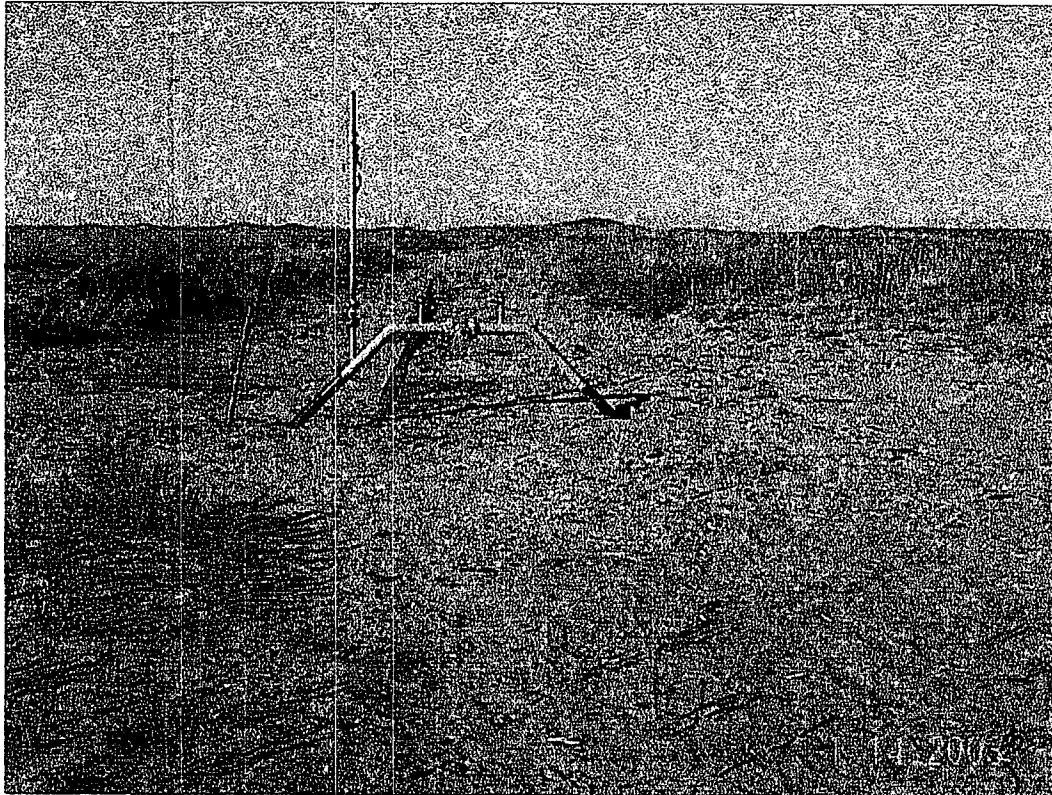
Historical condensate release caused by subsurface external corrosion. Years prior to excavation activities the active 12" steel pipeline (C-23-2) was replaced with 10" polyline (Driscoll). An approximately 220' section of the inactive 12" steel pipeline (F-3), which was located approx. 10 feet south of the active pipeline, was removed one day prior to excavation activities. During excavation activities dark hydrocarbon-stained soil was visible along the active 12" polyline pipeline, particularly where it joined a 4-inch diameter riser. Removal of impacted soil was requested by landowner (Clay Cooper).

- 1 View facing west showing the 4-inch riser and hydrocarbon-stained soil beneath it prior to excavation activities. A 120-ft section of the inactive 12-inch steel (F-3) line, visible beneath the riser, was cut off and removed soon after this photo was taken.

Note: The area below sample "F" (3' directly below the riser where it connects to the active 10" poly pipeline) was excavated further until concentrations were below OCD guidelines as confirmed by subsequent sample F (9').

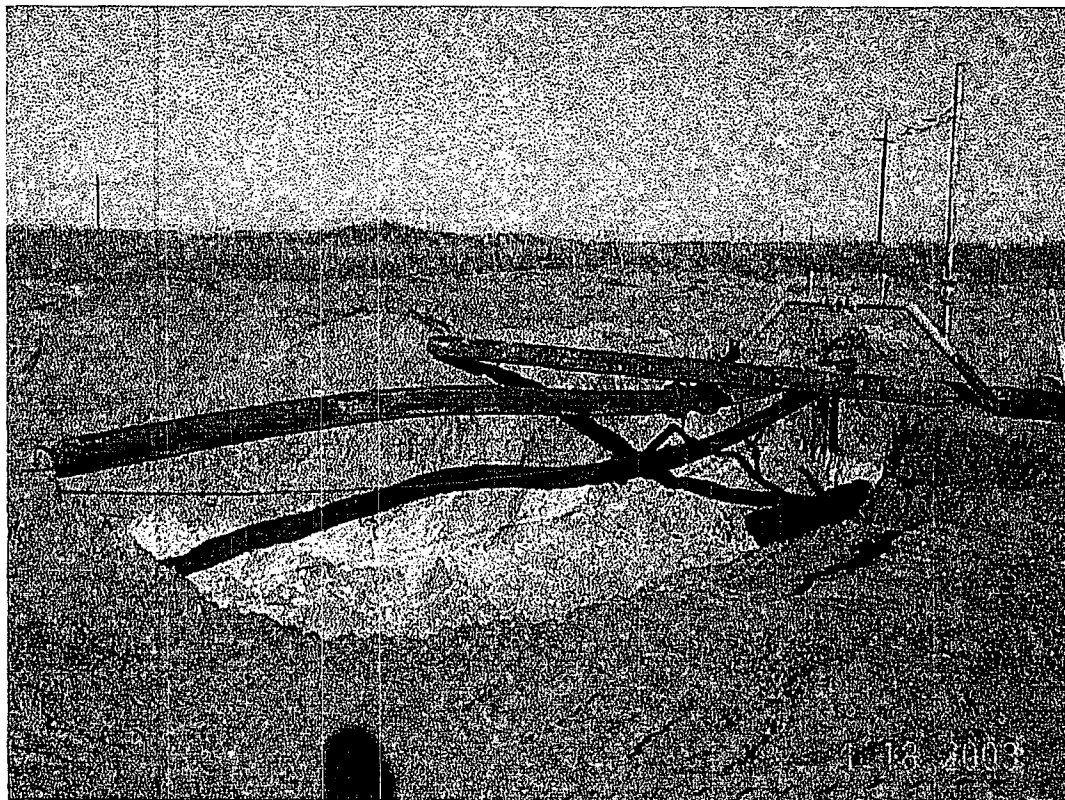
4 View facing northeast showing floor, north wall, and east wall after completion of excavation.

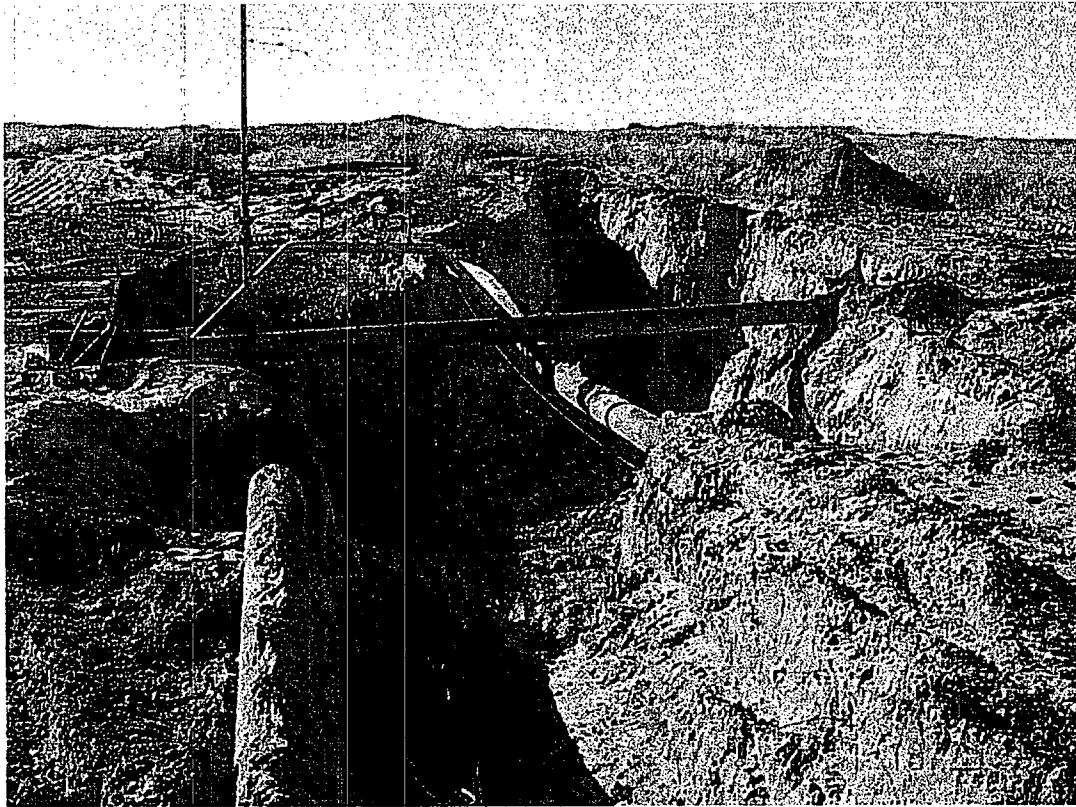
5 View facing west showing and west side of excavation and completion of excavation activities.
