Re: Removal of Hydrocarbon-Impacted Soils from the C-23-2 (Site #2) site  
Township 20 South, Range 36 East, Section 25, Unit C

Trident Environmental (Trident) was retained by Duke Energy Field Services, LP. (DEFS) to oversee the removal of hydrocarbon-impacted soil from an area along a pipeline right-of-way operated by DEFS near Monument, New Mexico in Lea County. The site, C-23-2 (Site #2), is located in Section 25 (Unit C), Township 20 South, Range 36 East on property owned by Dale Cooper and managed by Clay Cooper. The location of the C-23-2 (Site #2) is shown on the topographic map in Attachment A. The work was conducted in accordance with the work plan submitted to the New Mexico Oil Conservation Division (OCD). Trident personnel periodically collected soil samples to characterize the extent of hydrocarbon-impact and to verify when cleanup target levels had been achieved. This letter report describes the methods and results of the excavation, sampling, waste disposition, and backfilling operations for documentation that closure requirements have been satisfied.

# SITE MAP

C-23-2 (Site #2)

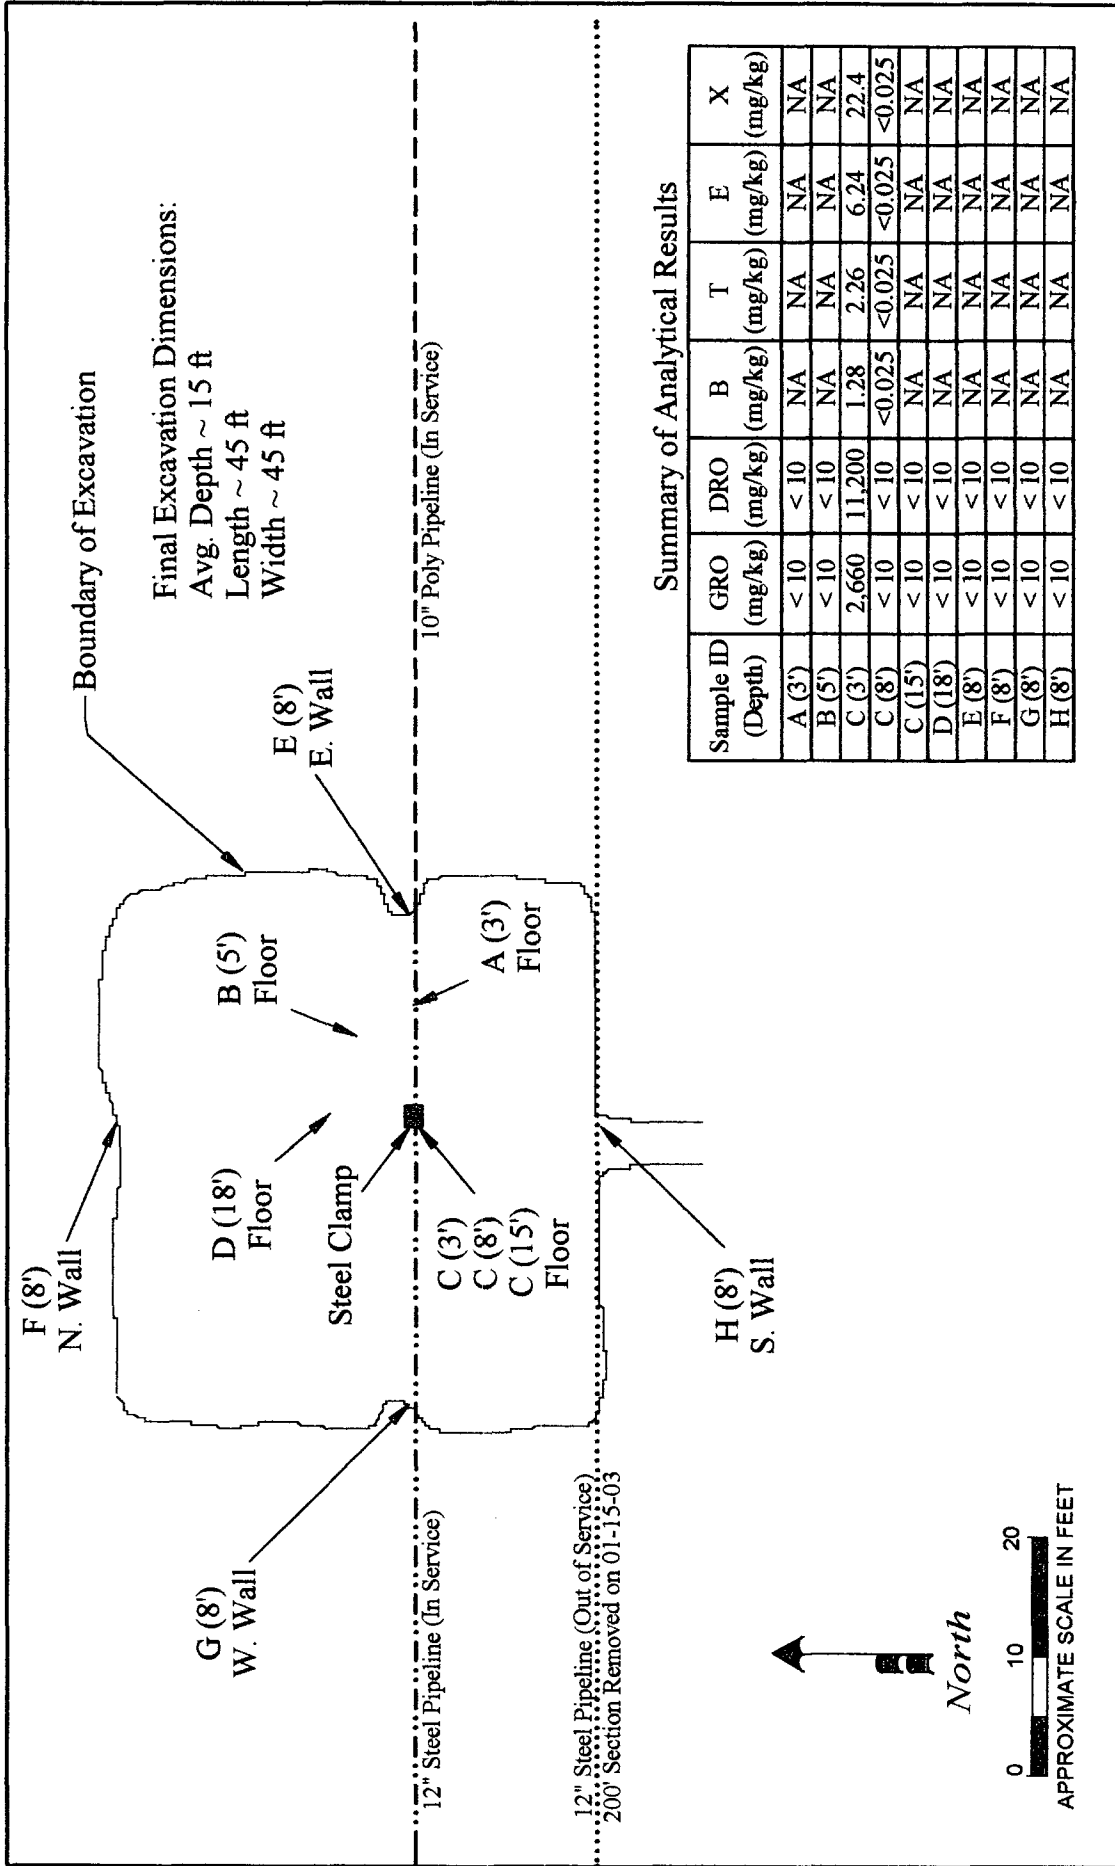
Sample ID (Depth)	GRO (mg/kg)	DRO (mg/kg)	B (mg/kg)	T (mg/kg)	E (mg/kg)	X (mg/kg)
A (3')	< 10	< 10	NA	NA	NA	NA
B (5')	< 10	< 10	NA	NA	NA	NA
C (3')	2,660	11,200	1.28	2.26	6.24	22.4
C (8')	< 10	< 10	< 0.025	< 0.025	< 0.025	< 0.025
C (15')	< 10	< 10	NA	NA	NA	NA
D (18')	< 10	< 10	NA	NA	NA	NA
E (8')	< 10	< 10	NA	NA	NA	NA
F (8')	< 10	< 10	NA	NA	NA	NA
G (8')	< 10	< 10	NA	NA	NA	NA
H (8')	< 10	< 10	NA	NA	NA	NA

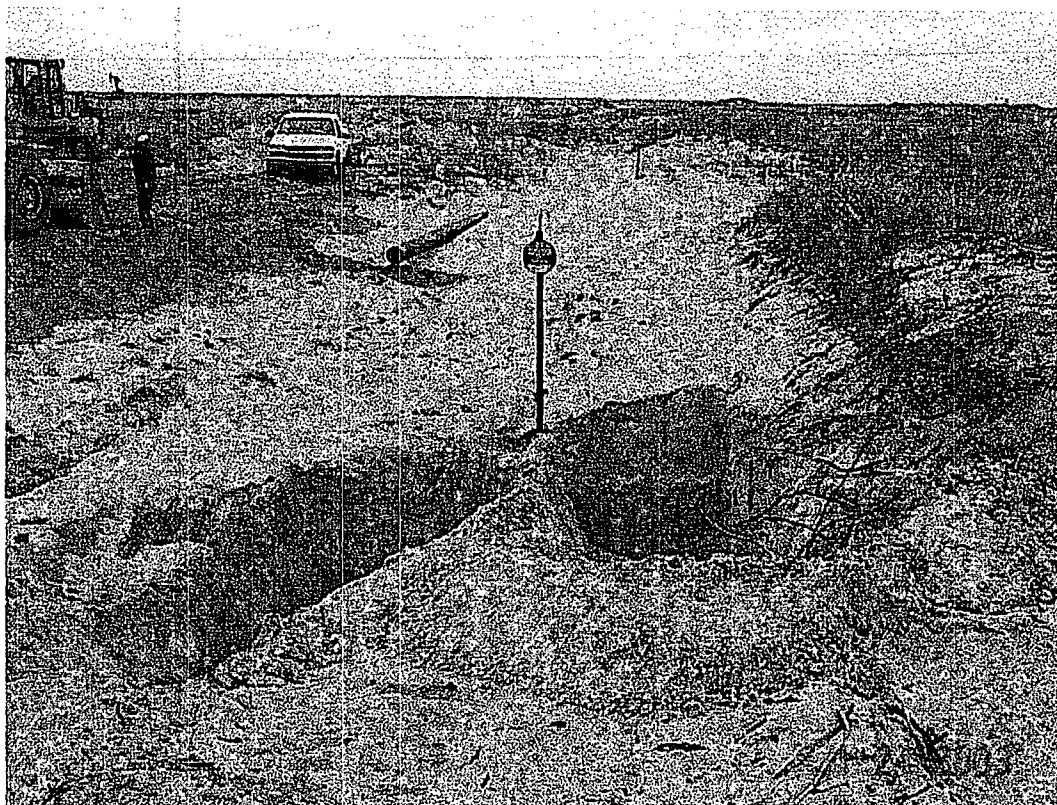
1 View facing west showing initial excavation. Pipeline marker (center) marks where 12-inch steel line (west side) is joined with 10-inch poly line (east side) along active pipeline. Inactive 12-inch steel pipeline (upper left) is shown where a 200-ft section was cut off and removed. 01-24-03

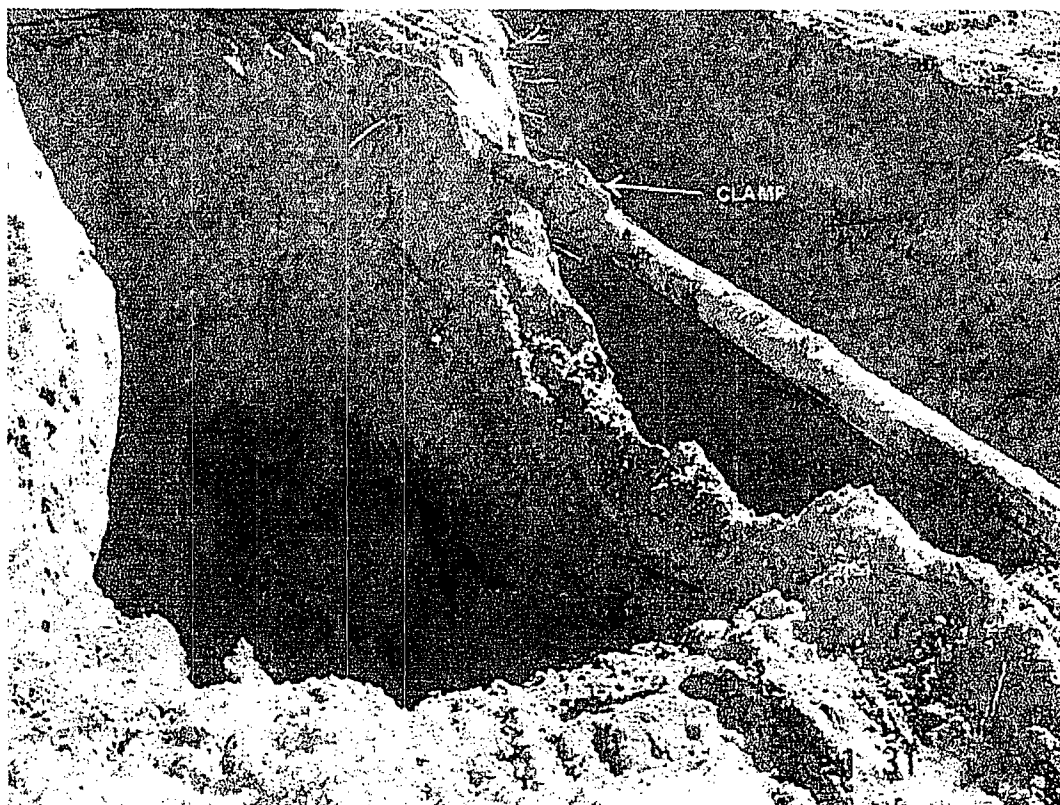
2 View facing southeast showing hydrocarbon-stained soil and location of pipe clamp along 12-inch active pipeline (top center). 01-31-03

Comments: The area below sample C ( 3' ), directly below the clamp along the active 12" steel pipeline, was excavated further until concentrations were below OCD guidelines as confirmed by subsequent samples C (8'), C (15'), and D (18').

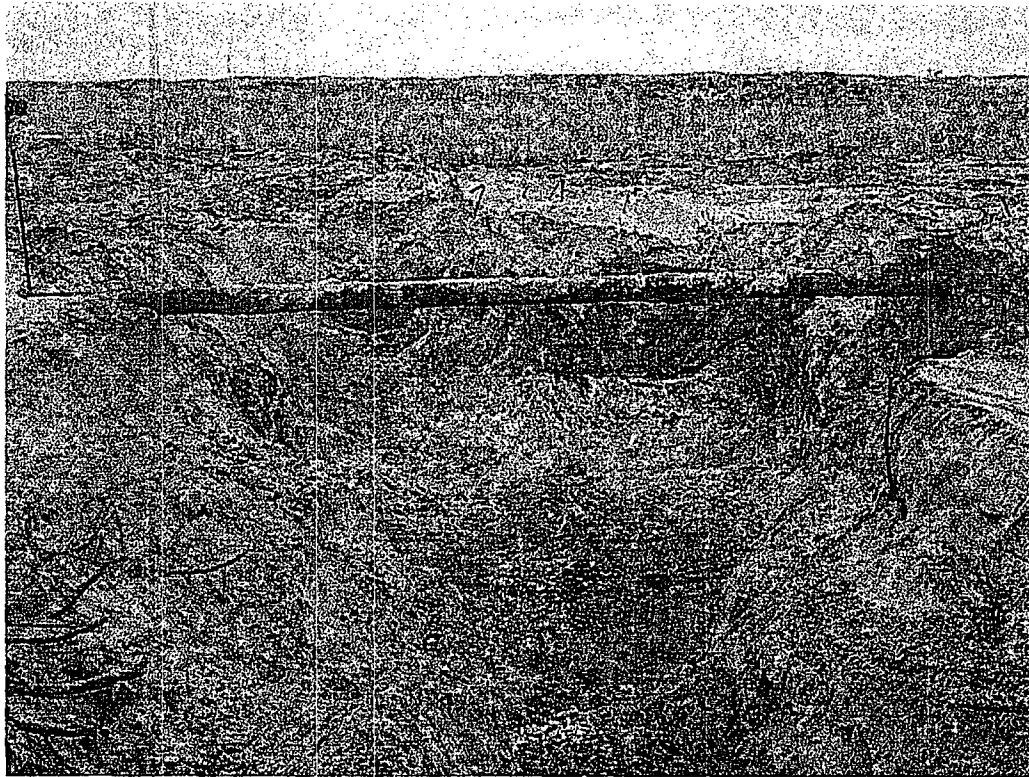
3 View facing north showing floor and north wall after completion of excavation. 02-07-03

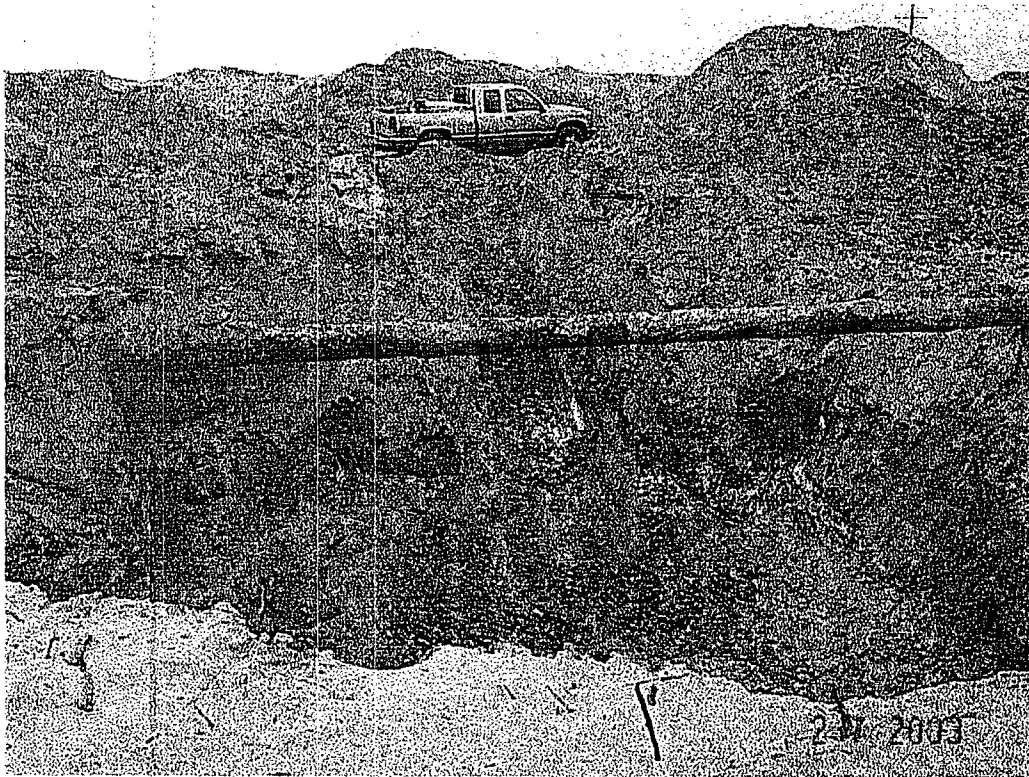
4 View facing south showing floor and south wall after completion of excavation. 02-07-03
