**Corrective Action
Report**

GROUNDWATER DISCHARGE PERMIT GW-049-2

Blanco Products Storage
Off County Road 4900
Bloomfield, San Juan County, New Mexico

March 6, 2012
Project No. 0107039

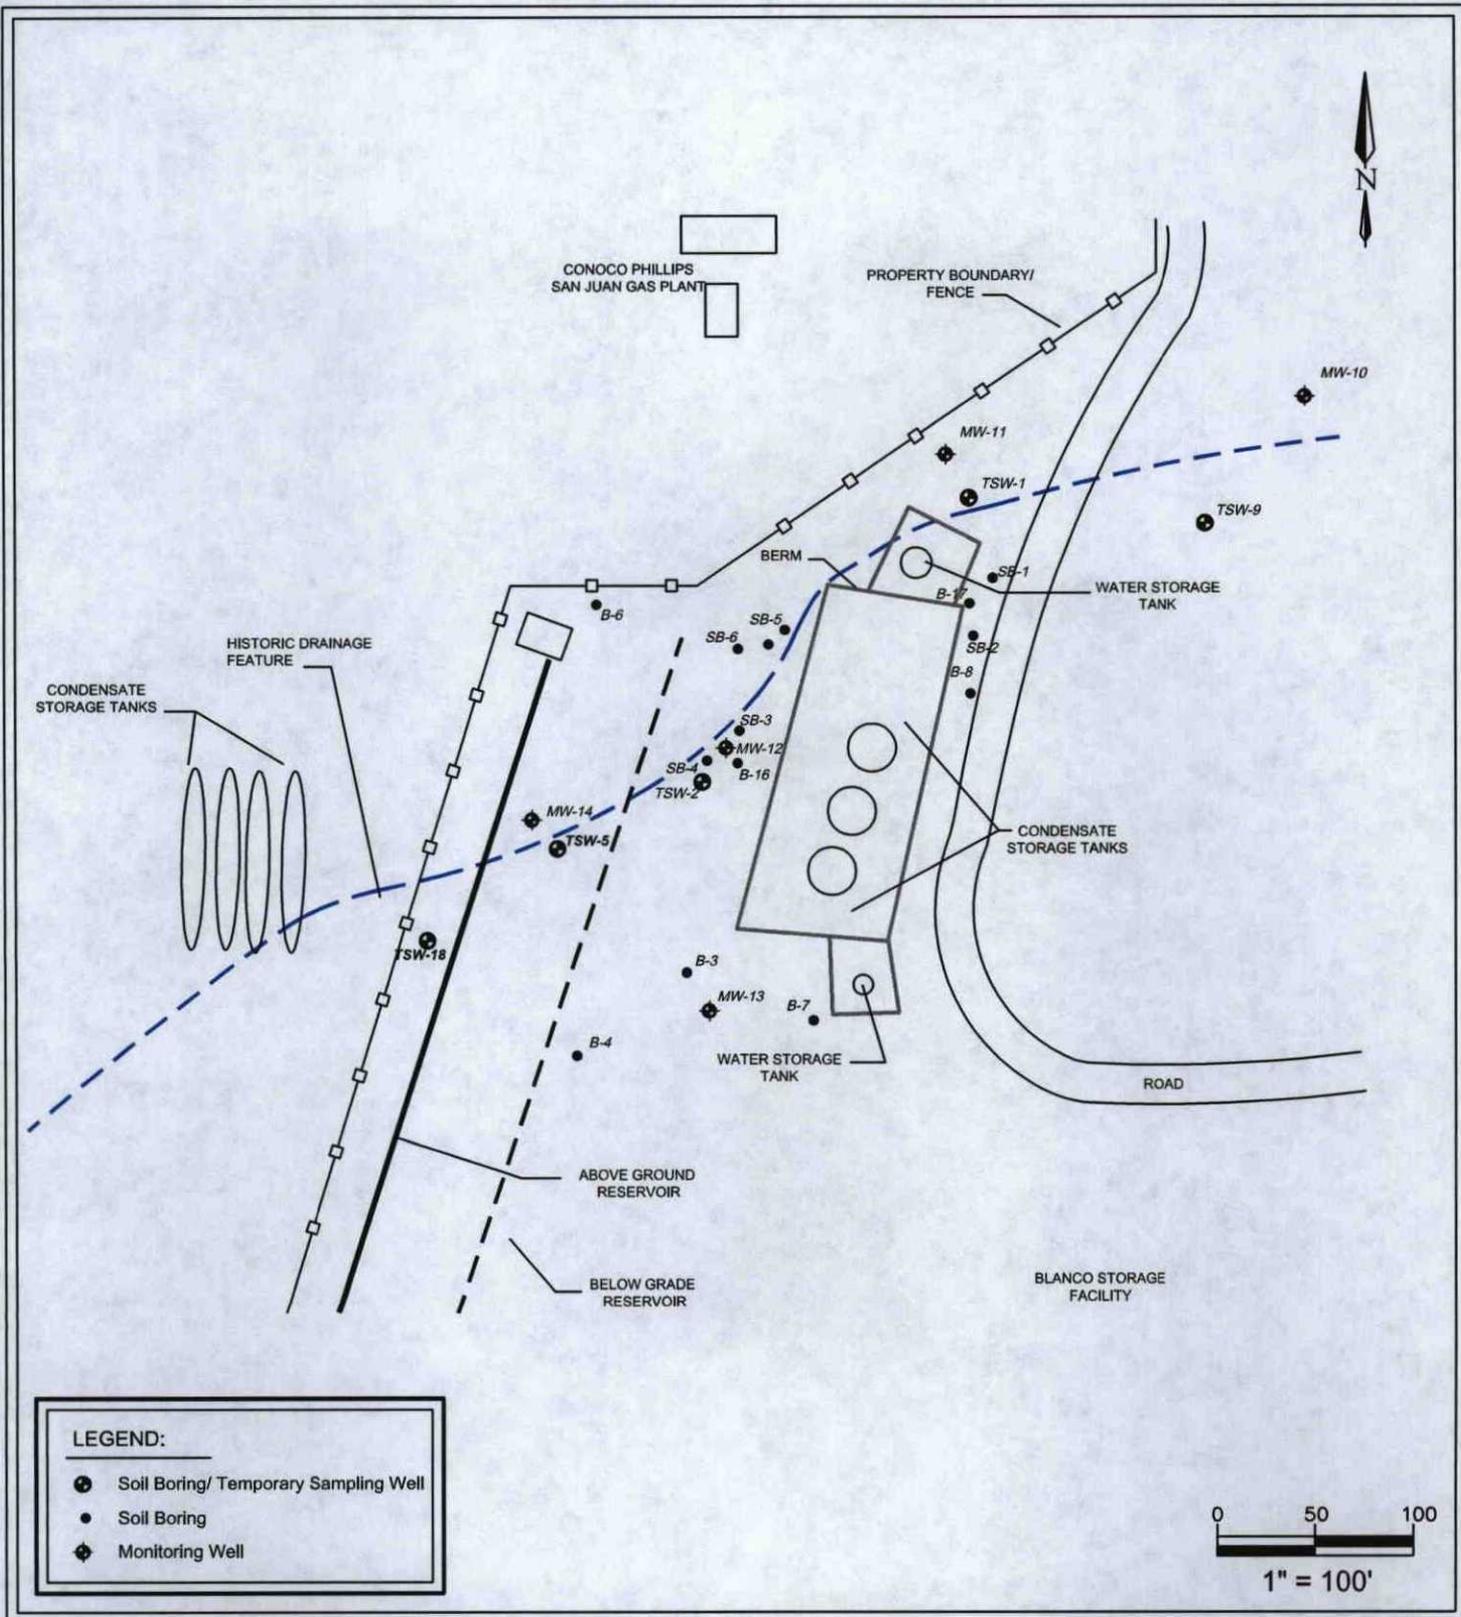
FIGURE 3
 Site Map

Figure 3 indicates the approximate locations of the source phase injection points and existing borings/monitoring wells in relation to pertinent Site features and general Site boundaries.

The aqueous reagent was injected through forty (40) injection points installed on approximate twelve foot centers upgradient of the primary release area (Injection Points IP-1 through IP-5), in the vicinity of and immediately down-gradient of the source area (Injection Points IP-18 through IP-40), and along the down-gradient property boundary as a reactive permeable wall (Injection Points IP-6 through IP-17). The injection points were constructed of 1.5-inch diameter schedule 40 PVC with a ten foot screened interval, similar to monitoring well construction.

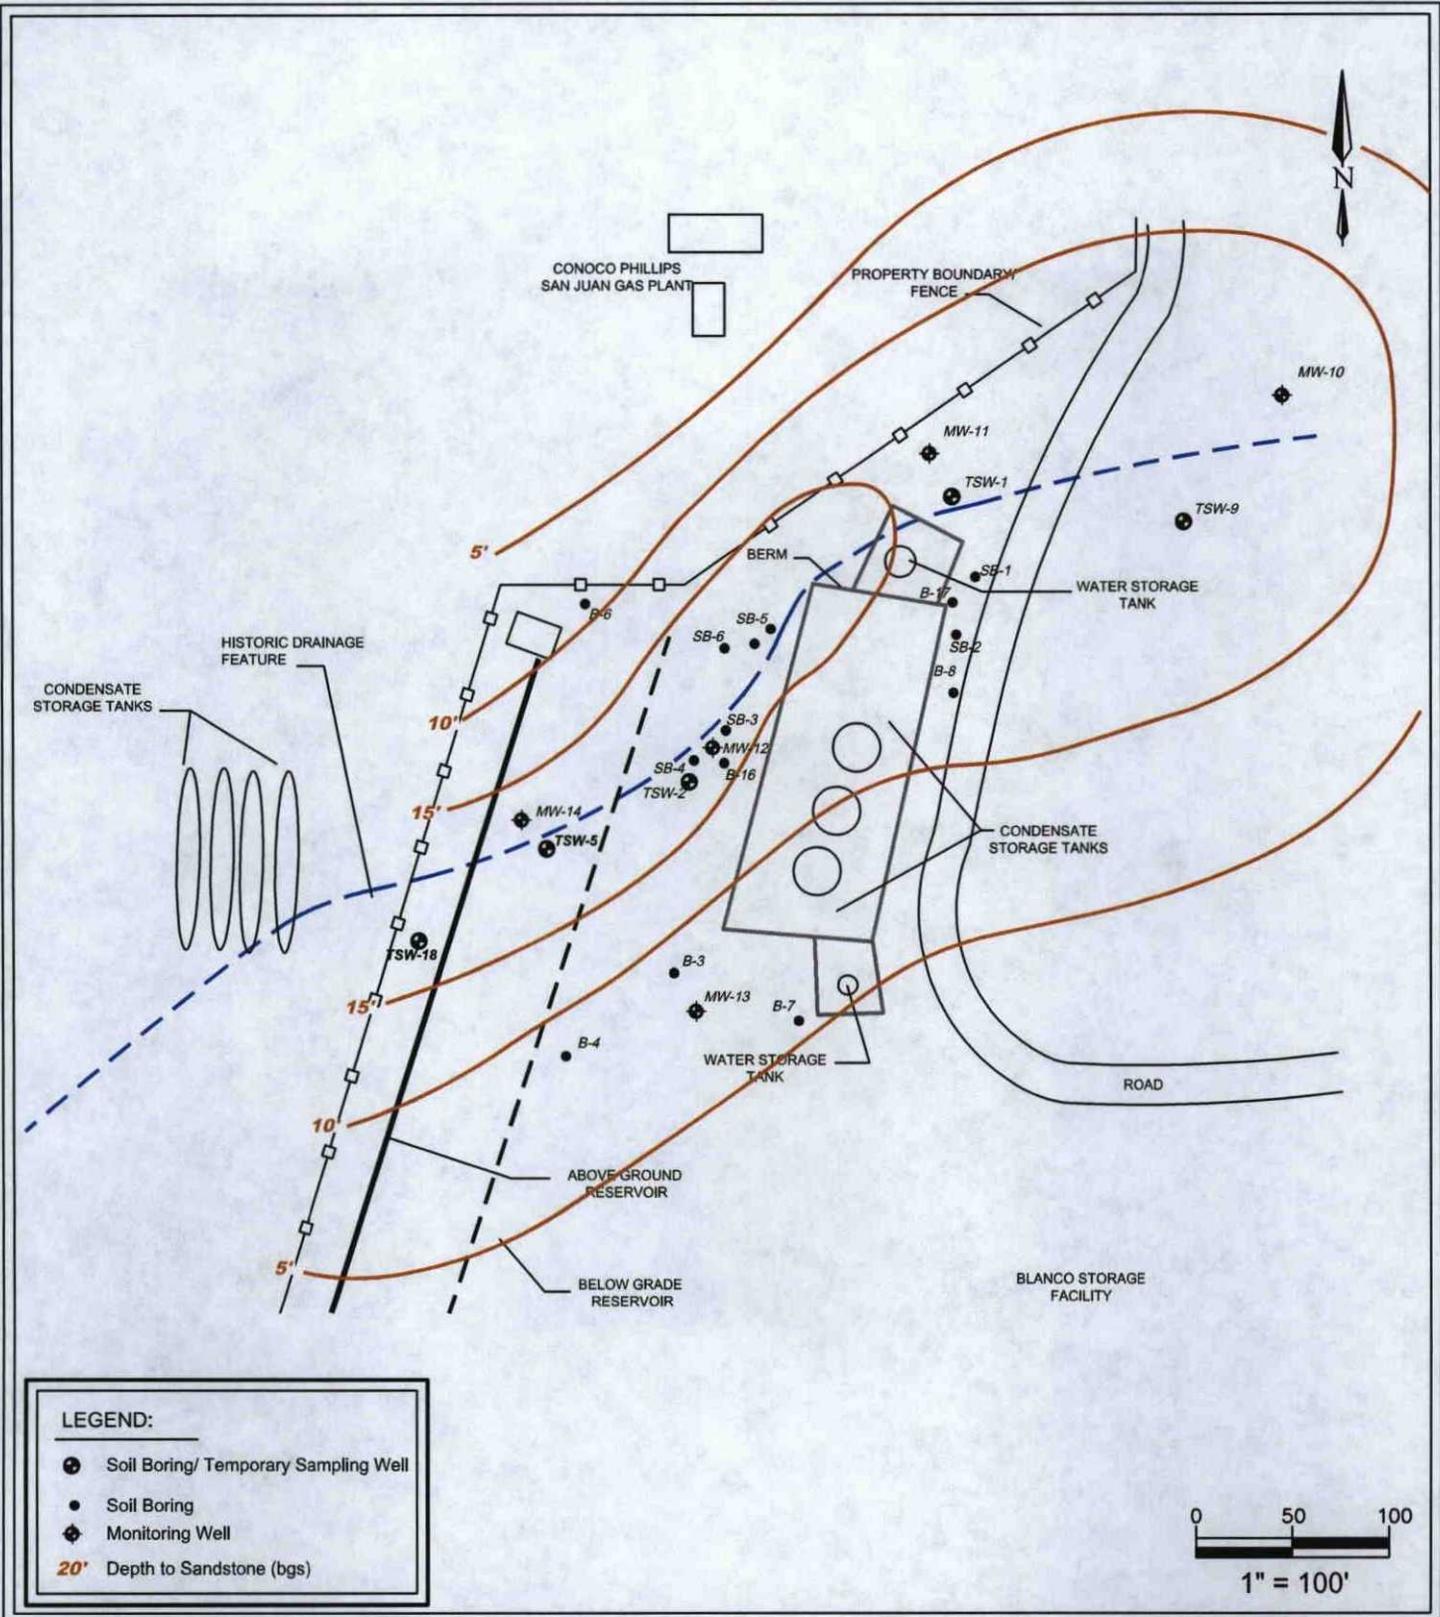
FIGURE 4
 Sandstone Elevation
 Map

Soil boring results in the immediate vicinity of the primary release area indicate a narrow basin or buried drainage channel in the sandstone bedrock. Liquids from the 2006 release have apparently settled into this bedrock depression. Numerous active above- and below-grade pipelines, operated by differing entities, traverse the affected area, limiting corrective action options and creating a substantial safety risk for any subsurface activities performed in the vicinity. Although subsurface water in the primary release area remains affected, naturally occurring subsurface boundaries seem to indicate a relatively finite source of recharge, resulting in a somewhat isolated pocket of affected water. Based on SWG's review of the available data, the affected groundwater at the Site may qualify for a *Regulatory Exemption for Groundwater Contamination*, in which case confirmation sampling of groundwater would not be required subsequent to the completion of abatement activities.

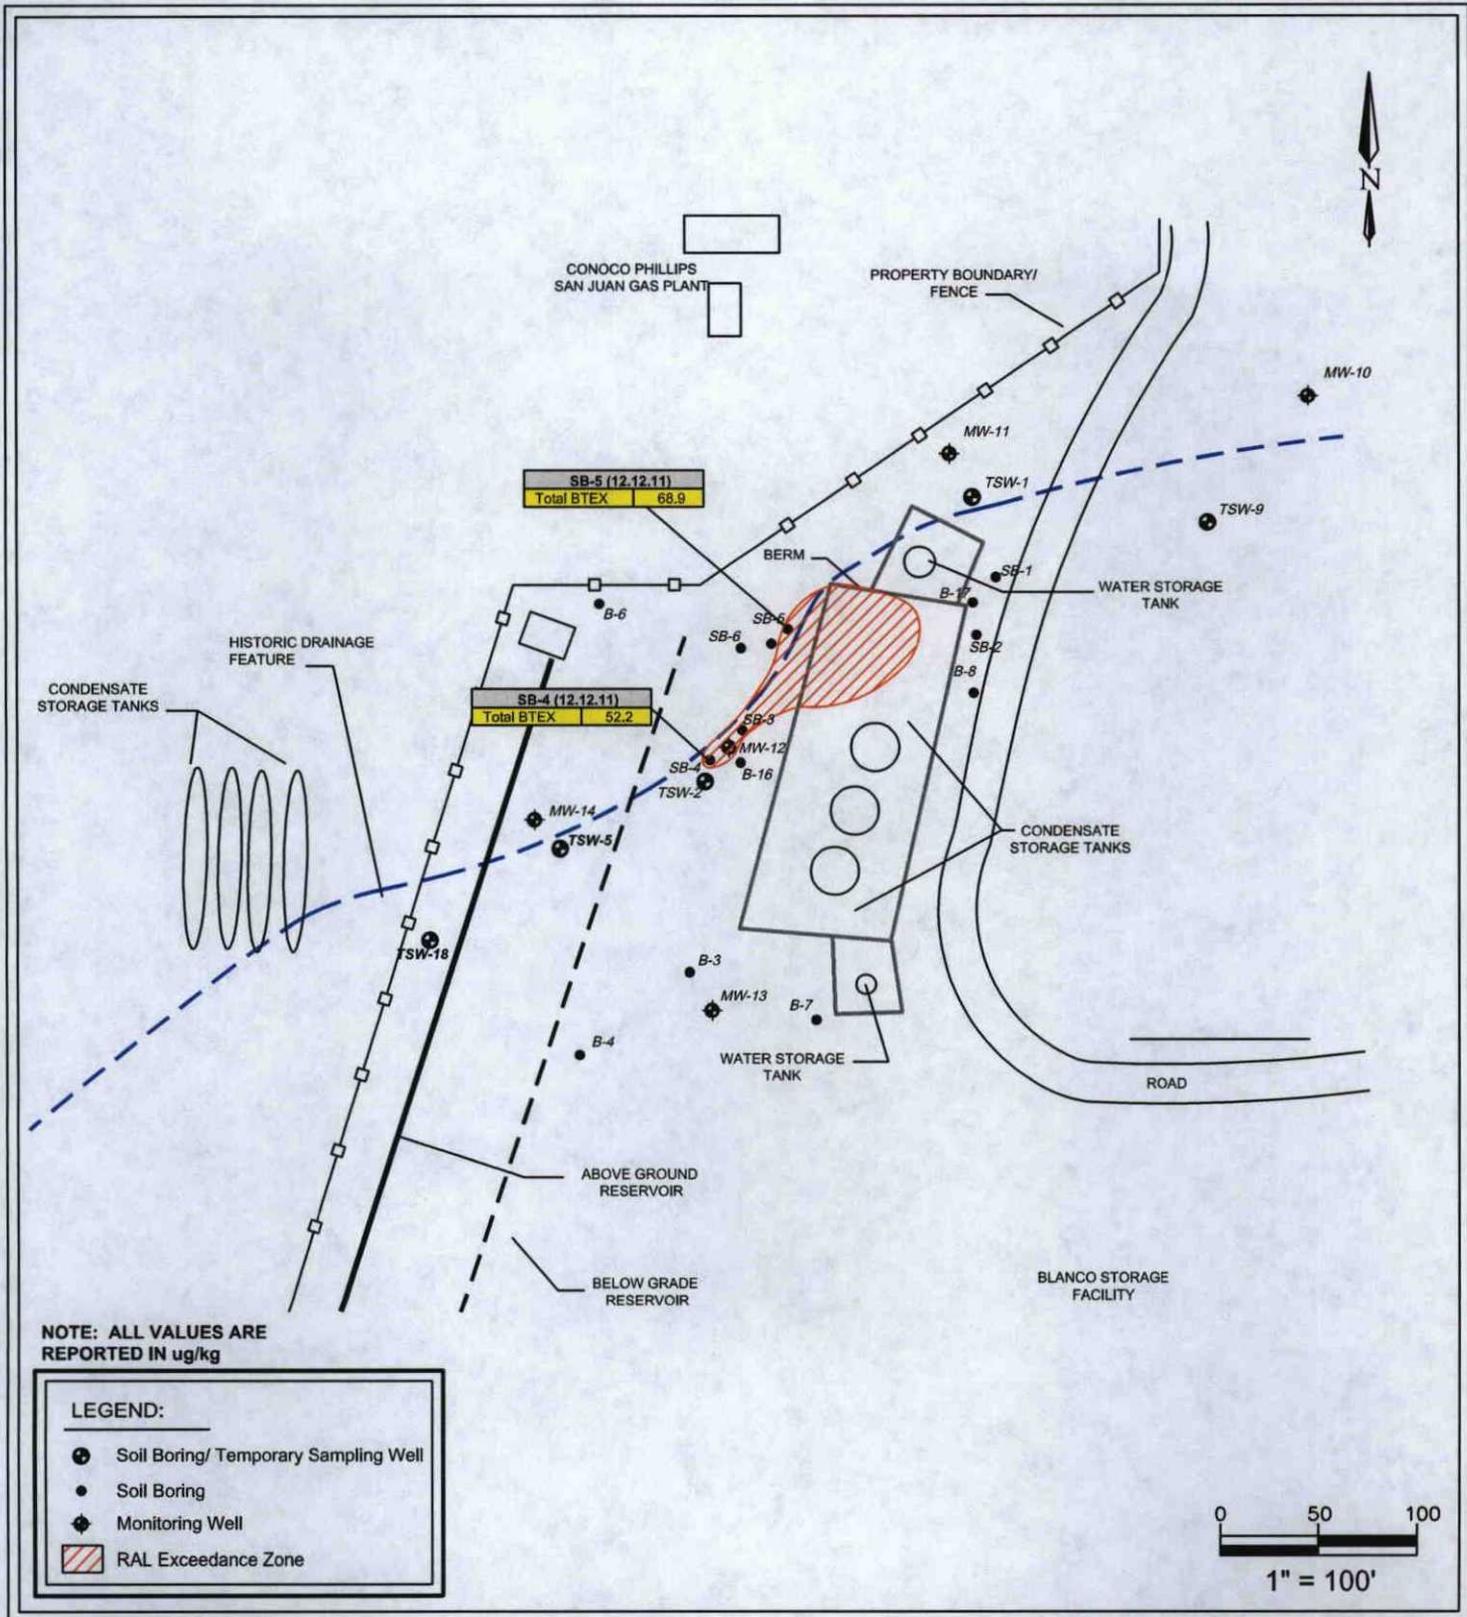
FIGURE 6
RAL Exceedance
Zone Map
(12.12.11)

Additionally, analytical data from the confirmation soil sampling indicates that some soils in the primary release area are affected with total BTEX concentrations that are above the OCD RALS. These affected soils appear to be localized, with most exceedances only slightly above the default action level, and do not appear to pose a significant risk in the current industrial setting. These soils could be re-assessed when the facility is ultimately decommissioned, or when pipeline and industrial hazards in the vicinity of the release pose less inherent hazard.

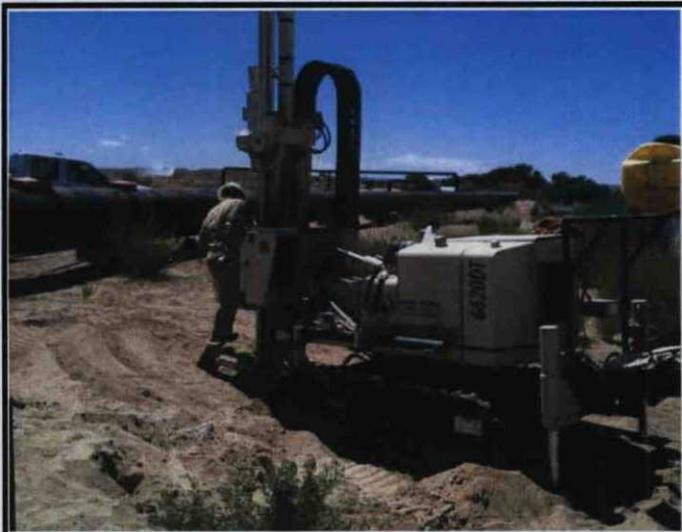
1.) General view of the installation of injection points 6 through 17 along the western property boundary.

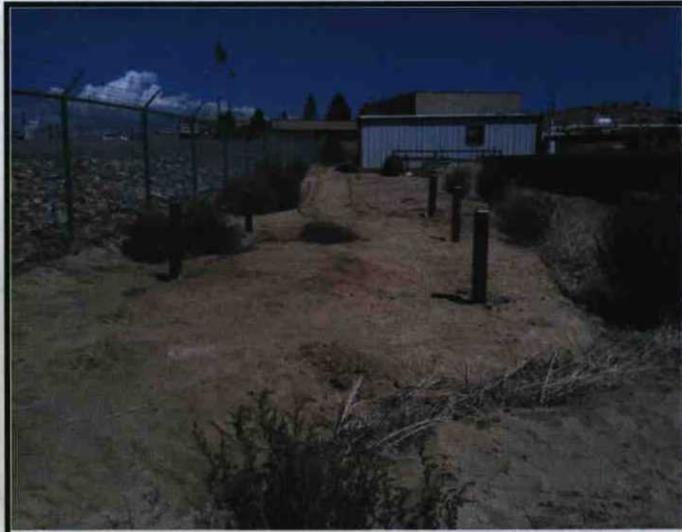
2.) Representative view of select injection points along the western boundary subsequent to completion.

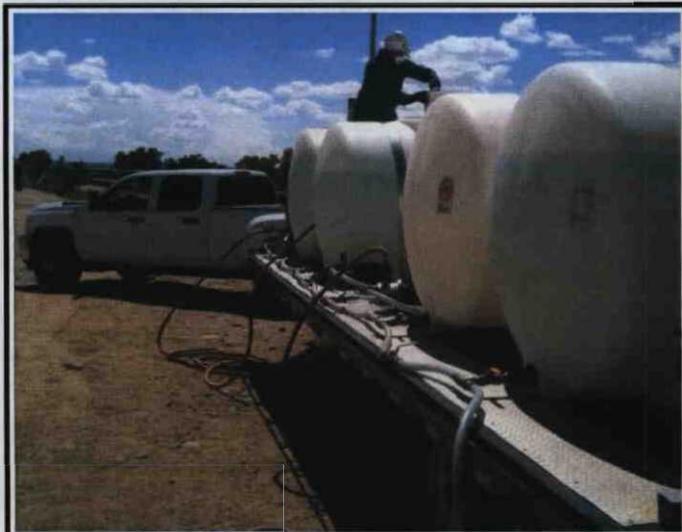
3.) Representative view of the preparation of chemical oxidant solution prior to injection activities.

Initially, the formation was prepared for contaminant oxidation by inoculating the treatment area with an alkaline oxidative de-ionizing solution. This served as a wetting agent, de-ionizing clay platelets and optimizing aqueous reagent contact with contaminants. The initial reagent was delivered through a specifically sequenced treatment train. An aqueous solution containing sodium percarbonate and sodium persulfate was injected through forty (40) injection points. The pre-oxidation alkaline de-ionizing solution also served as a persulfate catalyst (producing sulfate radicals).

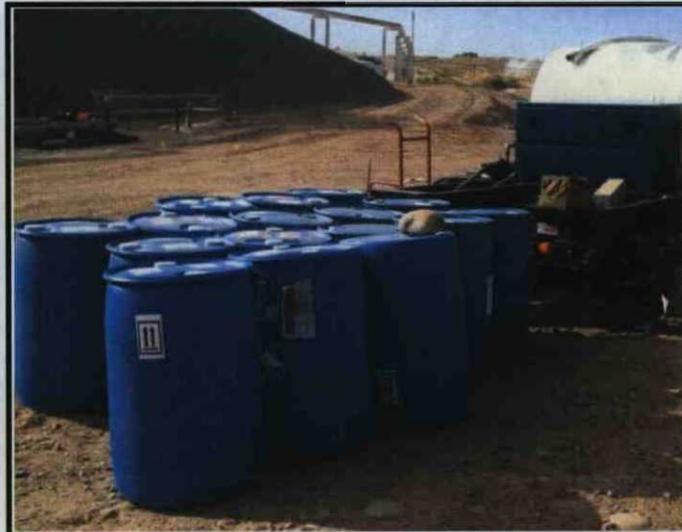
4.) General view of the VeruSOLV-HP prior to mixing and in-situ treatment.

The second phase was conducted within twenty four (24) hours after injecting the de-ionizing/catalyst solution. During these activities, the treatment area was inoculated using VeruSolve-HP™ aqueous reagent as a Surfactant-Enhanced In-Situ Chemical Oxidation (S-ISCO™) Coelution Technology™. VeruSOLVE-HP™ is a

stabilized surfactant-cosolvent/oxidant combination effective for surgical destruction of source term contaminants. Because the rate of partitioning of contaminants into the aqueous phase determines the overall rate of reaction, as the concentration of stabilized surfactant-cosolvent fraction is increased, the partitioning and subsequent rate of chemical oxidation is increased. VeruTEK's stabilized surfactant-cosolvent/oxidant blend achieves Winsor Type I solubilization, where the contaminant is solubilized as a single-phase micro-emulsion and dissolution of constituents occur without mobilization. This allows for the destruction of the contaminants that are currently in a non-aqueous phase (i.e. the source term). The resulting redox reaction will occur over a very long period of time. Reaction kinetics are controlled, sustaining a highly oxidative environment for weeks. Extended persistence greatly increases the contaminant-oxidant contact occurrence, thereby producing very favorable results. Manufacturer's information for VeruSOLVE-HP™ is included in Appendix F.

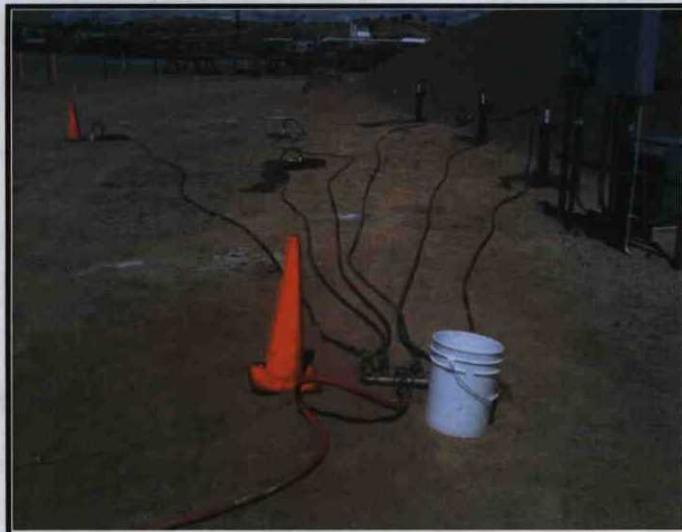
5.) Representative view of the injection of treatment chemicals into select injection points located immediately west of the condensate storage tank containment.

Due to the presumed aquifer properties, the aqueous solution of oxidant reagent was injected at a low flow rate and pressure (<30 psi at the well head) to ensure an effective distribution of oxidant in the subsurface and limit breakthrough to the surface.

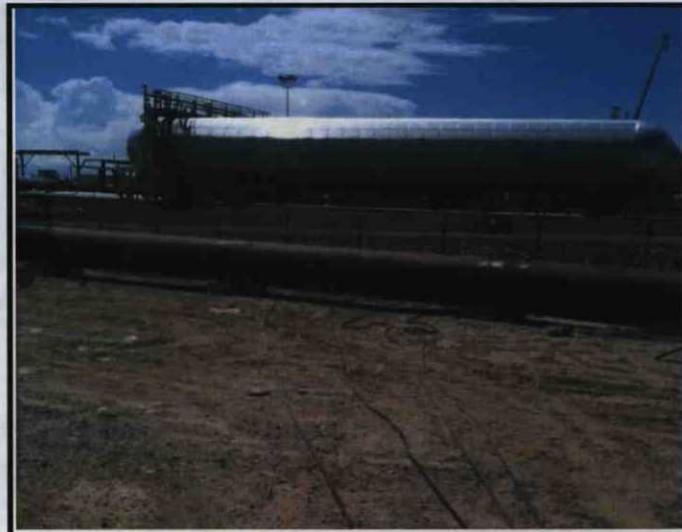
6.) General view of the injection of treatment chemicals into select injection points located along the western boundary of the Site.

SWG injected an estimated 10,000 gallons of aqueous reagent, proportionately, through the forty (40) injection wells.
