**3R-451**

**Site Assessment  
Report**

**RE: Release Assessment Report  
Lateral K-7 August 2012 Pipeline Release  
Rio Arriba County, New Mexico**

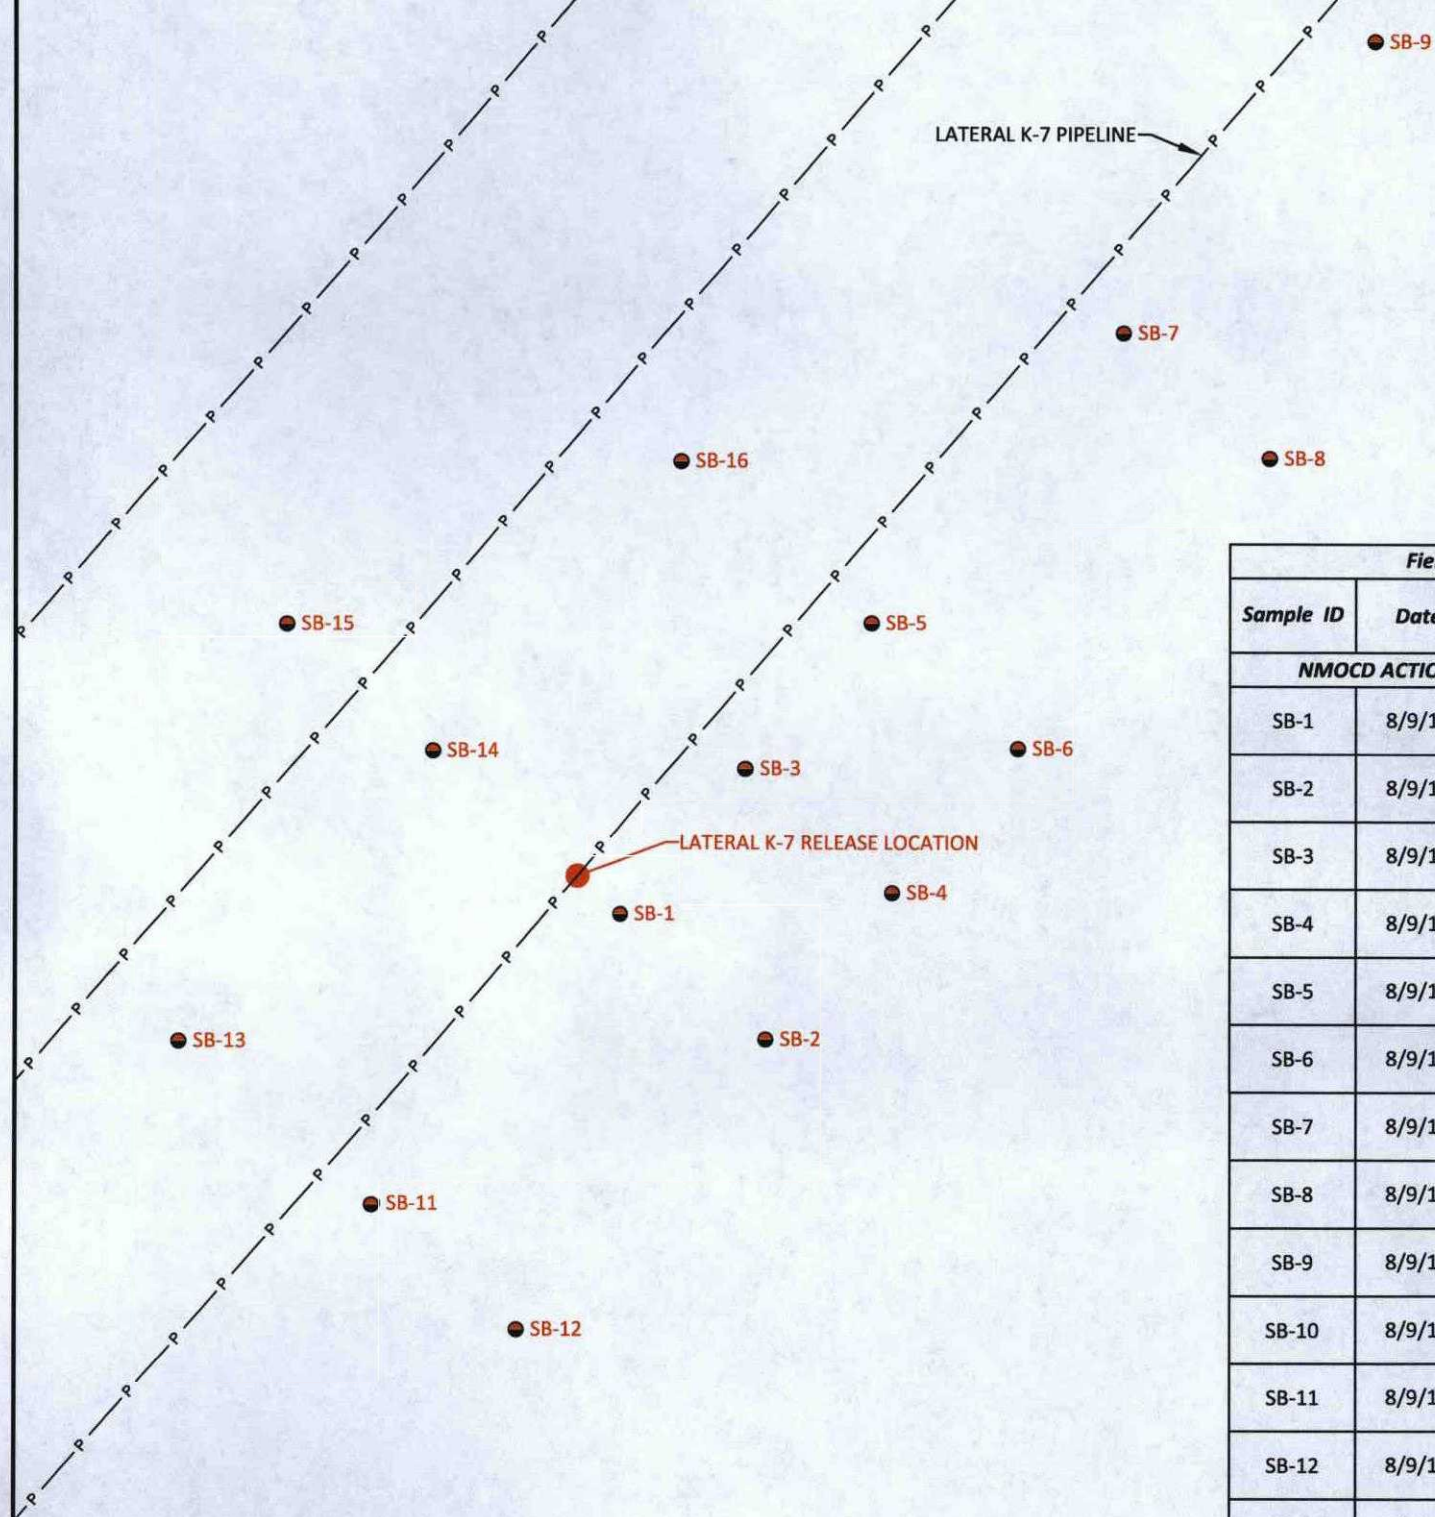
**FIGURE 9**  
**SAMPLE LOCATIONS AND RESULTS**  
**AUGUST 2012**  
ENTERPRISE PRODUCTS COMPANY  
LATERAL K-7 LINE RELEASE  
RIO ARriba COUNTY, NEW MEXICO  
NW¼ SE¼, SECTION 15, T26N, R7W  
N36.48489, W107.56028

Soil field screening results showed that VOC concentrations ranged from 25.3 ppm in SB-11 up to 1,175 ppm in SB-1. Field TPH concentrations ranged from 48.3 mg/kg in SB-7 up to 114 mg/kg in SB-1.

1 and SB-3 are below NMOCD action levels within the release area. Based on interpolation of field screening values and corresponding laboratory QA/QC results, AES believes the elevated VOC field screening reading of 327 ppm in SB-14 would correspond with laboratory analytical results that are also below applicable NMOCD action levels. No further work is recommended.

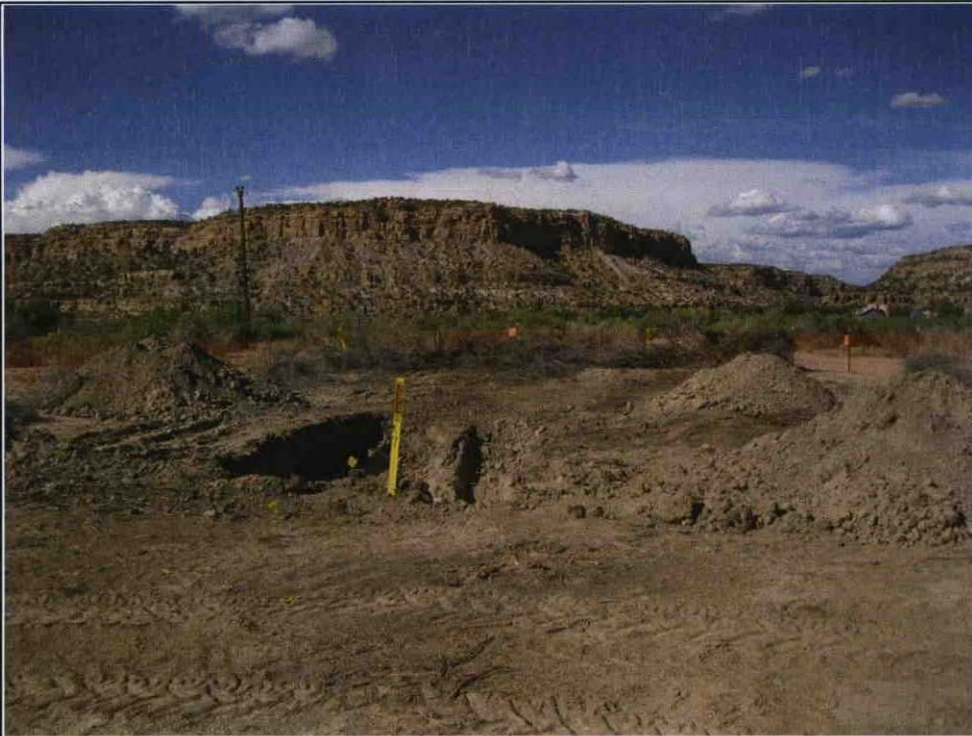
Photo #1

Client: Enterprise Products Company	
Project: Lateral K-7 August 2012 Pipeline Release Assessment	
Taken by: Tom Long	
August 9, 2012	
AES Project No: 120806	Description: View of dead vegetation and stained soils along pipeline corridor.

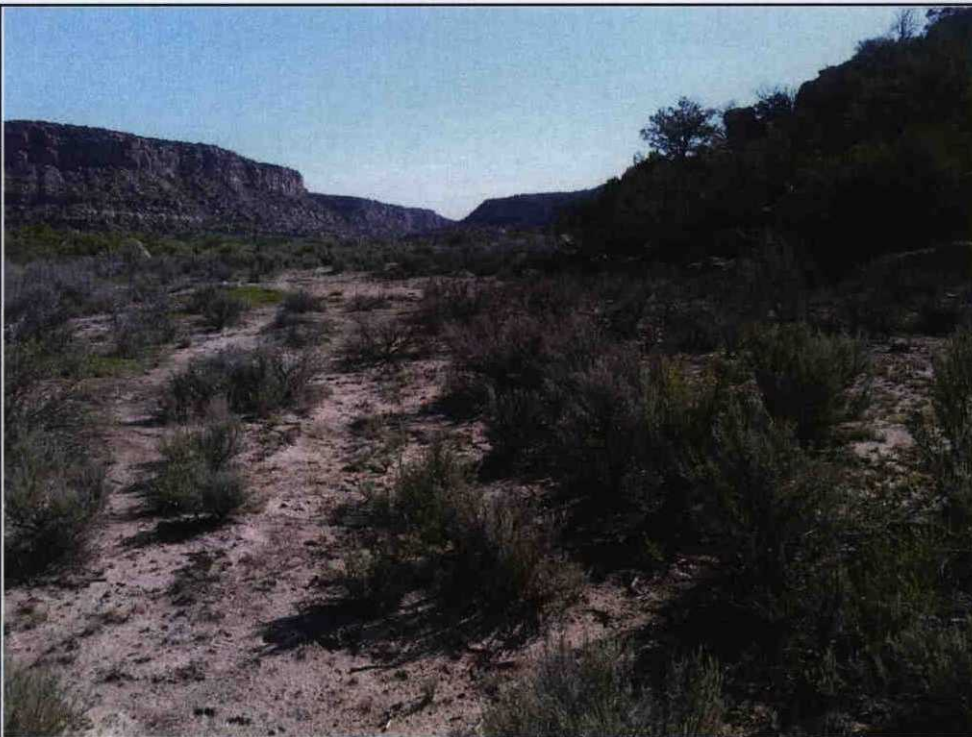
Photo #2

Client: Enterprise Products Company	
Project: Lateral K-7 August 2012 Pipeline Release Assessment	
Taken by: Tom Long	
August 9, 2012	
AES Project No: 120806	Description: View of stressed and dead vegetation along pipeline corridor.

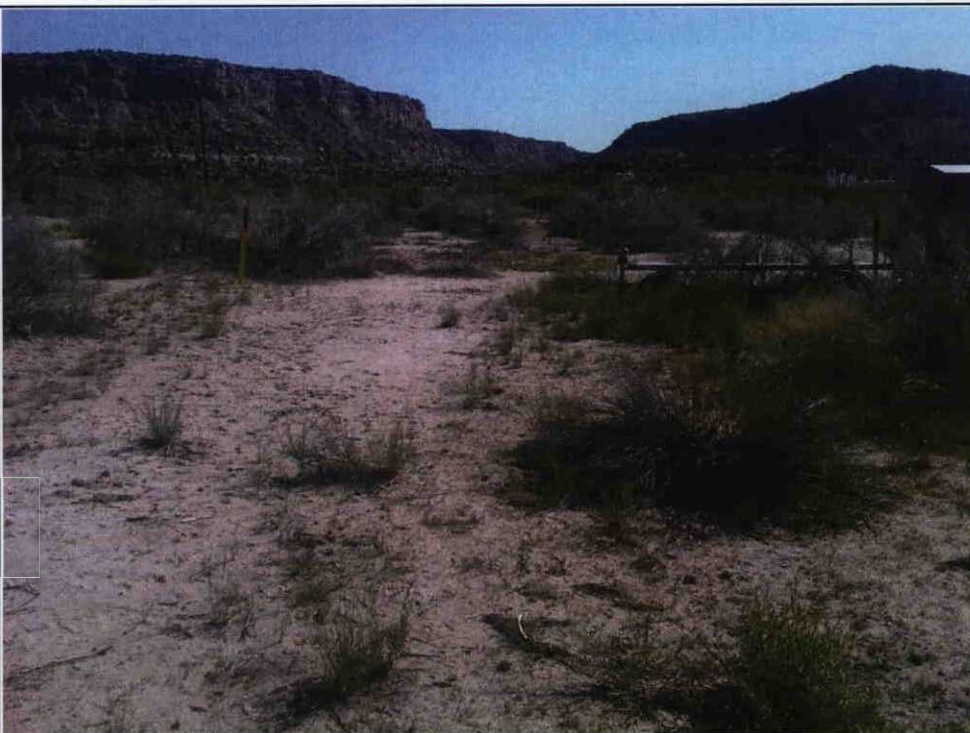
Photo #3

Client: Enterprise Products Company	
Project: Lateral K-7 August 2012 Pipeline Release Assessment	
Taken by: Tom Long	
August 9, 2012	
AES Project No: 120806	Description: View of stressed and dead vegetation along pipeline corridor.

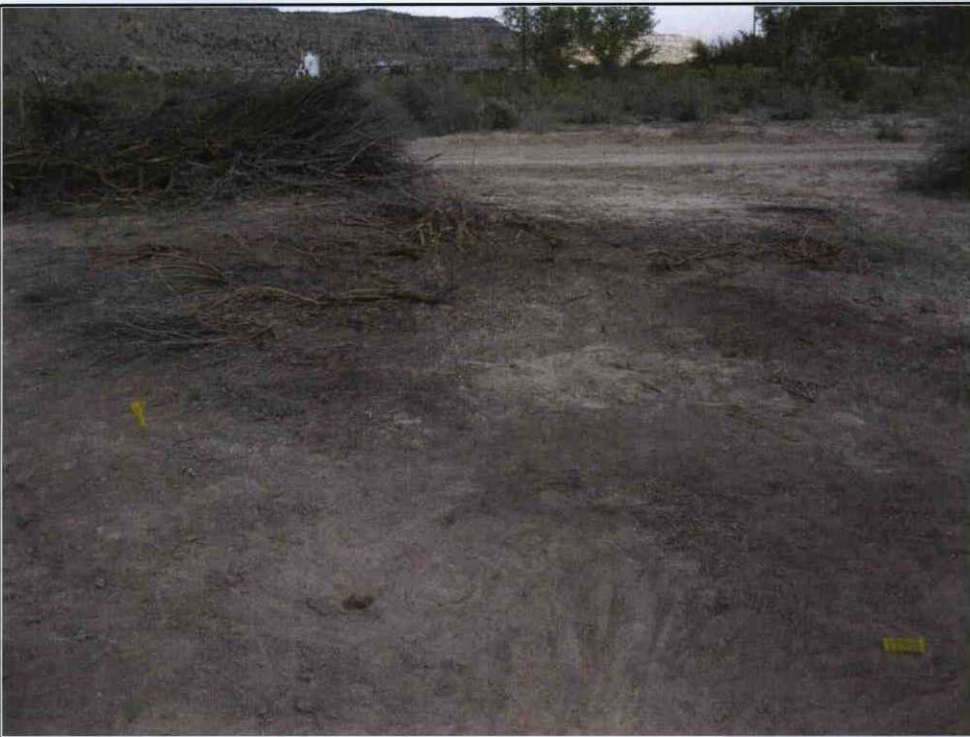
Photo #4

Client: Enterprise Products Company	
Project: Lateral K-7 August 2012 Pipeline Release Assessment	
Taken by: Tom Long	
August 9, 2012	
AES Project No: 120806	Description: View soil boring and dead vegetation along pipeline corridor.
