3R-1011

**Release Report/ General
Correspondence**

Enterprise SJ

Release Notification and Corrective Action

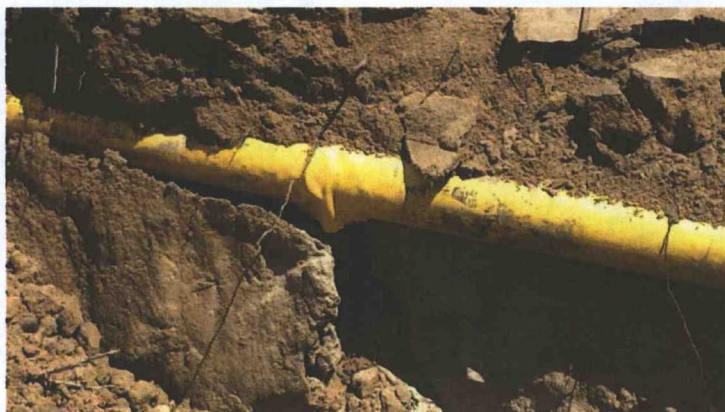
Photograph 3

View of line repair in process, facing north.

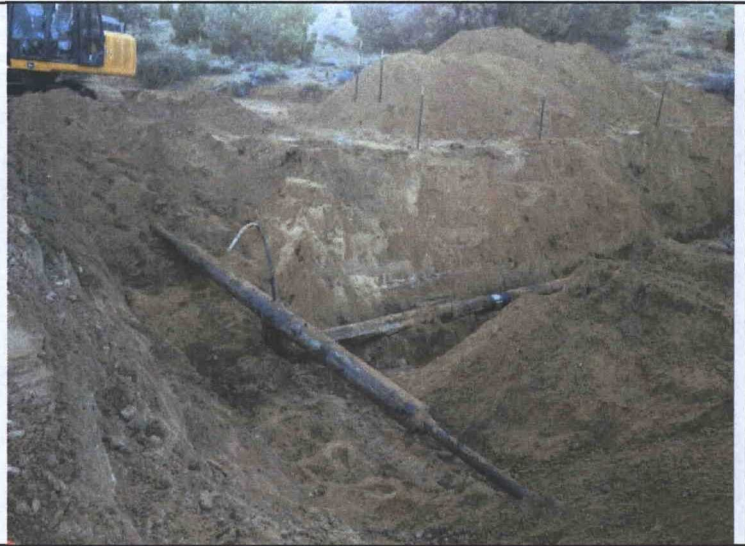
Photograph 2

View of the repaired pipeline, facing northeast.

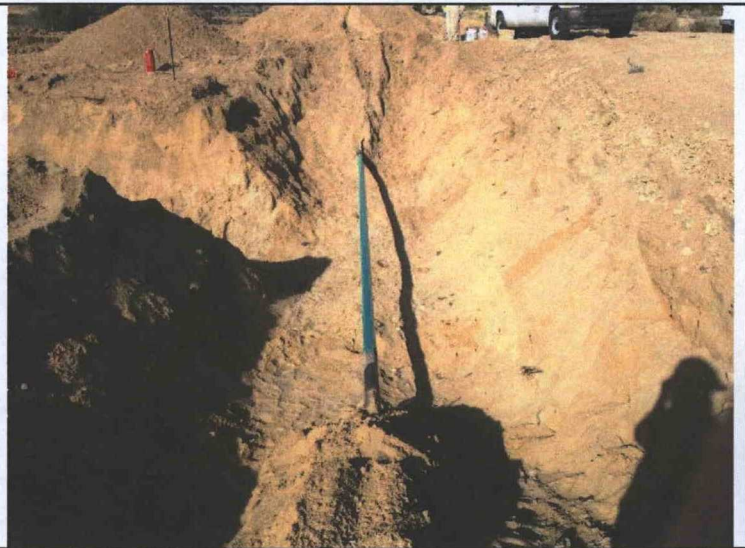
Photograph 3

View of the former line drip location and repaired pipeline, facing south.

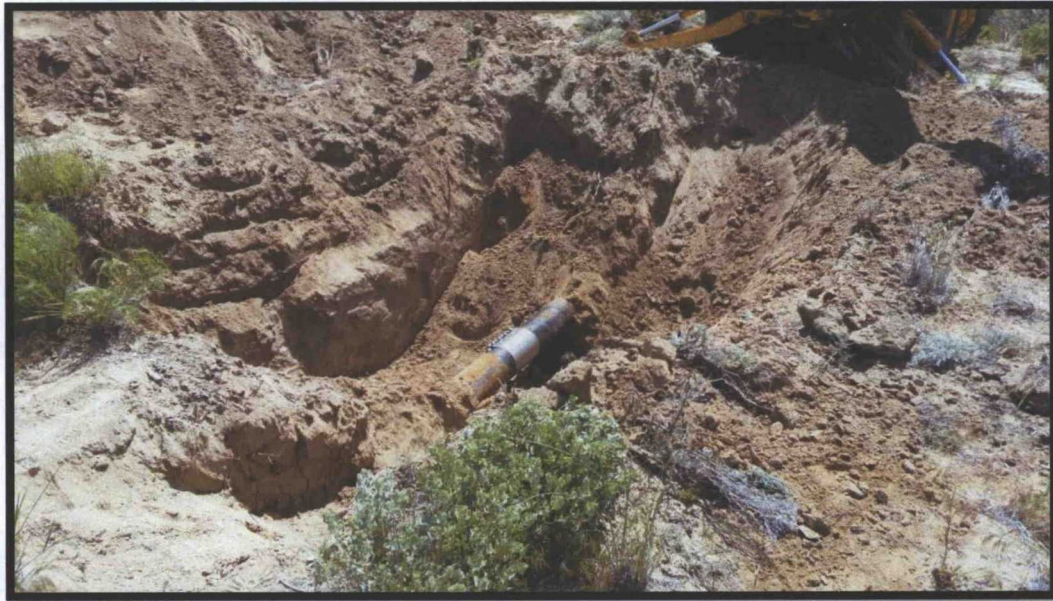
Photo 1: Lateral 2A-4 South site, initial excavation for pipeline inspection and repair, photo aspect to south west. Soil material consists of tight dry sandy clay.

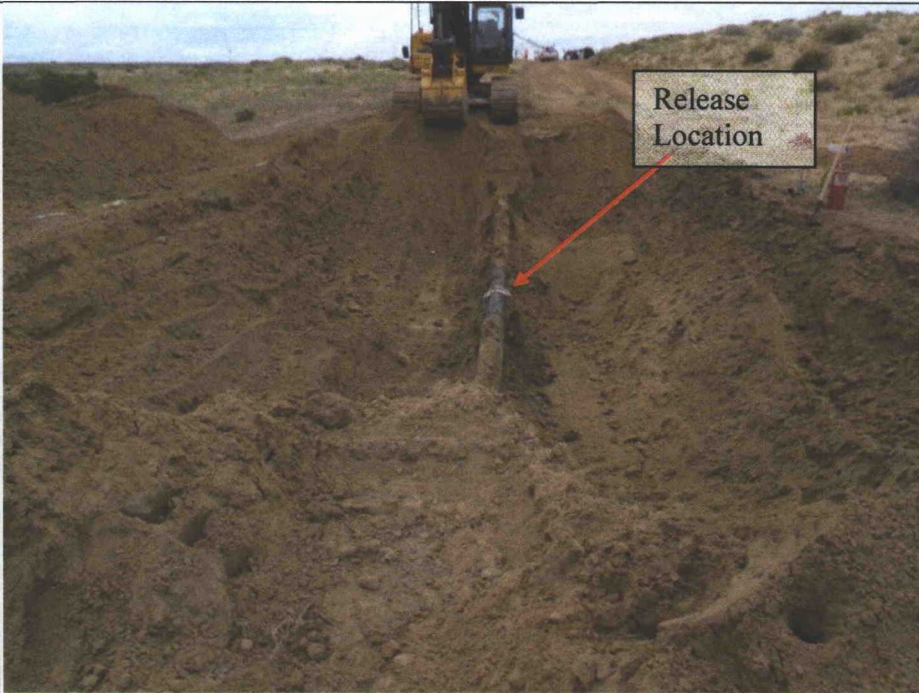
Photograph #3

Client: Enterprise Products	
Site Name: Lateral 10D-5 Pipeline Release	
Date Photo Taken: June 9, 2015	
Location: N36.50216, W108.07131 L-12-26N-12W San Juan County, New Mexico	
Photo Taken by: Deborah Watson	Description: facing SE, looking at excavation and exposed pipeline. Corrosion holes were repaired on June 9, 2015.

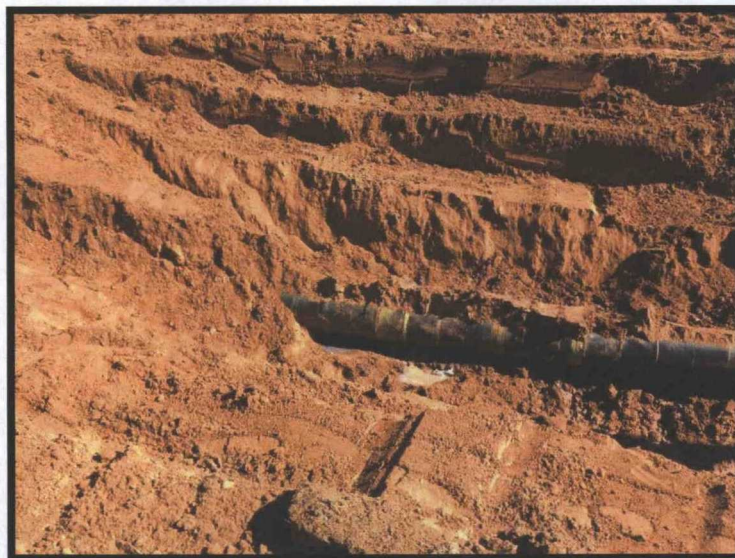
Photo 1: Trunk K #2 release point, result of failed I-Wrap repair, liquids visible in photo.

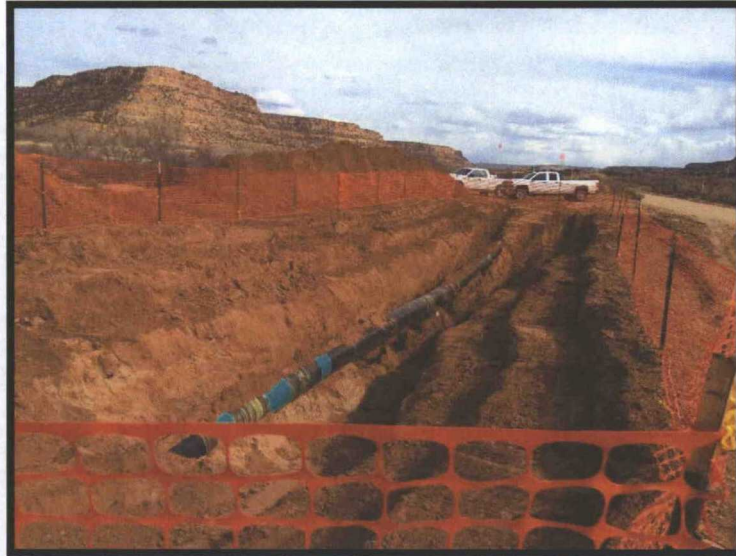
Photo 3: Trunk K #2 release location after repairs were completed in the spring of 2015.

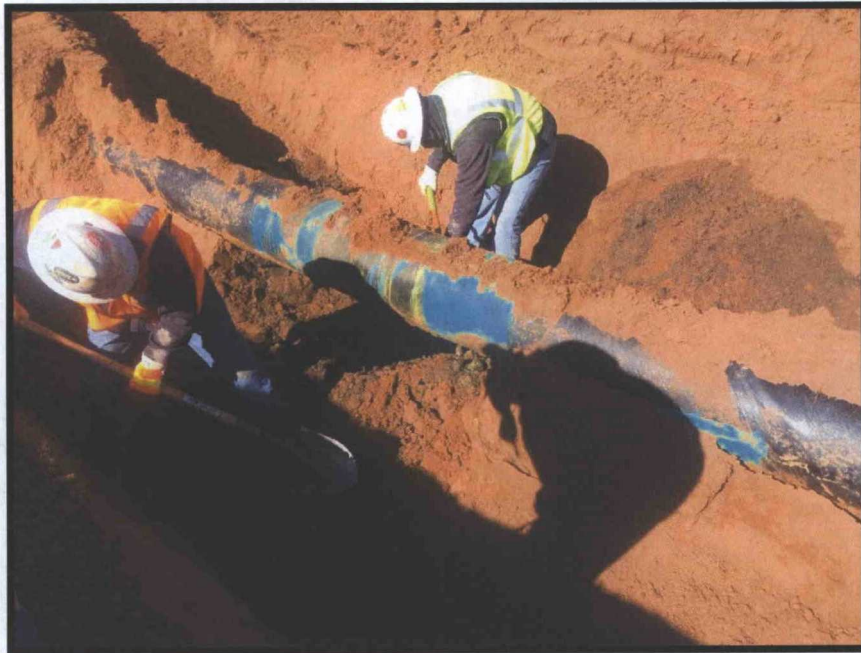
Photo 1: Trunk K #5 Excavation showing failed I-wrap repairs, impacted soil being removed from beneath the pipeline.

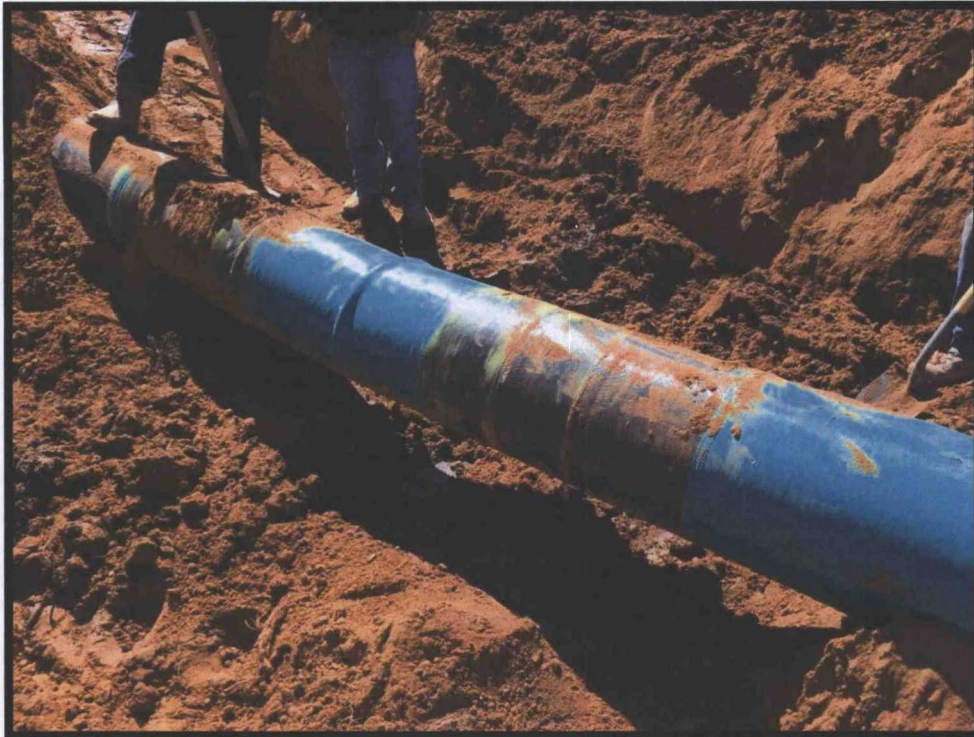
Photo 1: Trunk K #6 Excavation exposes the failed I-Wrap repair from October 2014.

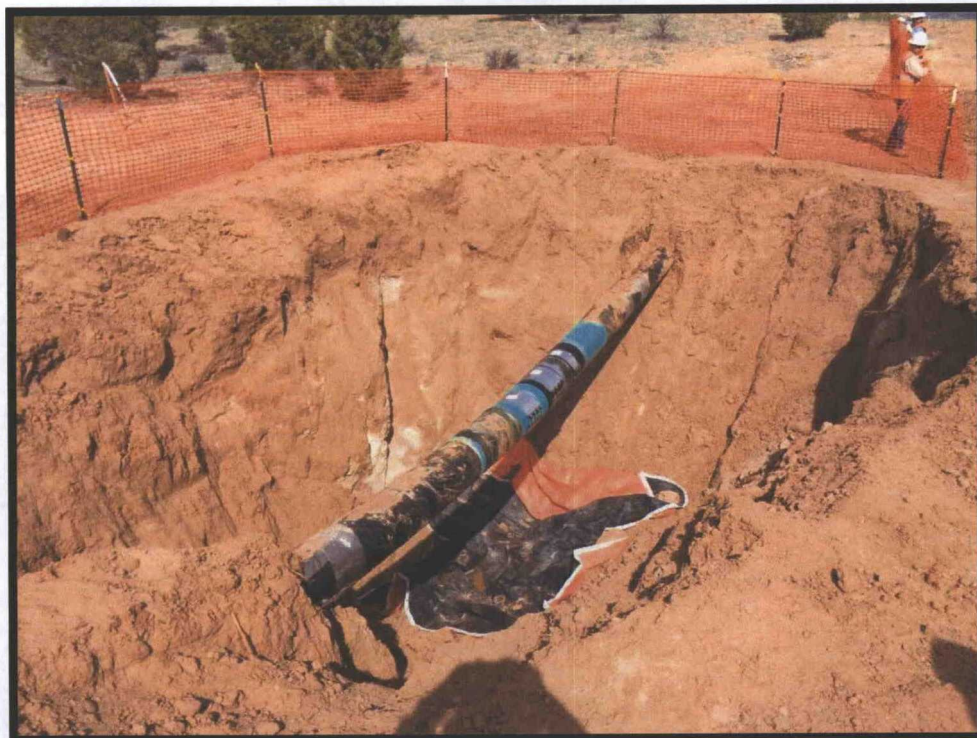
Photo 3: Trunk K #6 Excavation waiting for repair, plastic liner used to catch any liquids dripping from pipe before repairs took place.

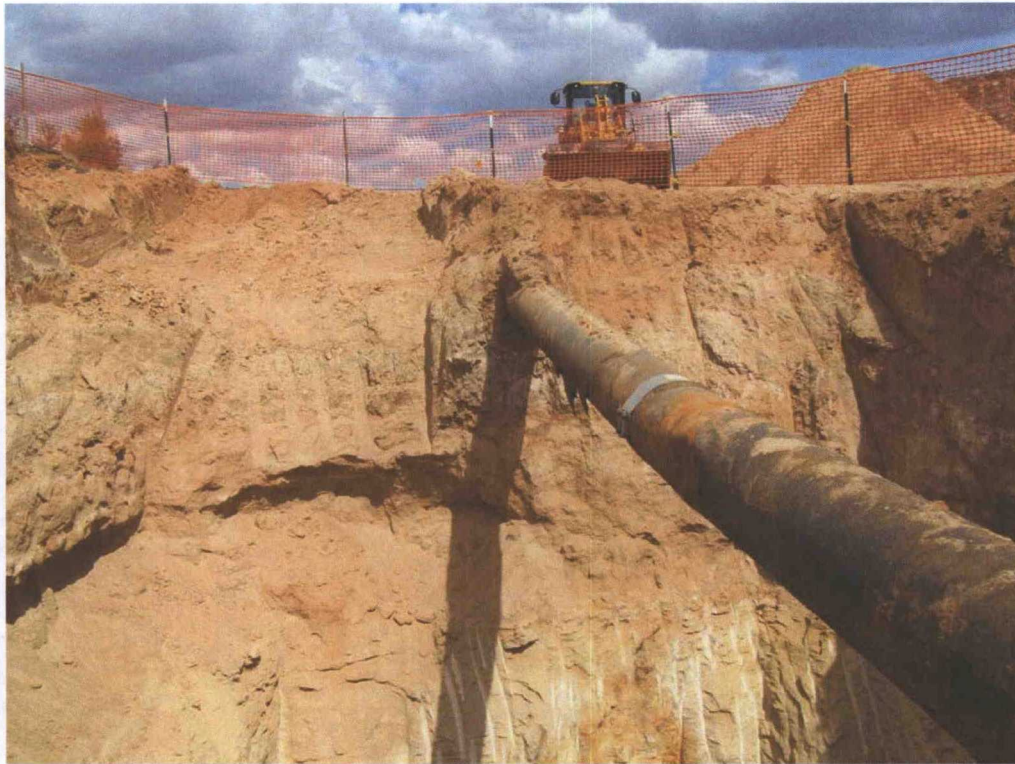
Trench 2 with repaired pipe.

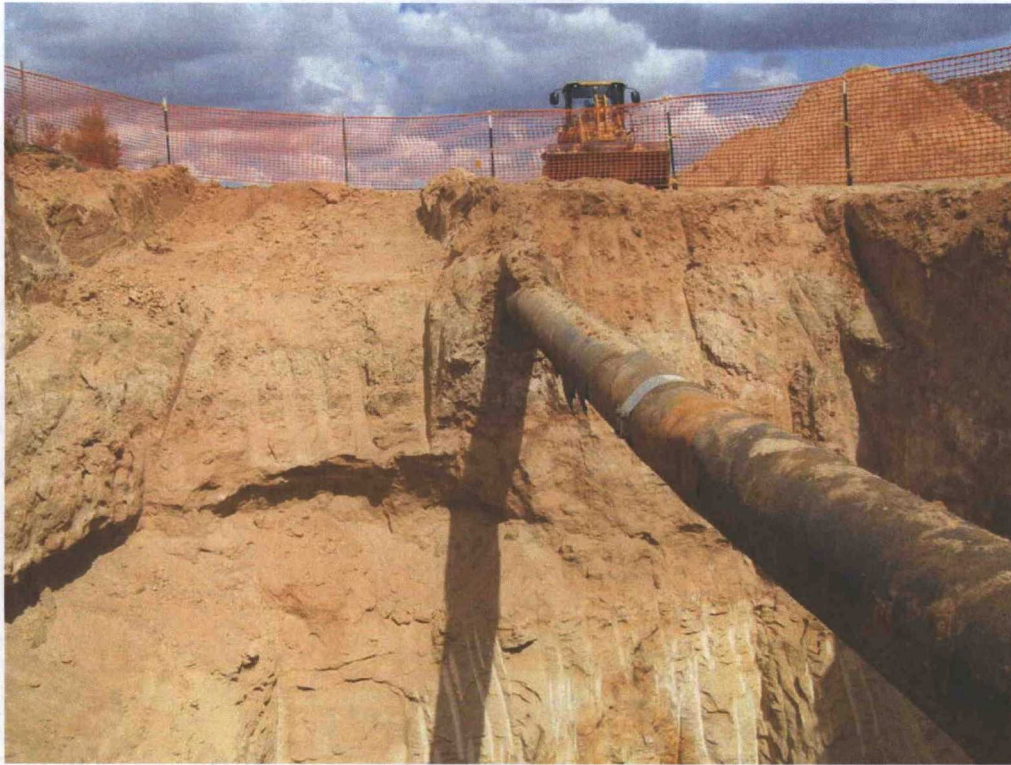
Trench 2 with repaired pipe.
