## SITE REMEDIATION SUMMARY

Southwest Royalties, Inc.  
Malaga A #002  
Section 2, Township 24S, Range 28E  
Eddy County, New Mexico

Re: **Closure Report  
Southwest Royalties, Inc.  
Malaga A #002  
Section 2, T-24-S, R-28-E  
Eddy County, New Mexico**

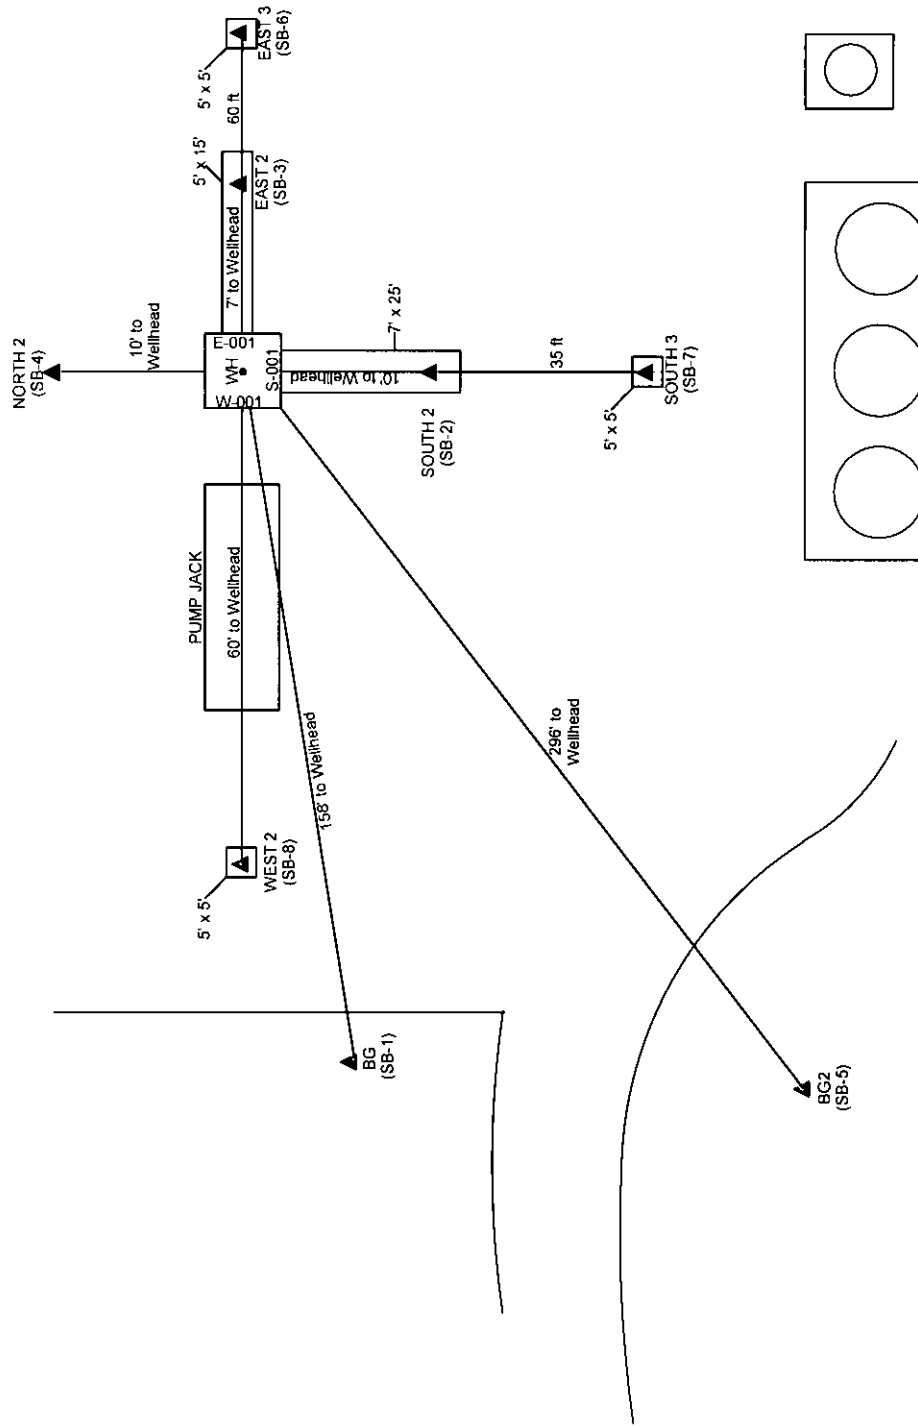
Excavation  
Sampling Events

After meeting with Mr. Bratcher, Harol Creech and Nick Williams met on location to begin remedial efforts. As agreed upon, all soils around the wellhead down to the cellar floor was excavated and placed on a liner. The heavily hydrocarbon stained soils have been disposed of at an approved off-site disposal facility. See attached waste disposal manifests. In addition to removing the soil around the wellhead, an area approximately 15 feet in length, 5 feet in width and 5 feet in depth was excavated on the east side of the wellhead. Similarly, an area 25 feet in length, approximately 7 feet in width and 5 feet in depth was excavated from the south side of the wellhead. These hydrocarbon-impacted soils were removed as a result of NMOCD site visits and analytical results.

There were also three additional locations that were excavated as required by Mike Bratcher, NMOCD. Locations denoted on the sample plan East3, South3 and West2 were excavated in a 5-foot by 5-foot area in order to remove hydrocarbon surface contamination. After these areas were excavated, chloride field-testing was performed and resulted in elevated chloride concentrations. A phone call was placed to Mike Bratcher of the NMOCD and after a discussion of the results and based on his multiple site visits he decided that due to the unique conditions on this location that it was not feasible to try and "chase chlorides." Mr. Bratcher requested sidewall and floor samples to confirm that TPH levels were reduced to below 100 ppm (parts per million) per the site ranking criteria form. The attached analytical report shows that the excavation performed achieved this.
