2RP-1300

## Report Type: Work Plan

**Re: Work Plan for the Cimarex Energy, White City 14 Fed Com #10, Section 14, Township 25 South, Range 26 East, Eddy County, New Mexico.**

Cimarex Energy  
White City 14 Fed Com #10  
Eddy County, New Mexico

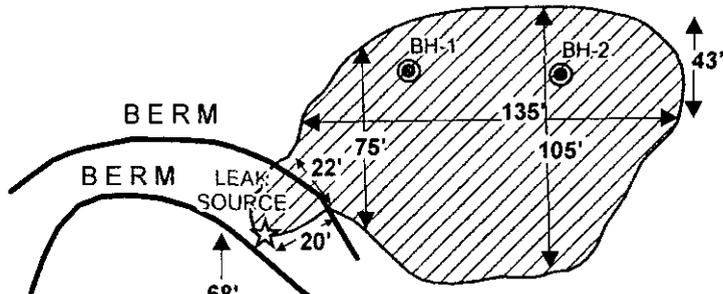
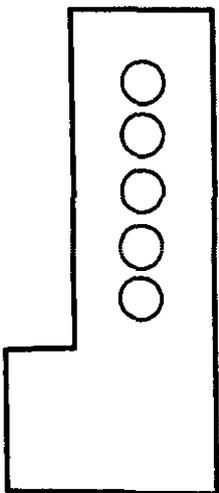
Figure 3

On September 20, 2013, Safety and Environmental Solutions, Inc. out of Hobbs, New Mexico personnel inspected and sampled the spill area. Two (2) bore holes (BH-1 & BH-2) were installed using a hollow stem auger drilling rig to assess the impacted soils. Selected samples were analyzed for TPH analysis by EPA method 418.1 modified, BTEX by EPA Method 8021B and chloride by EPA method 300.0. Copies of laboratory analysis and chain-of-custody documentation are included in Appendix C. The results of the sampling are summarized in Table 1. The bore hole locations are shown on Figure 3.

White City 14 Fed Com 10  
Spill Assessment Map  
Eddy County, New Mexico

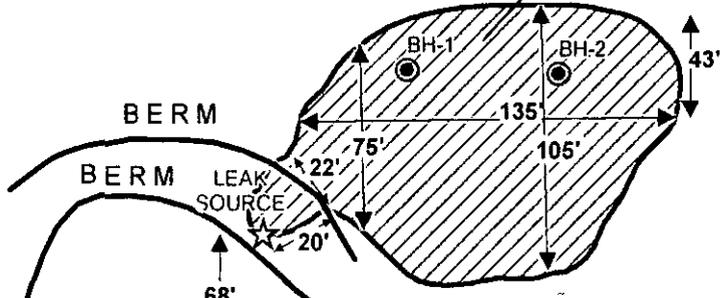
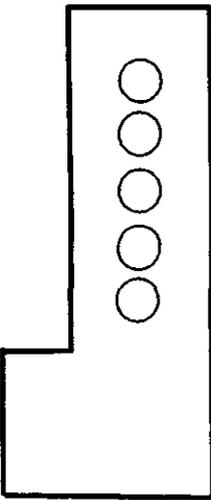
Figure 4

4' - 5' DEEP W/ LINER

White City 14 Fed Com 10  
 Proposed Excavation Area & Depth Map  
 Eddy County, New Mexico

Cimarex proposes to remove impacted material as highlighted (green) in Table 1 and shown on Figure 4. The area of BH-1 and BH-2 will be excavated to a depth of approximately 4.0' to 5.0' below surface and a 40 mil liner will be installed. The excavated areas will be backfilled with clean backfilled material to grade. The excavated material will be transported to proper disposal.

The proposed excavation depths may not be reached due to wall cave ins and safety concerns for onsite personnel. In addition, impacted soil around oil and gas equipment, structures or lines may not be feasible or practicable to be removed due to safety concerns for onsite personnel. As such, Tetra Tech will excavate the impacted soils to the maximum extent practicable. The remaining impact will be deferred until the abandonment of the facility.

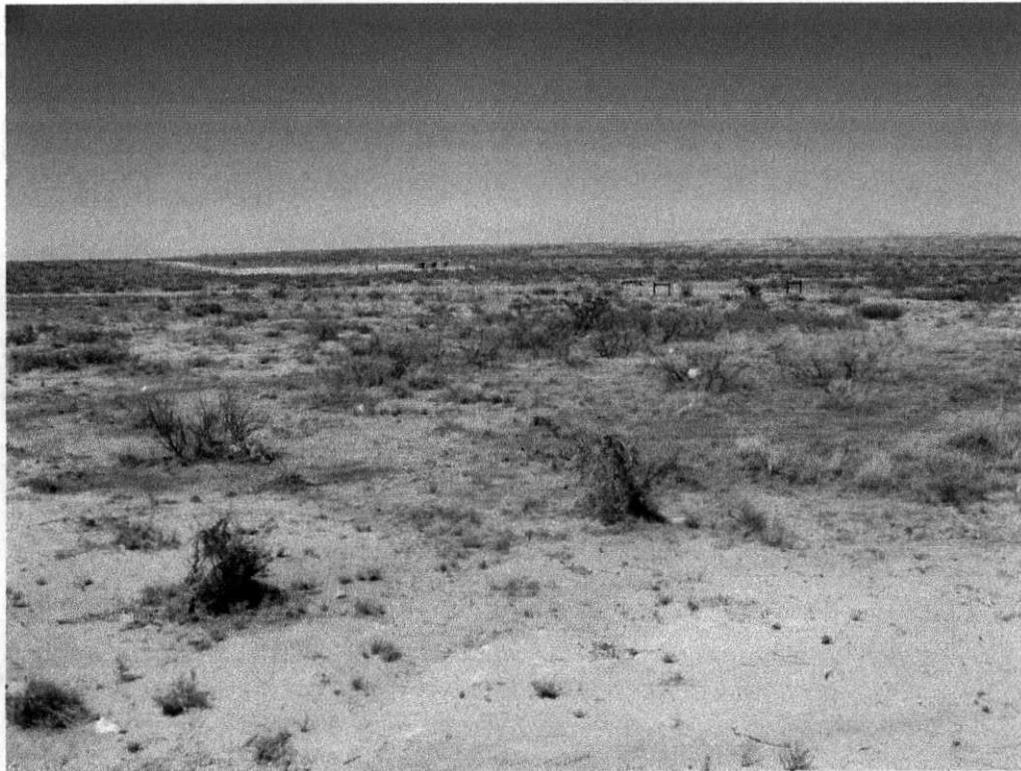
According to the State of New Mexico C-141 Initial Report, the leak was discovered on August 6, 2012, and released approximately ten (10) barrels of acid from a frac tack. None of the released acid was recovered. The spill affected an area of approximately 75' x 135' in the pasture. The initial C-141 form is enclosed in Appendix A.

View Northeast – Spill area in pasture.

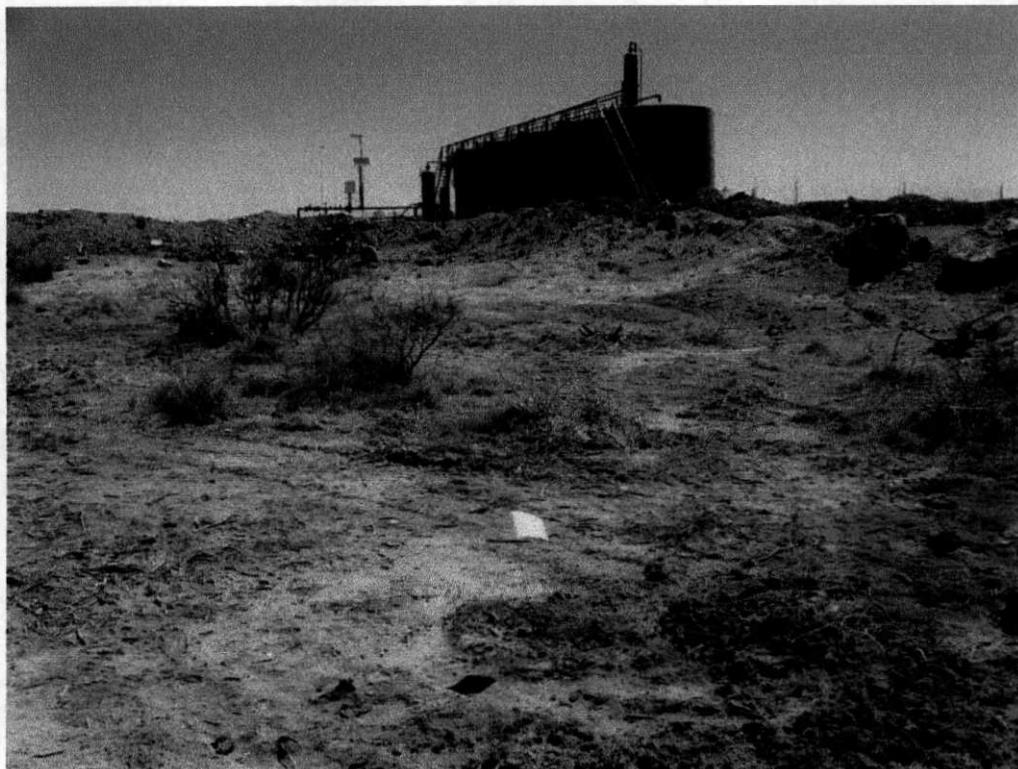
Referring to Table 1, bore hole samples were below the RRAL for BTEX. A shallow TPH impact of 147 mg/kg was detected in BH-1 at 15' and 172 mg/kg in BH-2 at 5' below surface and declined to <100 in BH-1 at 20' and <100 in BH-2 at 10' below surface.

A chloride impact was detected in bore holes BH-1 and BH-2, which showed a maximum chloride concentration at the surface (0-1') of 30,800 mg/kg and 22,000 mg/kg, respectively. The chloride concentrations in BH-1 declined with depth showing 17,400 mg/kg at 10' and 464 mg/kg at 15' below surface. The chloride concentrations in BH-2 showed 5,860 mg/kg at 10' and 944 at 15' below surface.

View Southwest– Area of BH-1.

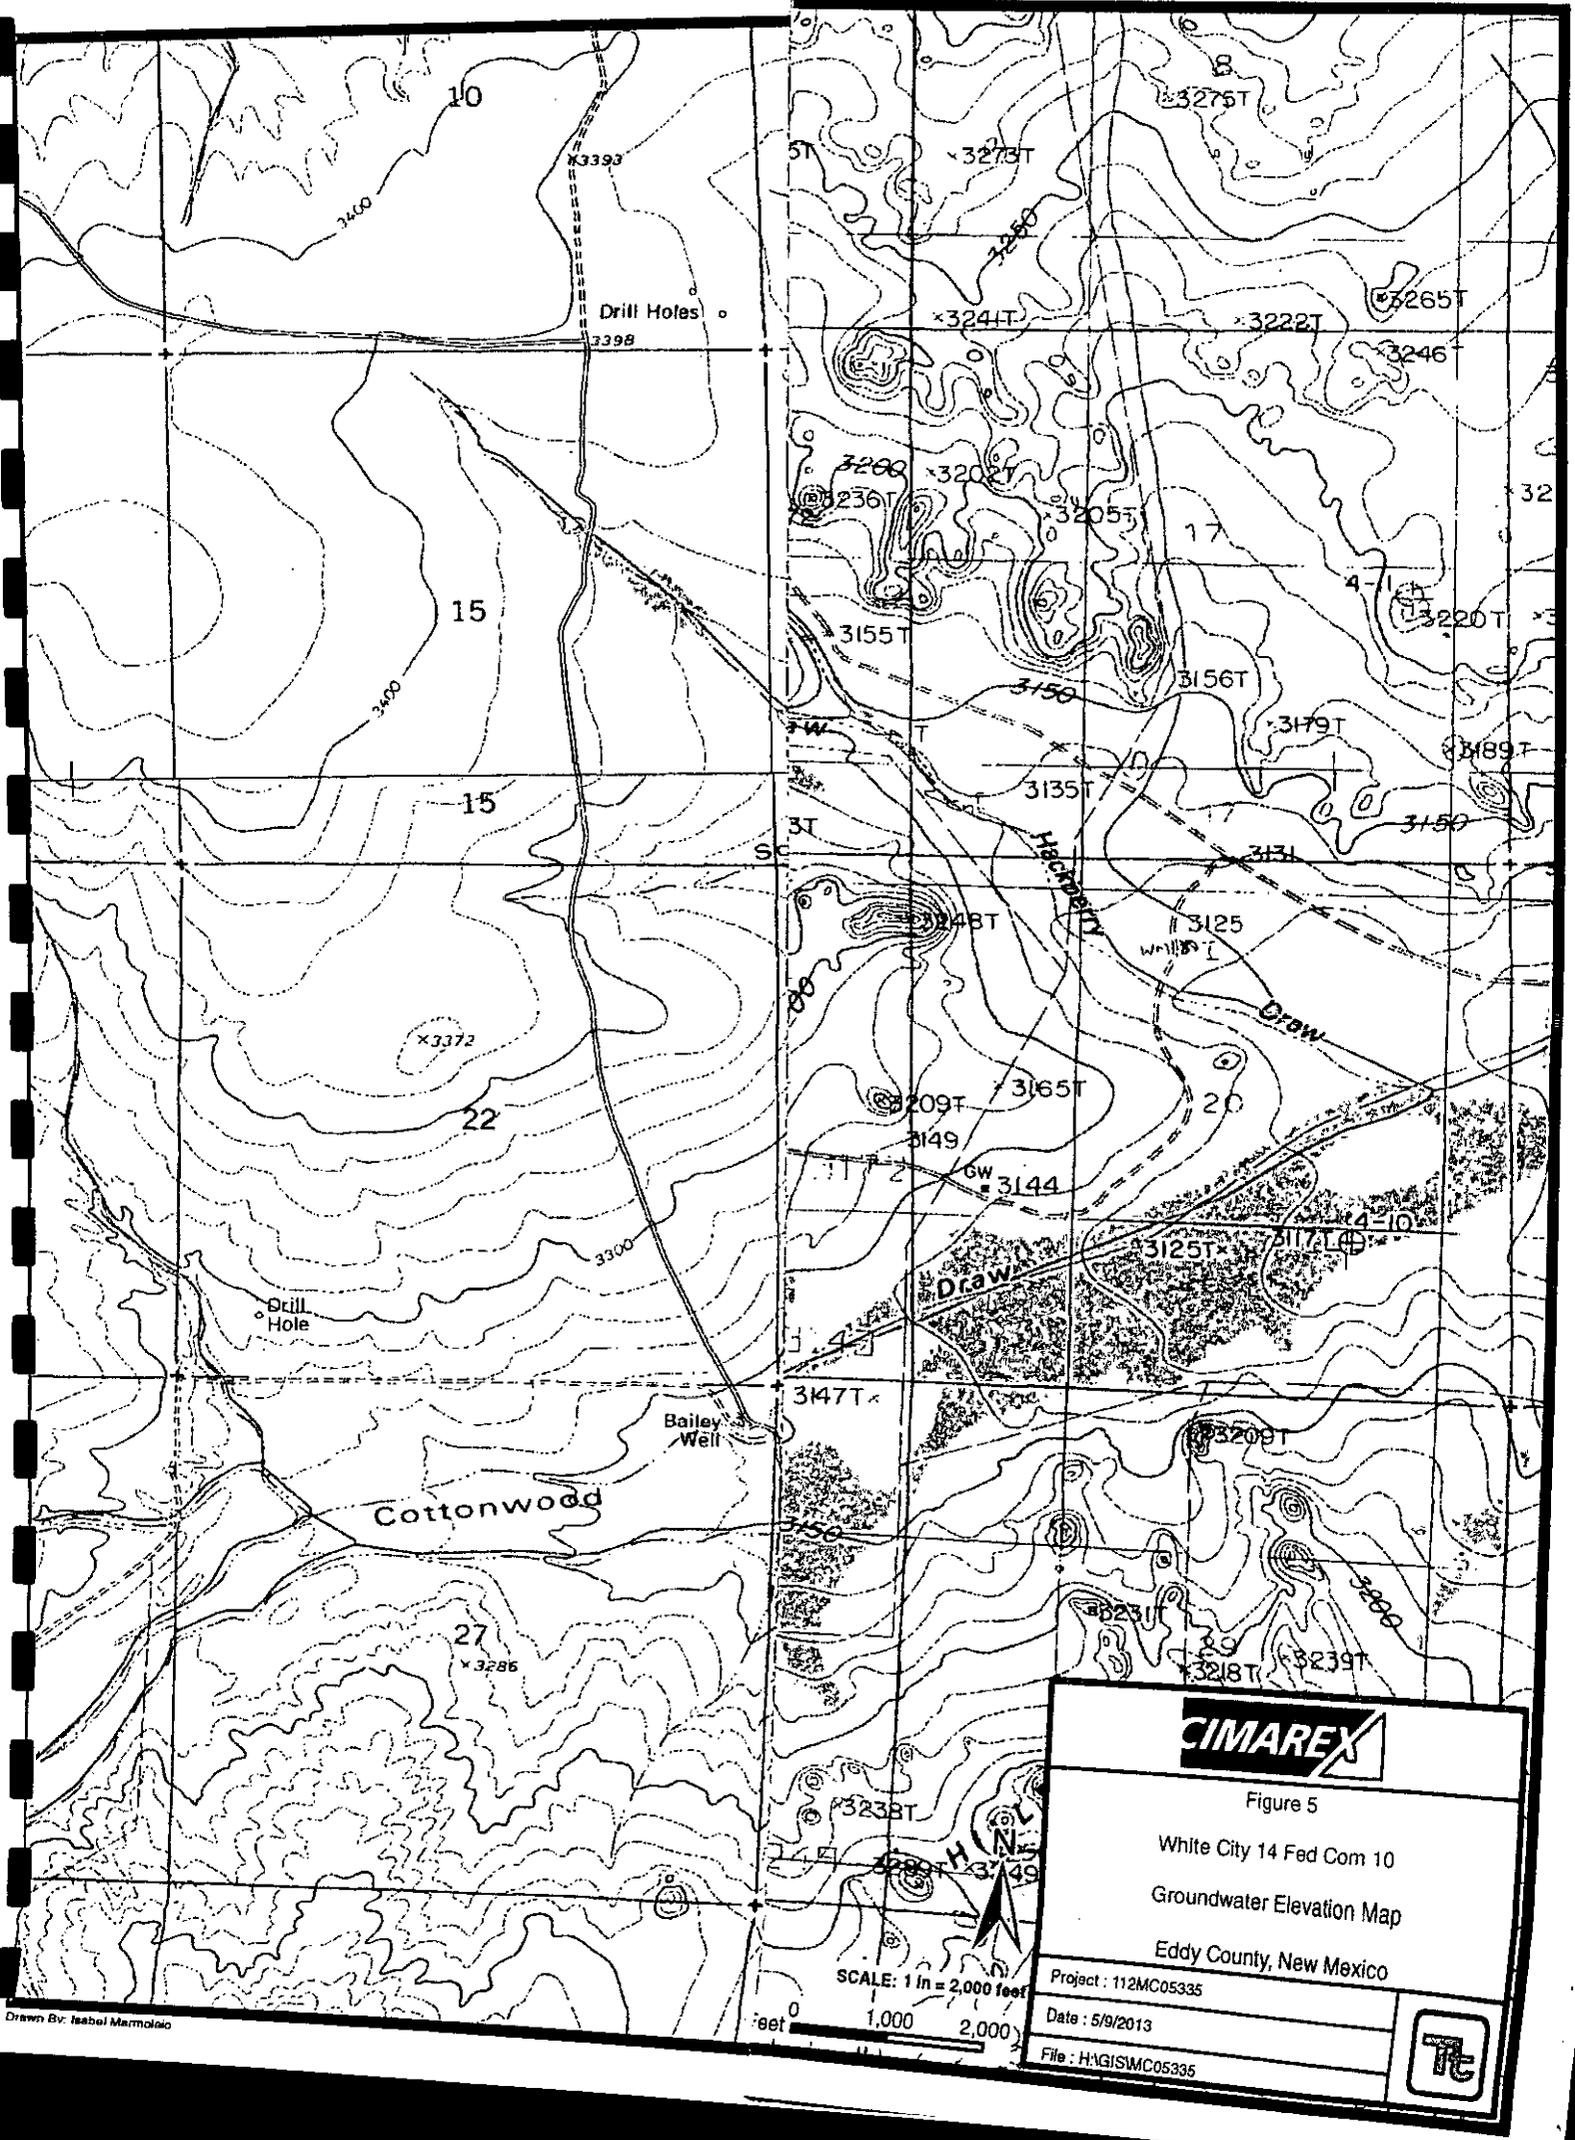
Based on the Site surface elevation of 3,350 feet, the projected water level at the Site should be greater than 100 feet bgs. In addition, it appears the majority of the shallow groundwater may be limited to the alluvial sand and gravel deposits in the vicinity of Cotton Wood Draw. A topographical map showing the surface elevations (Figure 5), The New Mexico State Engineer, and USGS water well reports are shown in Appendix B.

<b>CIMAREX</b>	
Figure 5	
White City 14 Fed Com 10	
Groundwater Elevation Map	
Eddy County, New Mexico	
Project : 112MC05335	
Date : 5/9/2013	
File : H:\GIS\MC05335
