Release Notification and Corrective Action

XTO Energy, Inc.
Eunice Monument South Unit Satellite #4
Township 22 South, Range 36 East, Section 6
Lea County, New Mexico

Delineation Report/Work Plan

March 2, 2011

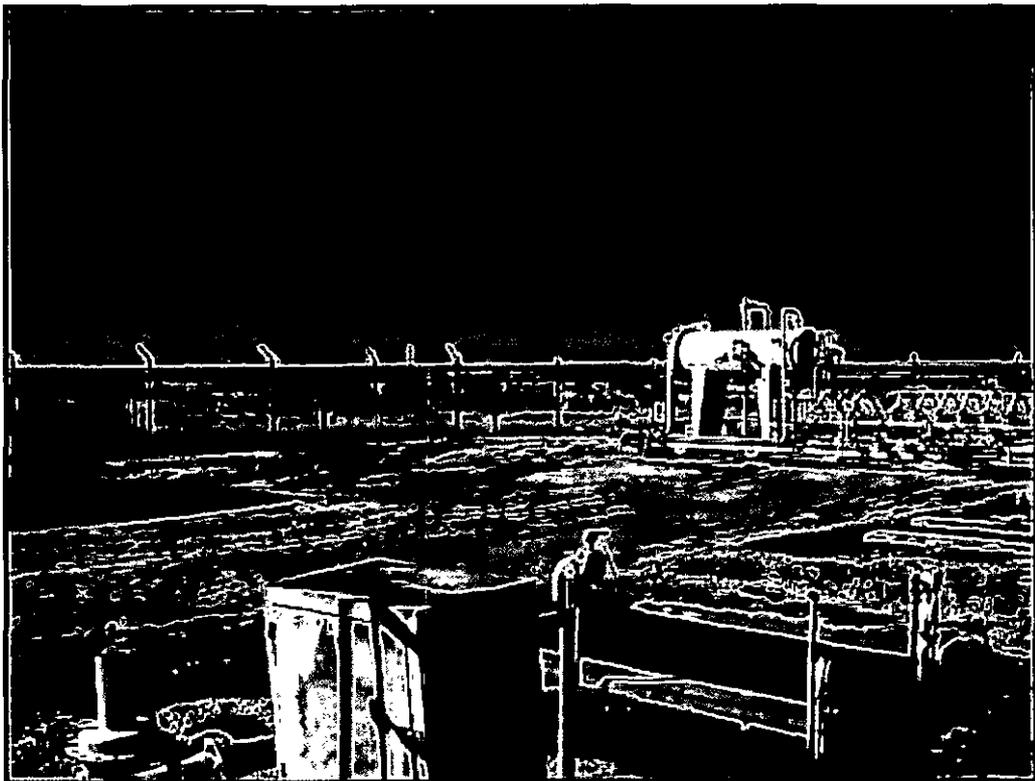
Release area facing northwest

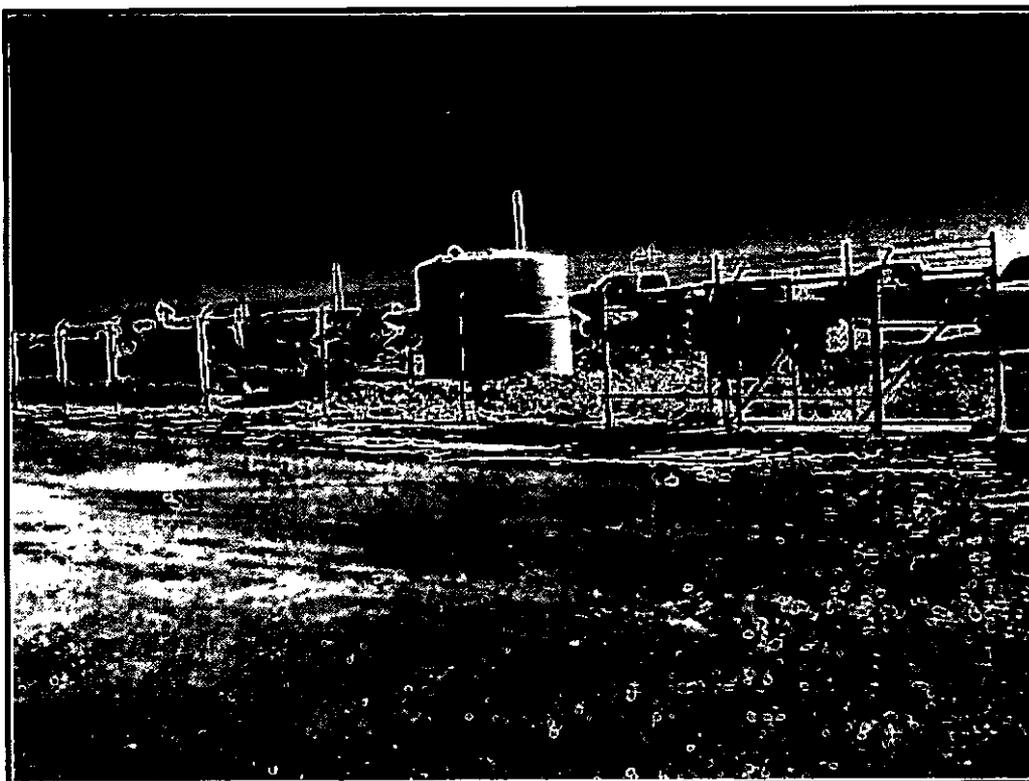
Release area facing south
