**3R-1011**

**Release Report/ General  
Correspondence**

**Enterprise SJ**

**Date: Oct-Dec 2015**

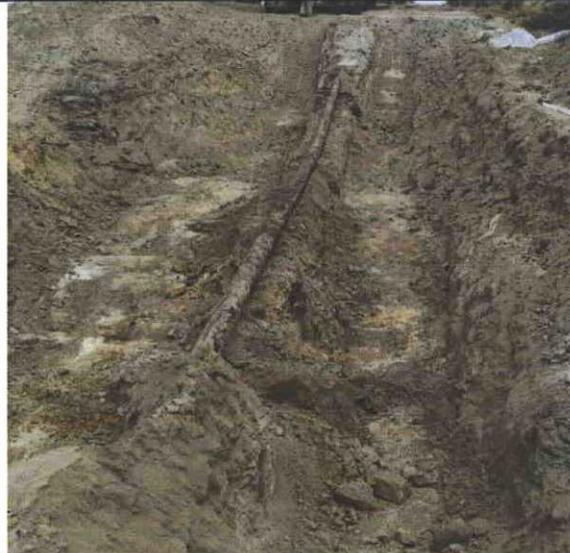
**Photograph 1**

View of the fully exposed Lateral 2B-24 pipeline and initial excavation, facing east.

Beginning on July 28, 2015, Enterprise initiated excavation activities at the Site to repair the subsurface leak, and remediate potential hydrocarbon impact. The pipeline was subsequently repaired by replacing approximately 40 feet of pipe. Natural gas was released from the pipeline as a result of internal corrosion. The surface expression of the release was identified by soil discoloration at the ground surface and a small liquid flow path to the north of the release. Moist subsurface soil conditions at the time prevented significant vertical migration of the liquids that surfaced. During corrective action activities, West States Contractors, Inc., provided heavy equipment and labor support. Kyle Summers and Rane Deechilly, Apex environmental professionals, provided environmental support.

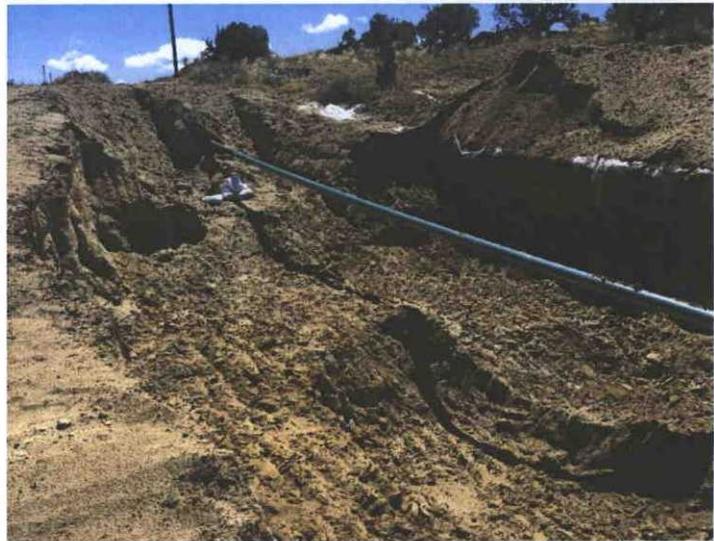
**Photograph 2**

View of the final excavation and repaired pipeline, facing southeast.

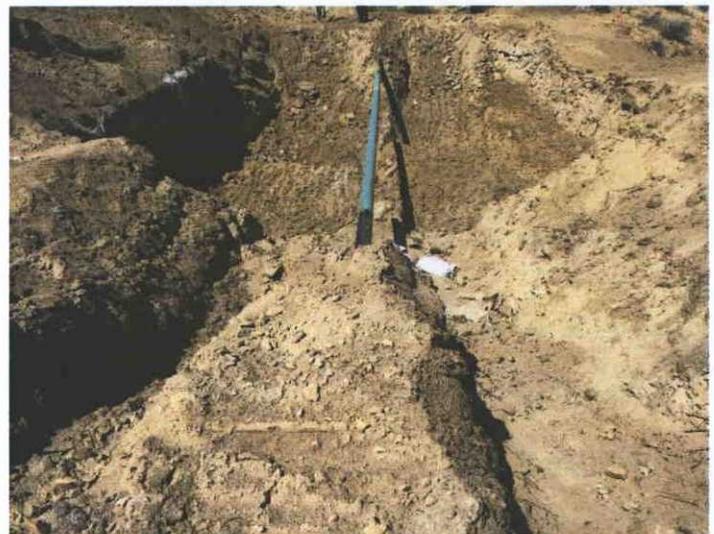
**Photograph 3**

View of the final excavation, facing west.

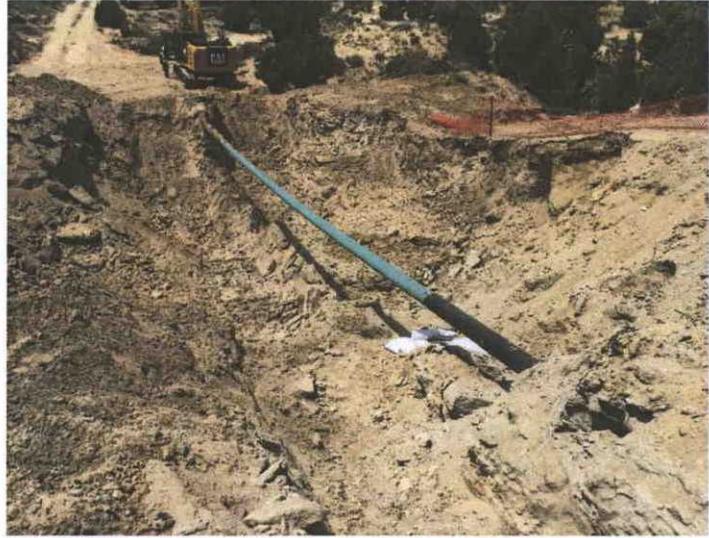
**Photograph 4**

View of the over-excavated Site,  
facing northwest.

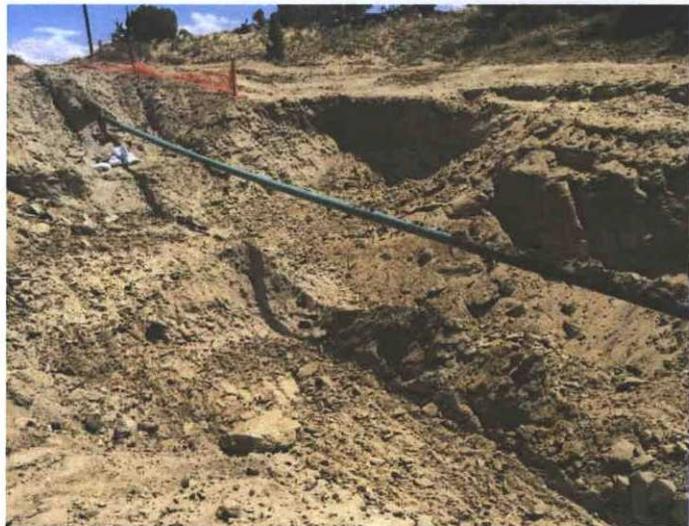
**Photograph 5**

View of the over-excavated Site,  
facing southeast.

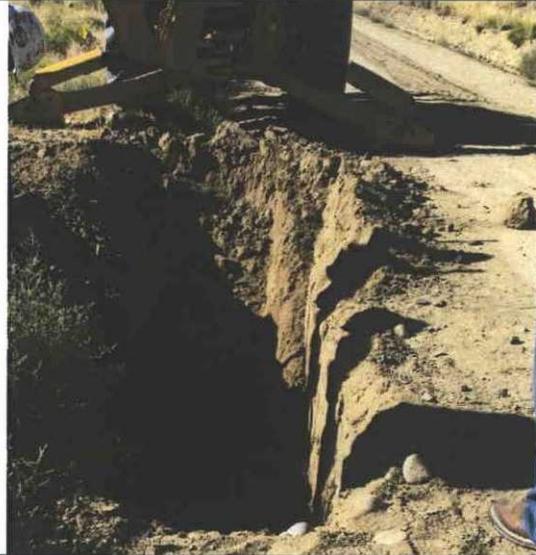
**Photograph 1**

View of early excavation activities, facing south.

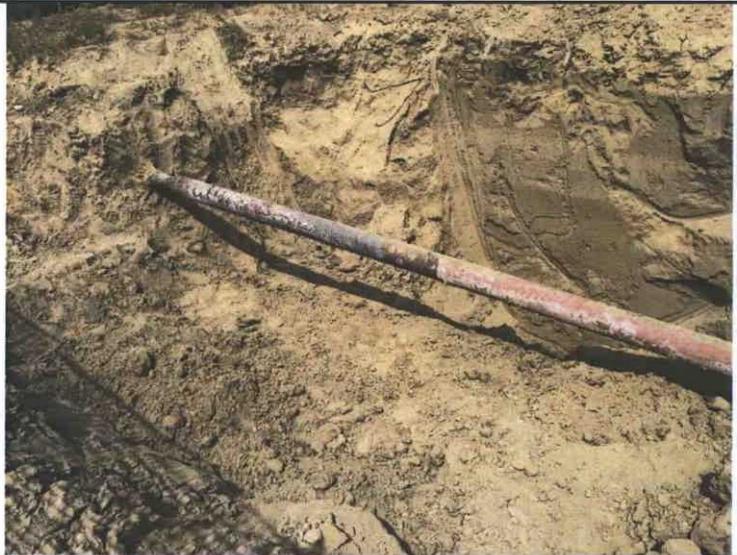
**Photograph 2**

View of the fully exposed Lateral 2A-4 pipeline and initial excavation, facing northeast.

After a brief delay to evaluate pipeline repair options (the leak was located relatively near a pipe reduction weld connecting a 6-inch diameter pipe with a 4-inch diameter pipe), excavation activities were completed on August 10, 2015, resulting in a final excavation measuring approximately 27 feet long by 15 feet wide, with a total depth of approximately 11.5 feet bgs. Confirmation soil samples C-1 through C-8 were collected from the sidewalls and base of the excavation.

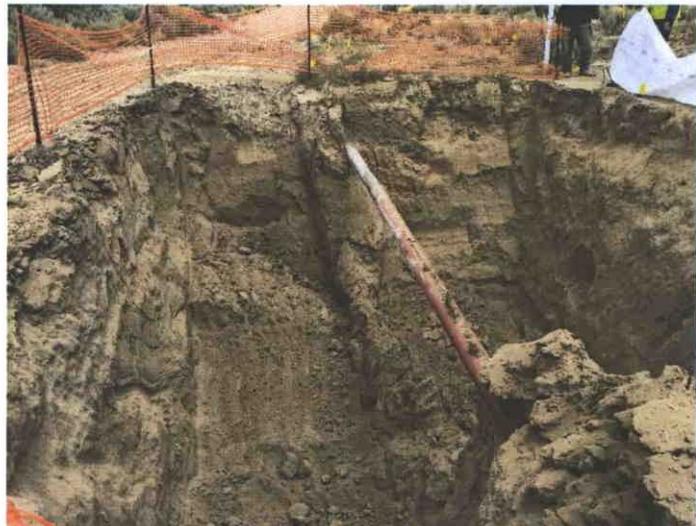
**Photograph 3**

View of the final excavation, facing north.

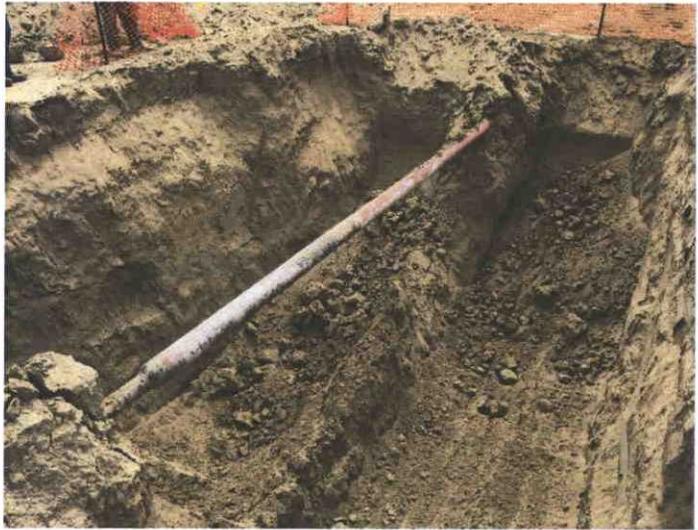
**Photograph 4**

View of the final excavation, facing southeast.

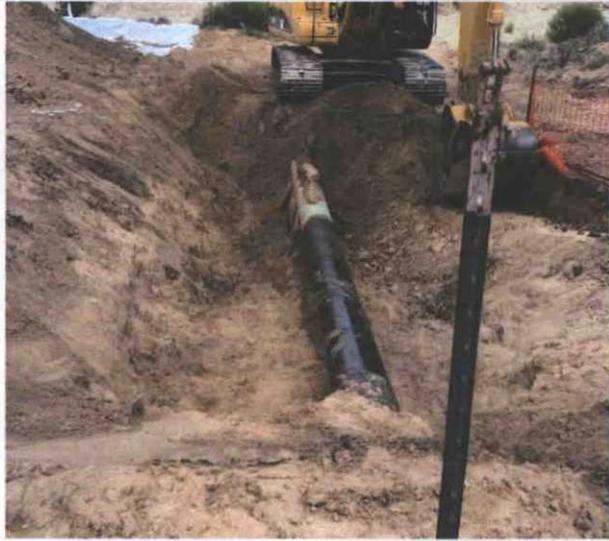
**Photograph 1**

View of the partially exposed Lateral 2C pipeline, facing northeast.

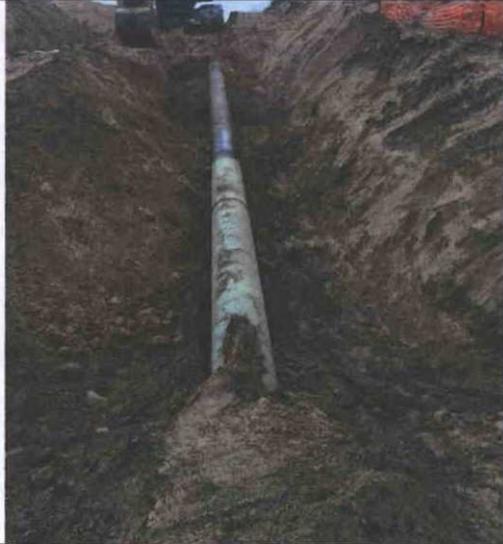
**Photograph 2**

View of the initial excavation and fully exposed pipeline, facing southwest.

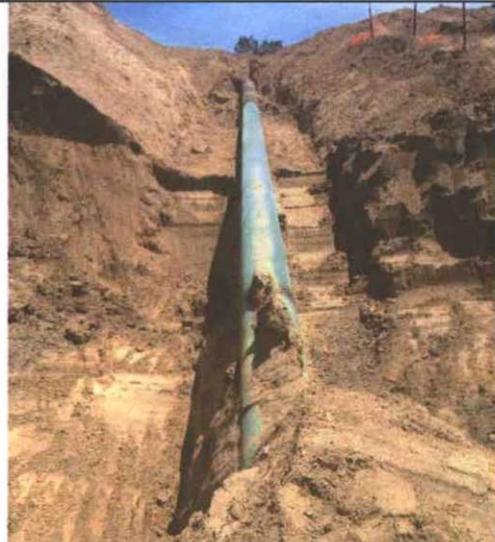
**Photograph 3**

View of the final excavation and repaired pipeline, including additional excavation to replace a longer section of pipeline, facing southwest.

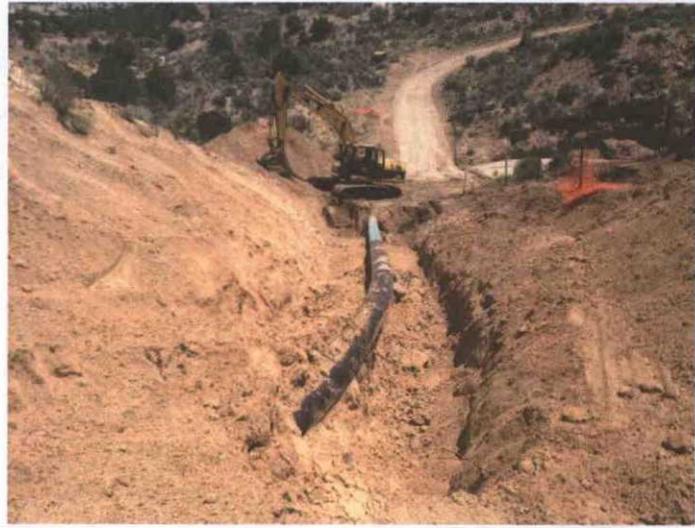
**Photograph 4**

View of the final excavation and repaired pipeline, including additional excavation to replace a longer section of pipeline, facing northwest.

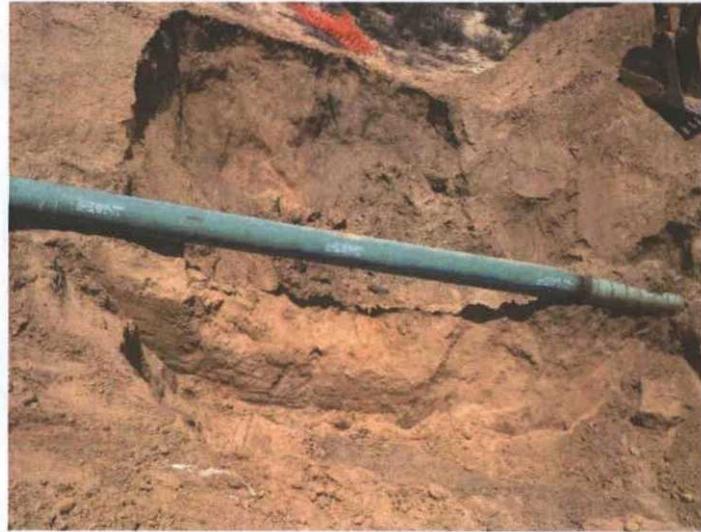
**Photograph 5**

View of the final excavation and repaired pipeline, facing north.

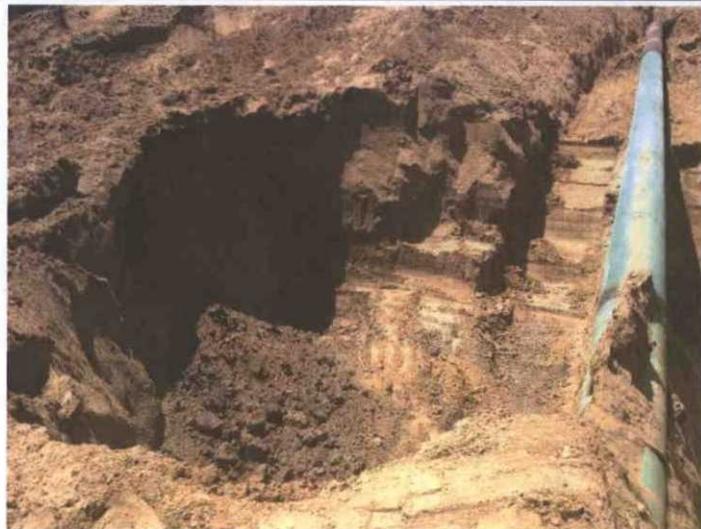
**Photograph 5**

View of the final excavation and repaired pipeline, facing south.

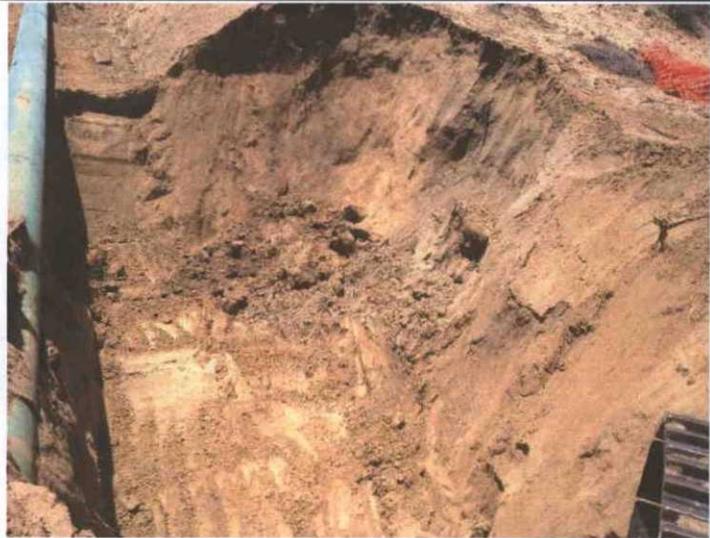
**Photograph 5**

View of the final excavation and repaired pipeline, facing southwest.

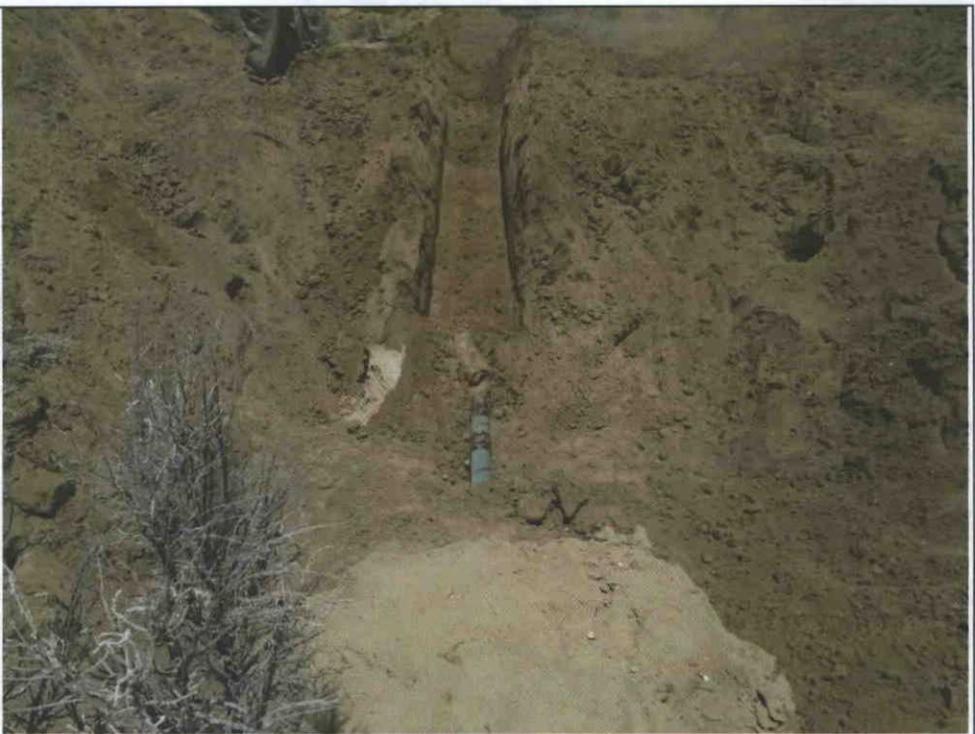
Photograph #1

Client: Enterprise	
Site Name:  Navajo C #2M Well Tie Pipeline (7/10/15) Release	
Date Photo Taken: July 24, 2015	
Release Location: N36.53067, W107.72828  L-21-27N-4W San Juan County, NM	
Photo Taken by: Debbie Watson	
Description: Facing north, general view of initial excavation activities.

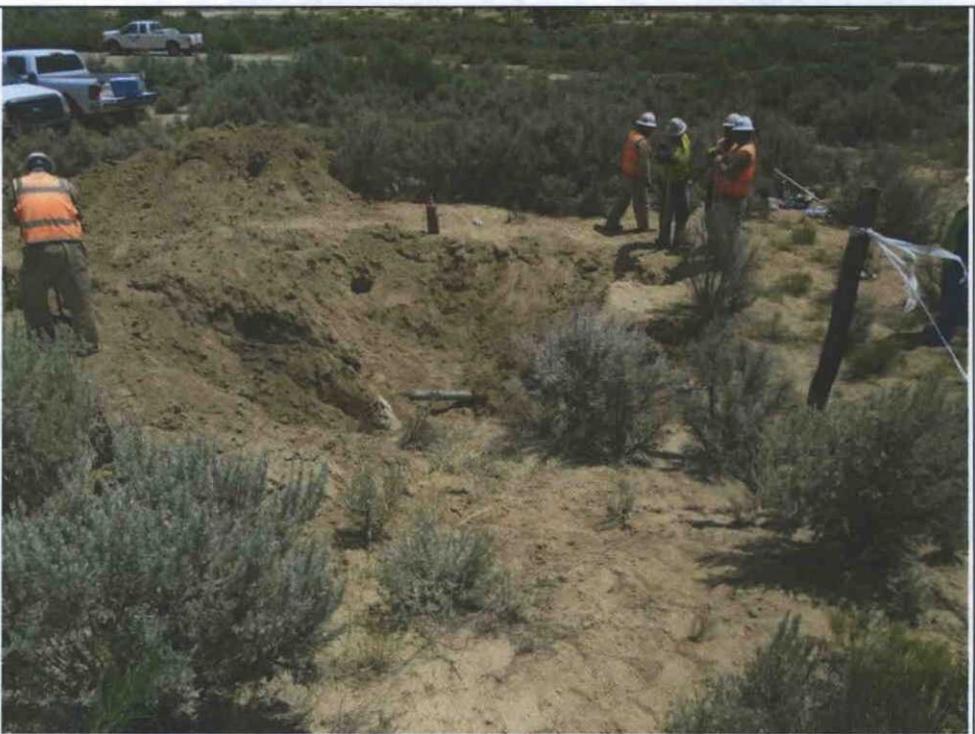
Photograph #2

Client: Enterprise	
Site Name:  Navajo C #2M Well Tie Pipeline (7/10/15) Release	
Date Photo Taken: July 24, 2015	
Release Location: N36.53067, W107.72828  L-21-27N-4W San Juan County, NM	
Photo Taken by: Debbie Watson	
Description: Facing east, general view of initial excavation activities.

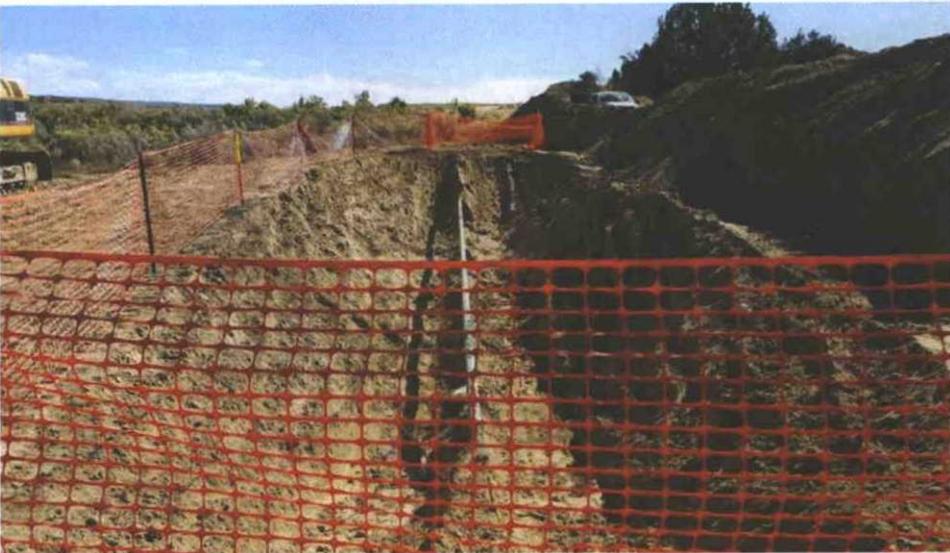
Photograph #3

Client: Enterprise	
Site Name:  Navajo C #2M Well Tie Pipeline (7/10/15) Release	
Date Photo Taken: October 1, 2015	
Release Location: N36.53067, W107.72828  L-21-27N-4W San Juan County, NM	
Photo Taken by: Heather Woods	
Description: Facing south, general view of the final excavation.
