Release Notification and Corrective Action

**Cimarex Energy Company
Pipeline Deep Federal Com #1
Section 7, Township 19S, Range 34E
Lea County, New Mexico**

Closure Report

January 28, 2011

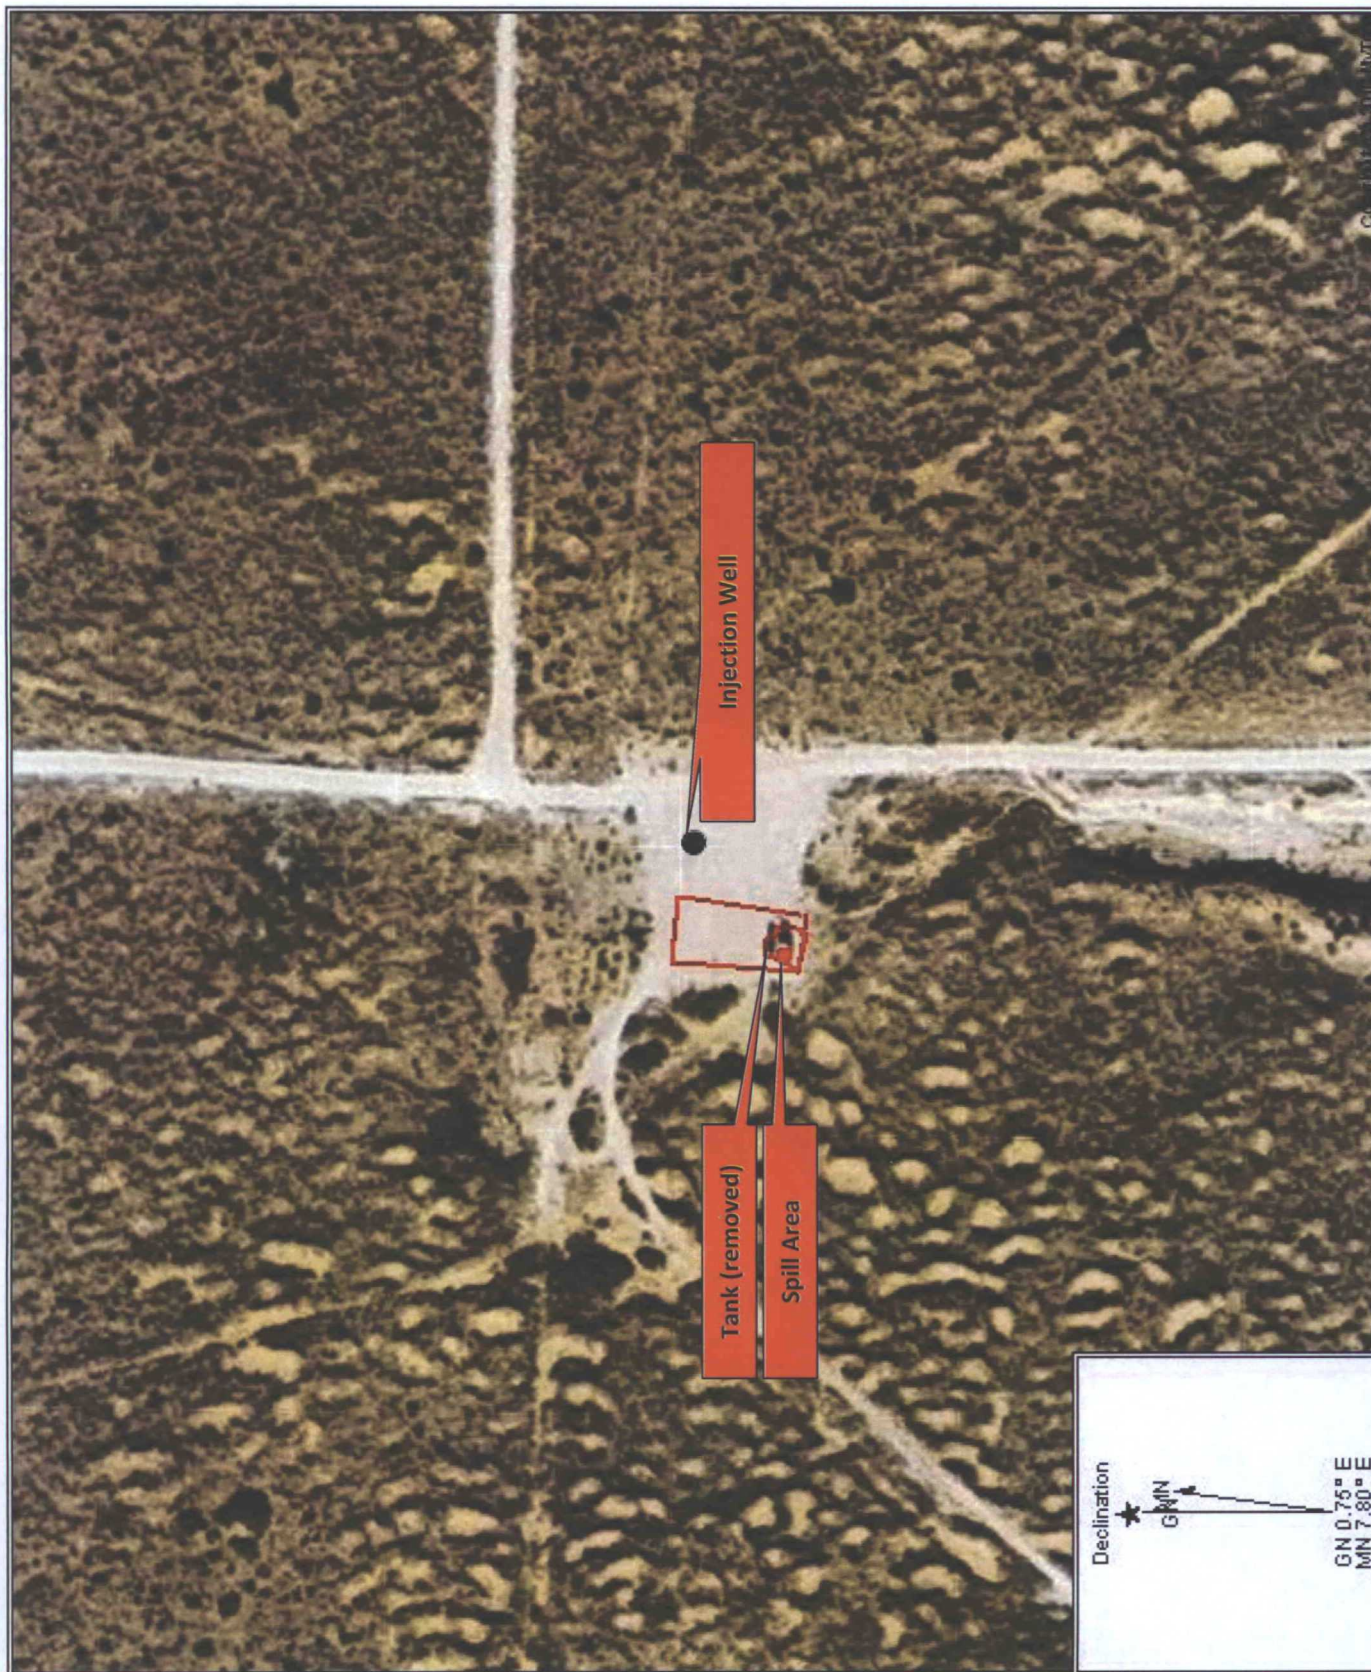
Figure 2 – Site Map

Map Name: SW IRONHOUSE Scale: 1 inch = 250 ft. Map Center: 032° 40' 35.48" N Horizontal Datum: WGS84

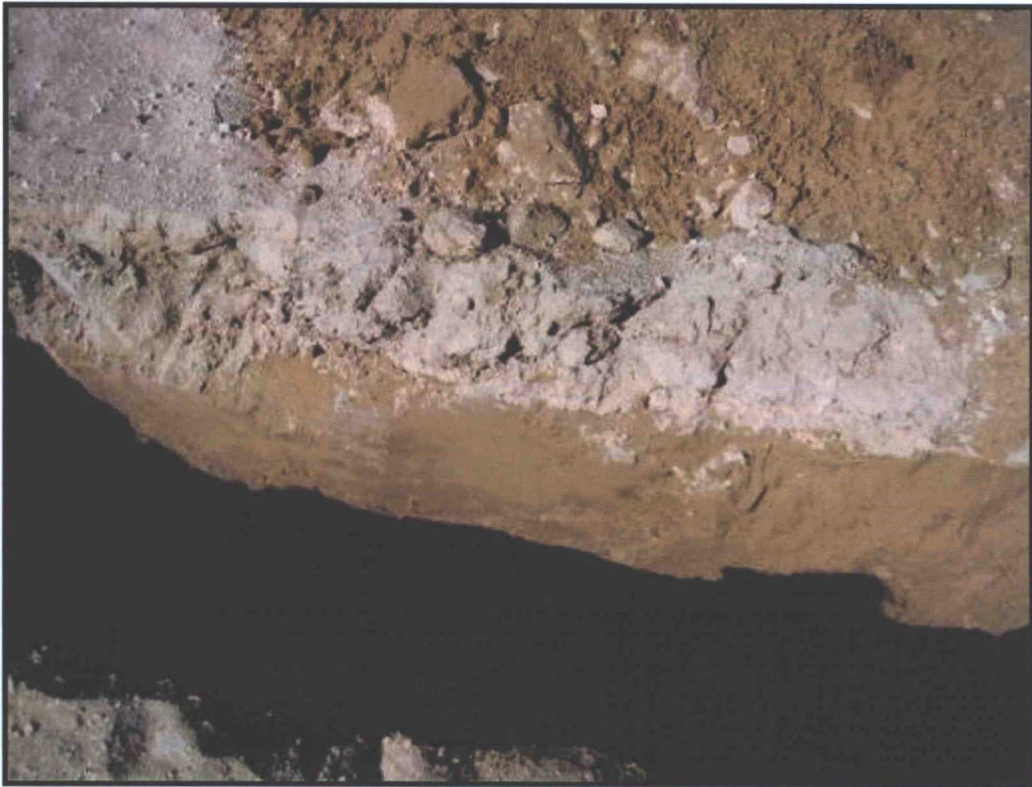
Test Trench #1

On December 15, 2010, SESI was onsite with Hungry Horse, LLC. to install five (5) test trenches (TT) in the southwest corner of location pad. Grab samples were retrieved at depths ranging from one (1) foot below grade surface (bgs), to five (5) feet bgs. Comparative samples were transported under Chain of Custody to Cardinal Laboratories in Hobbs, New Mexico to be analyzed for Chlorides (EPA Method 4500B) Total Petroleum Hydrocarbons (TPH EPA Method 418.1) and Benzene, Toluene, Ethyl Benzene, and Total Xylenes (BTEX EPA Method 8021B).

Sample ID	Chlorides (mg/kg)	TPH 418.1 (mg/kg)	Benzene (mg/kg)	Toluene (mg/kg)	Ethylbenzene (mg/kg)	Xylenes (mg/kg)
TT #1 1'bgs	<16.0	<100	<0.050	<0.050	<0.050	<0.150
TT #1 3'bgs	<16.0	<100	<0.050	<0.050	<0.050	<0.150
TT #2 1'bgs	<16.0	<100	<0.050	<0.050	<0.050	<0.150
TT #2 3'bgs	<16.0	<100	<0.050	<0.050	<0.050	<0.150
TT #3 1'bgs	<16.0	<100	<0.050	<0.050	<0.050	<0.150
TT #3 3'bgs	<16.0	<100	<0.050	<0.050	<0.050	<0.150
TT #4 1'bgs	<16.0	406	<0.050	<0.050	<0.050	<0.150
TT #4 3'bgs	<16.0	<100	<0.050	<0.050	<0.050	<0.150
TT #4 5'bgs	<16.0	<100	<0.050	<0.050	<0.050	<0.150
TT #5 1'bgs	<16.0	<100	<0.050	<0.050	<0.050	<0.150
TT #5 3'bgs	<16.0	<100	<0.050	<0.050	<0.050	<0.150

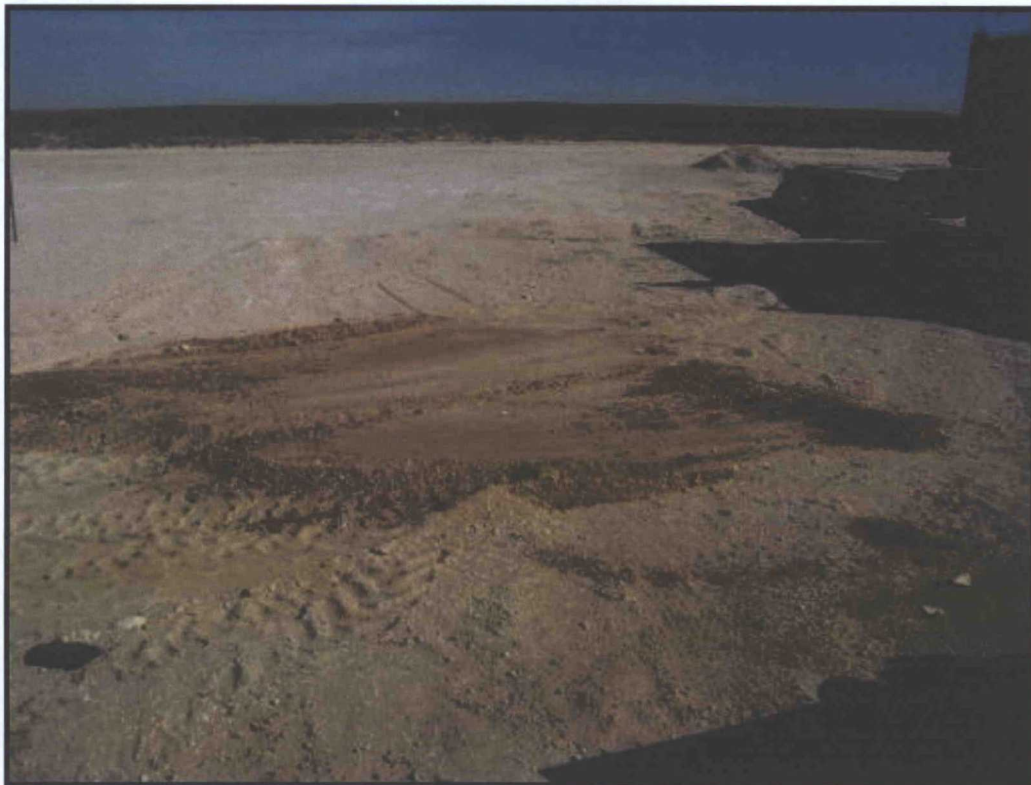
Test Trench #1 facing east

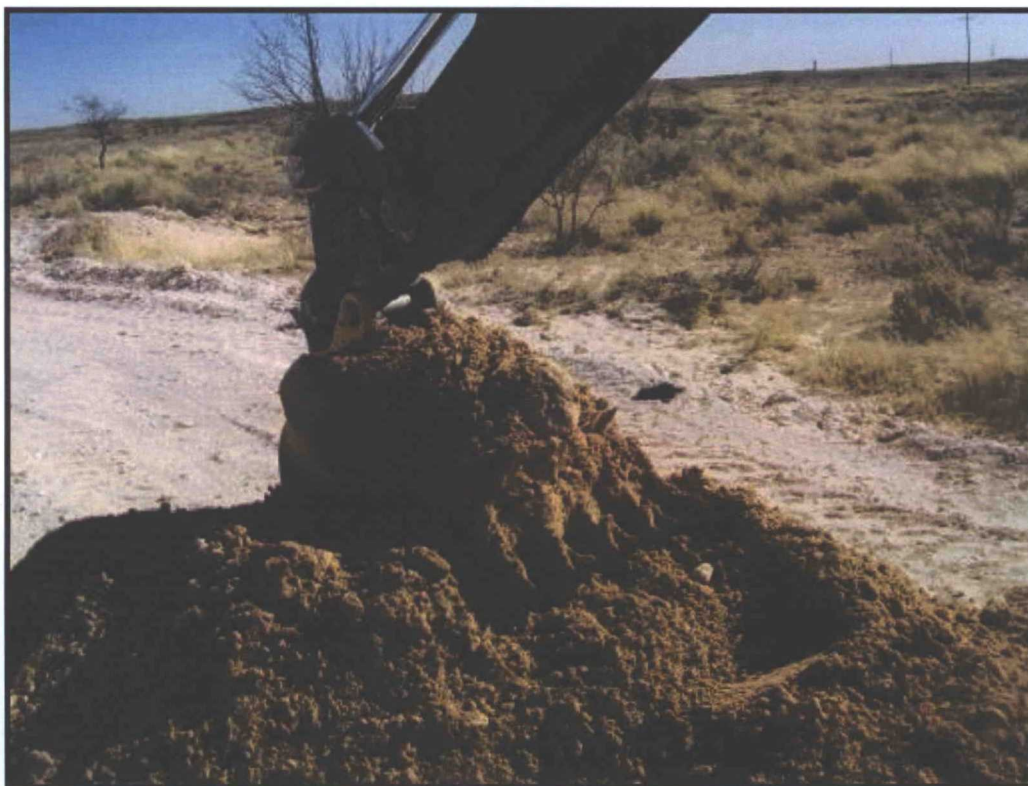
Test trench #2 soils

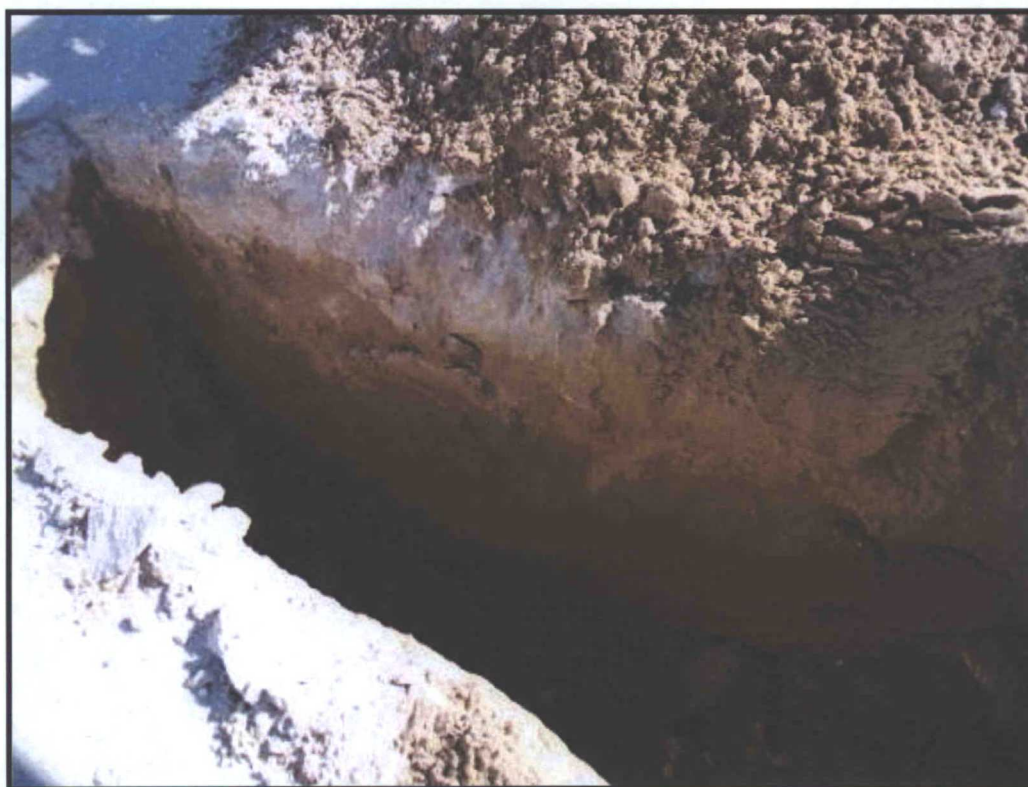
Test Trench #2

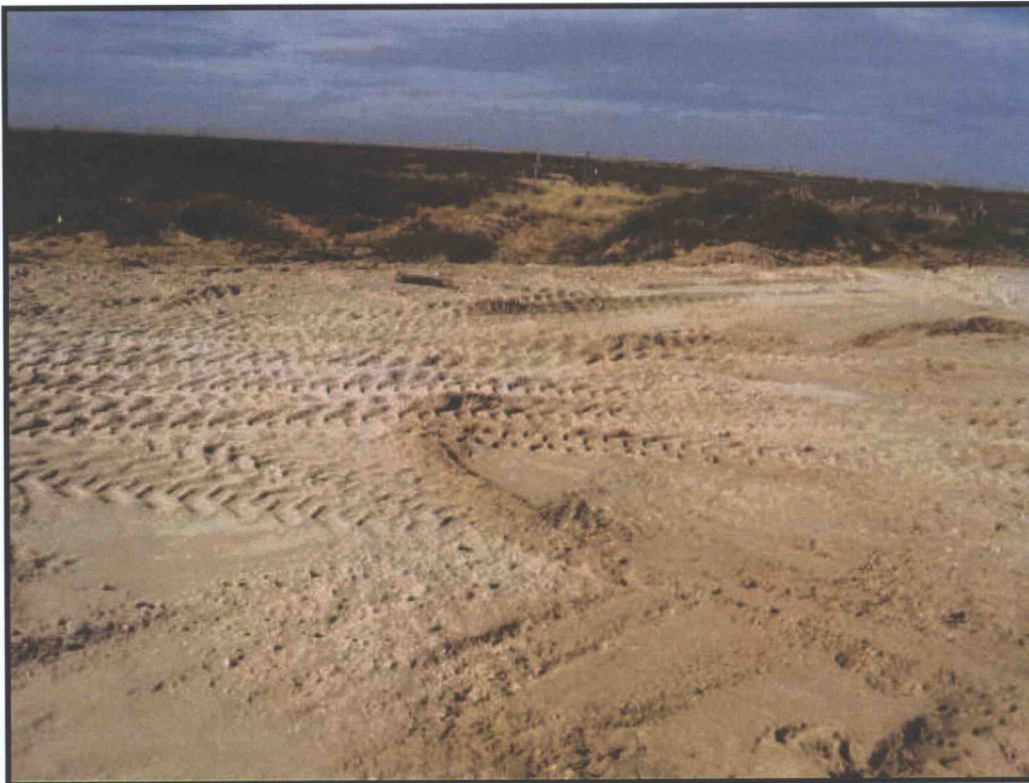
Test Trench #2 facing northwest

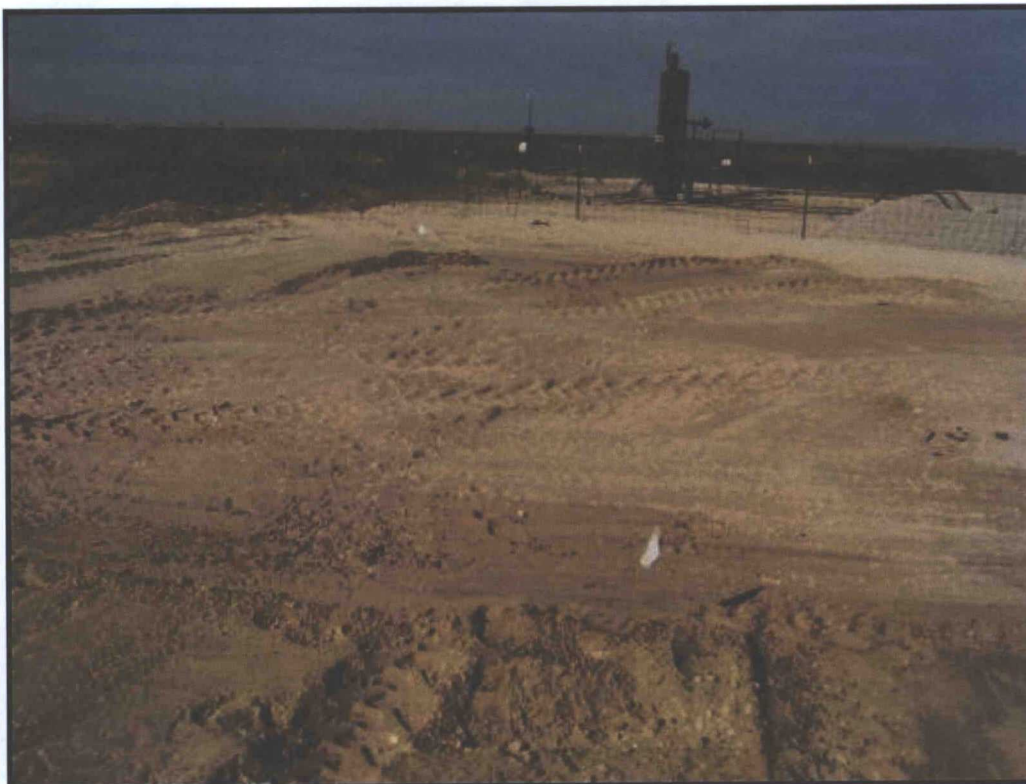
Test trenches facing north

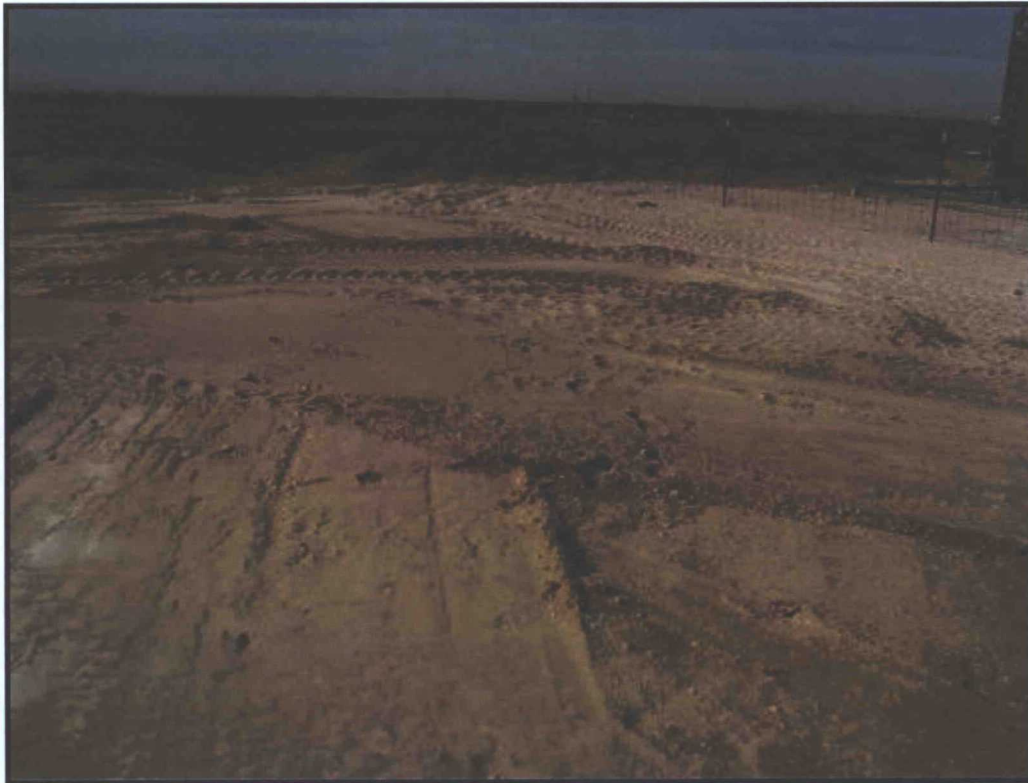
Test Trenches facing west

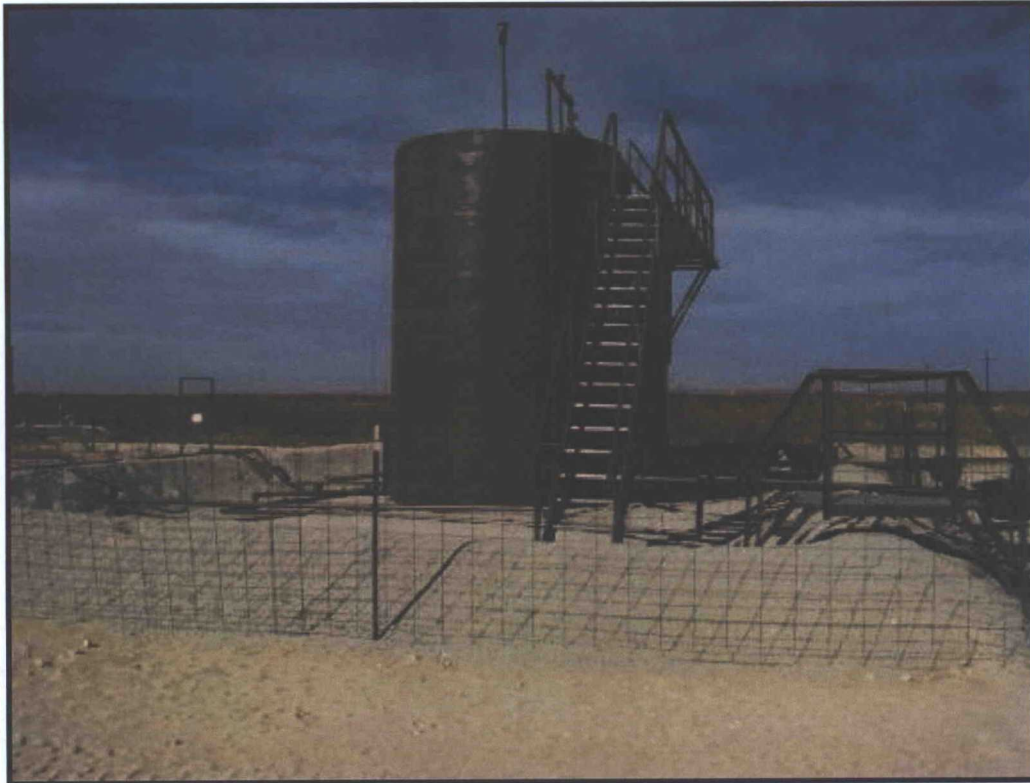
Tank batteries facing north

Internal corrosion caused a hole in the bottom of the tank. Vac truck onsite to recover standing fluid within the tank.

Safety and Environmental Solutions, Inc. (SESI) was engaged by Cimarex Energy Company to perform a site assessment at the Pipeline Deep Federal Com #1. This location is the site of an active well and battery. The location is located in Section 7, Township 19 South, and Range 34 East. Internal corrosion in the bottom of the tank released approximately 122 barrels of crude oil with no recovery.

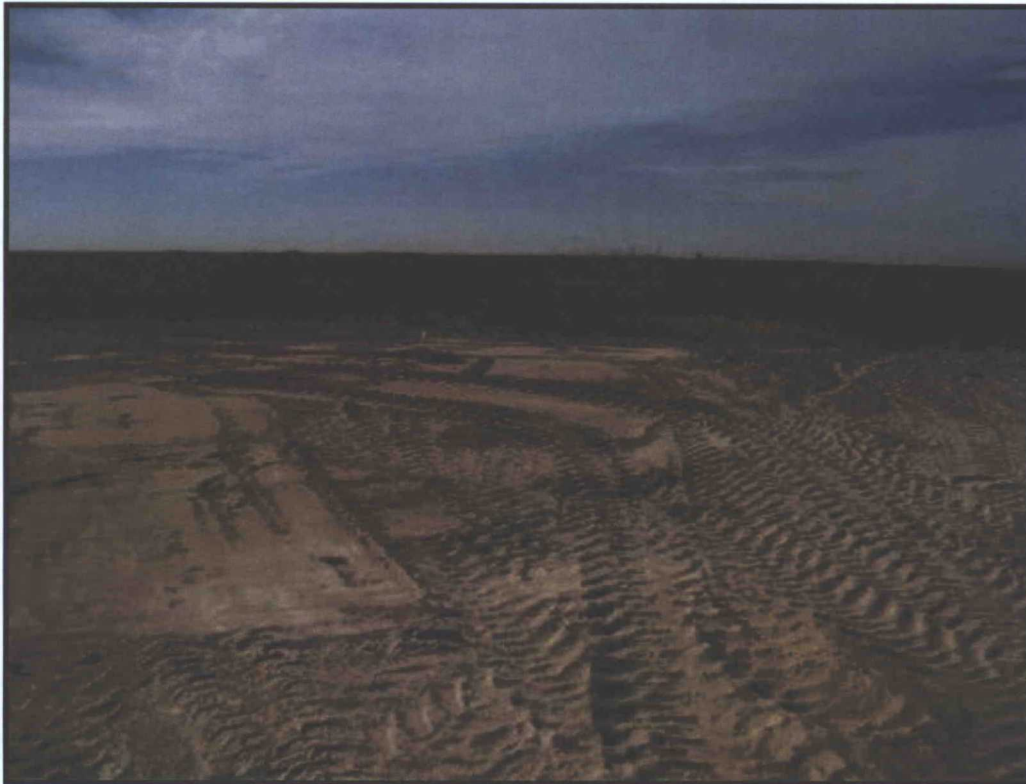
Test trenches backfilled facing west

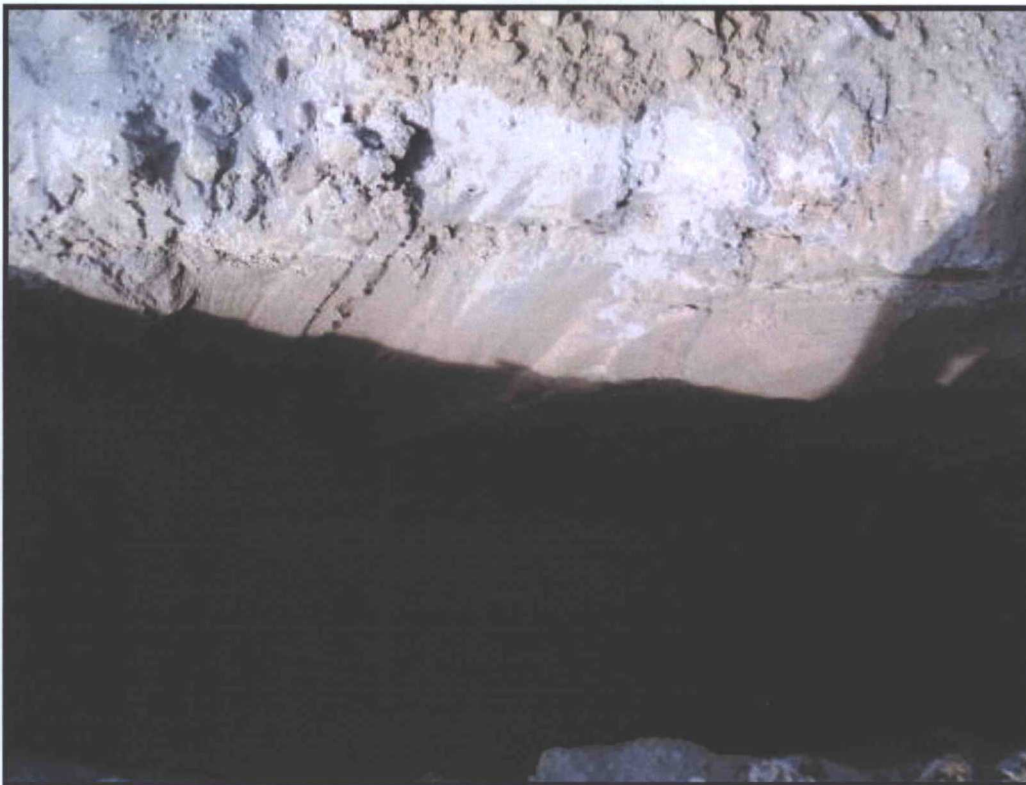
Test trench #4

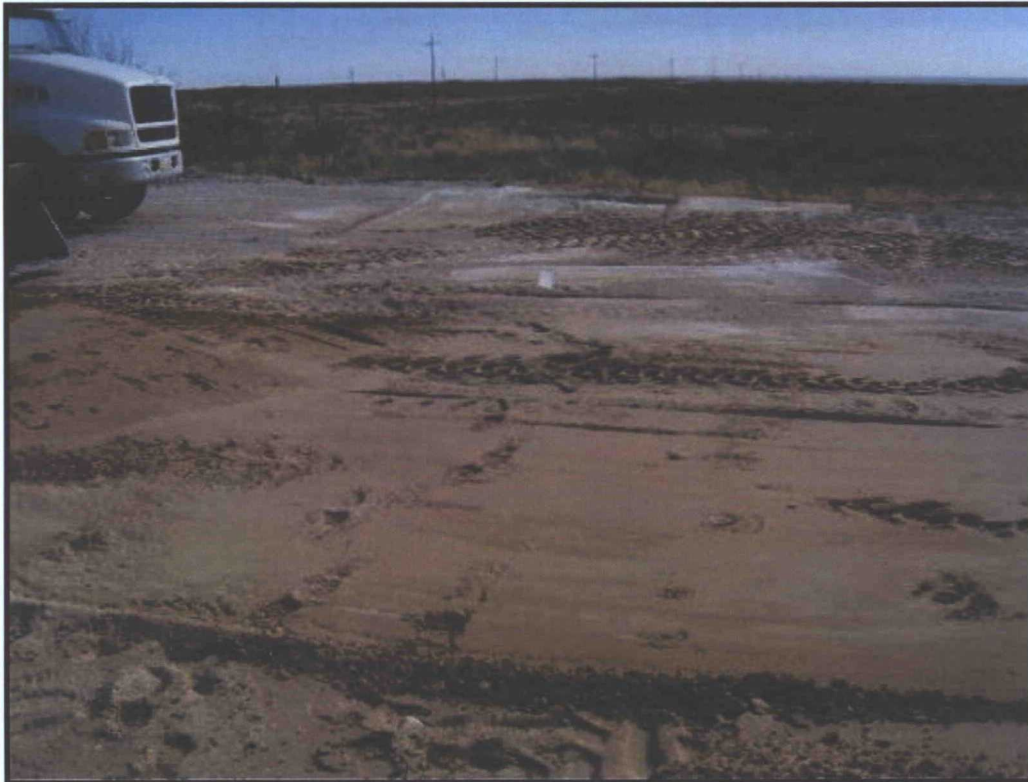
Test trenches facing south

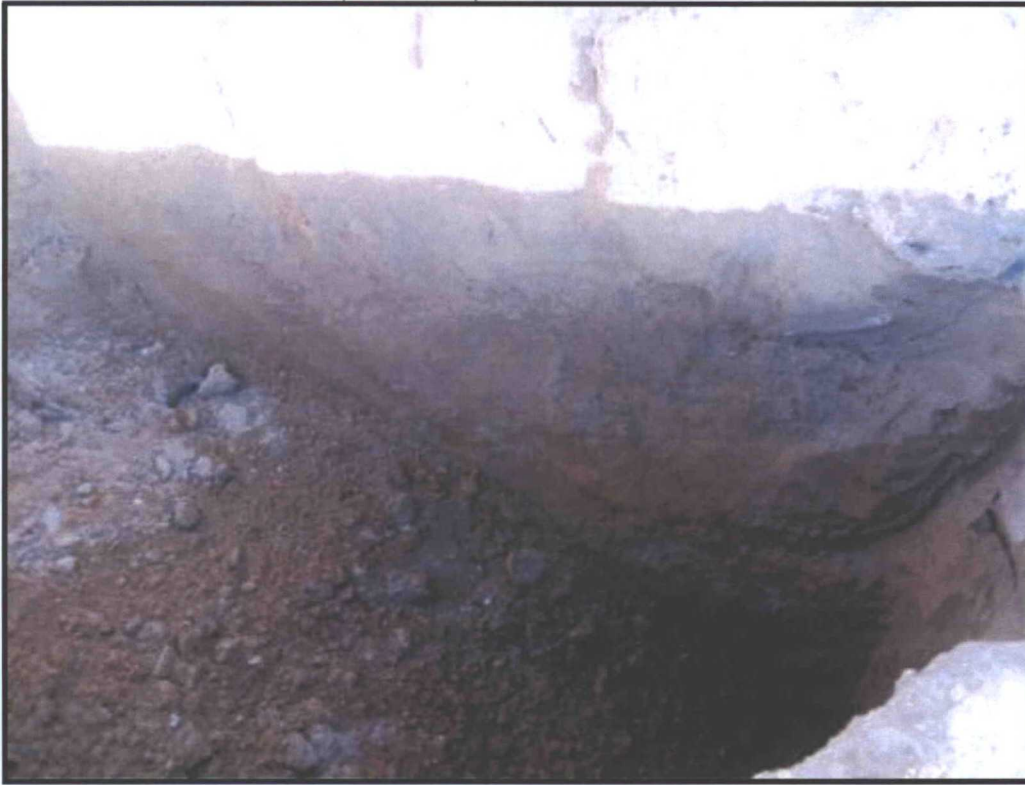
Test Trench #4 12'bgs

On January 20, 2011, SESI was onsite with Gandy's Corp. to re-install test trench #4 to a depth of 12'bgs per Mr. Leking, NMOCD. A bottom sample (extent of backhoe) was obtained and transported under Chain of Custody to Cardinal Laboratories in Hobbs, New Mexico to be analyzed for Total Petroleum Hydrocarbons (TPH)(EPA Method 418.1) and Benzene, Toluene, Ethyl Benzene, and Total Xylenes (BTEX)(EPA Method 8260B):

Sample ID	TPH 418.1 (mg/kg)	Benzene (mg/kg)	Toluene (mg/kg)	Ethylbenzene (mg/kg)	Total Xylenes (mg/kg)
TT #4 12'bgs	<100	<0.050	<0.050	<0.050	<0.150
