Release Notification and Corrective Action

Name of Company Linn Energy	Contact Gary Wink	
Address 2130 W. Bender Blvd., Hobbs, NM 88240	Telephone No. (575) 738-1739	
Facility Name East Hobbs San Andres Unit #515, Unit K	Facility Type Production Pump Jack	
Surface Owner Arena Resources Inc.	Mineral Owner	API No. 30-025-07941

East Hobbs San Andres Unit #515 Unit K

Closure Report

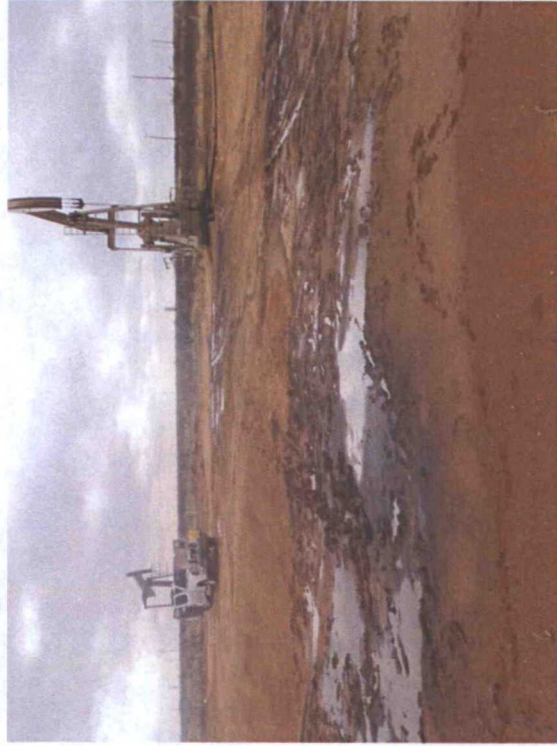
2/20/13

Initial release area, facing south

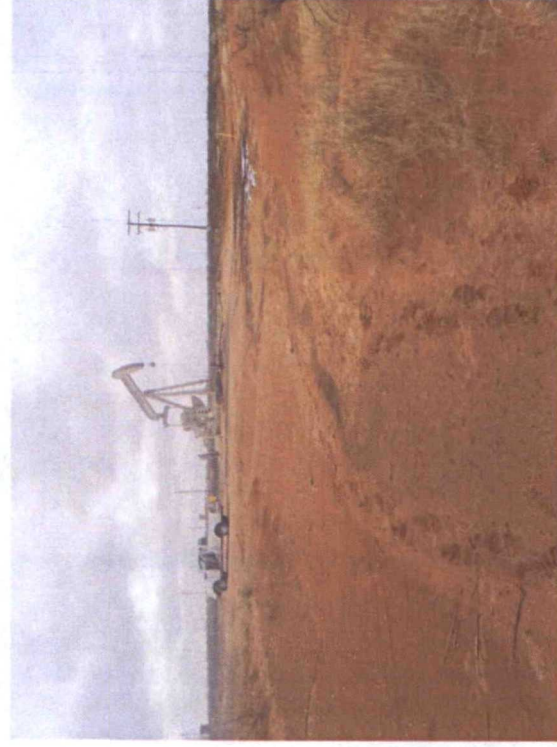
2/20/13

Initial release area, facing southwest

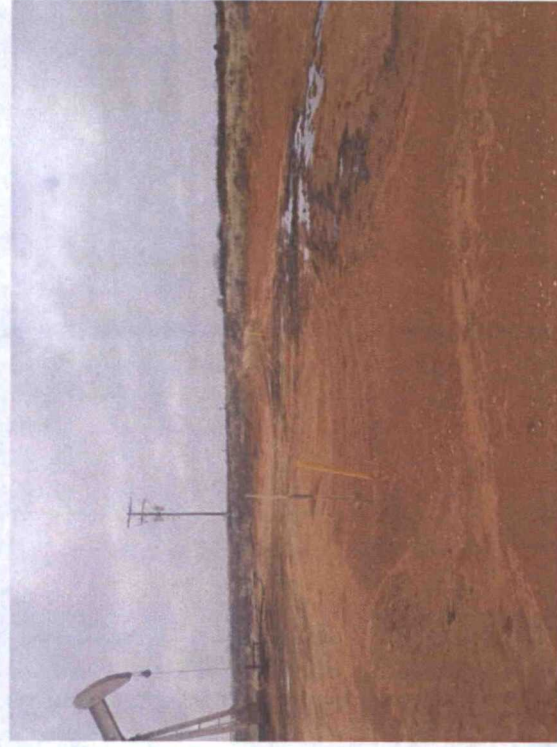
2/20/13

Initial release photo, facing west

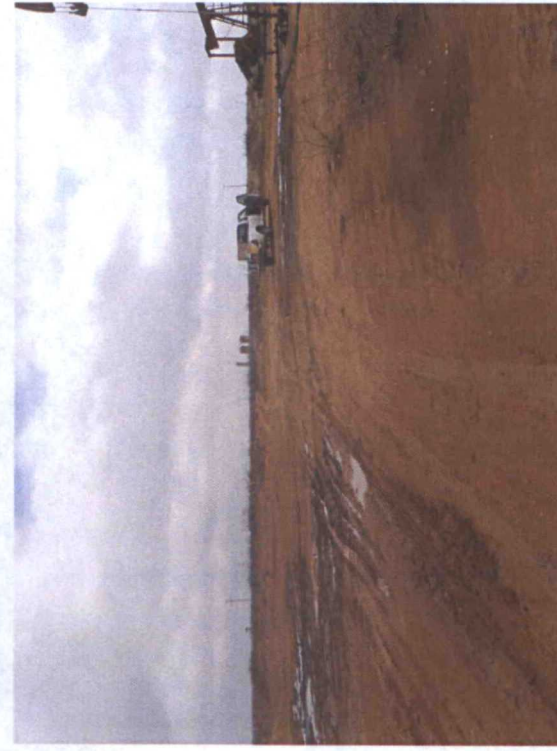
2/20/13

Initial release area, facing east
