Release Notification and Corrective Action

Name of Company BOPCO, L.P.	Contact Tony Savoie
Address 522 W. Mermod, Suite 704 Carlsbad, N.M. 88220	Telephone No. 432-556-8730
Facility Name: Hat Mesa State 31-32 Battery	Facility Type E&P

On April 18, 2012, BOPCO discovered a release had occurred at the Hat Mesa State 31-32 tank battery. Connections on a four-inch (4") truck load line had been leaking for an indeterminate period of time, resulting in the release of approximately five barrels (5 bbls) of crude oil. The release was confined to the earthen containment area surrounding the tank battery. During initial response activities, heavily impacted soil was excavated and stockpiled on-site, pending final disposition.

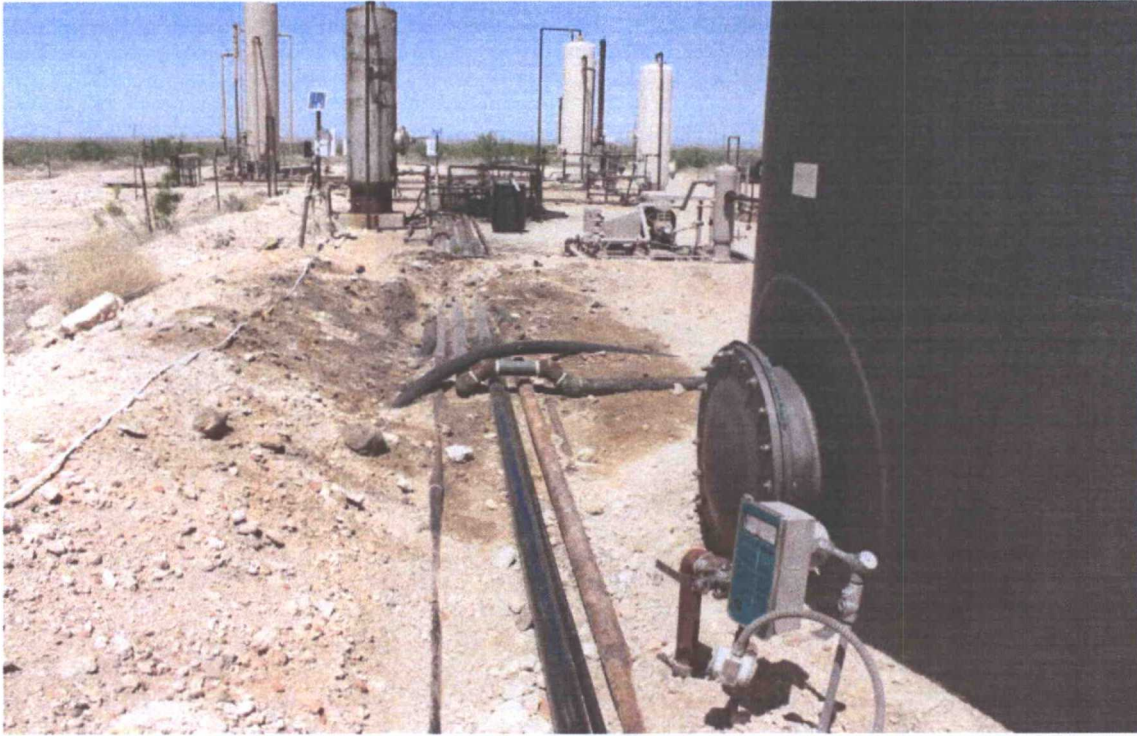
Hat Mesa State 31-32 Battery - Release Point (looking north)

Describe Cause of Problem and Remedial Action Taken.* Connections on the 4" truck load line had been leaking over a period of time. During initial response activities, the connections were repaired.

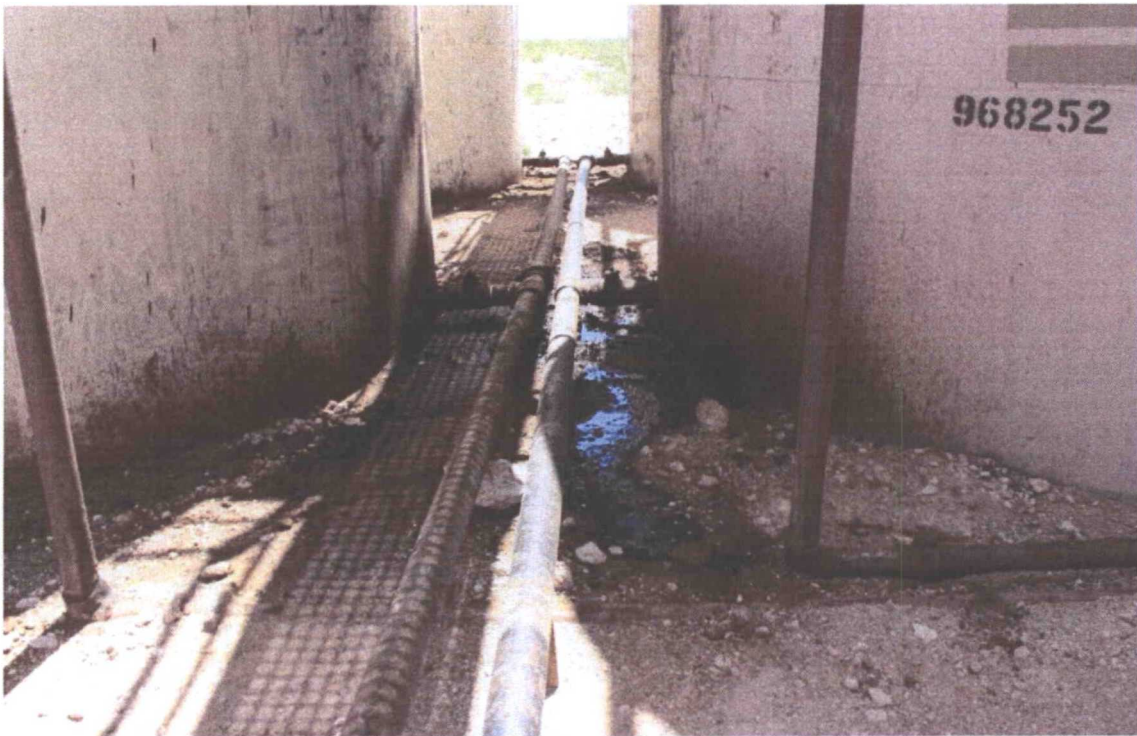
Hat Mesa State 31-32 Battery - Release Site

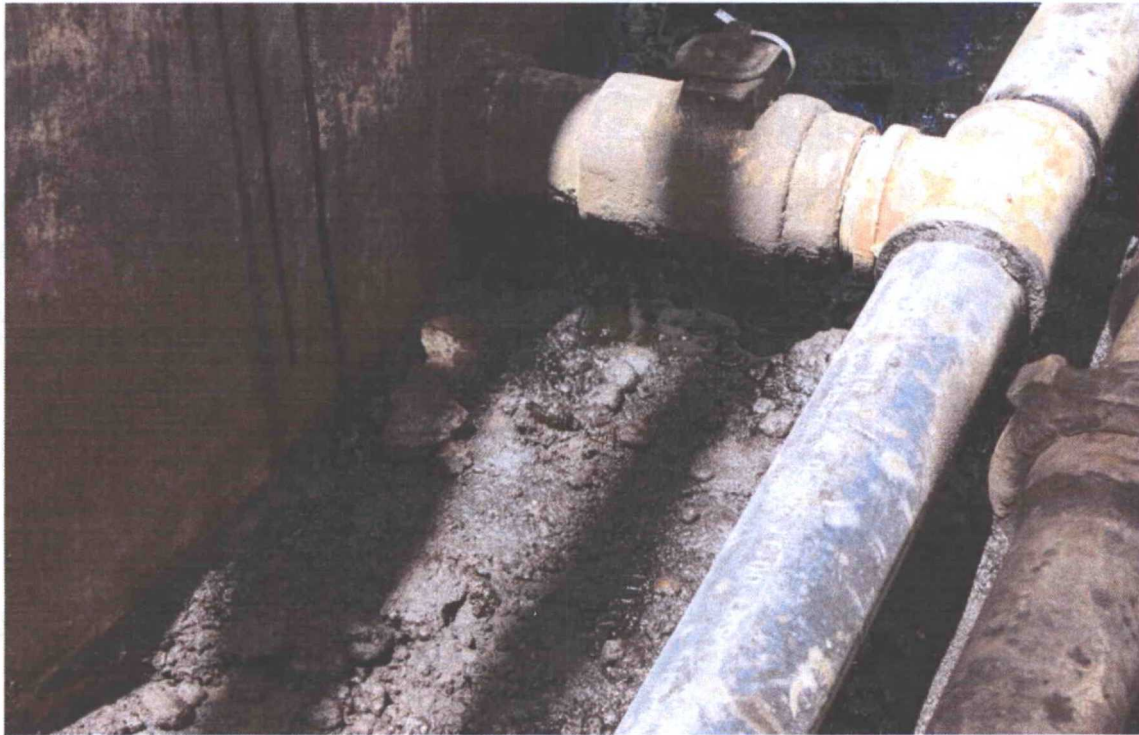
Hat Mesa State 31-32 Battery - Release Site

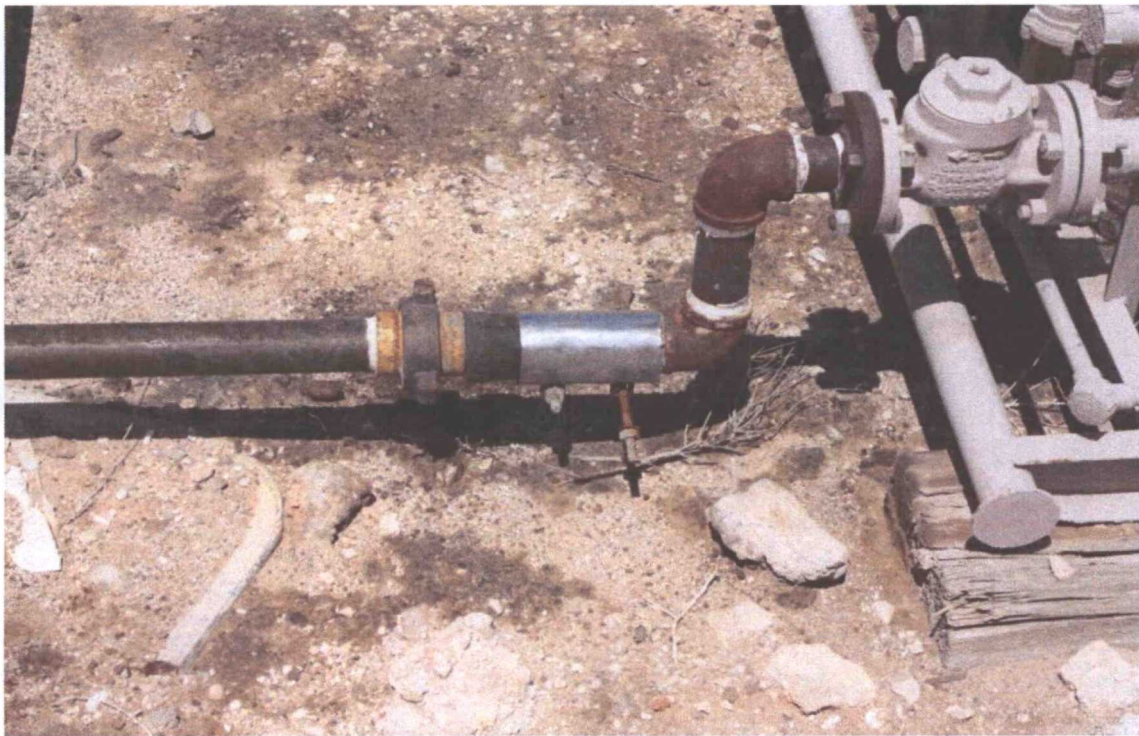
Hat Mesa State 31-32 Battery - Release Site

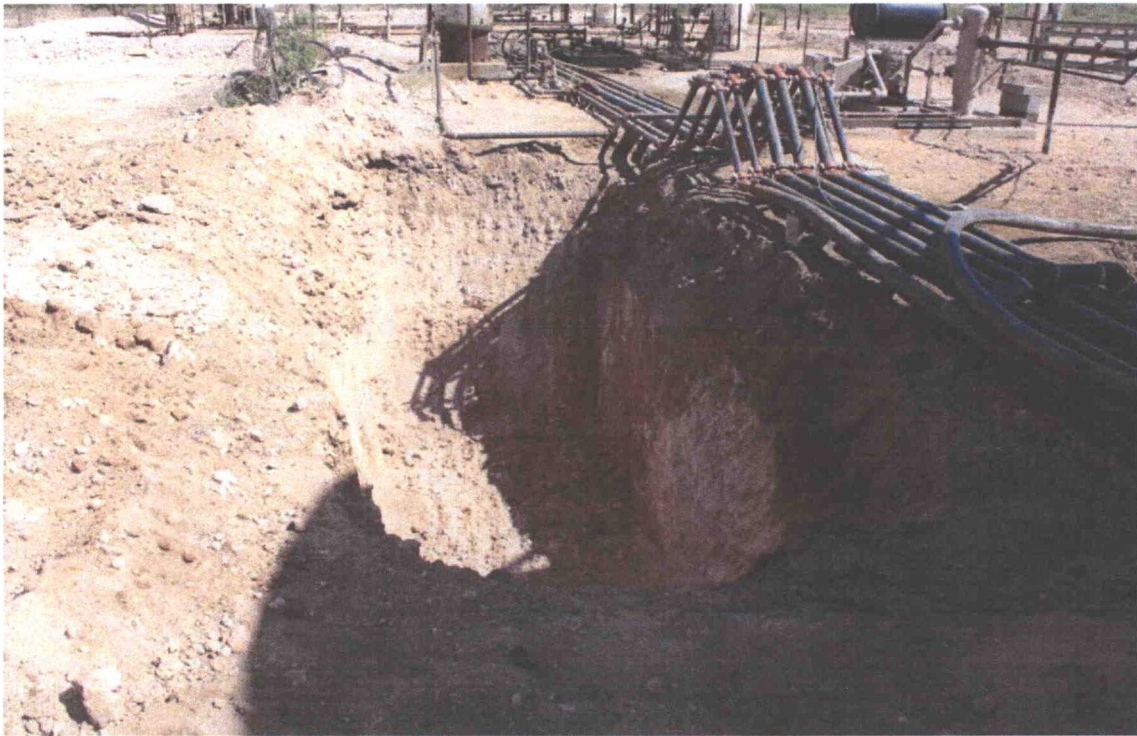
Hat Mesa State 31-32 Battery - North Excavation (looking north-northeast)

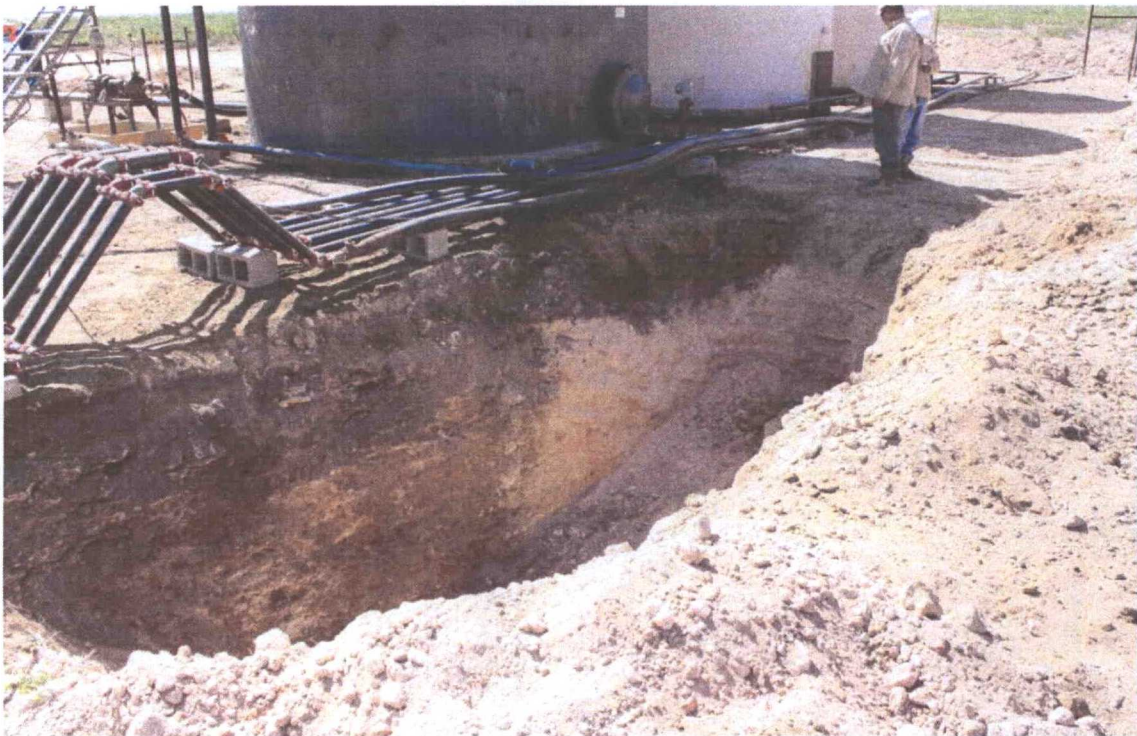
Hat Mesa State 31-32 Battery - North Excavation

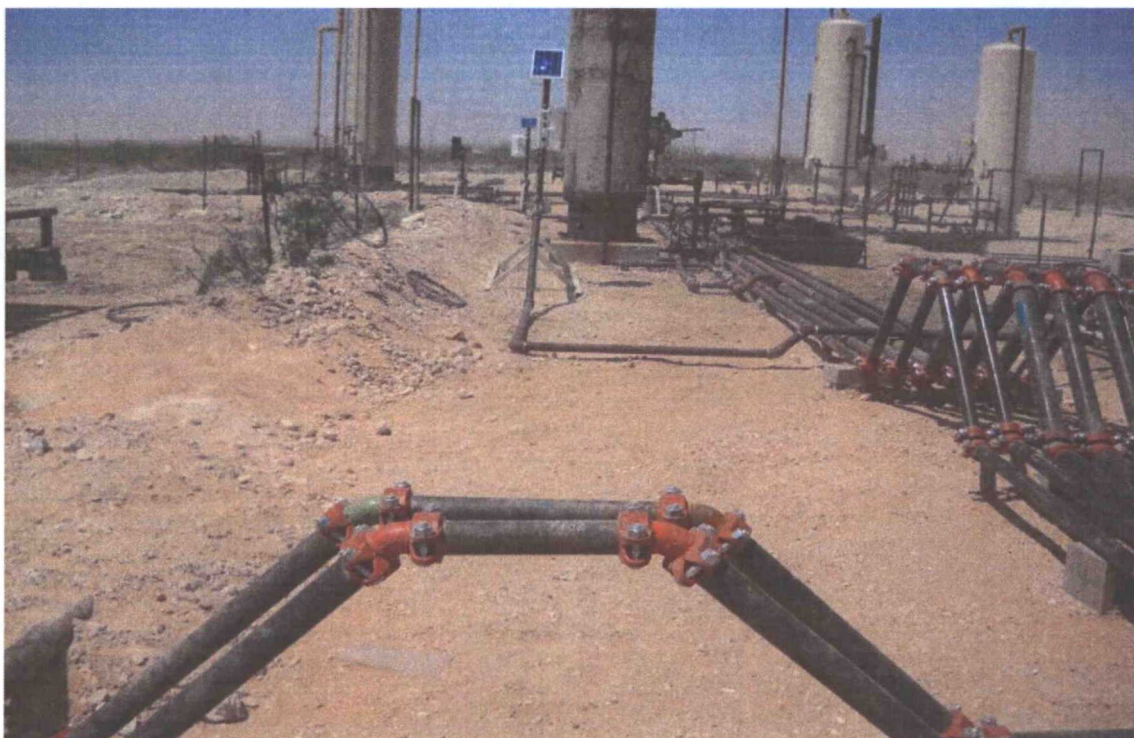
Hat Mesa State 31-32 Battery - North Excavation (following backfill, looking north)

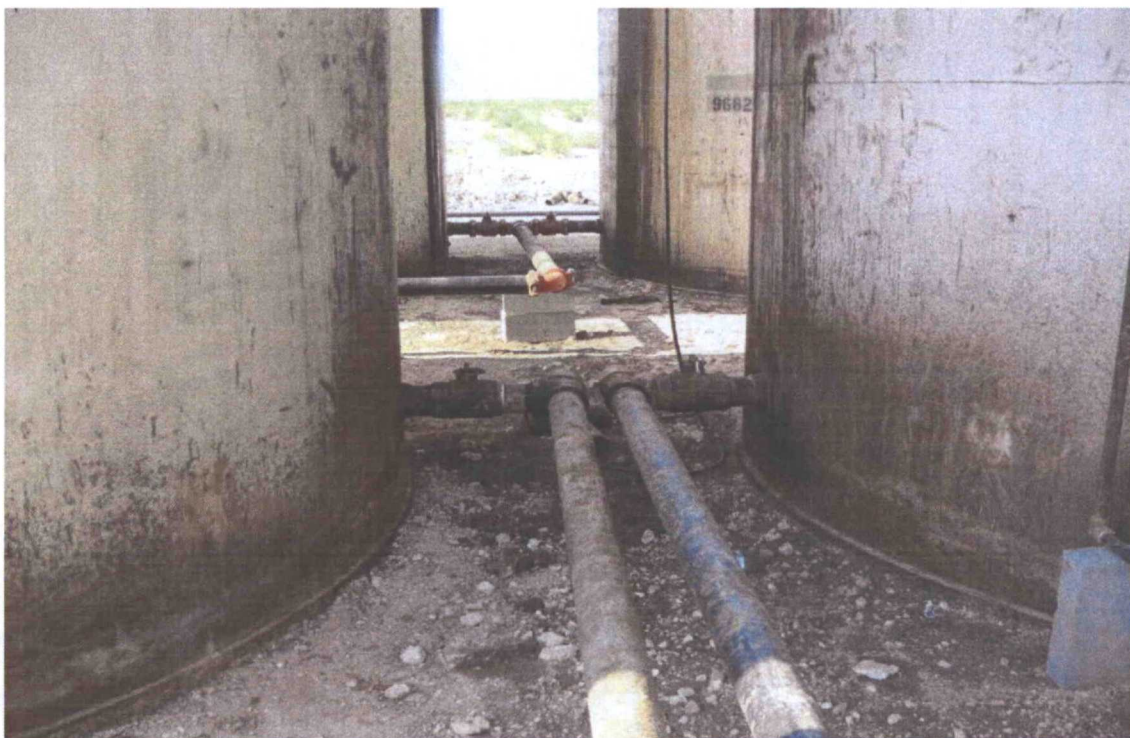
Hat Mesa State 31-32 Battery - Middle Excavation (following backfill)

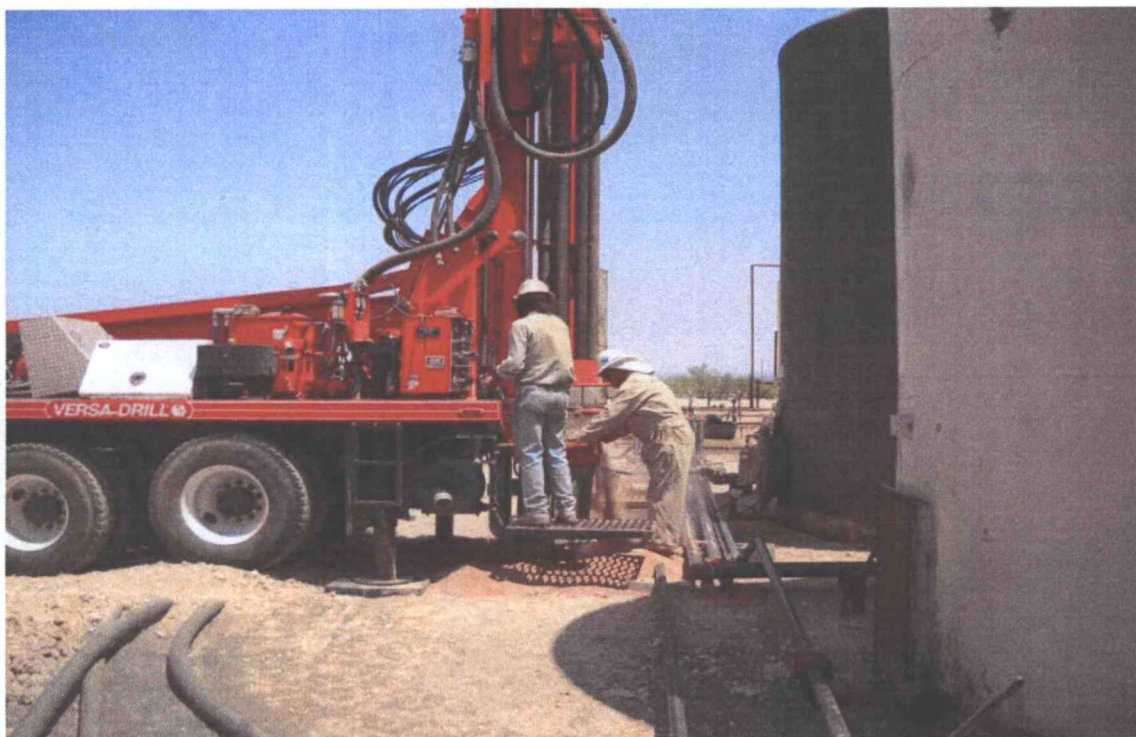
Hat Mesa State 31-32 Battery - Advancement of Soil Boring SB-2

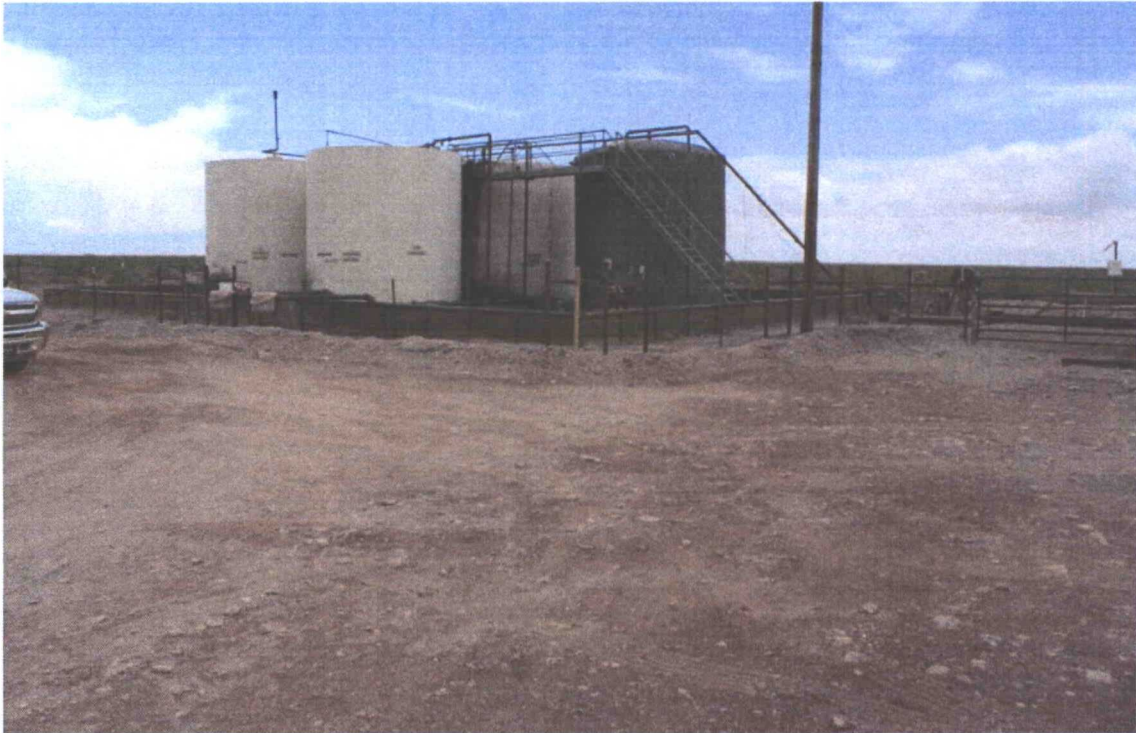
Hat Mesa State 31-32 Battery - Following Installation of Titan Liner (looking southwest)

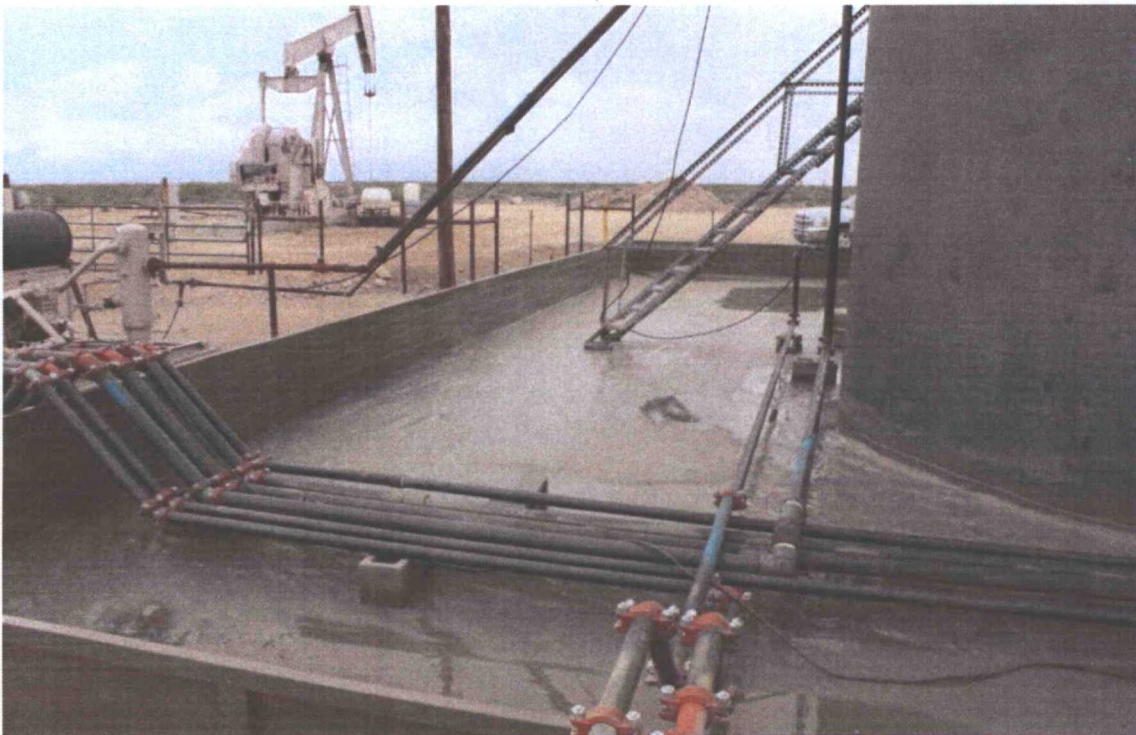
Hat Mesa State 31-32 Battery - North Excavation (following liner installation, looking east)

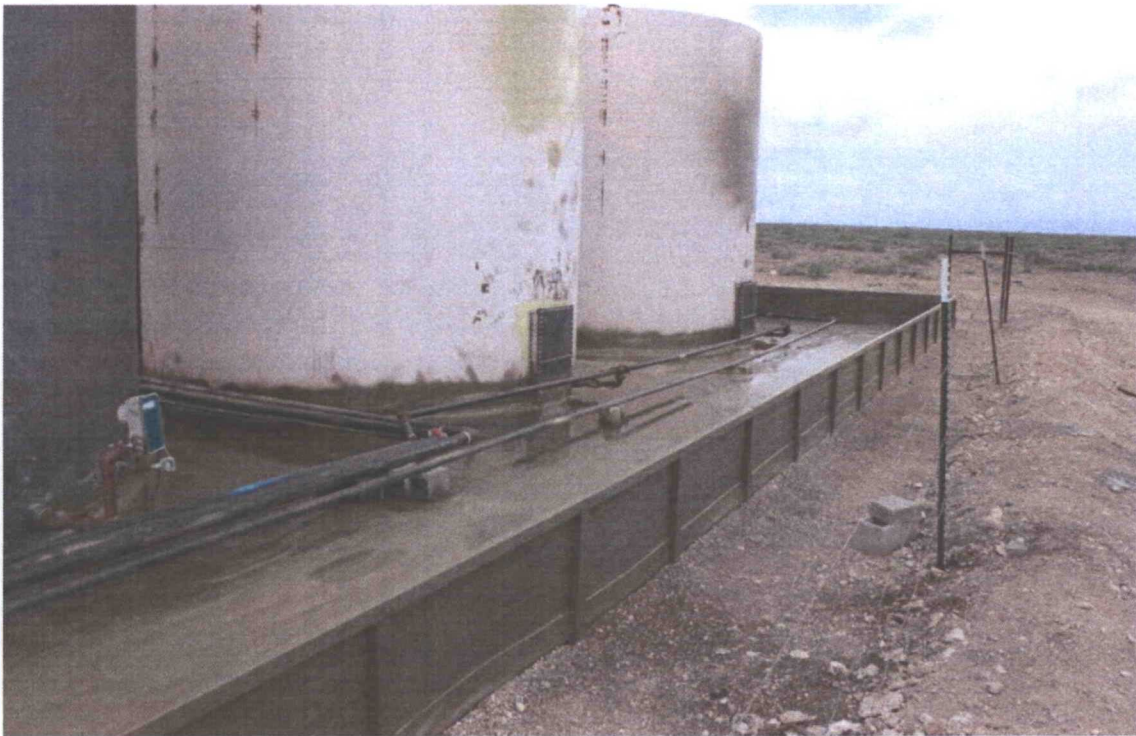
Hat Mesa State 31-32 Battery - Following Liner Installation (looking southeast)

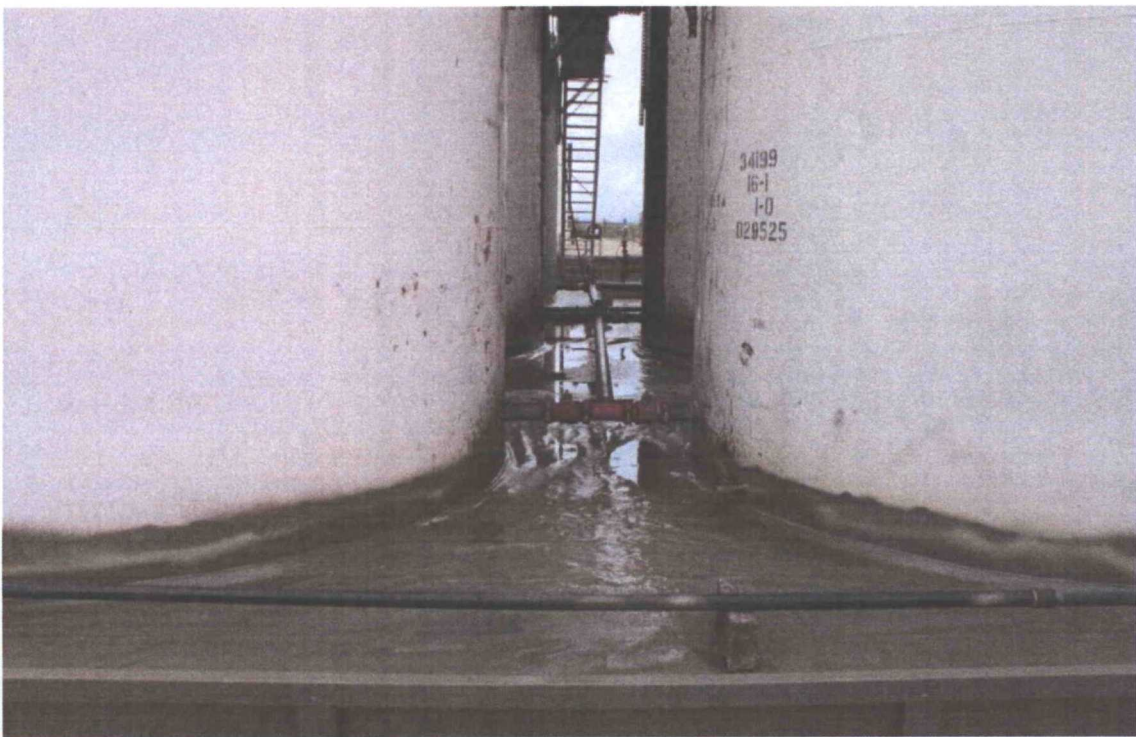
Hat Mesa State 31-32 Battery - Middle Excavation (following liner installation)
