Southeast Lusk 34 Federal #006

Closure Report

RE: TERMINATION REQUEST

Apache – Southeast Lusk 34 Federal #6 AD

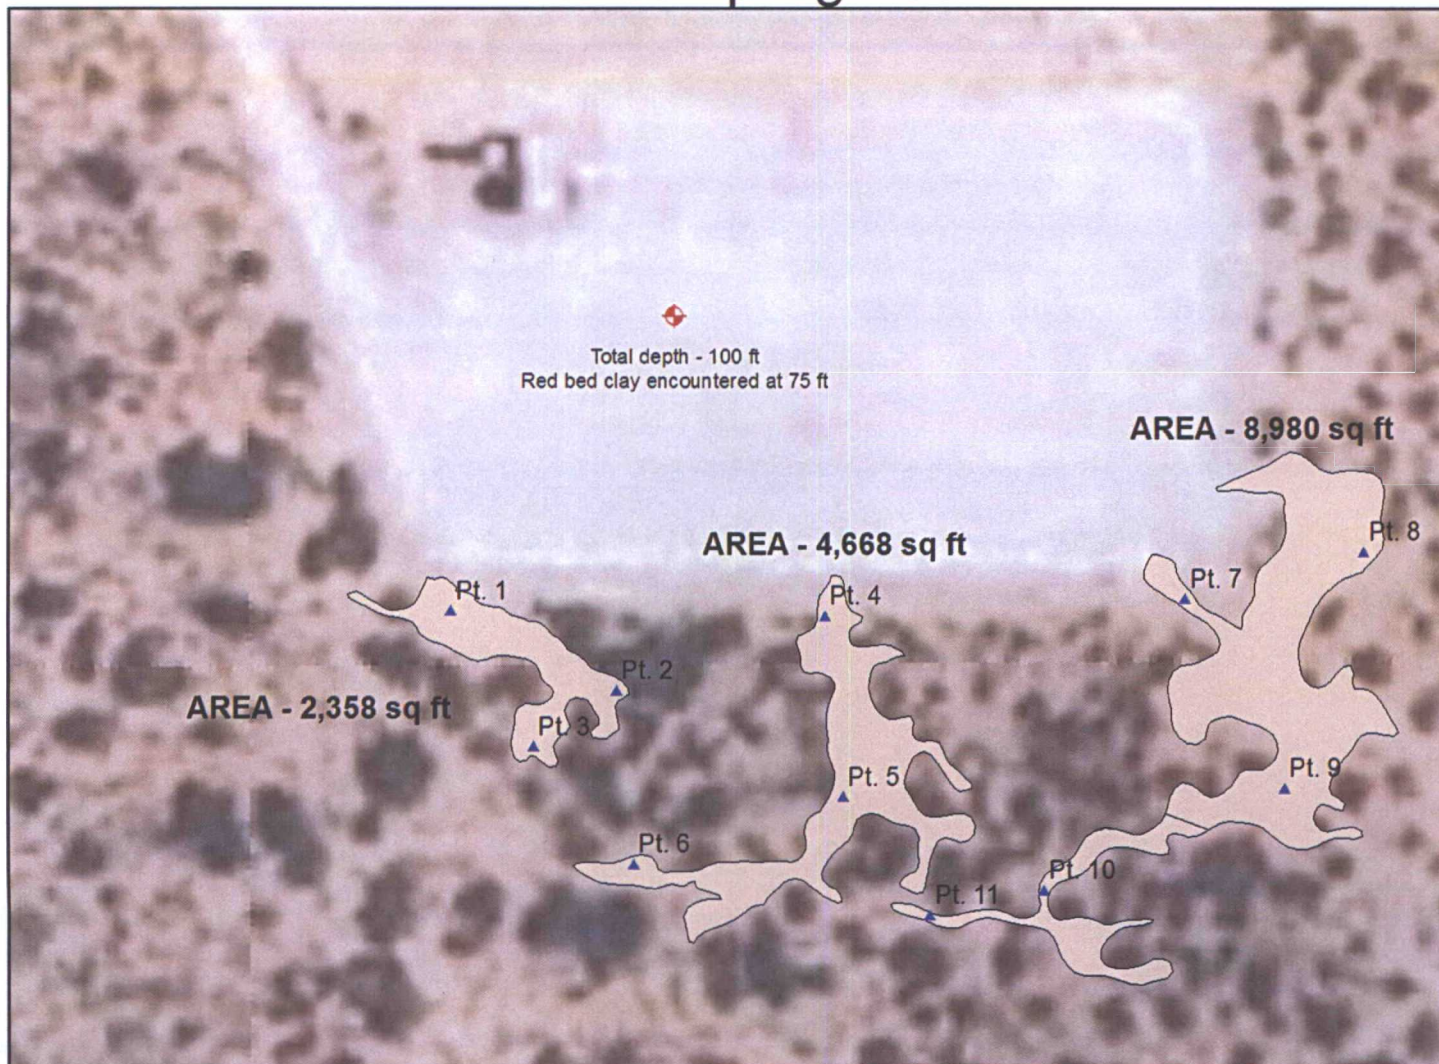
Figure 1

Initial Sampling Data

- ▲ SAMPLE POINTS
- ◆ TEMPORARY MW - INSTALLED 7-25-11
- STAIN (16,006 sq ft)

On April 11, 2012, RECS personnel initiated work on the Southeast Lusk 34 Federal #6 (Figure 1). Surface soil samples were collected and field tested for chloride. Headspace measurements were also taken in the field using a Photo Ionization Detector (PID). The samples were submitted to a commercial laboratory for chloride analysis, and ranged from 8,400 ppm (parts per million or mg/kg) to 83,200 ppm (Appendix B). The samples from Pt.1, Pt.2, and Pt.3 were also analyzed for TPH (GRO/DRO) and ranged from <10.0 ppm to 845 ppm.

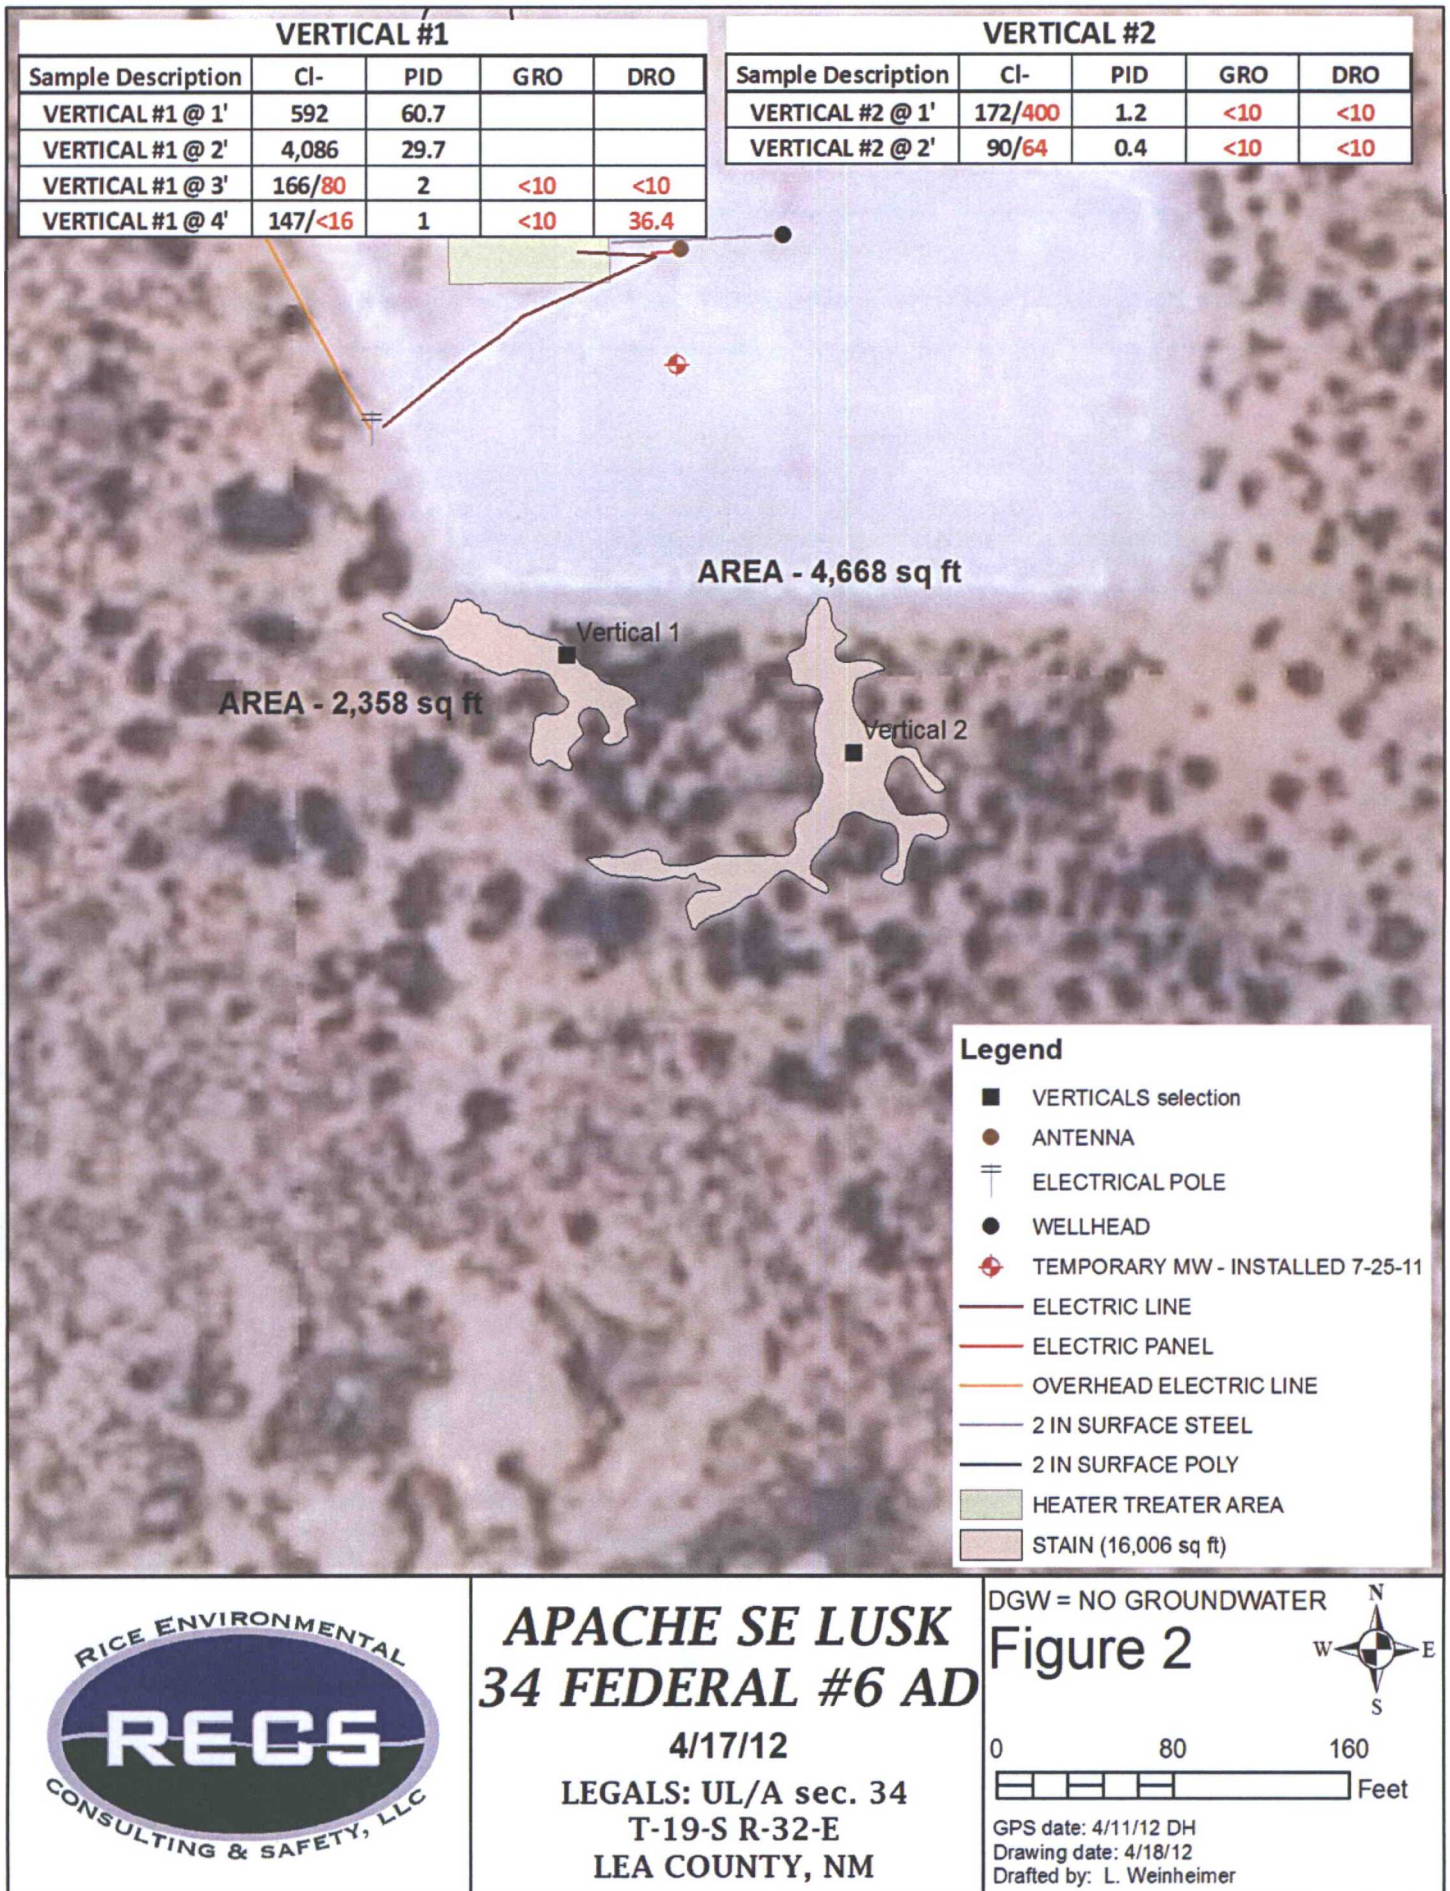
Southwest and Center Vertical Data

On April 17-18, 2012, RECS personnel collected and field tested samples from six (6) vertical sampling points throughout the leak areas. Representative grab samples were collected from the two (2) bottom most samples in each vertical. The samples were submitted to a laboratory for chloride and TPH analyses (Appendix B). Vertical 1 in the southwest leak area contained 80.0 ppm chloride at 3 ft. below ground surface (bgs), and Vertical 2 in the center leak area contained 64.0 ppm chloride at 2 ft. bgs (Figure 2). The remaining verticals were located in the southeast leak area (Figure 3). Vertical 3 contained 80 ppm chloride at 11 ft. bgs. Vertical 4 contained 160 ppm at 7 ft. bgs. Vertical 5 contained 96 ppm at 6 ft. bgs. Vertical 6 contained 208 ppm at 13 ft. bgs.

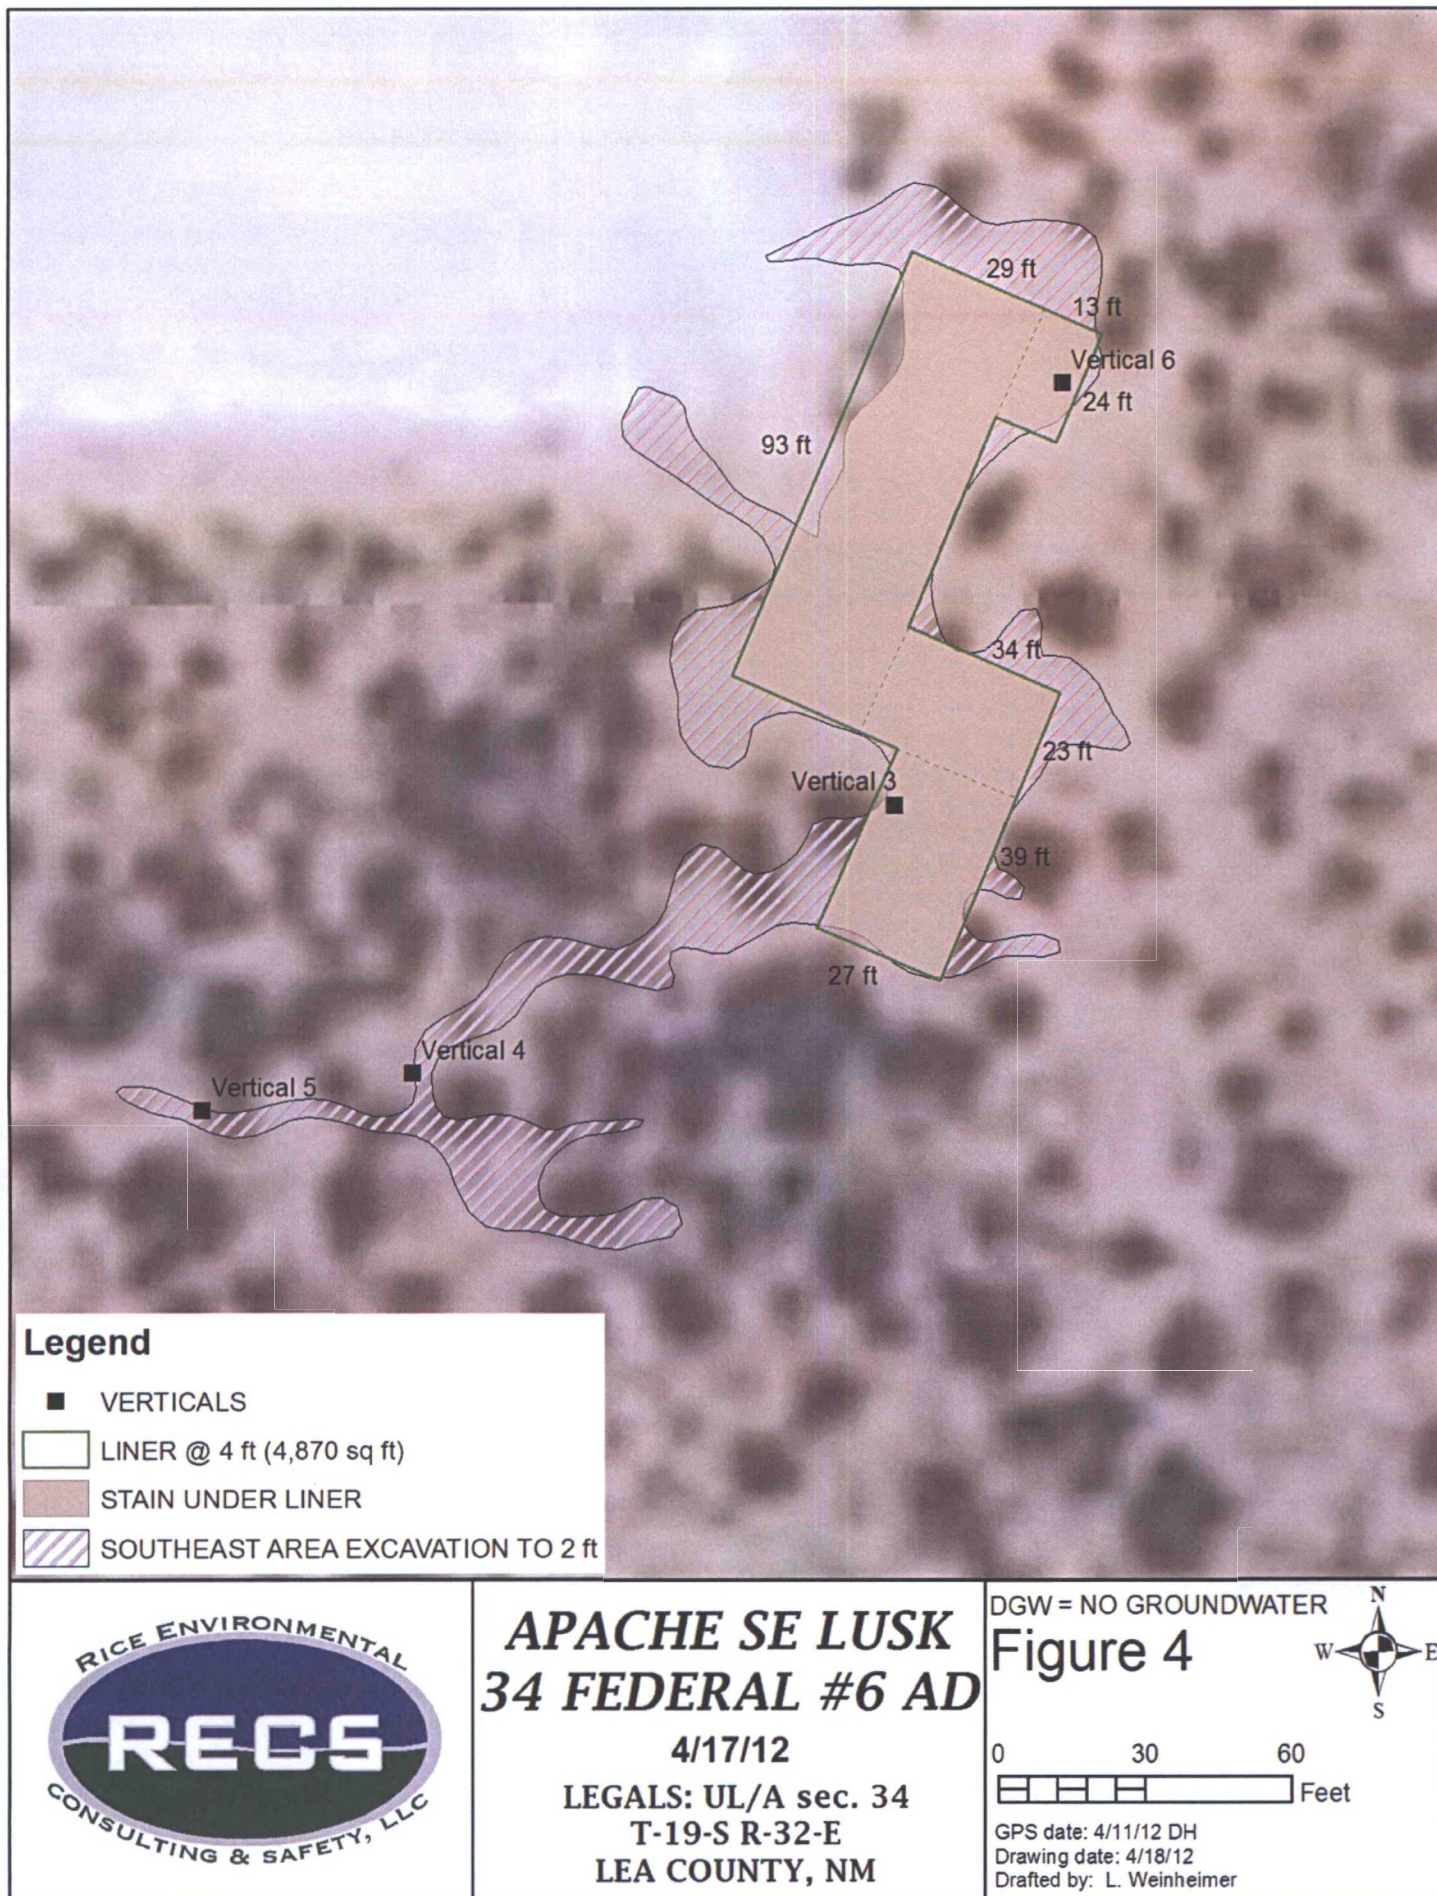
SOUTHEAST AREA - LINER INSTALLATION

Remediation of the leak proceeded according to discussion between RECS and NMOCD personnel on April 19, 2012 (Figure 5). Subsequently, the southwest area was excavated to 3 ft. bgs and the center area was excavated to 1 ft. bgs. The southeast area was excavated to 2 ft bgs. An area encompassing Verticals 3 and 6 was excavated to 4.5 ft. bgs, and a 20 mil reinforced plastic liner was installed in the bottom of the 4.5 ft. excavation (Figure 4).

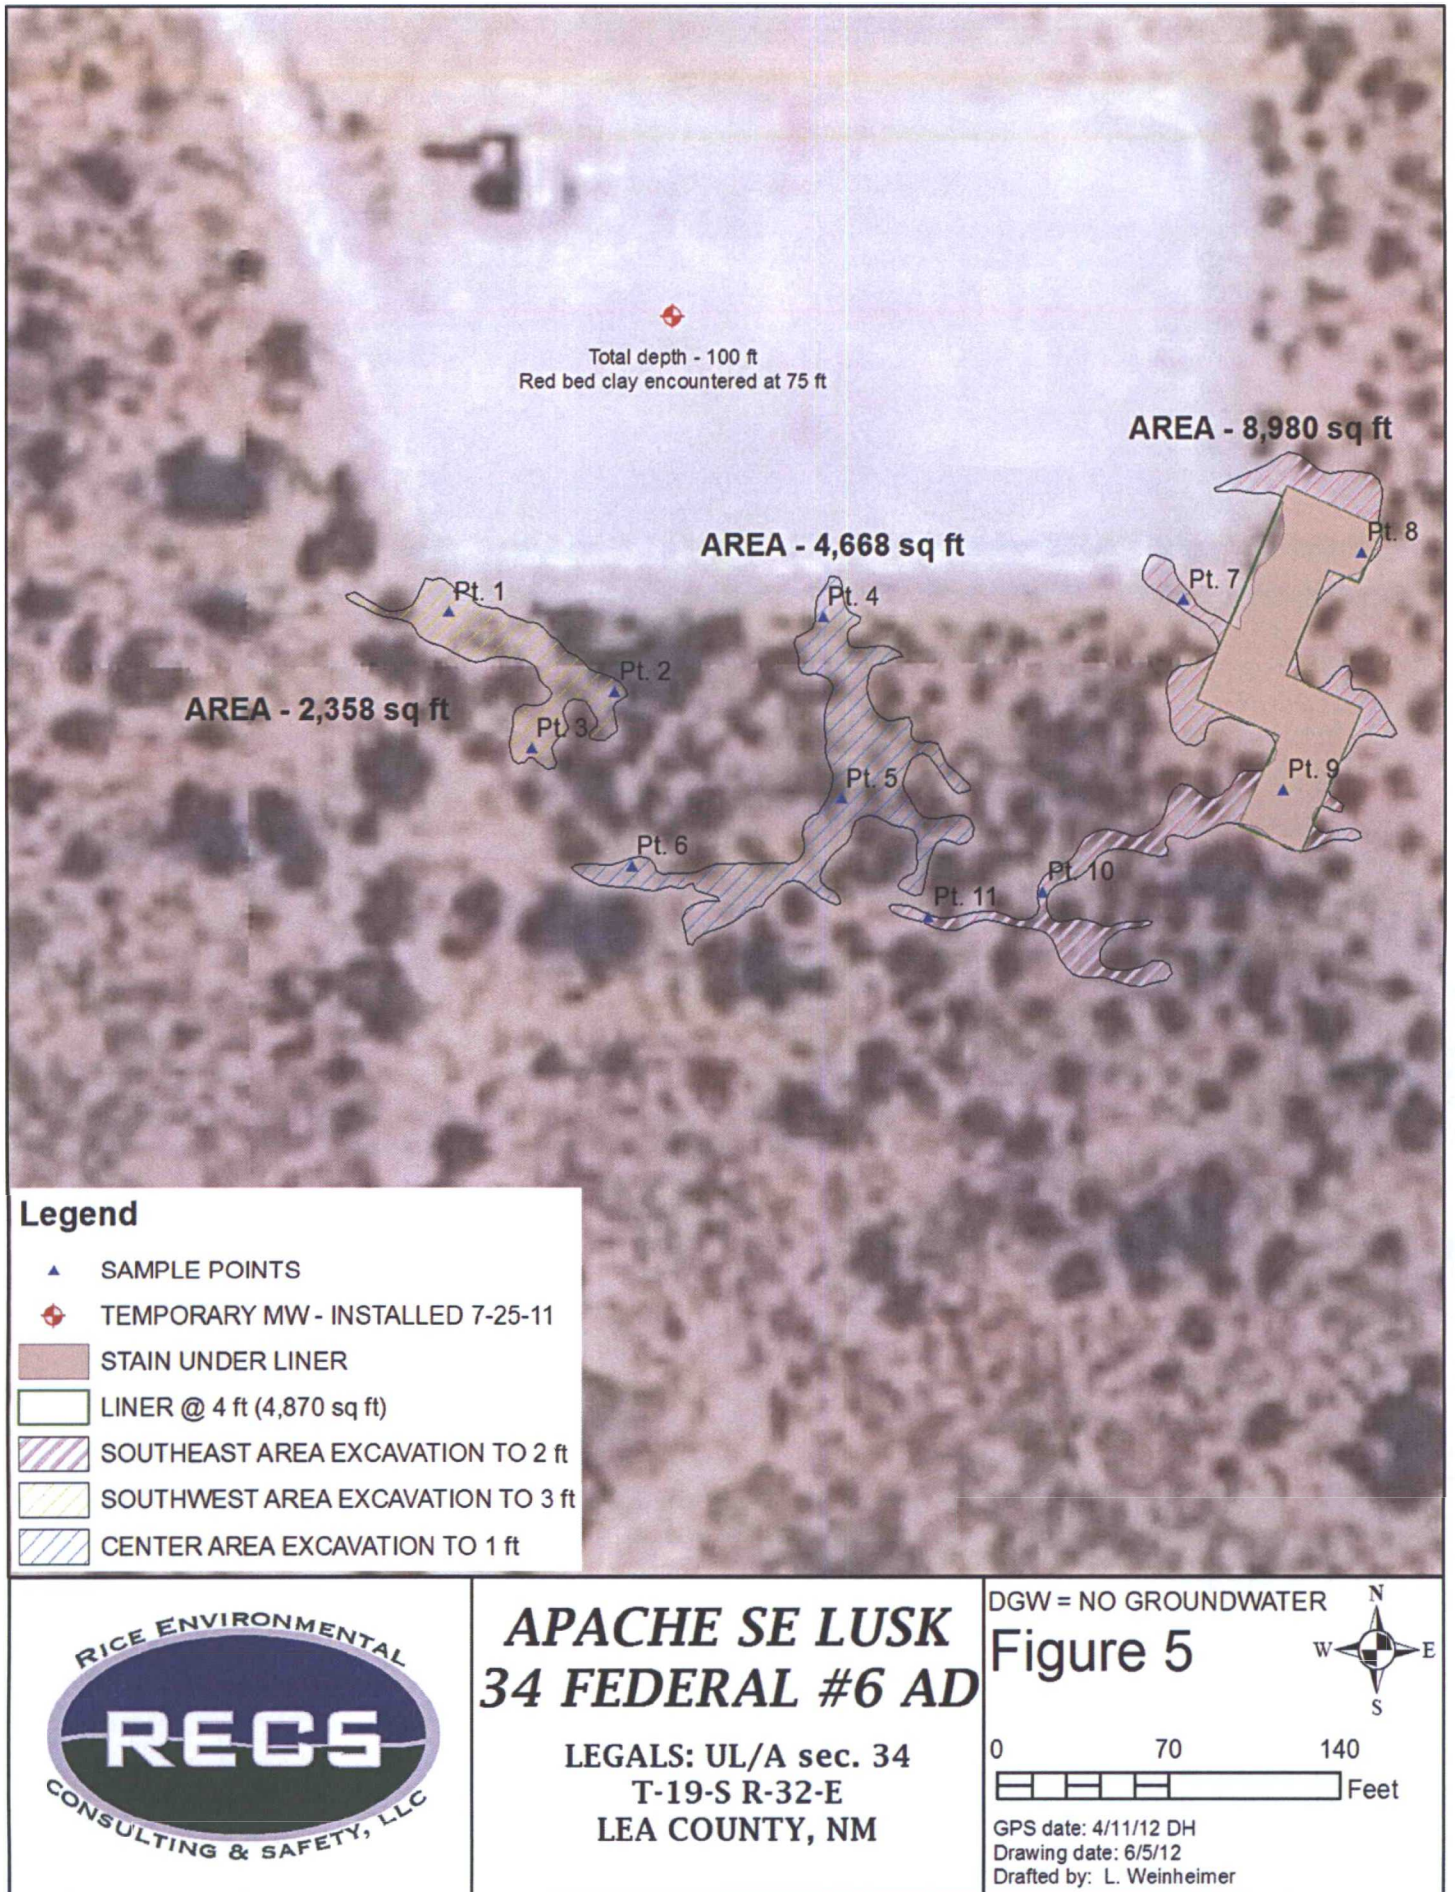
Final Excavation Areas

Impacted soils, totaling 2,768 cubic yards, were removed to a NMOCD approved disposal facility. The excavations were backfilled with 3,000 cubic yards of clean soil (Appendix B) and contoured to the surrounding area. See Appendix C for photographs of field activities.

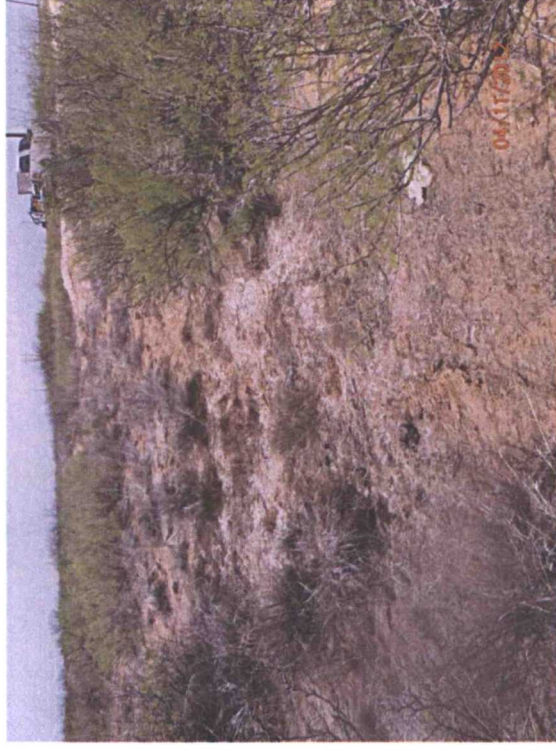
Initial southwest release area, facing northwest

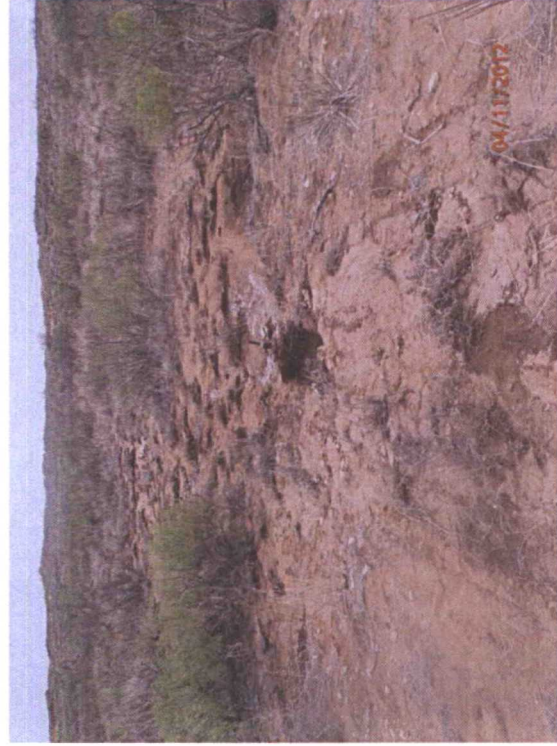
Initial center release area, facing south

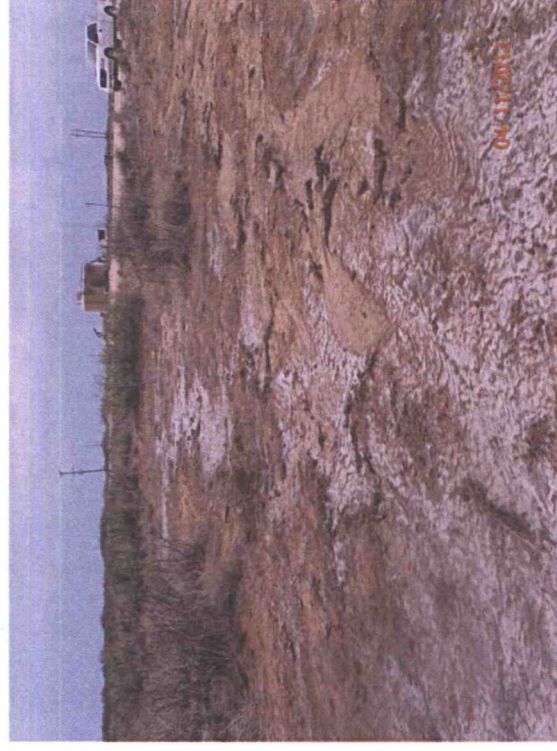
Initial southeast release area, facing northwest

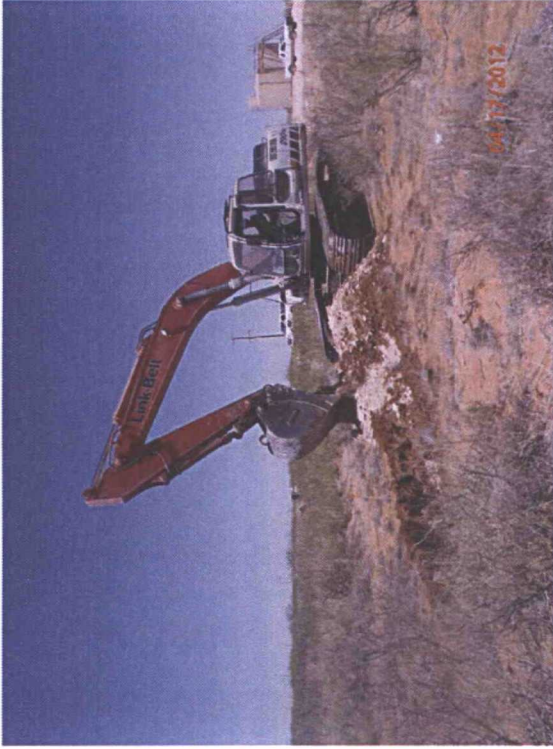
Digging vertical, facing northwest 4/17/2012

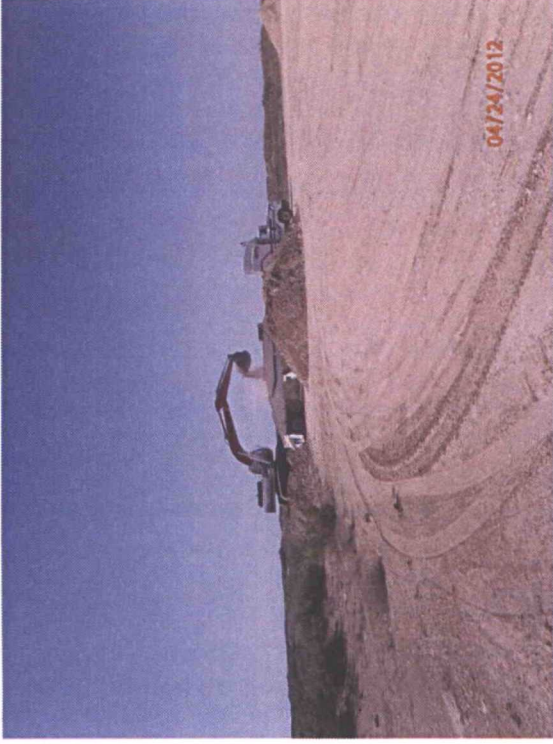
Exporting soil, facing south 4/24/2012

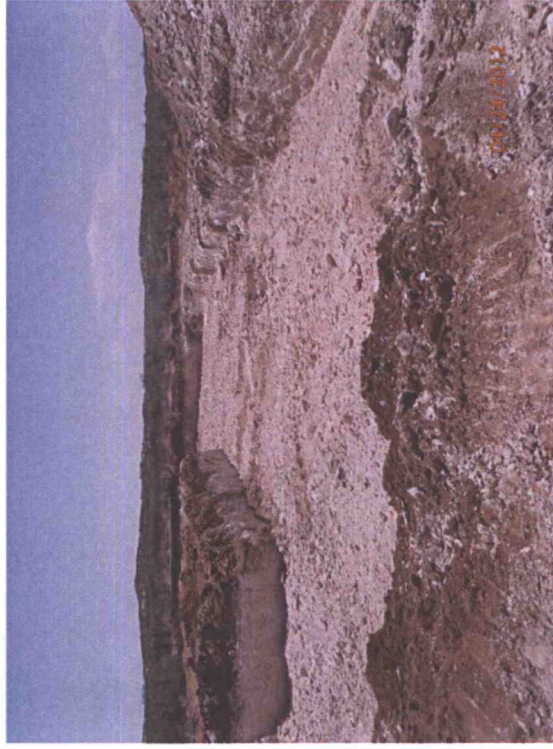
Southeast excavation ready for liner, facing south 4/24/2012

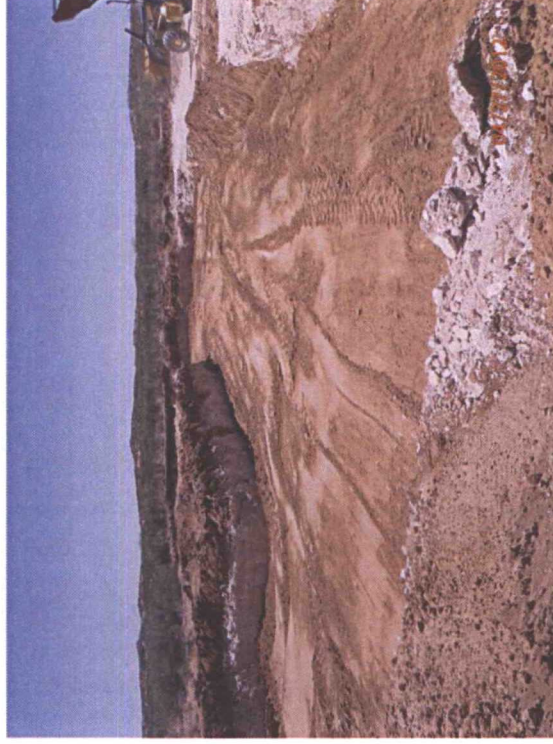
Southeast excavation padded for liner, facing south 4/27/2012

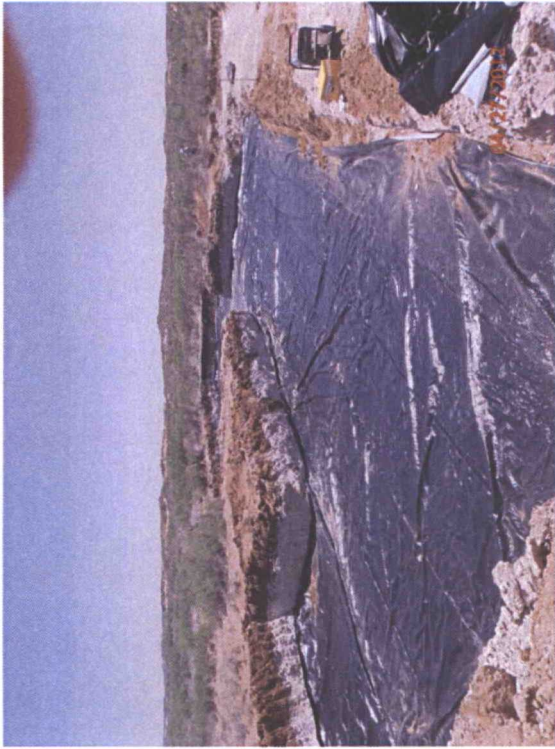
Liner at southeast excavation, facing south 4/27/2012

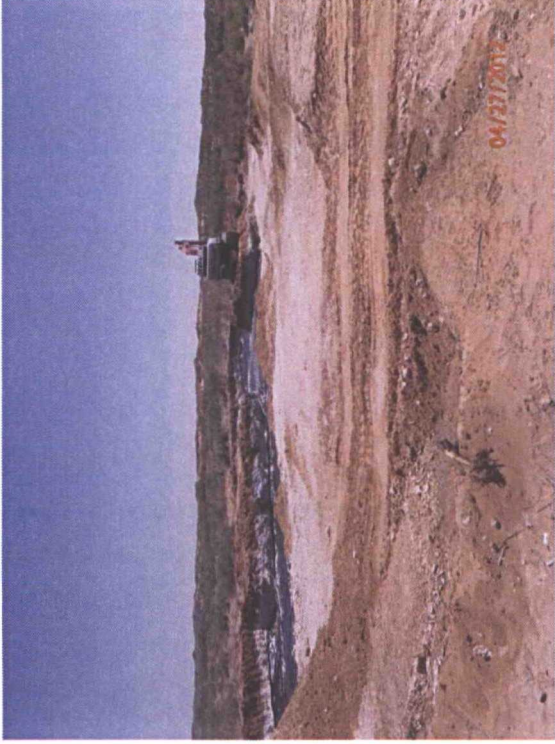
Final southeast excavation, facing south 4/27/2012

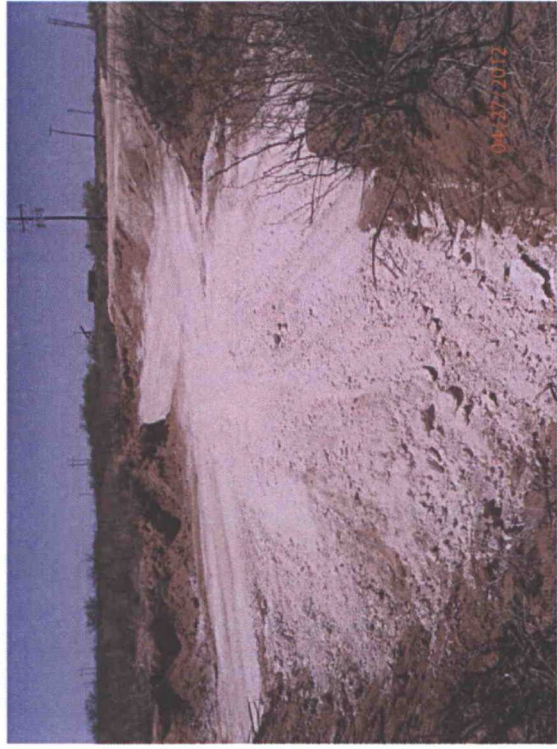
Final southwest excavation, facing northwest 4/27/2012

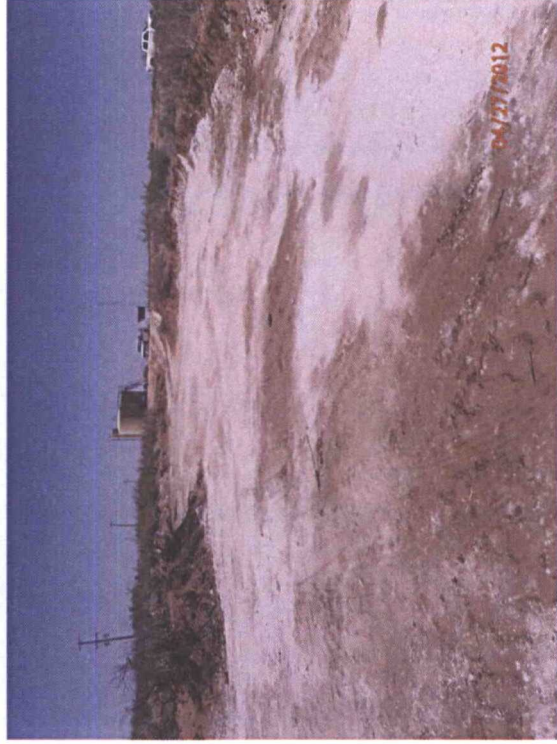
Final center excavation, facing north 4/27/2012

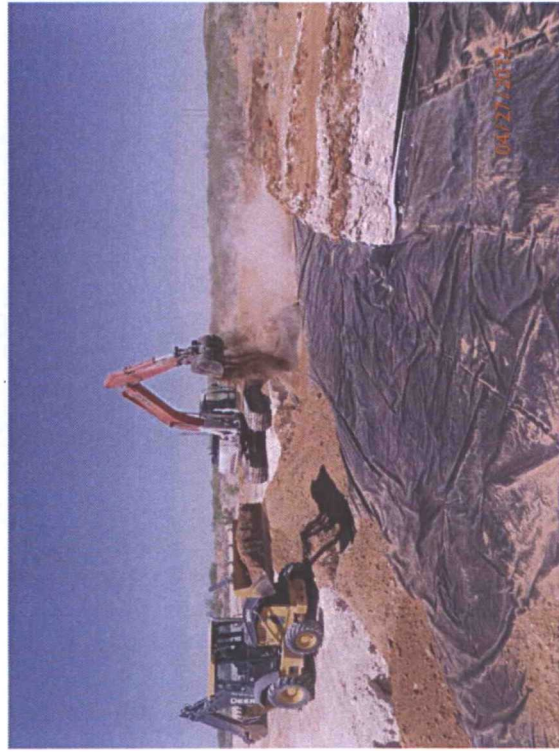
Backfilling with clean soil, facing northeast 4/27/2012

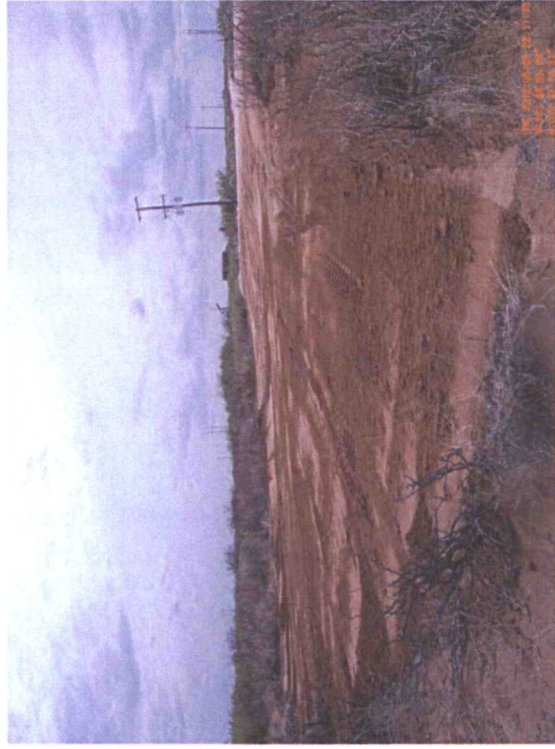
Southwest excavation backfilled, facing northwest 5/9/2012

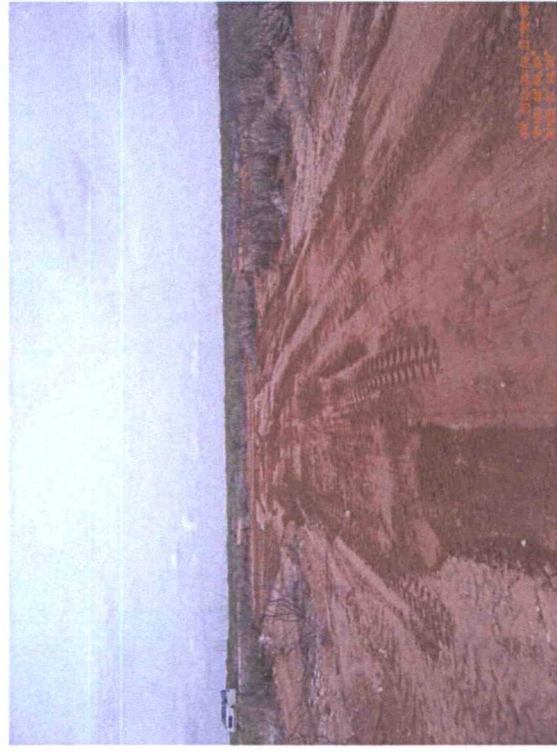
Center excavation backfilled, facing northeast 5/9/2012

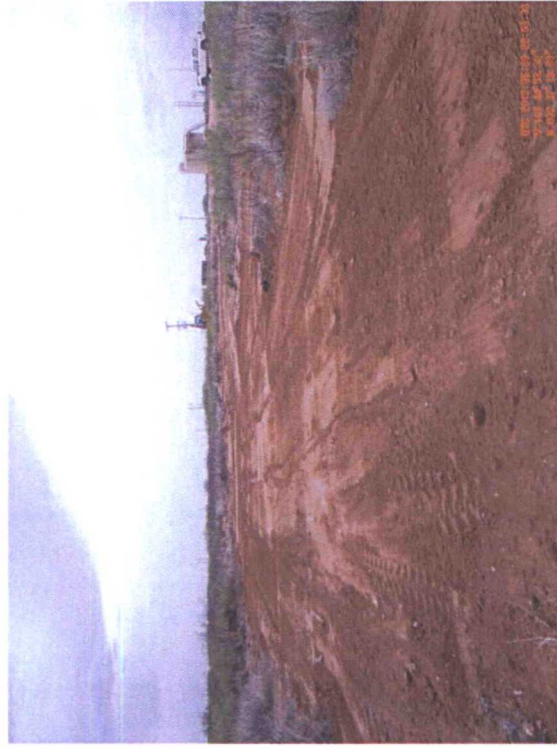
Southeast excavation backfilled, facing northwest 5/9/2012

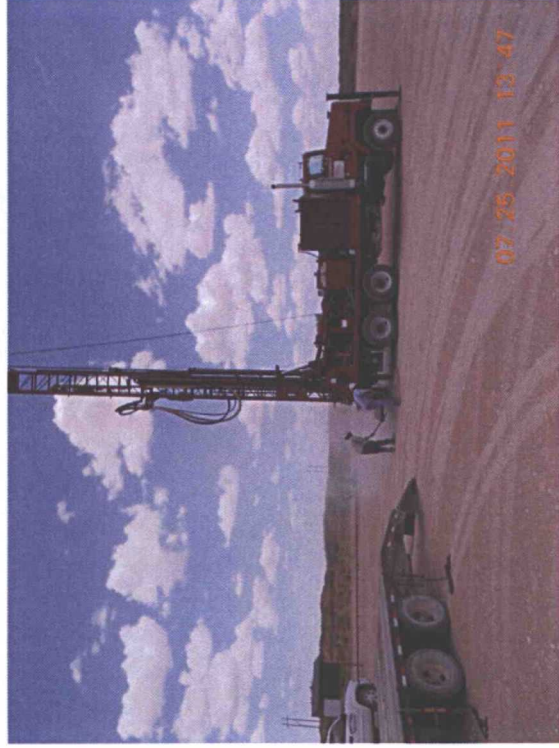
Drilling temporary MW, facing southwest 7/25/2011

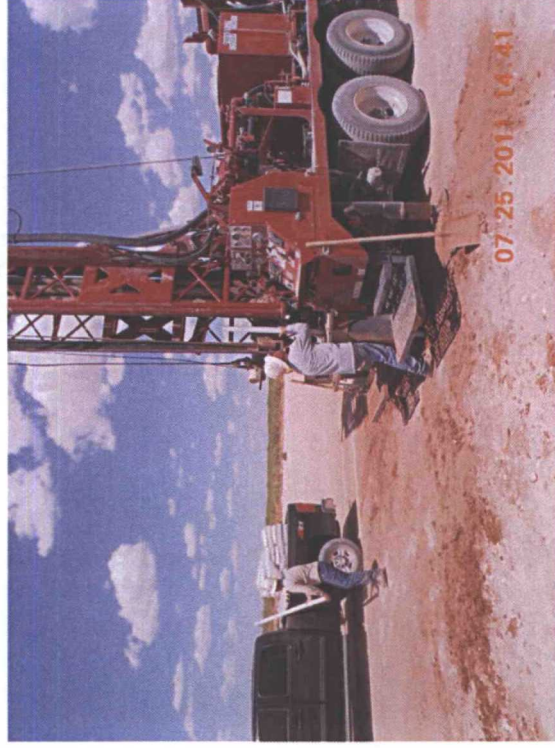
Installing casing in bore, facing west 7/25/2011

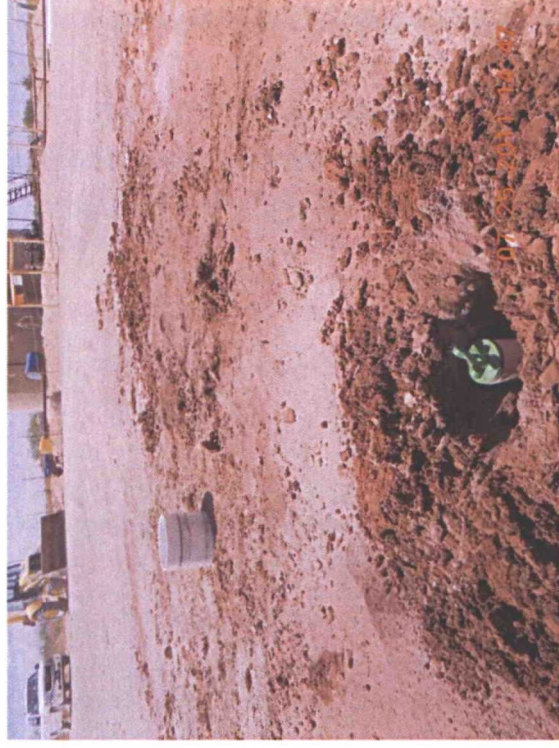
Temporary MW complete, facing southeast 7/25/2011

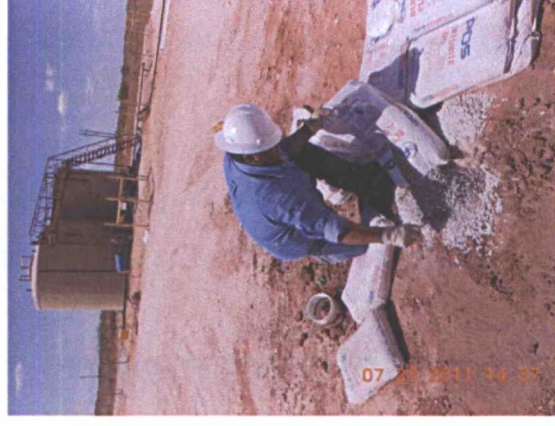
Plugging MW in total with bentonite 7/28/2011
