REMEDIATION SUMMARY & SITE CLOSURE REQUEST

SOUTHERN UNION GAS SERVICES

L-5 LINE (1RP-2086)

NMOCD Reference # 1RP-2086

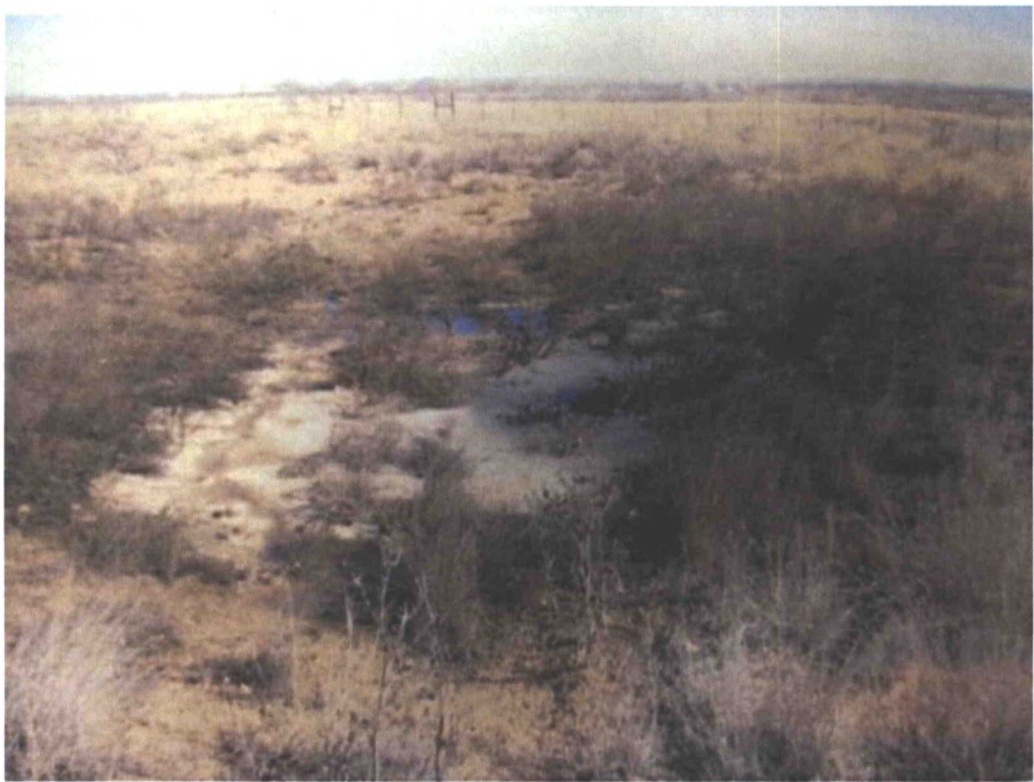
Photograph of the initial release at the L-5 Line Historical Release Site.

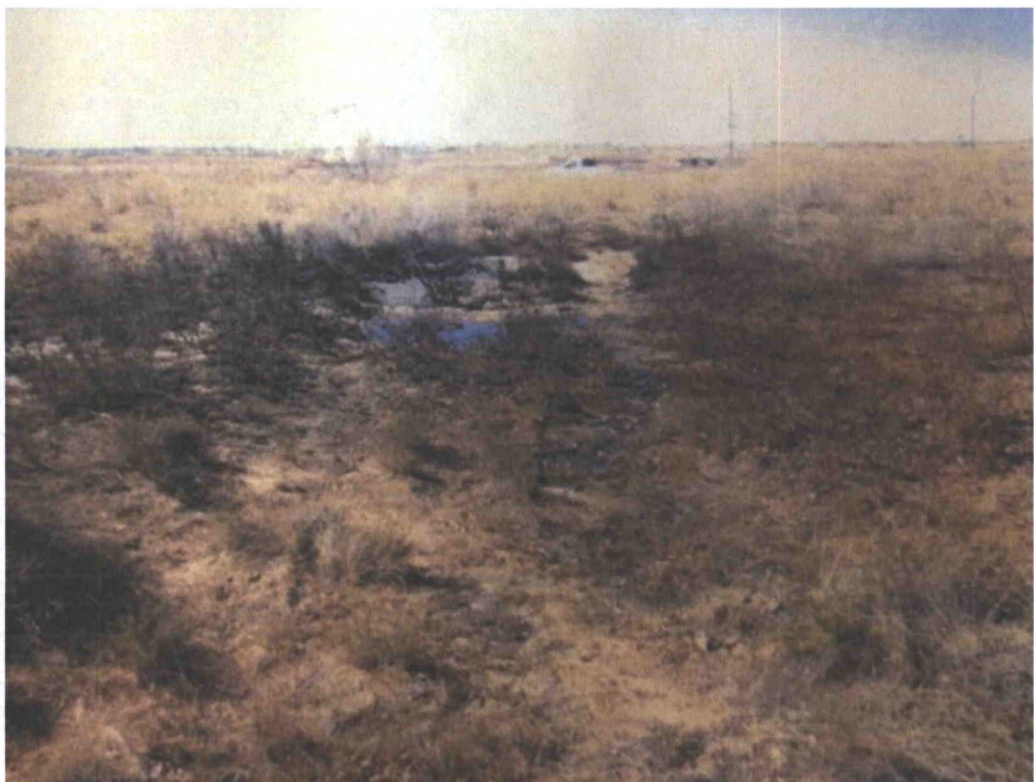
Photograph of the initial release at the L-5 Line Historical Release Site.

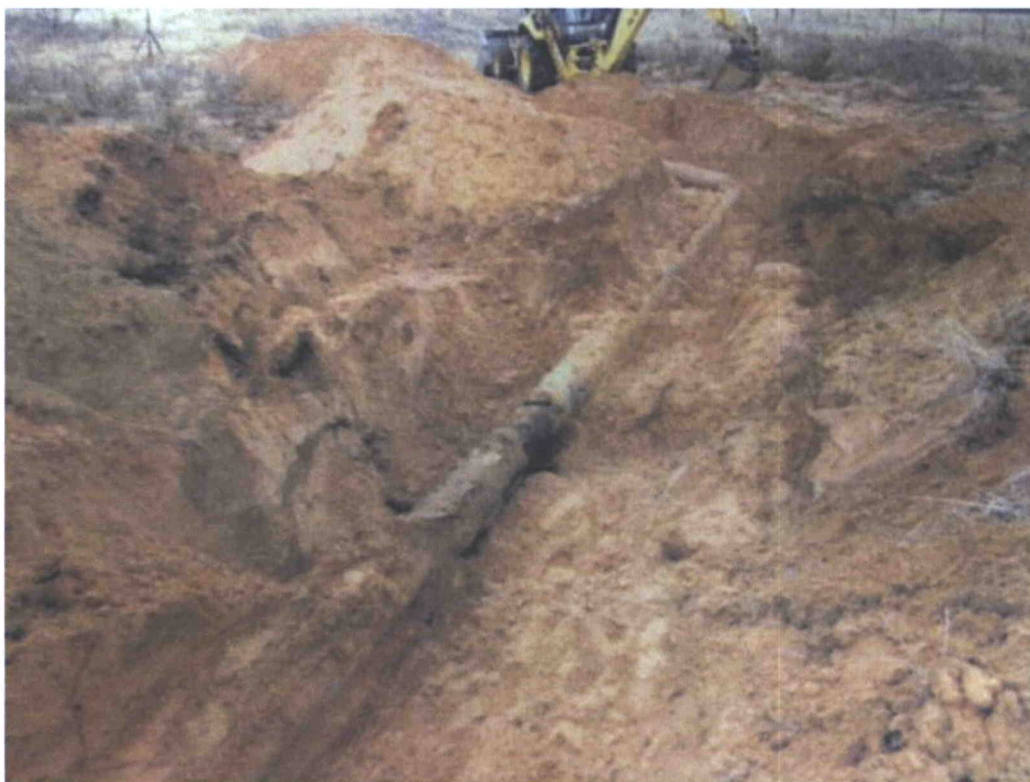
Photograph of the initial excavation at the L-5 Line Historical Release Site.

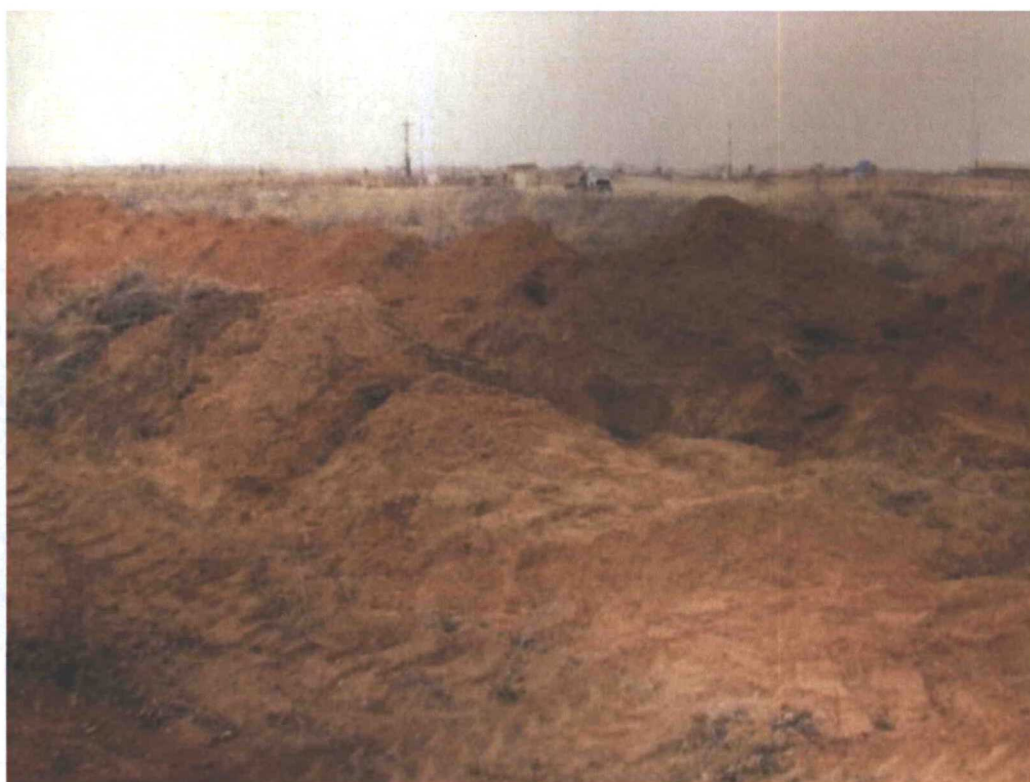
Photograph of the initial excavation at the L-5 Line Historical Release Site.

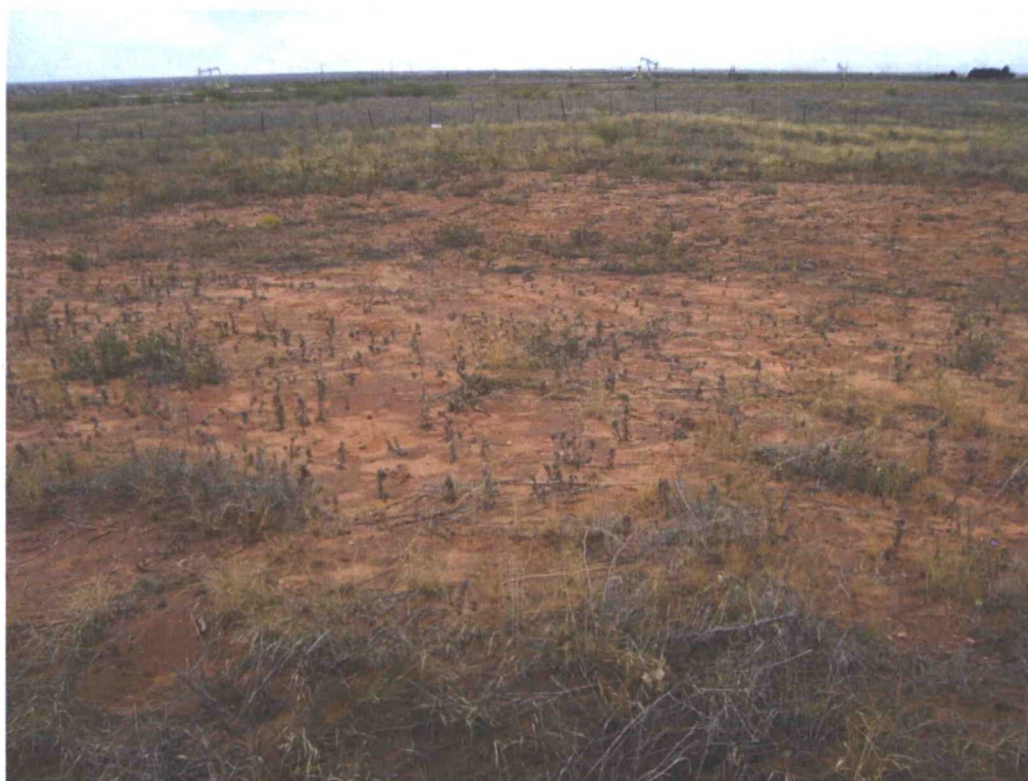
Photograph of the L-5 Line Historical Release Site during the site investigation.

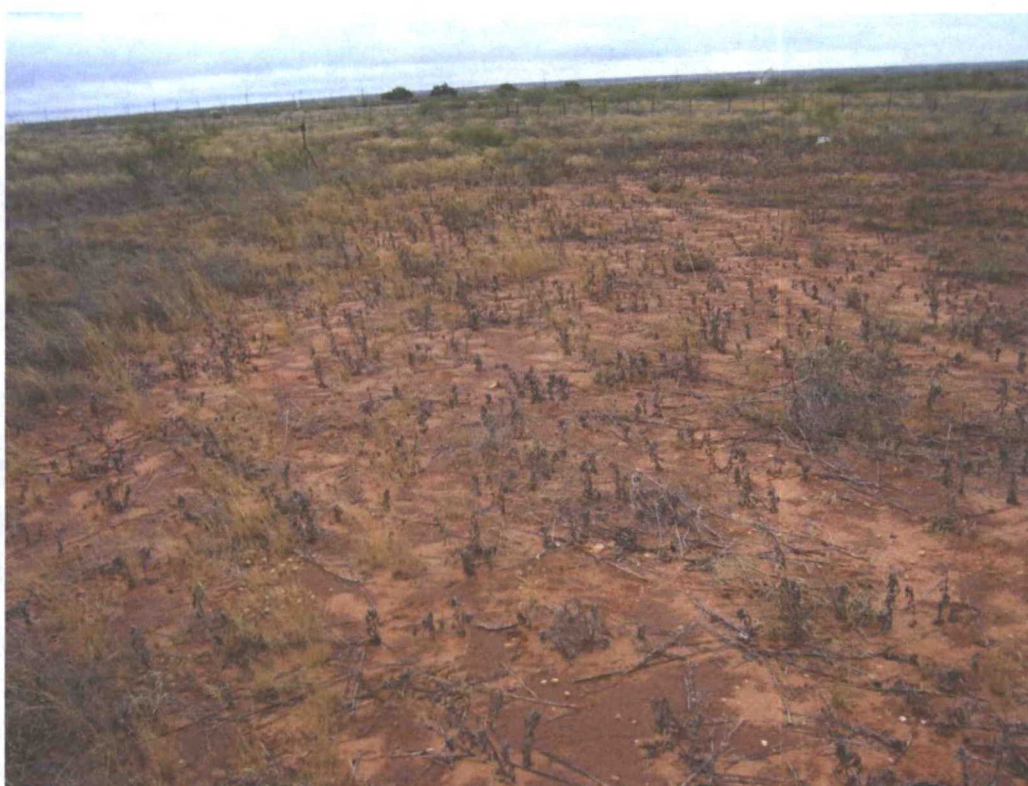
Photograph of the L-5 Line Historical Release Site during the site investigation.

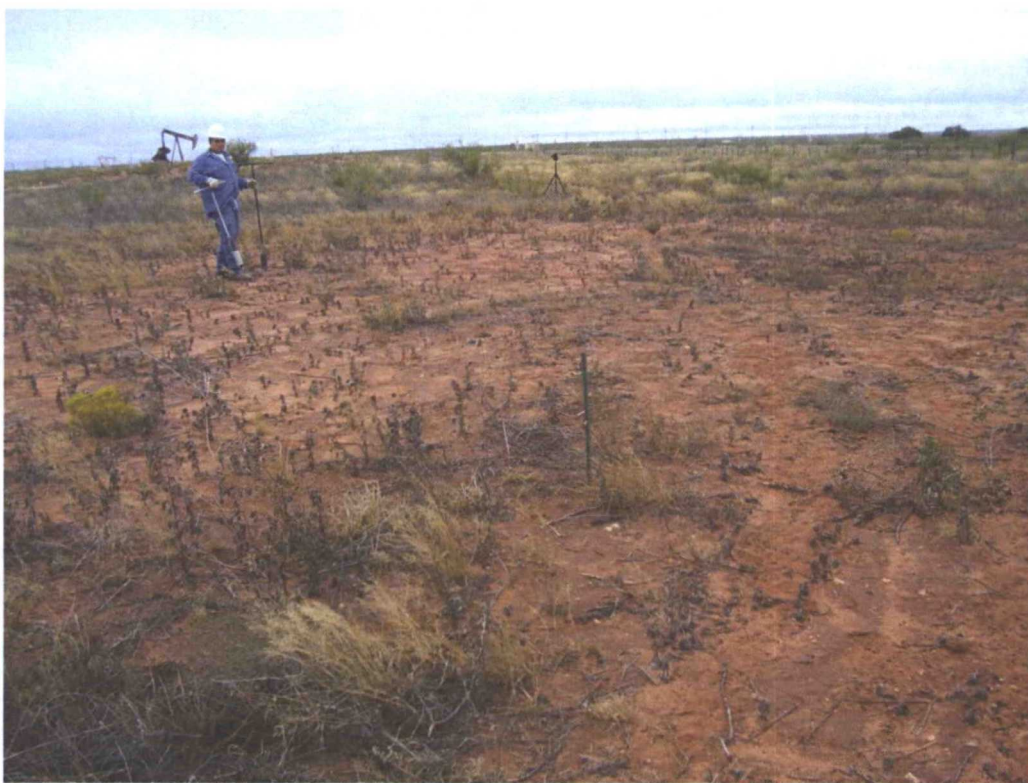
Photograph of the advancement of the soil boring at the L-5 Line Historical Release Site.

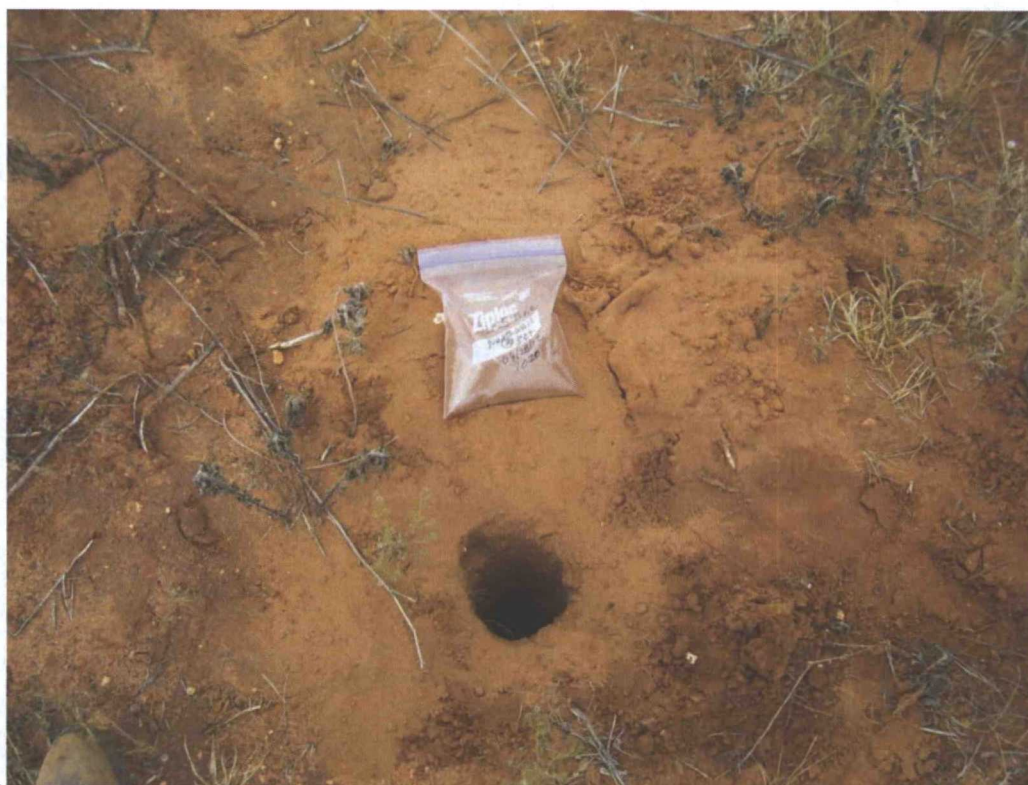
Photograph of soil sample "North Wall @ 3' bgs" collected from the L-5 Line Historical Release Site.

On September 28, 2012, Basin responded to the L-5 Line Historical Release Site. During the initial investigation, no impact was visible, and revegetation was noted. One (1) soil sample (North Sidewall @ 3' bgs) was collected near the northern margin of the disturbed area in an effort to achieve horizontal delineation. The soil sample was submitted to Xenco Laboratories, Inc., of Odessa, Texas, for determination of chloride concentrations in accordance with EPA Method 300/300.1. Laboratory analytical results indicated the chloride concentration was 8.15 mg/Kg. Based on these laboratory analytical results, the northern extent of soil impact had been delineated.
