**Release Notification and Corrective Action**

| Facility Name | Federal 11 20 34 #1 | Facility Type | Tank Battery |

Report Type: Closure Report

**Re: Closure Report for the COG Operating LLC., Federal 11 20 34 #1  
Tank Battery, Unit F, Section 11, Township 20 South, Range 34  
East, Lea County, New Mexico.**

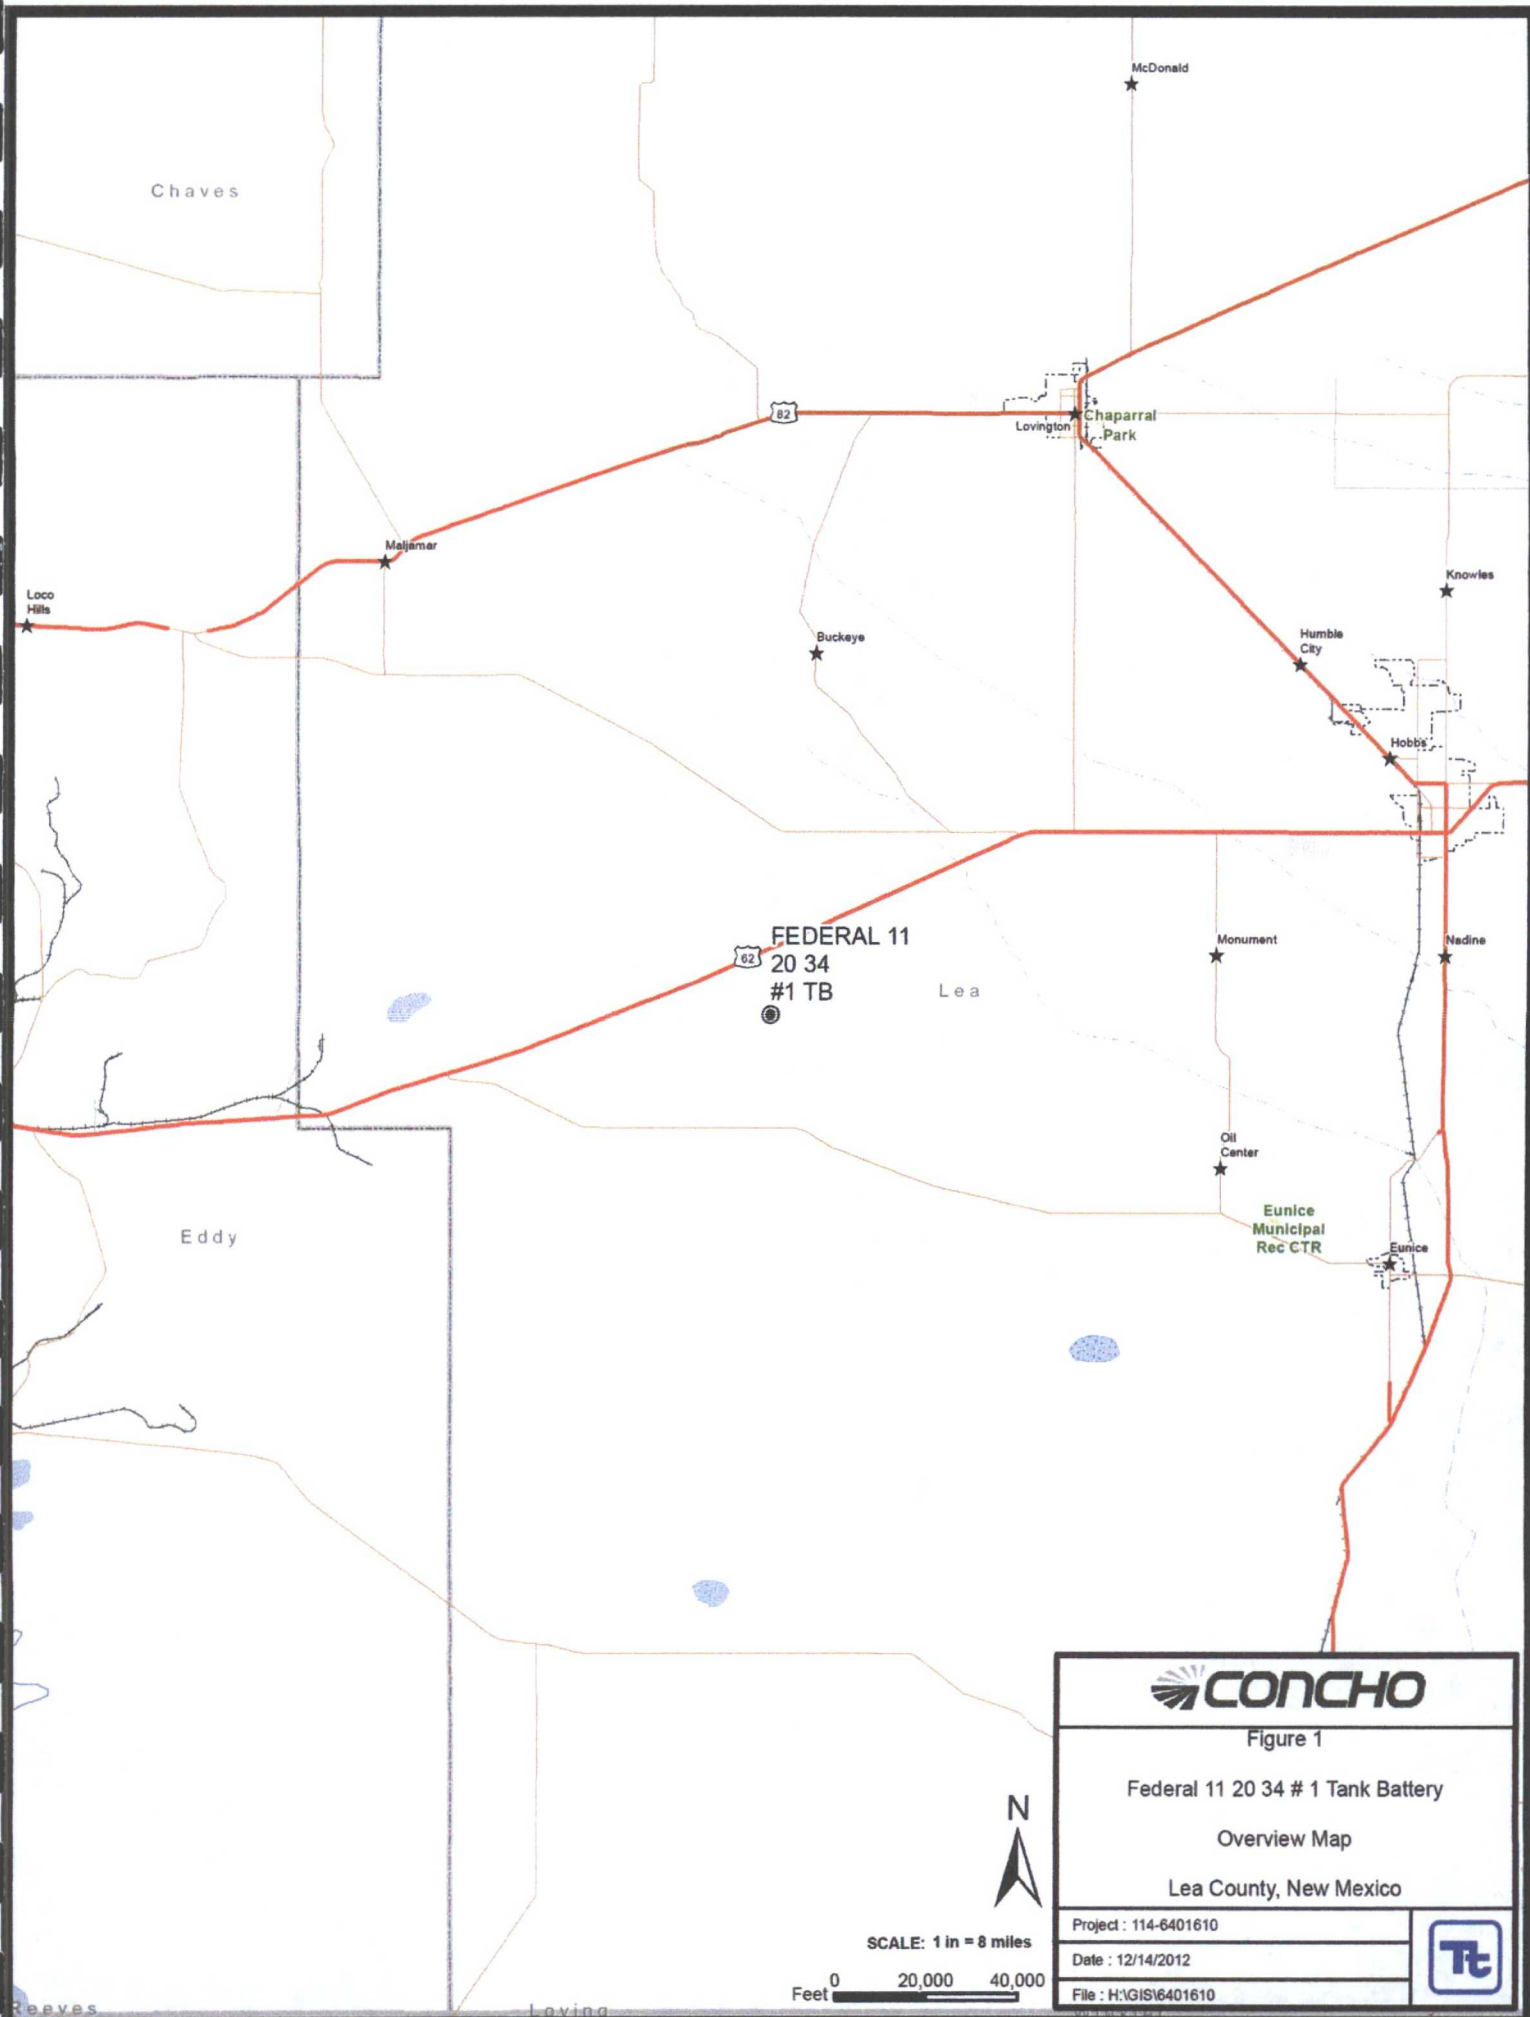
Figure 1

Federal 11 20 34 # 1 Tank Battery

Overview Map

Tetra Tech, Inc. (Tetra Tech) was contacted by COG Operating LLC. (COG) to assess a spill from the Federal 11 20 34 #1 Tank Battery located in Unit F, Section 11, Township 20 South, Range 34 East, Lea County, New Mexico (Site). The spill site coordinates are N 32.58929°, W 103.53169°. The site location is shown on Figures 1 and 2.

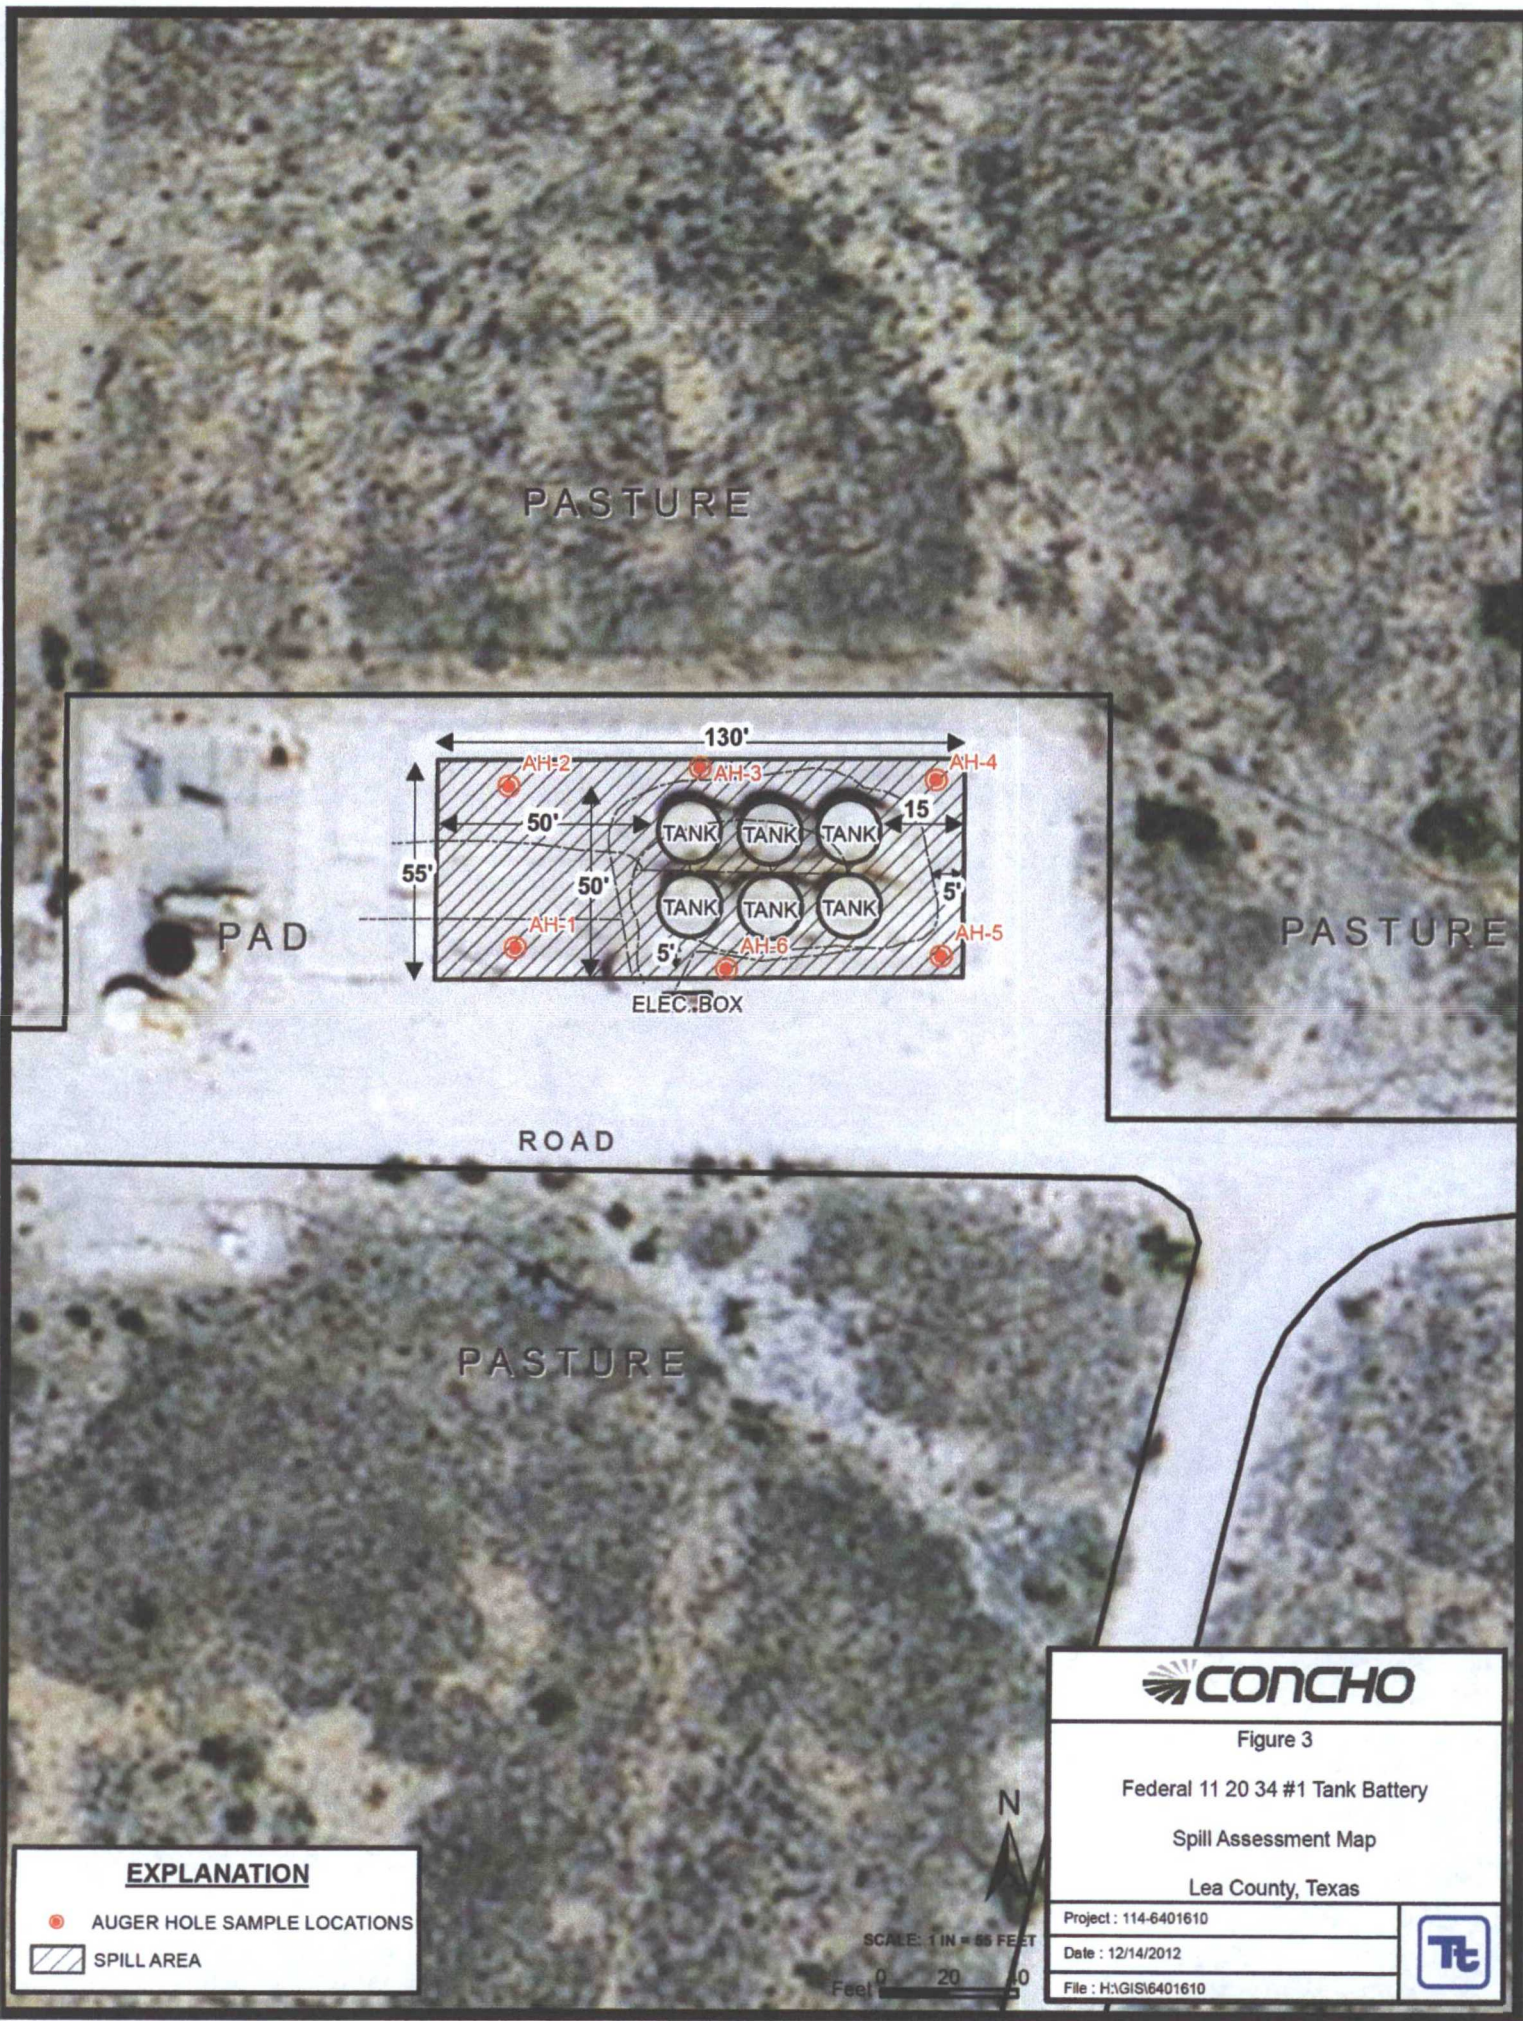
Figure 3

● AUGER HOLE SAMPLE LOCATIONS

▨ SPILL AREA

Spill Assessment Map

On December 10, 2012, Tetra Tech personnel inspected and sampled the spill area. Six (6) auger holes (AH-1 through AH-6) were installed using a stainless steel hand auger to assess the impacted soils. Selected samples were analyzed for TPH analysis by EPA method 8015 modified, BTEX by EPA Method 8021B and chloride by EPA method 300.0. Copies of laboratory analysis and chain-of-custody documentation are included in Appendix C. The sampling results are summarized in Table 1. The auger hole locations are shown on Figure 3.

Referring to Table 1, the auger hole samples showed a shallow hydrocarbon impact to the subsurface soils. In the areas of AH-1, AH-3 and AH-5, BTEX and TPH concentrations were detected above the RRAL to depth of approximately 2.0' to 3.0' below surface. In addition, AH-2, AH-4 and AH-6 samples either exceeded the RRAL for TPH or BTEX at 0-1', but declined below the RRAL at 1-1.5' below surface.

The highest total BTEX concentration of 1,325 mg/kg was detected in AH-1 at 2-2.5' and decreased to <0.0400 mg/kg at 3-3.5' below surface. The highest TPH concentration of 23,270 mg/kg was also detected in AH-1 at 2-2.5' and decreased to 9.90 mg/kg at 3-3.5' below surface. All BTEX and TPH concentrations decreased with depths and the spill was vertically defined.

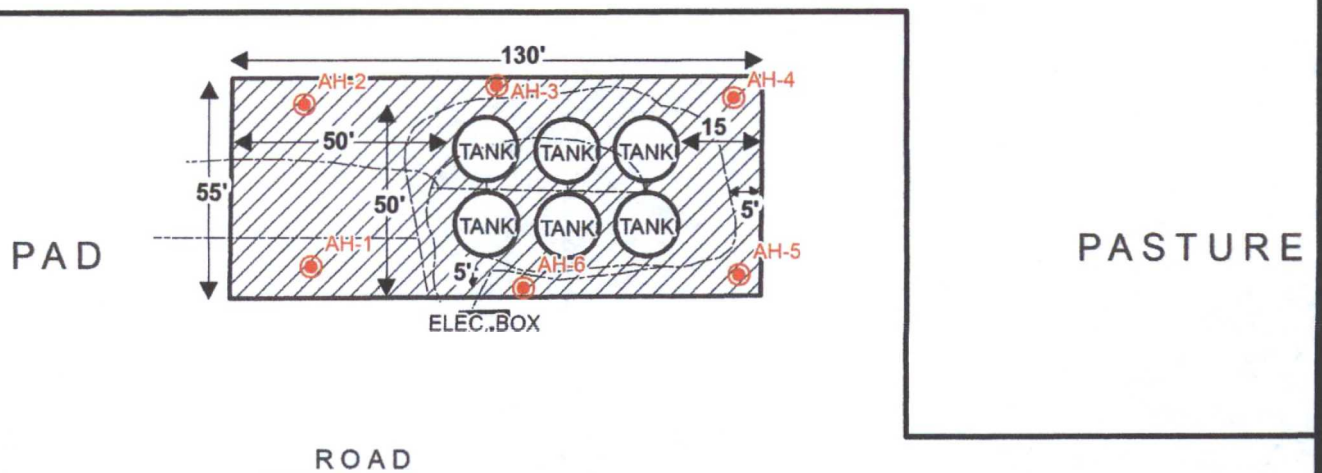
Figure 3

● AUGER HOLE SAMPLE LOCATIONS

▨ SPILL AREA

Spill Assessment Map

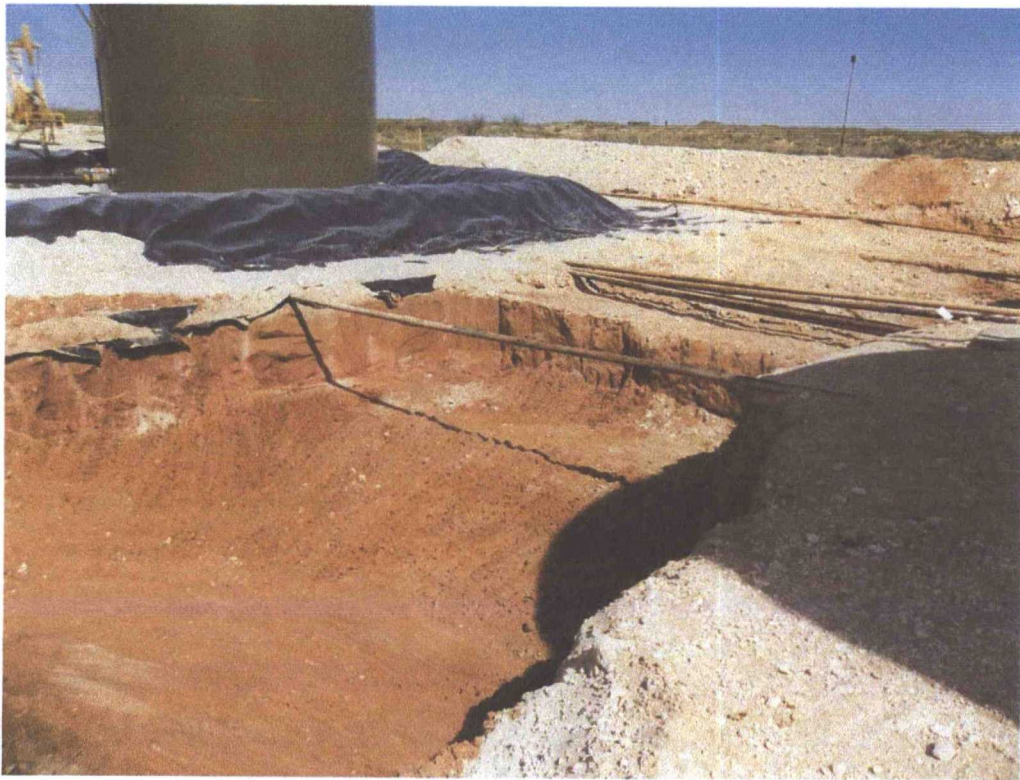
View Southeast – Area of AH-1 and AH-2.

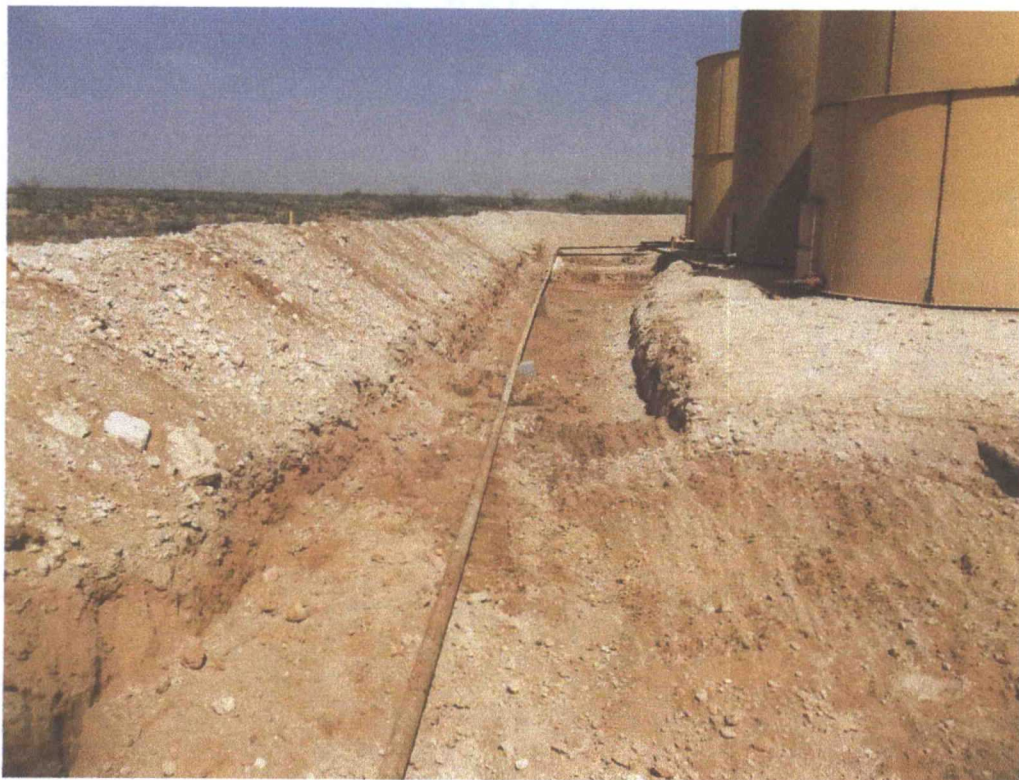
View East – Area of AH-3.

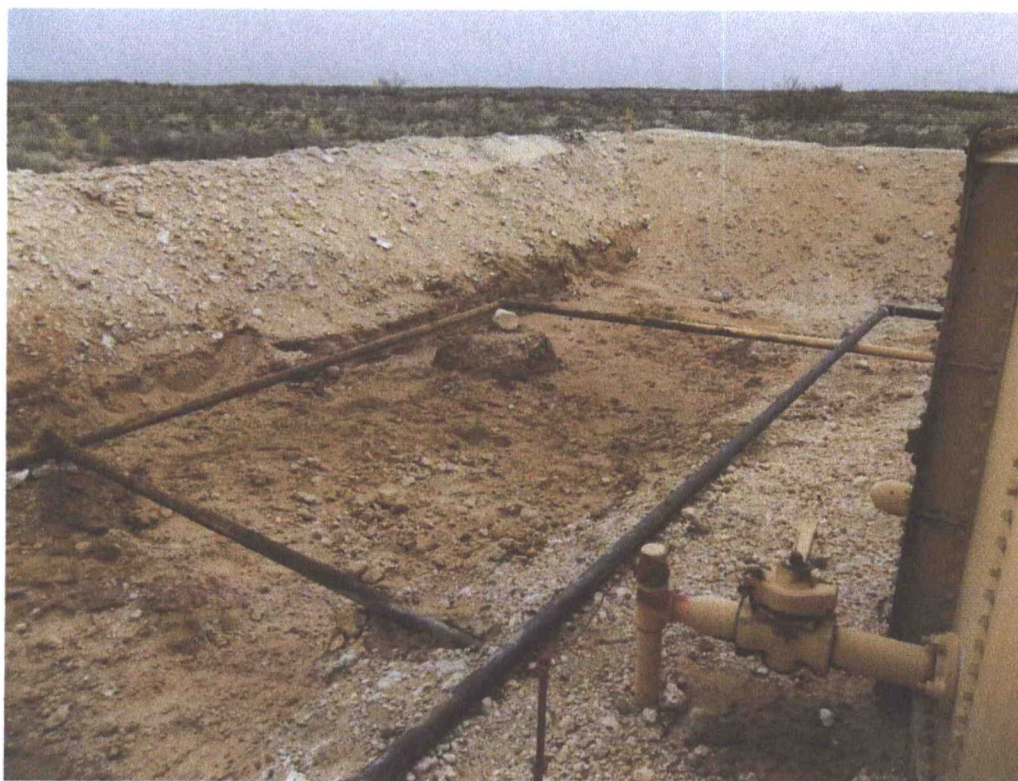
View South – Area of AH-4.

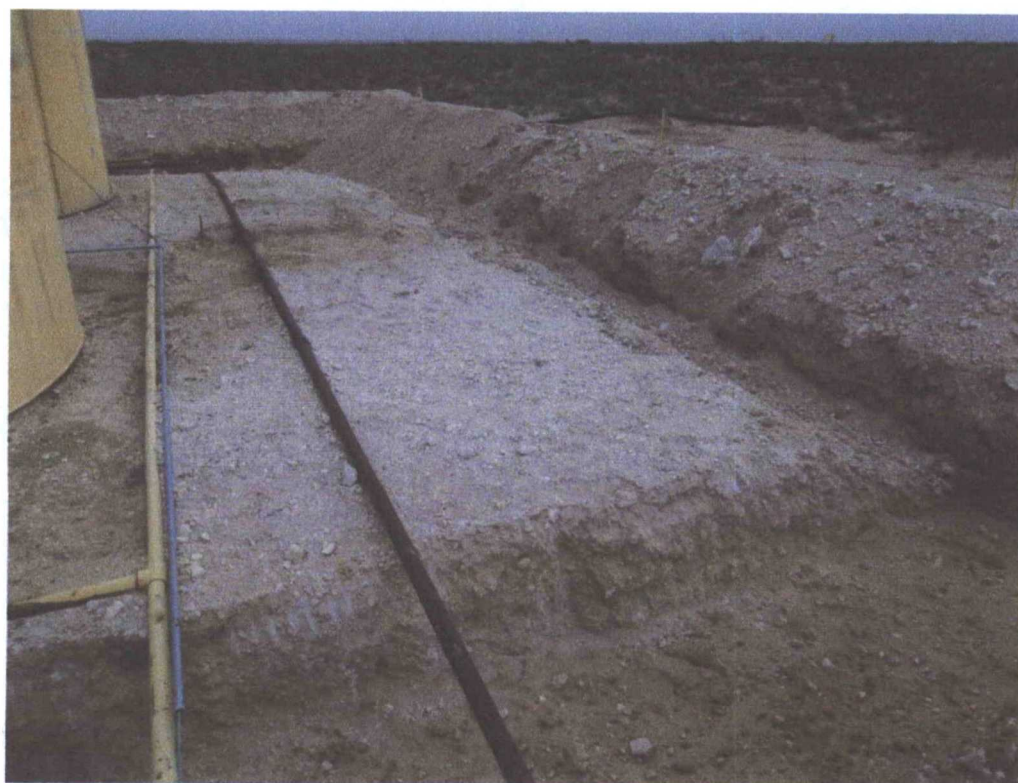
View West – Area of AH-4 and AH-5.

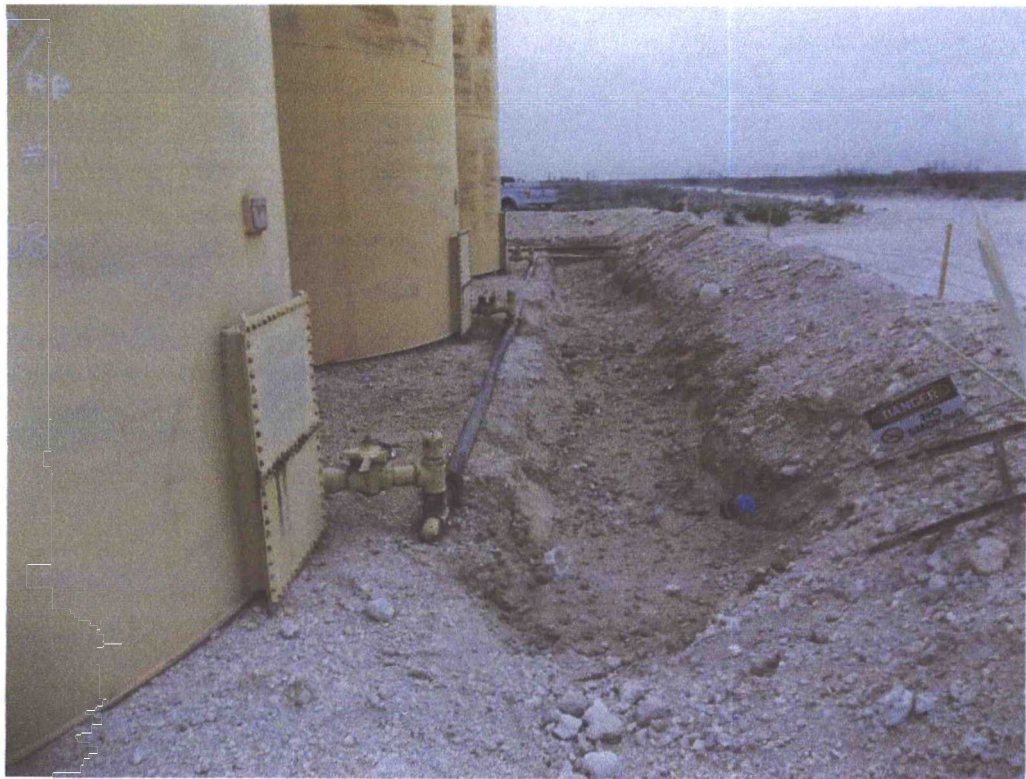
View West- Area of AH-5 and AH-6.
