REMEDIATION SUMMARY

SITE CLOSURE REQUEST

SOUTHERN UNION GAS SERVICES

Line MB-4 (2010-050)

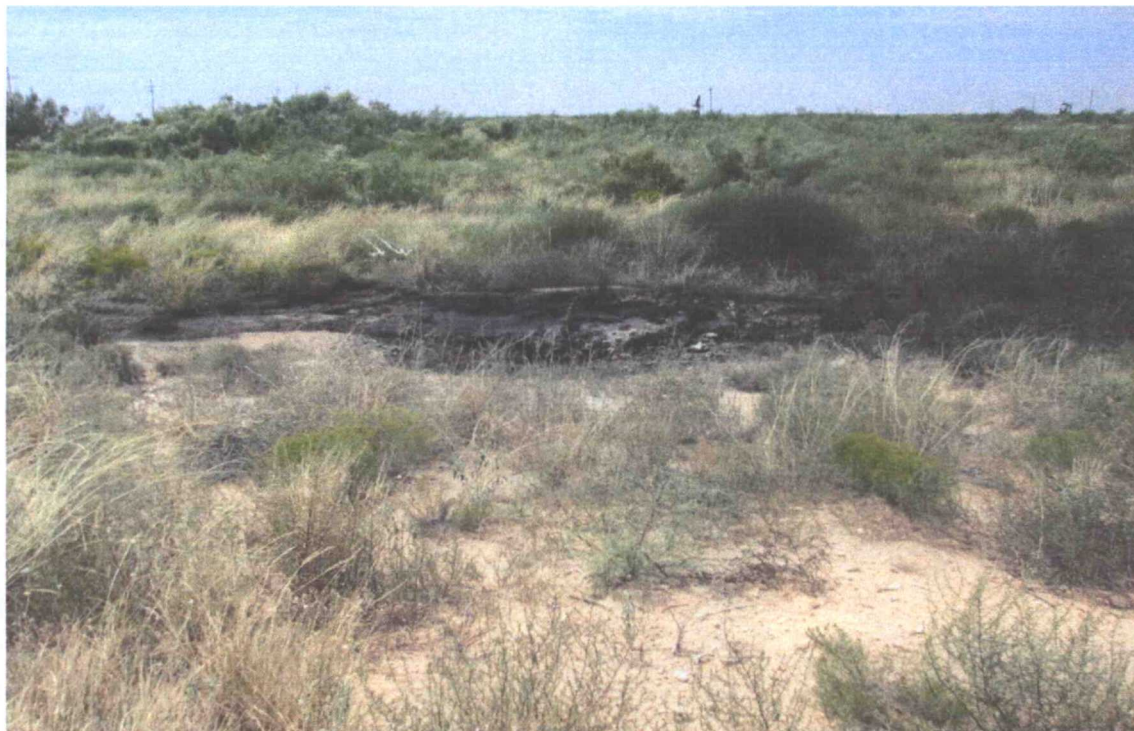
Line MB-4 Release Site

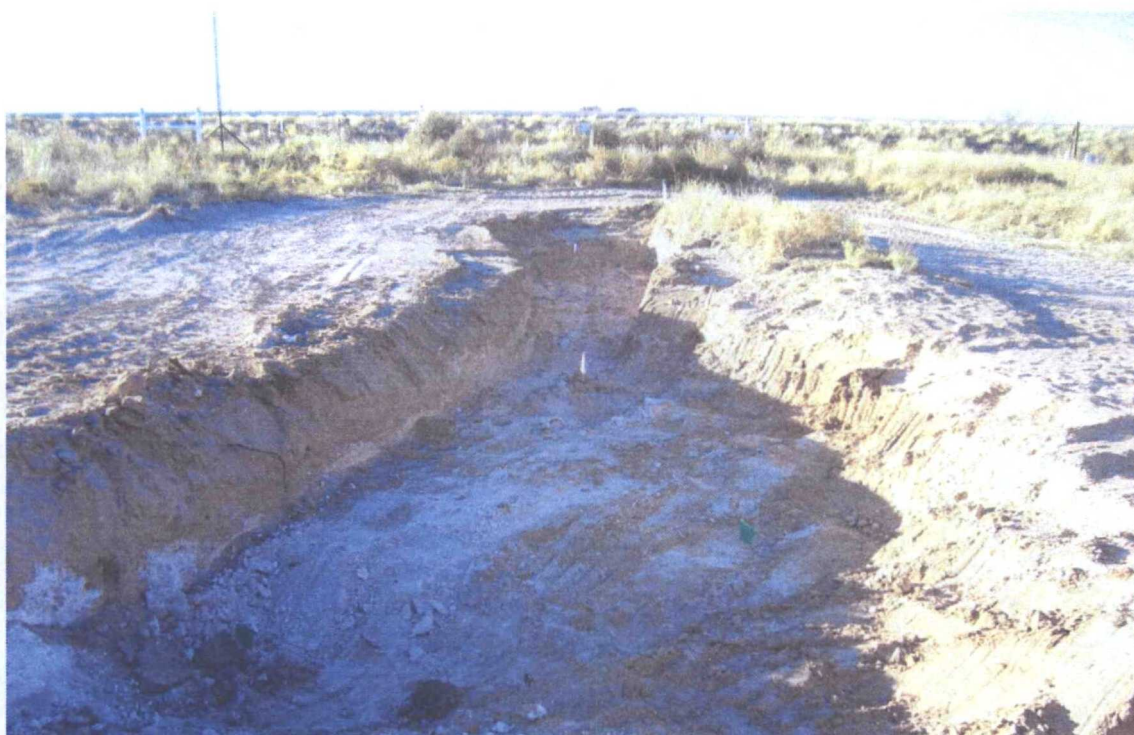
Line MB-4 Release Site - South Ditch
(looking North; sample locations flagged)

On December 9, 2010, following initial response activities, excavation of impacted soil began at the site. Hach Quantab Chloride Low Range (30-600 mg/Kg) Titrators were used to field-screen the horizontal and vertical extent of impacted soil and to guide the excavation. The excavation was divided into two sections: the "South Ditch" and the "West Ditch". Approximately twenty-four (24) cubic yards (cy) of

On December 14, 2010, approximately thirty-three (33) cy of impacted soil was excavated and transported to Sundance for disposal. In addition, eleven (11) soil samples (S Ditch E Wall #1, S Ditch E Wall #2, S Ditch Floor #1, S Ditch Floor #2, S Ditch W Wall #1, S Ditch W Wall #2, S Pooling Area, W Ditch N Floor, W Ditch N Wall, W Ditch S Floor, and W Ditch S Wall) were collected from the floor and sidewalls of the excavation and submitted to Xenco Laboratories (Odessa, TX) for analysis of benzene, toluene, ethyl-benzene, and xylenes (BTEX), total petroleum hydrocarbon (TPH), and/or chloride concentrations using EPA Method SW-846 8021b, EPA Method SW-846 8015M, and EPA Method 300.1, respectively.

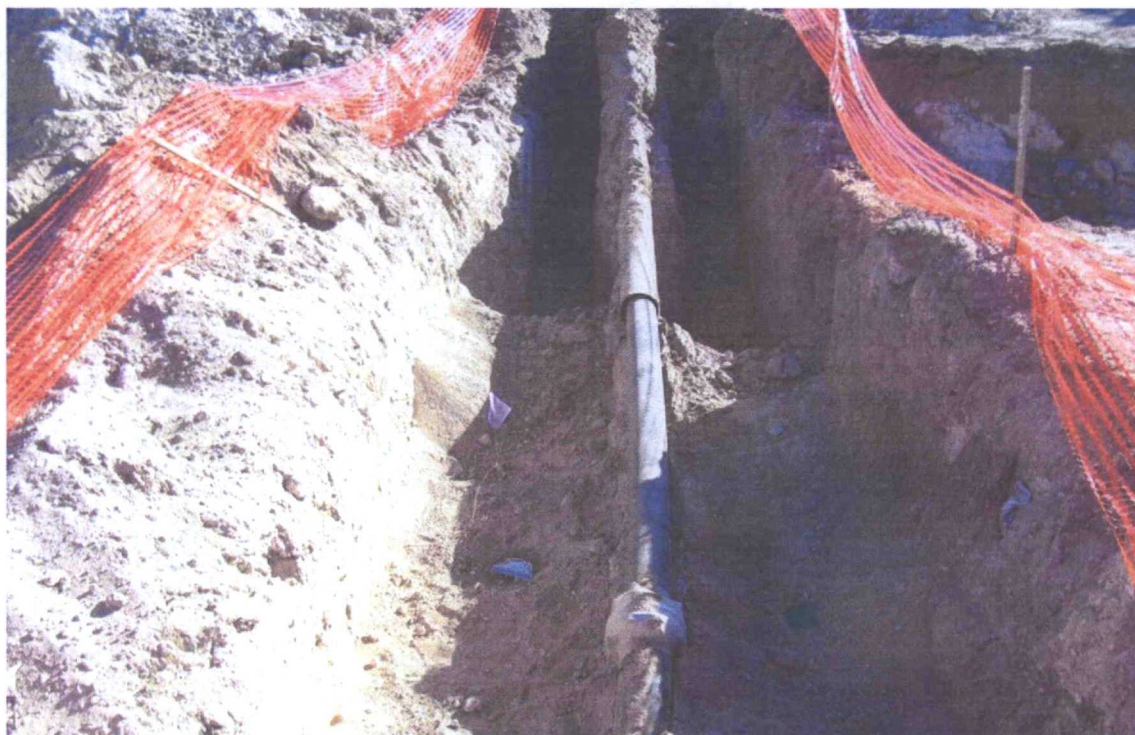
Line MB-4 Release Site - West Ditch
(looking East; sample locations flagged)

On January 3, 2011, an NMOCD representative approved Southern Union's request to allow soil represented by soil sample "W Ditch S Floor" to remain in place.

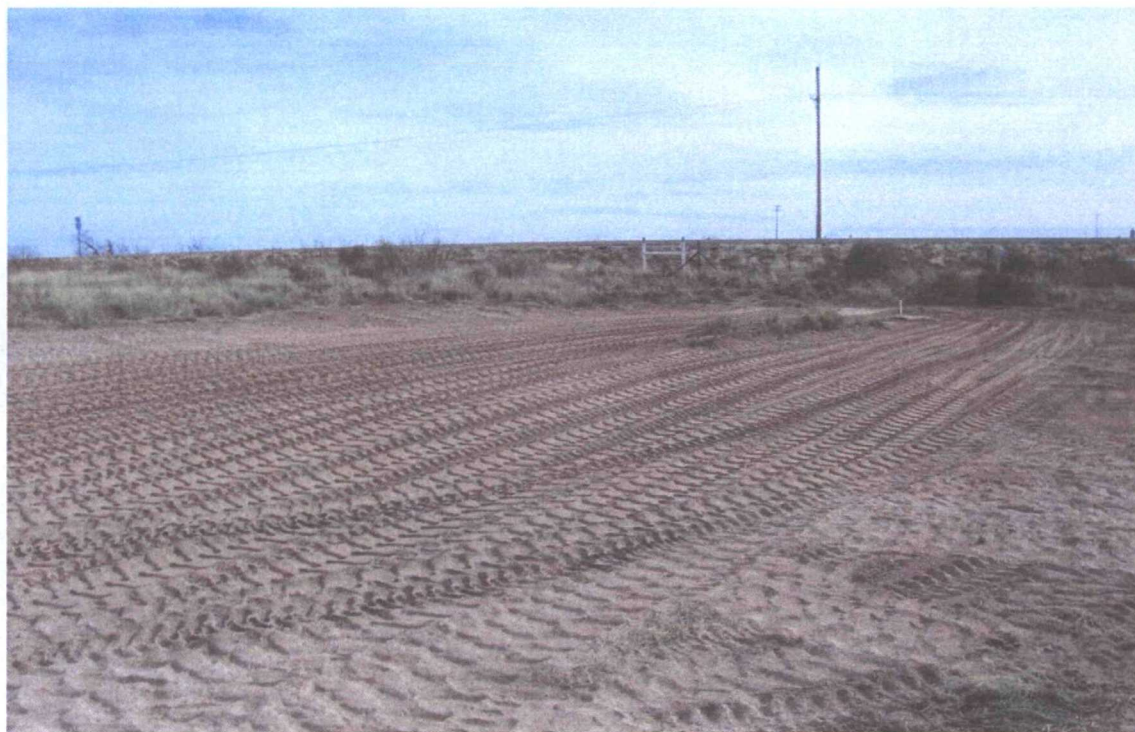
Line MB-4 Release Site (following backfilling)

Based on the laboratory analytical results, on January 5, 2011, the excavation was backfilled in eighteen (18)-inch lifts, compacted, and contoured to fit the surrounding topography. Prior to backfilling, final dimensions of the South Ditch were approximately seventy-two (72) feet in length, approximately twelve (12) feet in width, and approximately two (2) feet in depth. The West Ditch measured approximately twelve (12) feet in length, approximately forty-eight (48) feet in width, and ranging in depth from approximately three (3) feet to twelve (12) feet.
