Release Notification and Corrective Action

## **REMEDIATION SUMMARY AND SITE CLOSURE REQUEST**

**Southern Union Gas Services  
California "A" Line (2009-067)  
Lea County, New Mexico  
UNIT M (SW/SW), Section 3, Township 26 South, Range 34 East  
Latitude 32° 03.910' North, Longitude 103° 27.358' West  
NMOCD Reference # 1RP-2397**

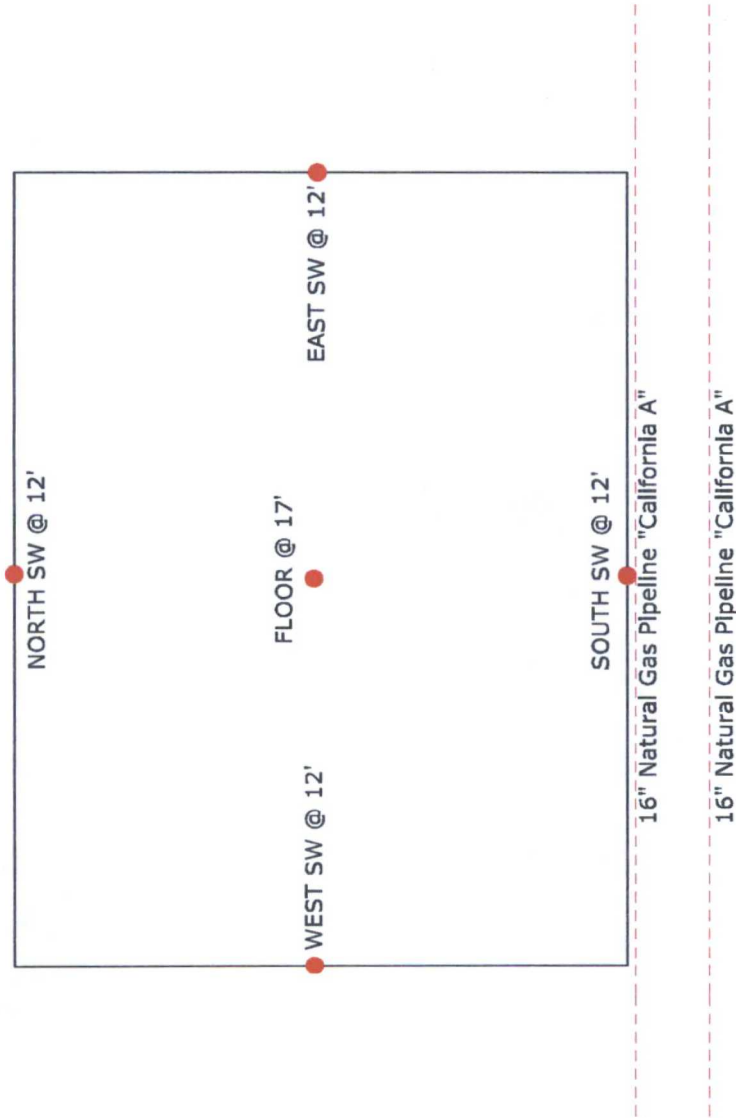
**Figure 2**  
**Site and Sample Location Map**  
Southern Union Gas Services  
California "A" Line  
Lea County, New Mexico

- Excavation
- - - Pipeline
- Sample Location

On May 20 and May 21, 2010, remedial activities commenced at the location. The sixteen (16) inch natural gas pipeline was excavated by hand and an excavator was utilized to advance the excavation to a depth of seventeen (17) feet bgs. The excavation sidewalls were advanced to the north, east and west until field test indicated TPH and chloride concentrations were below NMOCD regulatory standards. Advancement of the excavation to the south was restricted by the presence of two active sixteen (16) inch natural gas pipelines and a widely used oilfield access road. The final dimensions of the excavation were approximately twenty-five (25) feet in width by thirty-two (32) feet length and seventeen (17) feet in depth. Approximately 475 cubic yards of excavated material was stockpiled on-site.

On May 20 and May 21, 2010, five (5) confirmation soil samples (NORTH SW @ 12', EAST SW @ 12', SOUTH SW @ 12', WEST SW @ 12' and FLOOR @ 17') were collected from the excavation and submitted to Cardinal Laboratories for analysis of benzene, toluene, ethylbenzene and xylenes (BTEX) by EPA Method SW-846 8021b, total petroleum hydrocarbons (TPH) by EPA Method SW-846 8015M and chloride concentrations by EPA Method 4500 Cl. Benzene concentrations were less than the appropriate laboratory method detection limit (MDL) for each of the soil samples submitted. BTEX concentrations were less than the laboratory MDL for each of the soil samples submitted, with the exception of soil sample SOUTH SW @ 12' which exhibited a concentration of 11.84 mg/kg. TPH concentrations were less than the laboratory MDL for each of the soil samples submitted, with the exception of soil sample SOUTH SW @ 12' which exhibited a concentration of 7,920.8 mg/kg. Chloride concentrations ranged from 32 mg/kg for soil sample EAST SW @ 12' to 224 mg/kg for soil sample SOUTH SW @ 12'. A summary of analytical results are provided in Table 1.

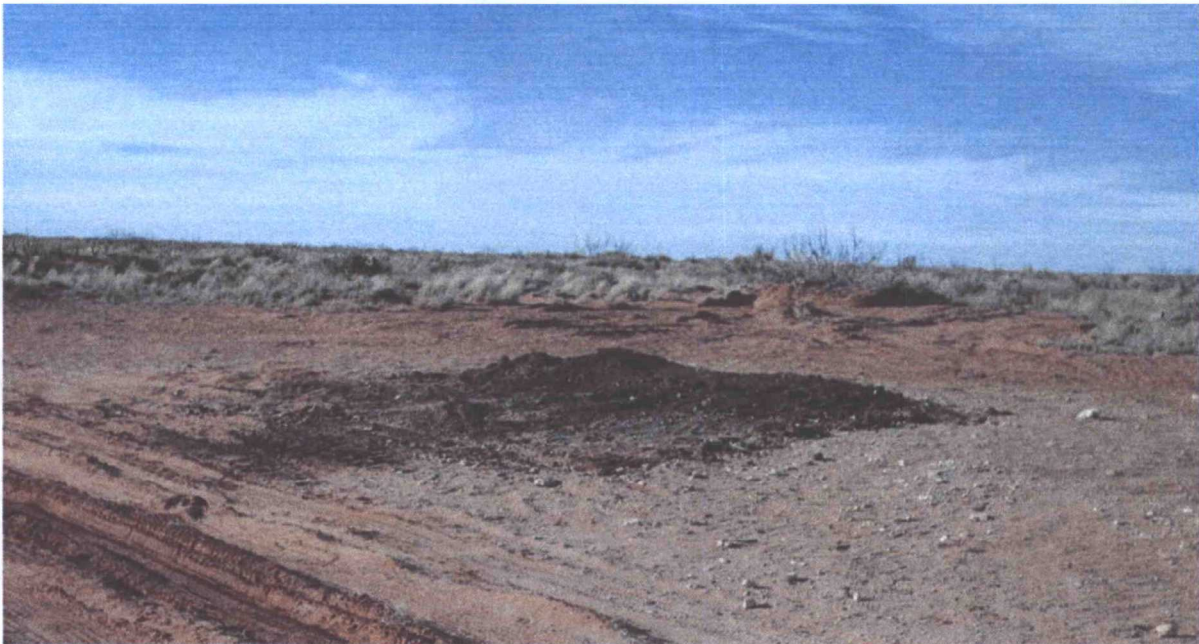
Photograph of initial release at the California "A" Line release site, looking North West.

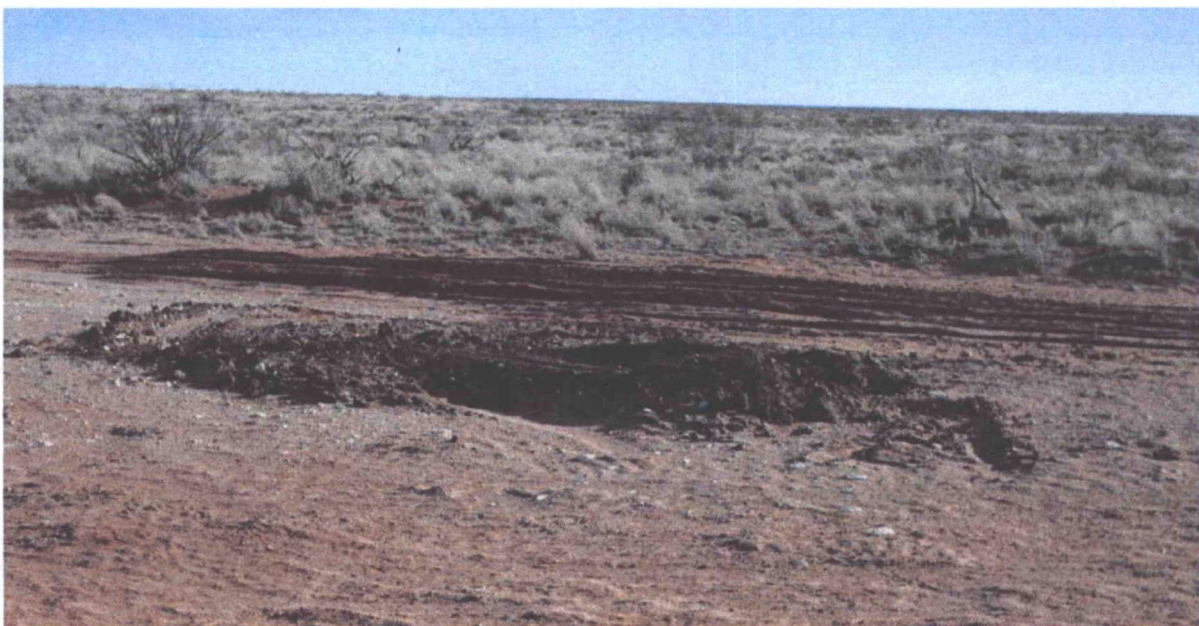
Photograph of initial spill at the California "A" Line release site, looking South.

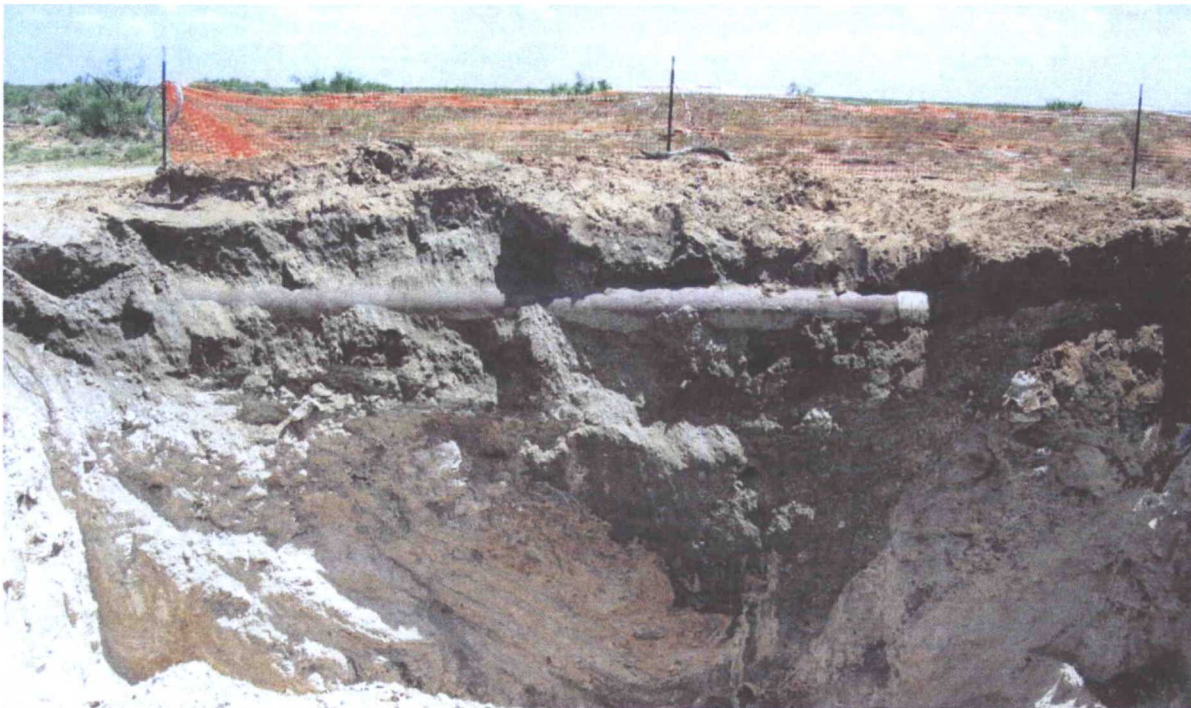
Photograph of excavation and sample locations at the California "A" Line release site, looking South.

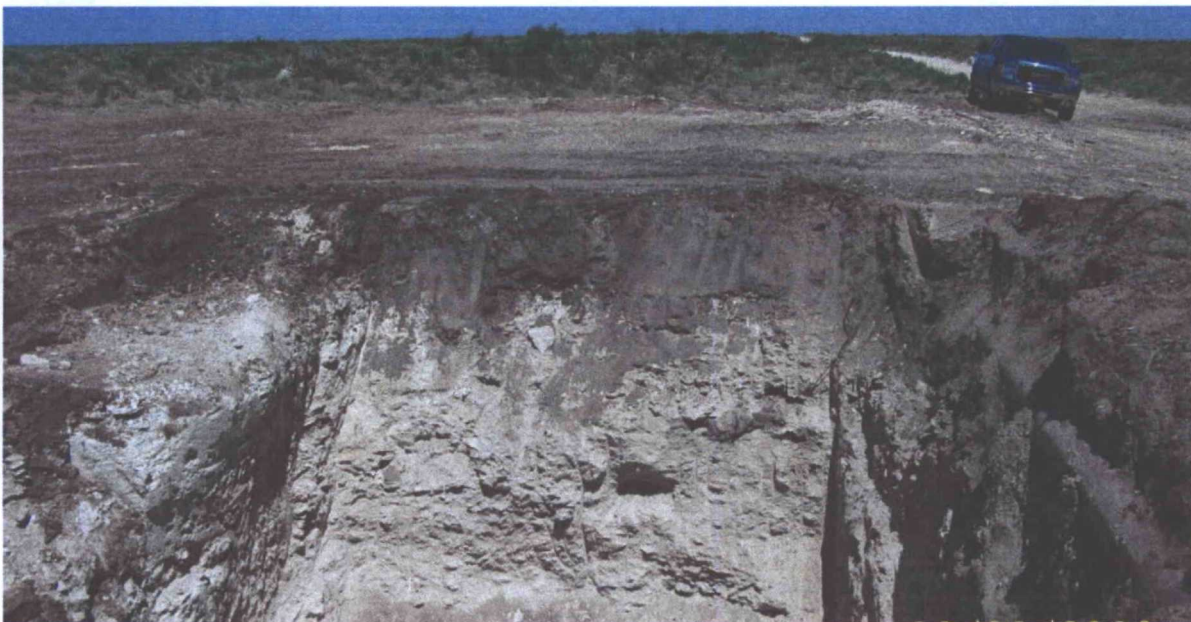
Photograph of excavation and sample locations at the California "A" Line release site, looking East.

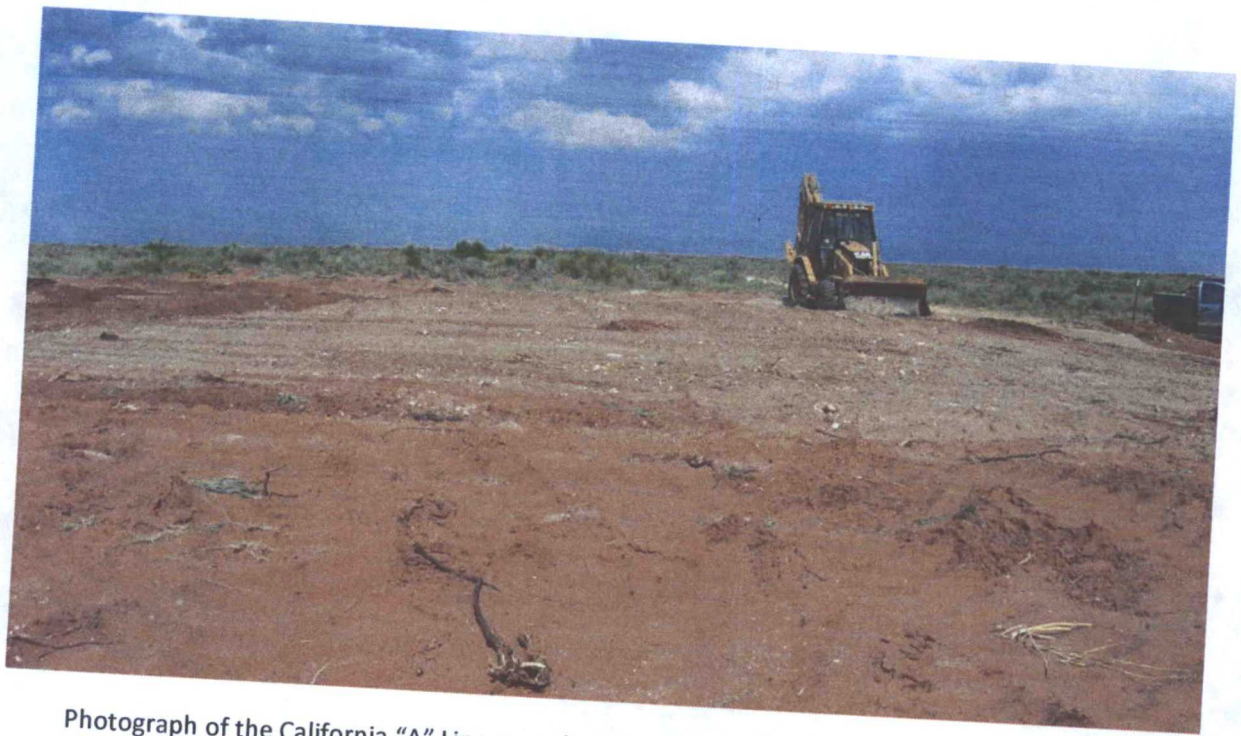
Photograph of the California "A" Line remediation site after backfilling activities, looking East.

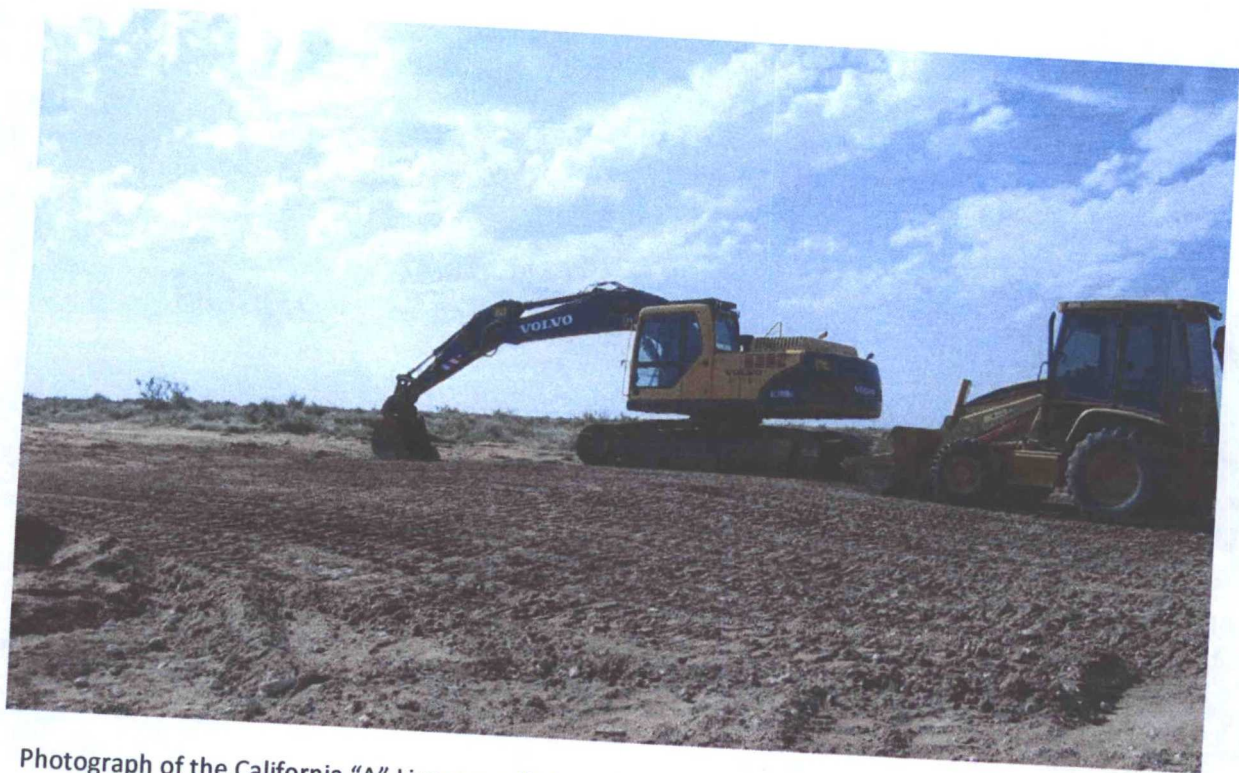
Photograph of the California "A" Line remediation site after backfilling and contouring, looking North.
