Release Notification and Corrective Action

Name of Company	Southern Union Gas Services	Contact	Rose Slade
Address	801 S. Loop 464, Monahans, TX 79756	Telephone No.	432-940-5147
Facility Name	Line #290 (East of Jal South)	Facility Type	Natural Gas Pipeline
Surface Owner	George Willis	Lease No.	30-025-38822

**Figure 1**  
**Site Location Map**  
**Southern Union Gas Services**  
**Line #290 (East of Jal South)**  
**Lea County, New Mexico**  
**NMOCD Ref. #: 1RP-11-11-2752**

Figure 2  
Site & Sample Location Map  
Southern Union Gas Services  
Line #290 (East of Jal South)  
NMOCD Ref #1RP-11-11-2752  
Lea County, New Mexico

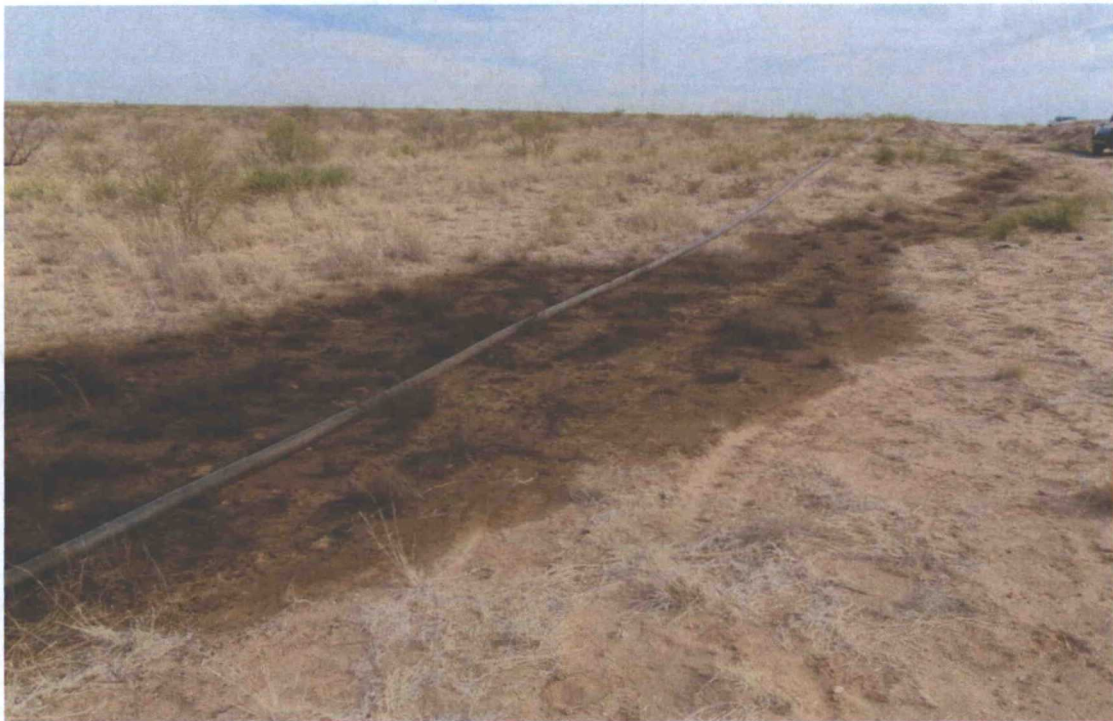
Line #290 (East of Jal South) - Release Site (Looking East-northeast)

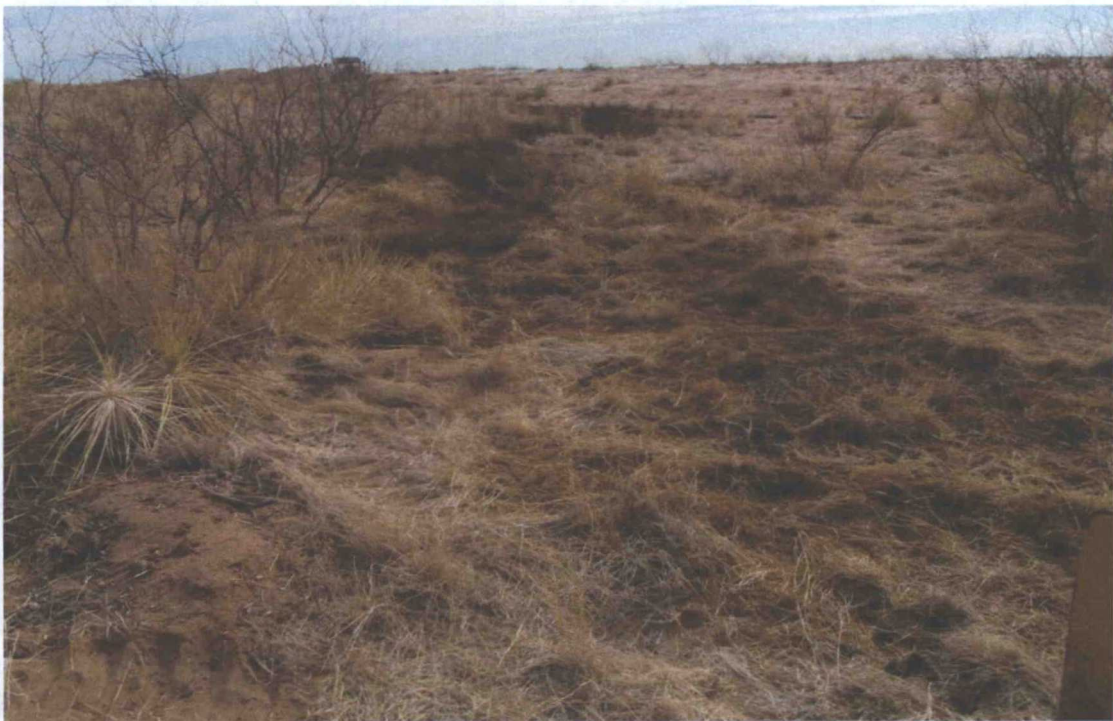
Line #290 (East of Jal South) - Release Site (Looking Southeast)

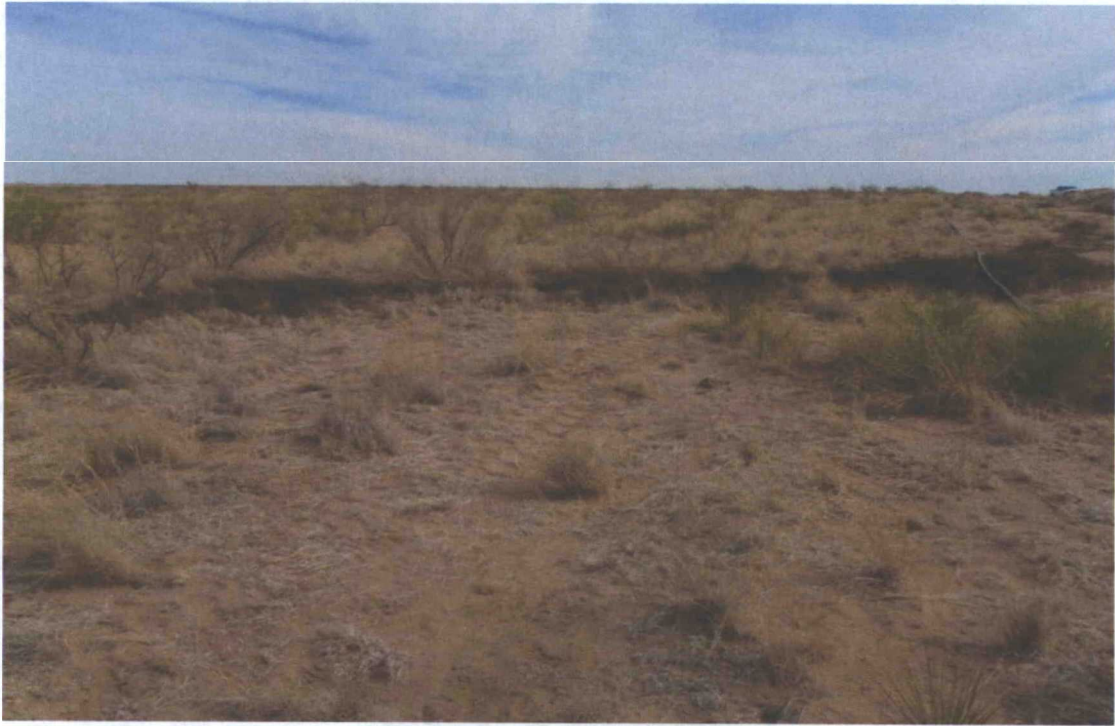
Line #290 (East of Jal South) - Release Site (Looking East)

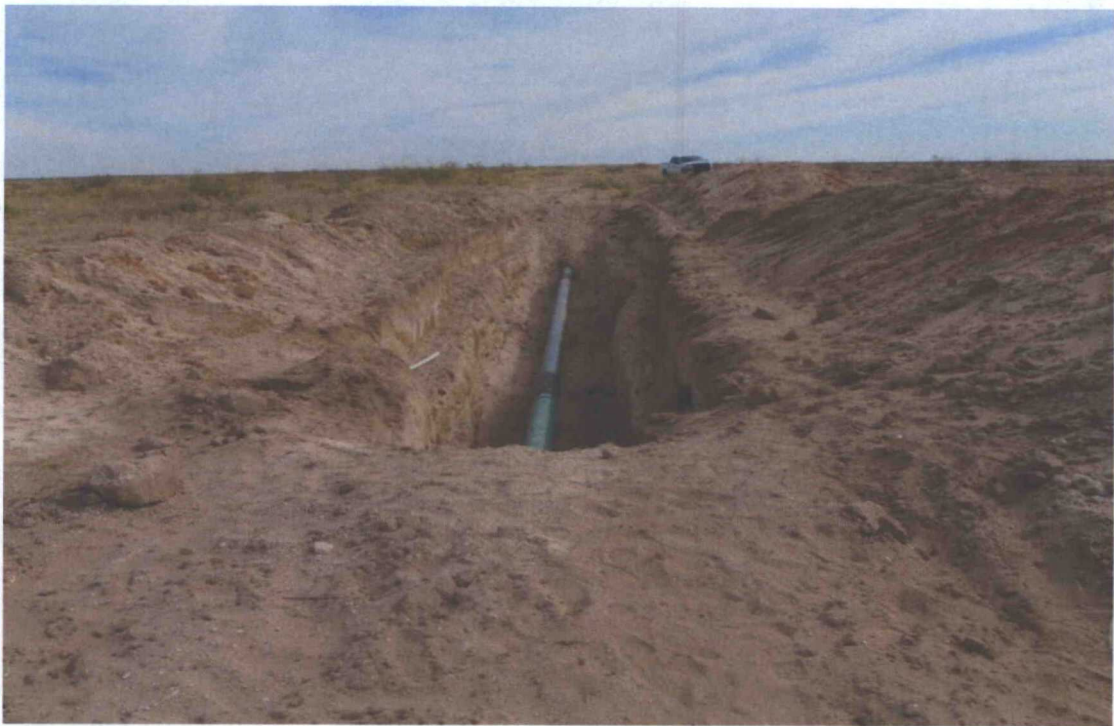
Line #290 (East of Jal South) - Initial Response Activities (Pipeline Clamp)

On October 26, 2011, Southern Union discovered a release had occurred on the Line #290 pipeline. Failure of a section of the twelve inch (12") steel, high-pressure natural gas pipeline resulted in the release of approximately twenty barrels (20 bbls) of a mixture of natural gas, crude oil, and produced water. During initial response activities, the pipeline was fitted with a temporary pipeline clamp to mitigate the release. Following initial response activities, the affected pipeline segment was replaced with twelve inch (12") steel pipe.

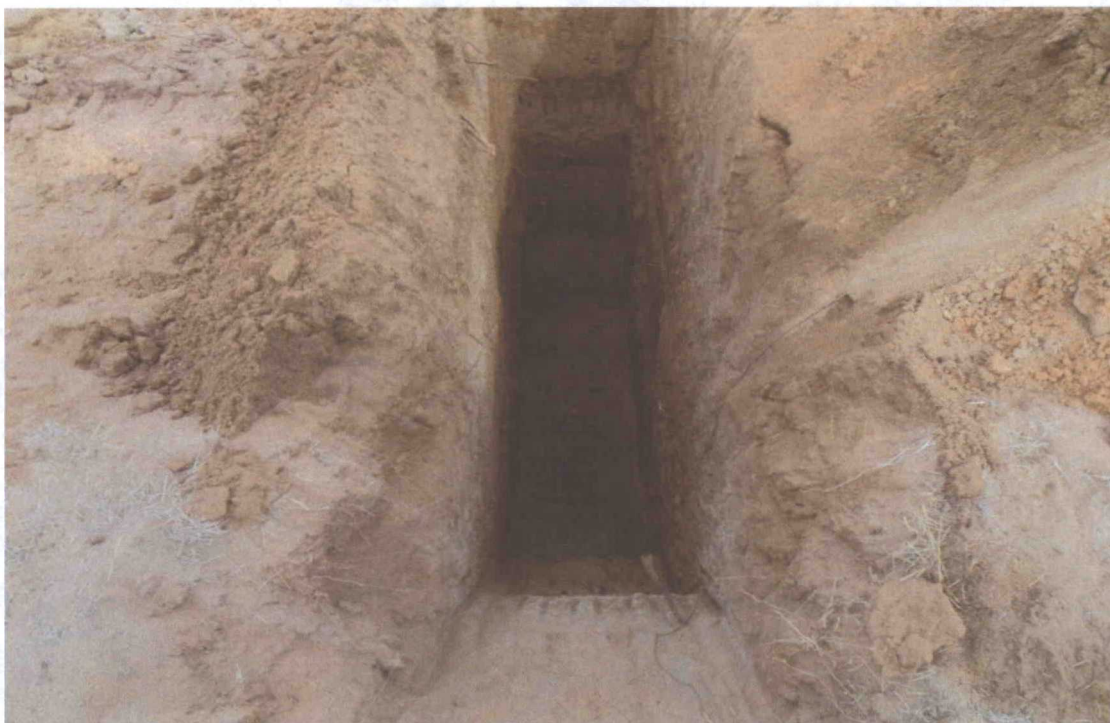
Line #290 (East of Jal South) - Delineation Trench

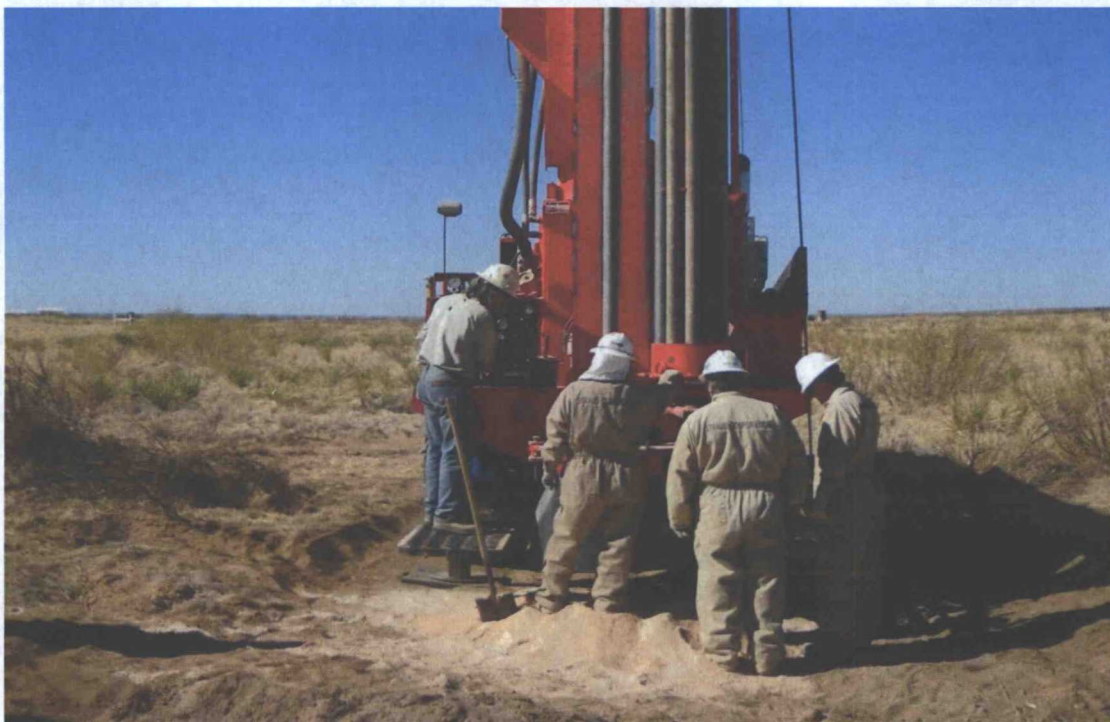
Line #290 (East of Jal South) - Advancement of Soil Boring SB-1

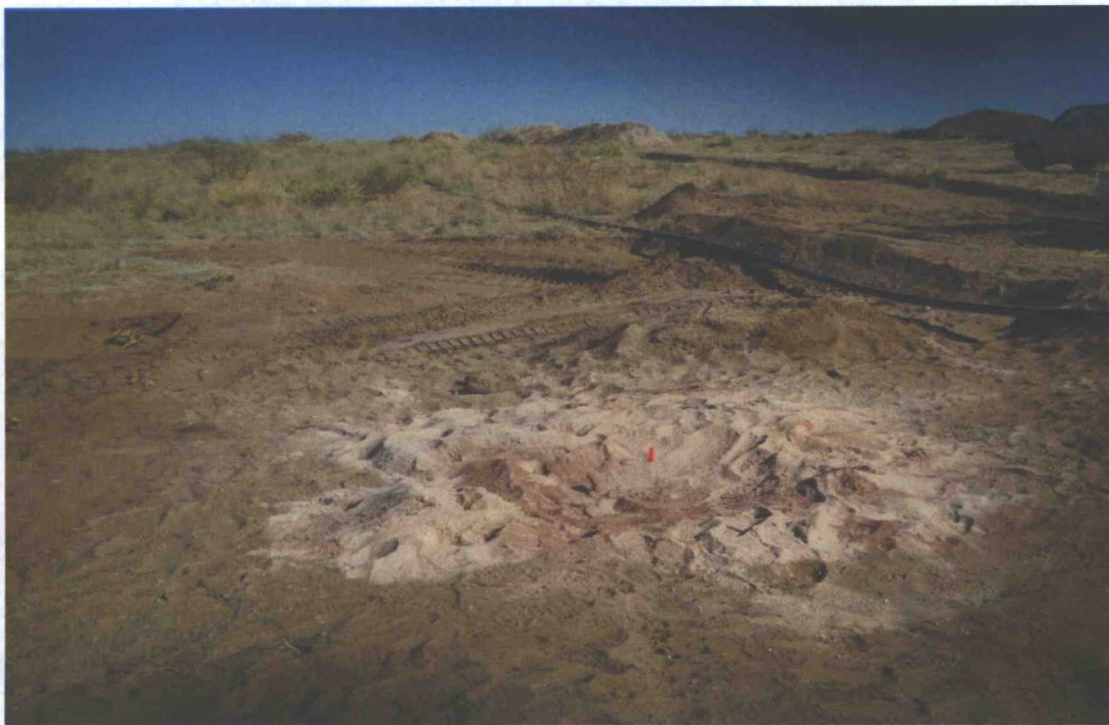
Line #290 (East of Jal South) - Soil Boring SB-1 (following P&A)

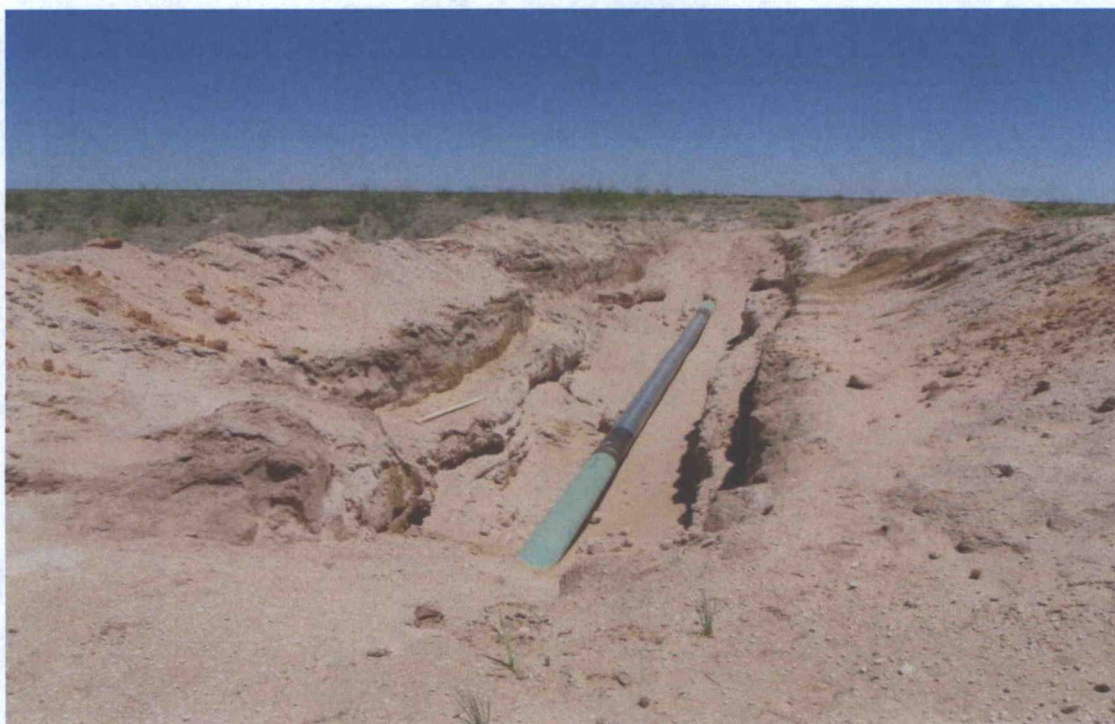
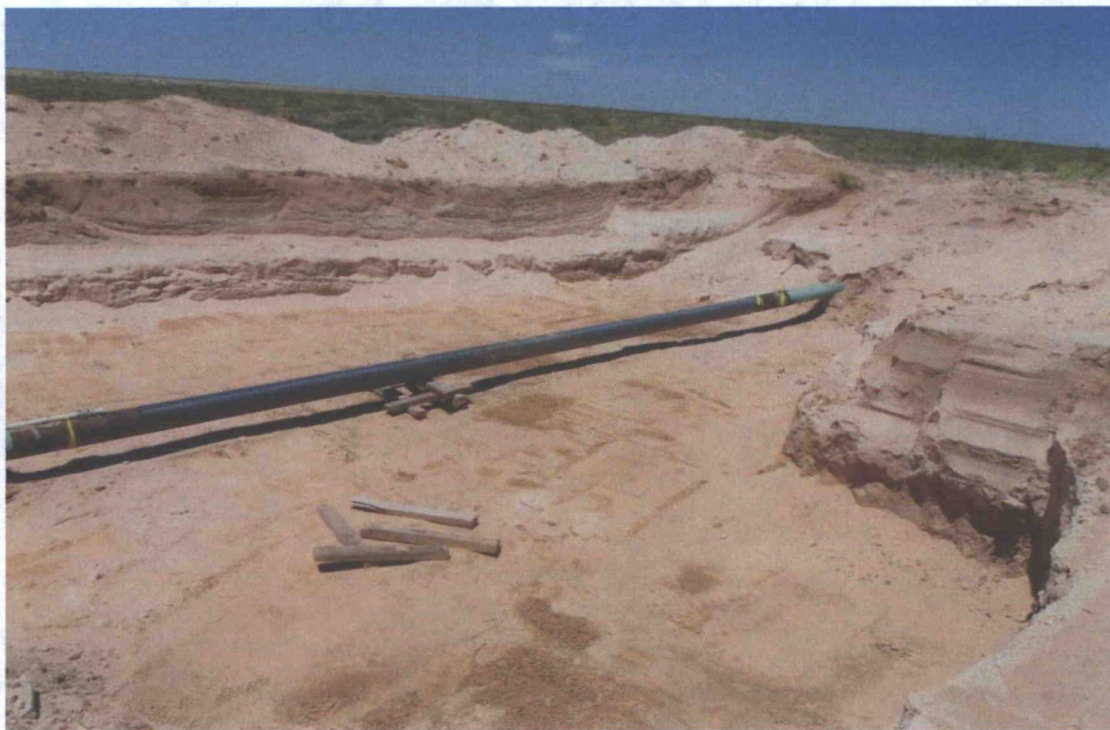
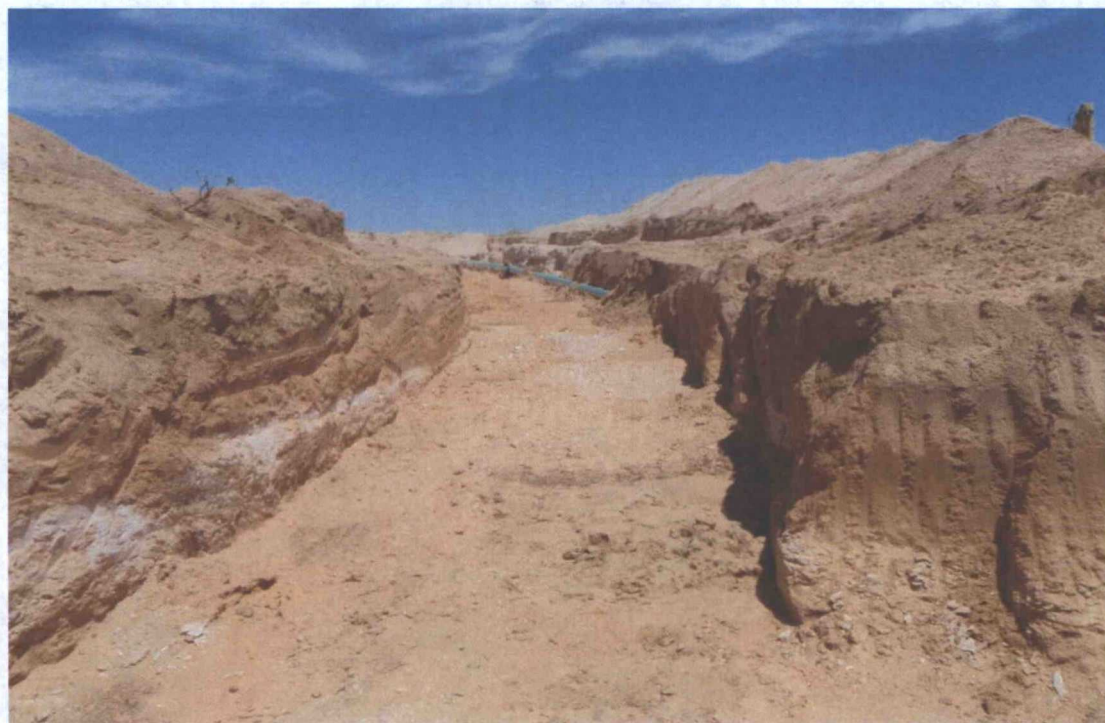
Line #290 (East of Jal South) – Remediation Activities

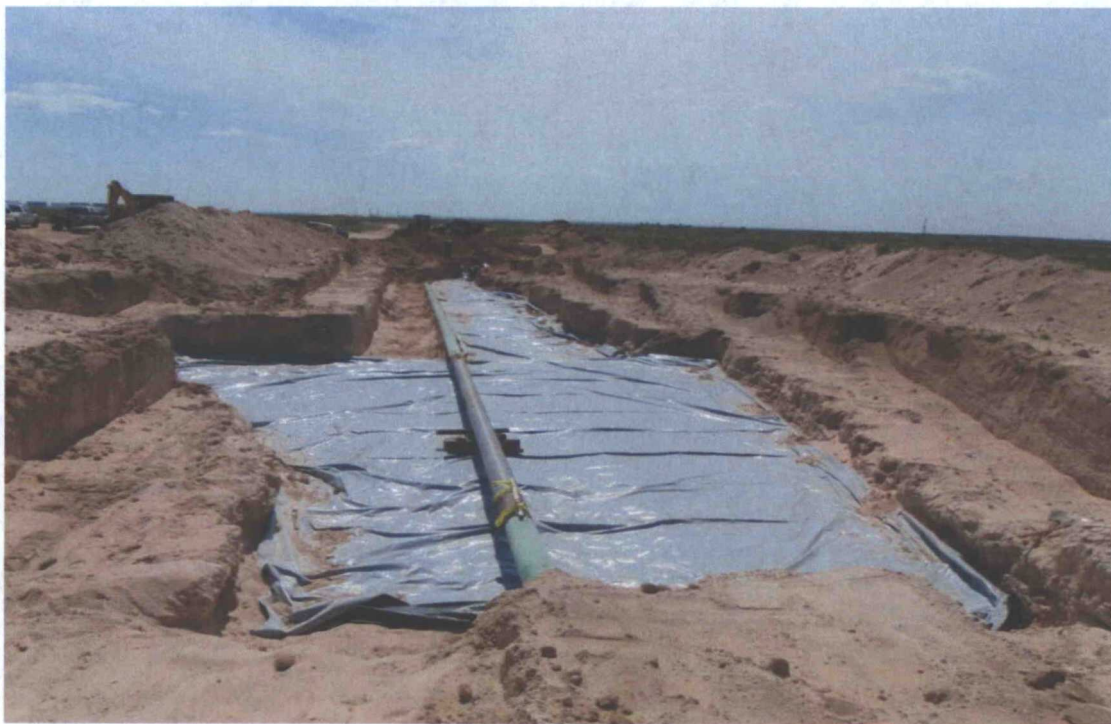
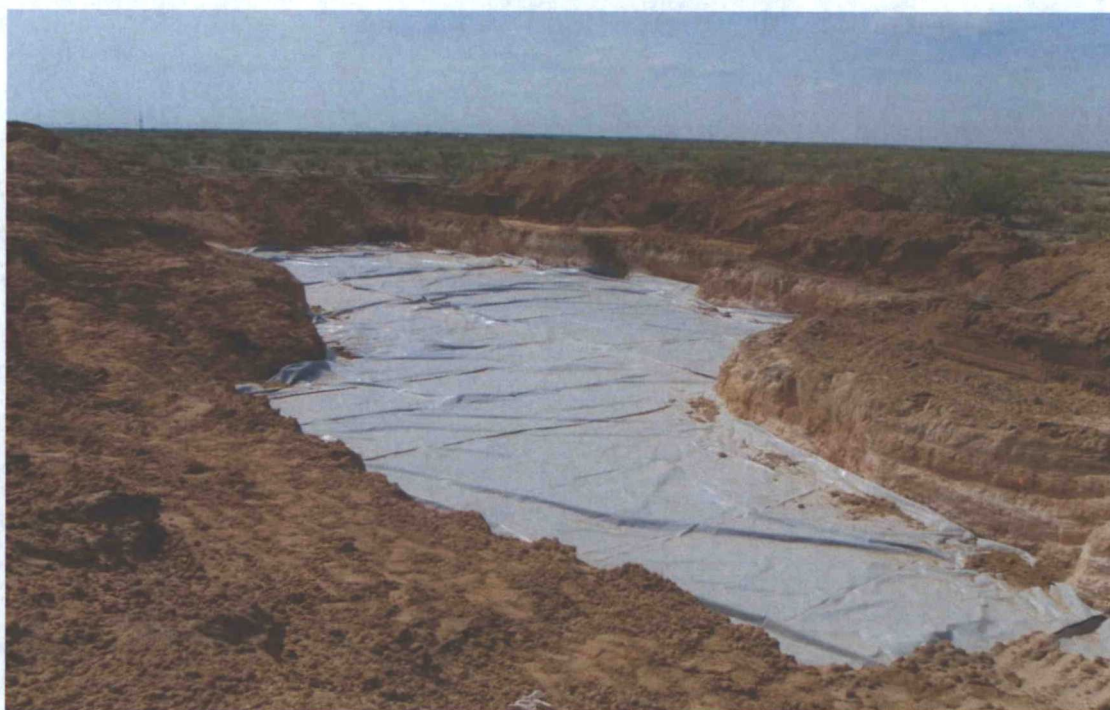
Line #290 (East of Jal South) – Remediation Activities (20-mil Polyurethane Liner)

On May 21, 2012, a twenty (20) mil polyurethane liner was installed on the floor of the excavation at approximately ten feet (10') bgs. Approximately one foot (1") of non-impacted pad sand was installed both above and below the liner to protect the liner from damage during installation and backfilling activities. The liner was fitted with eight inch (8") PVC conduit in three (3) locations to allow for the installation of groundwater monitor wells without compromising the integrity of the liner.

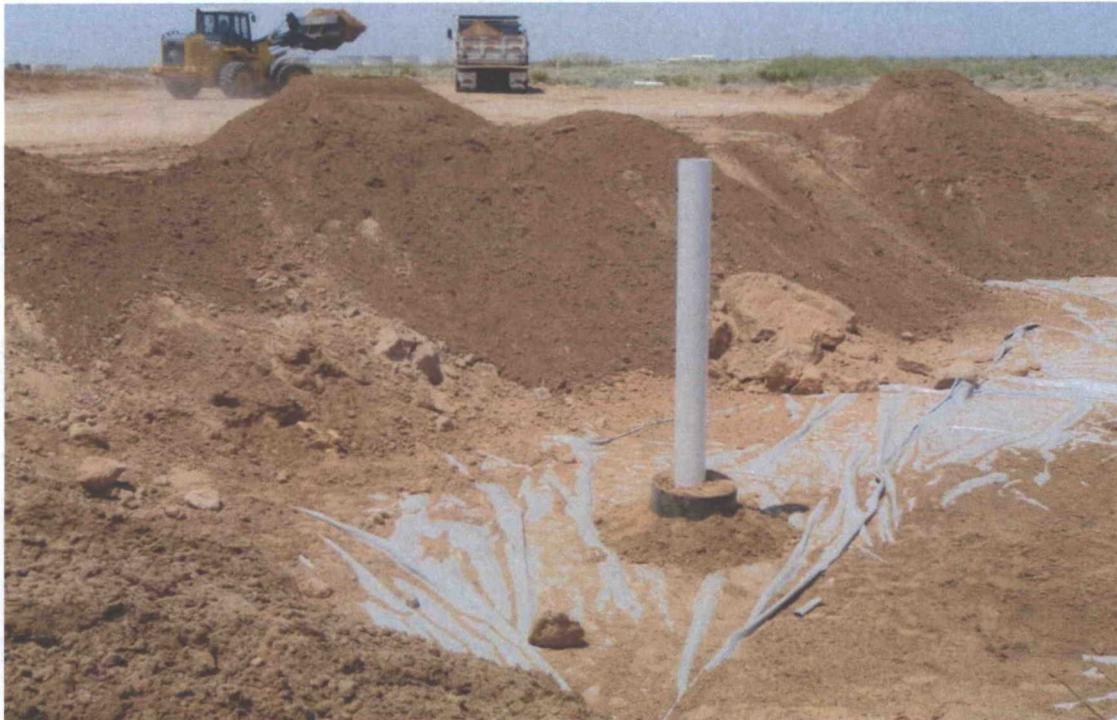
Line #290 (East of Jal South) – Remediation Activities (8" PVC Conduit)

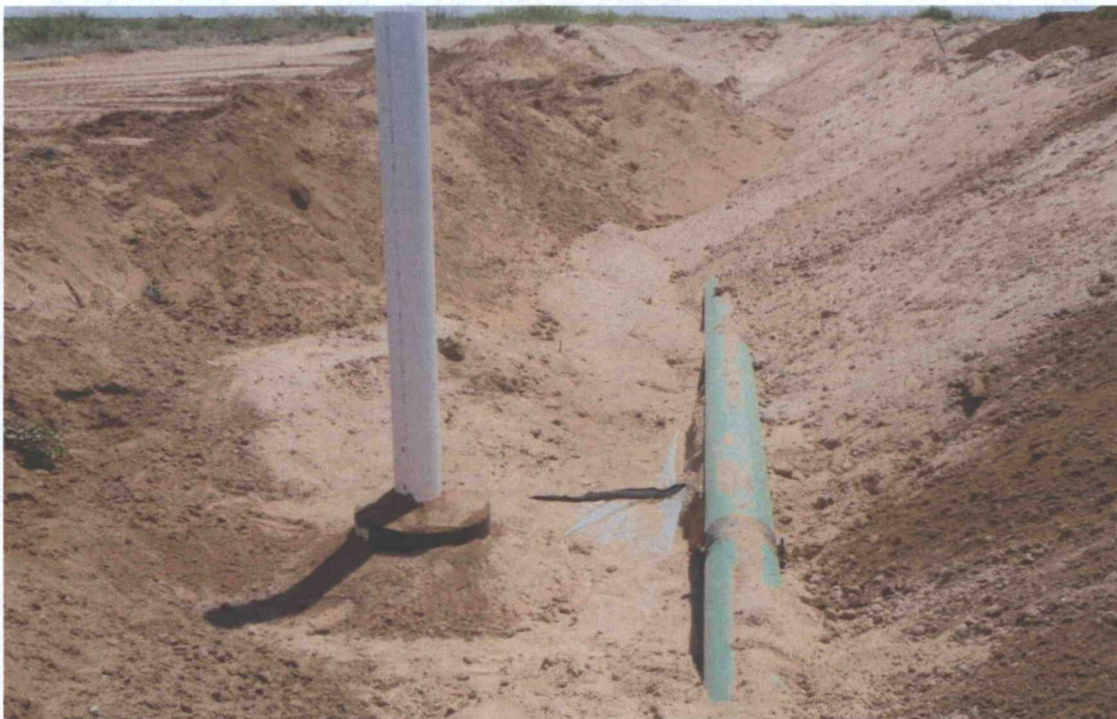
Line #290 (East of Jal South) – Backfilling Activities (8" PVC Conduit)

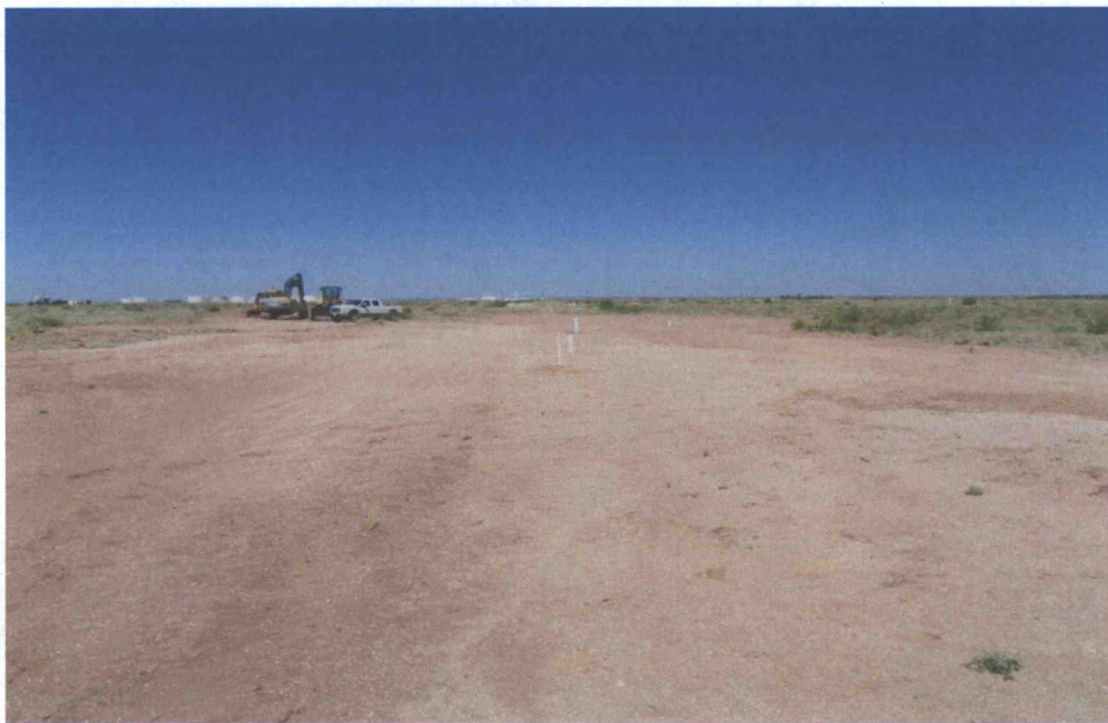
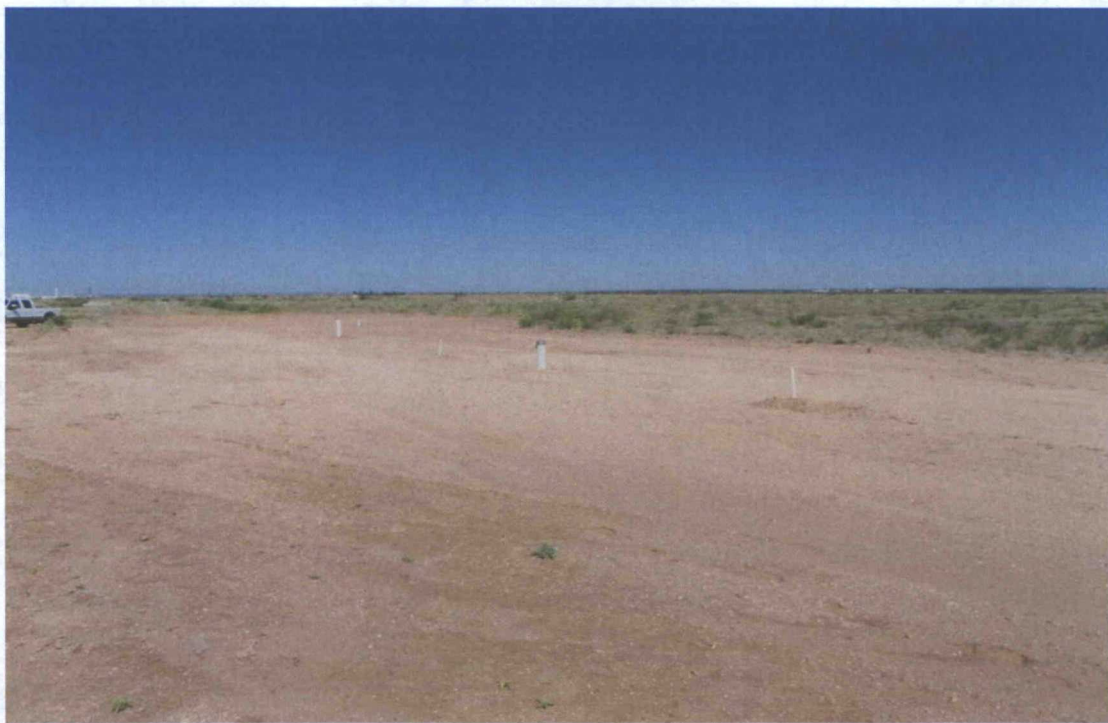
Line #290 (East of Jal South) – Post-Backfilling Activities
