# Closure Report

Prepared for  
Oxy USA

**Hannah 17 State 'H' #2**

1RP - 10 - 2 - 2416

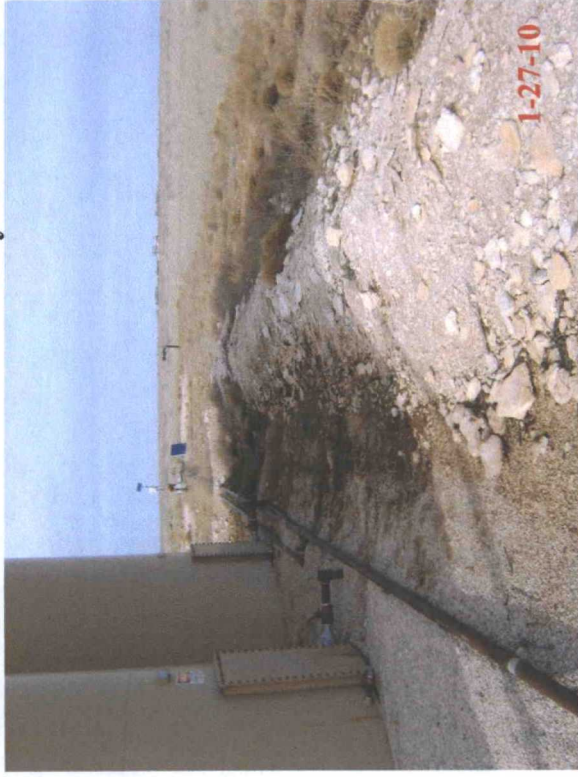
East side of battery before excavation of impacted soil.

A delineation of the site was completed using a backhoe. During the delineation no impacted soil was found below 3" bgs. The top three inches was excavated and blended and a field analysis was sampled of the pile. The pile was backfilled into the excavation because all levels were below the RAL's for this site. Attached is a plat map, field analytical, lab confirmation and pictures of the remediation. If you have any questions about the enclosed report please contact me at the office.

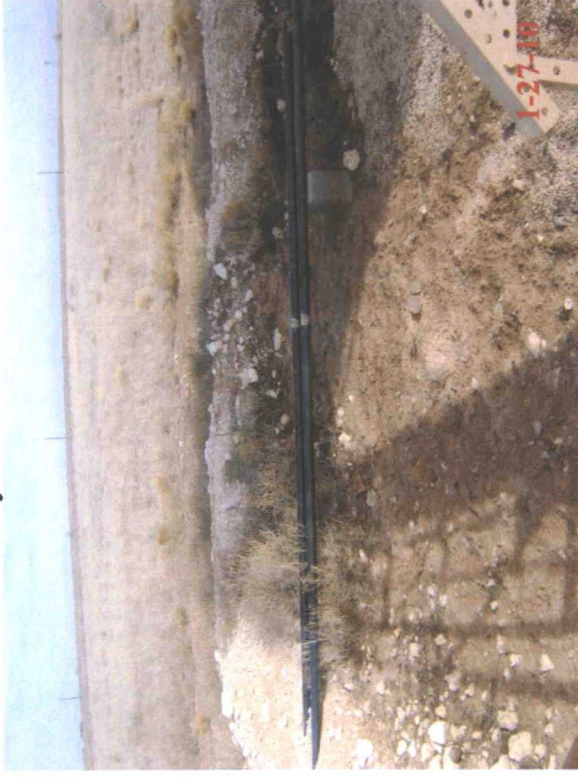
North side of battery before excavation of impacted soil.

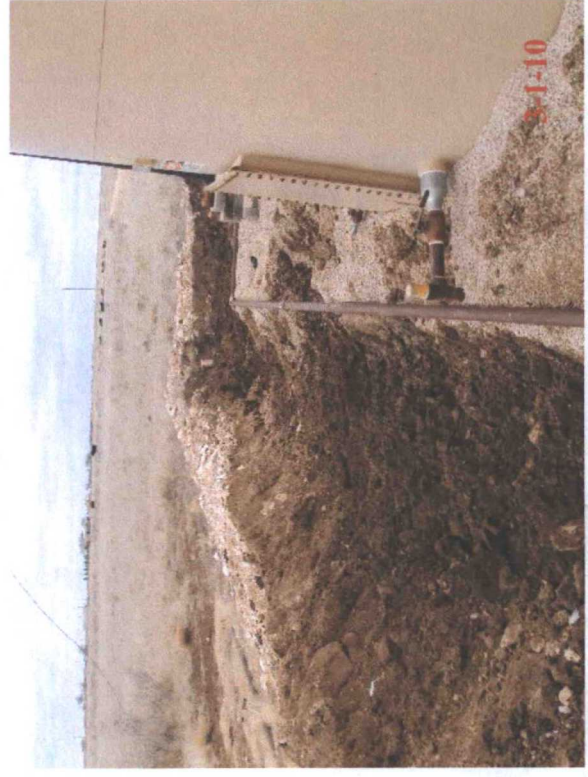
East side of battery after excavation of impacted soil.

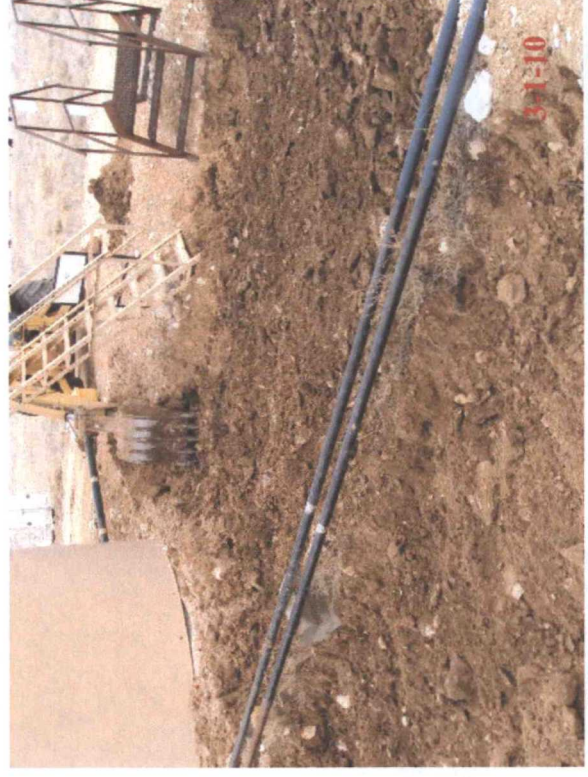
North side of battery after excavation of impacted soil.

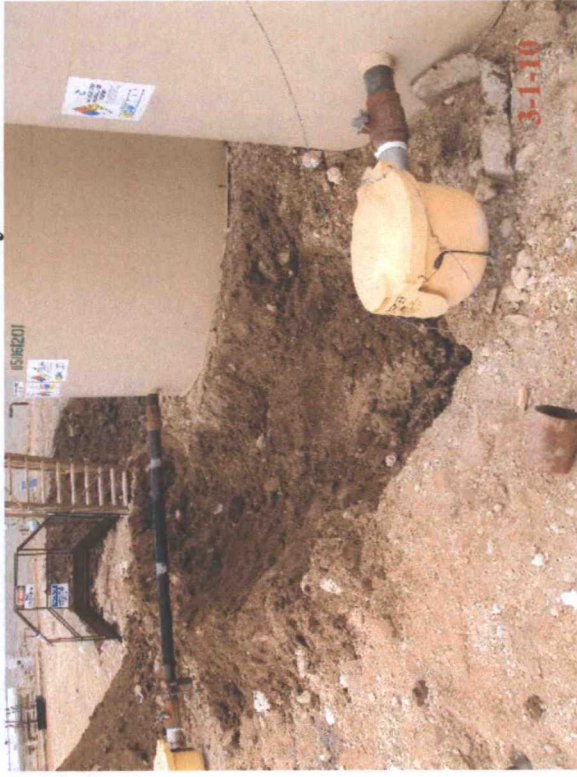
West side of battery after excavation of impacted soil.

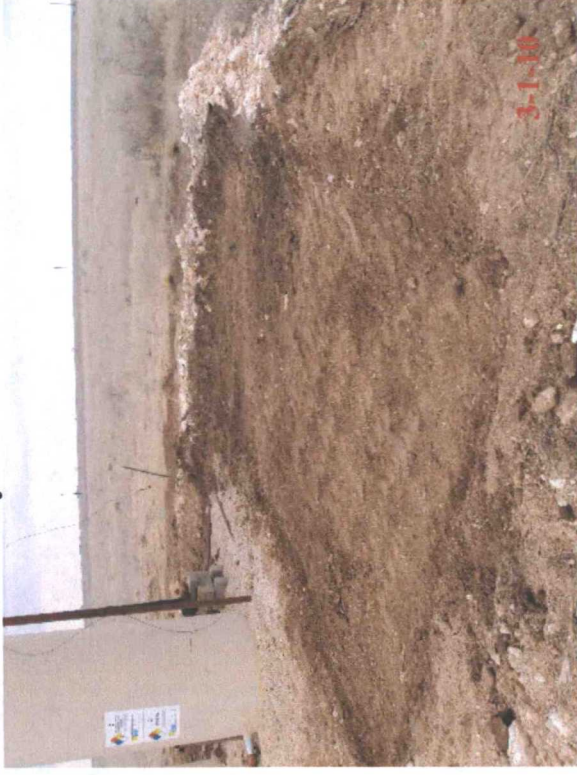
South side of battery after backfill of remediated soil.

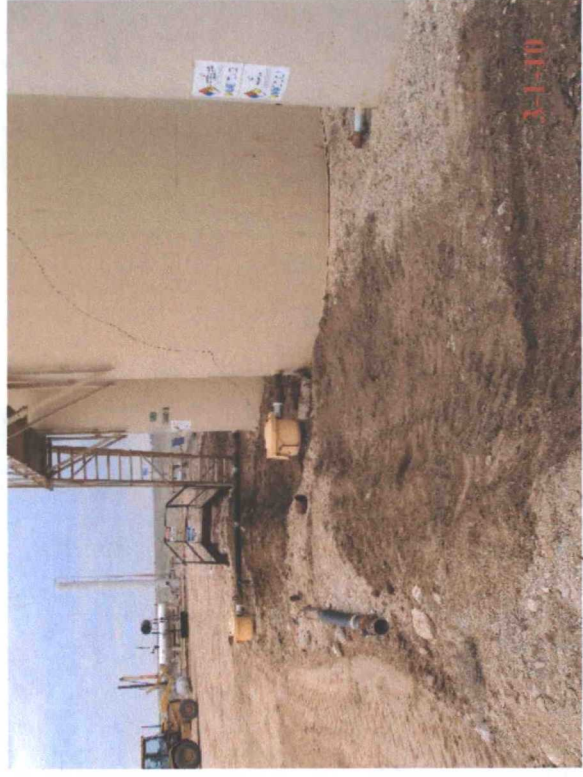
West side of battery after backfill of remediated soil.

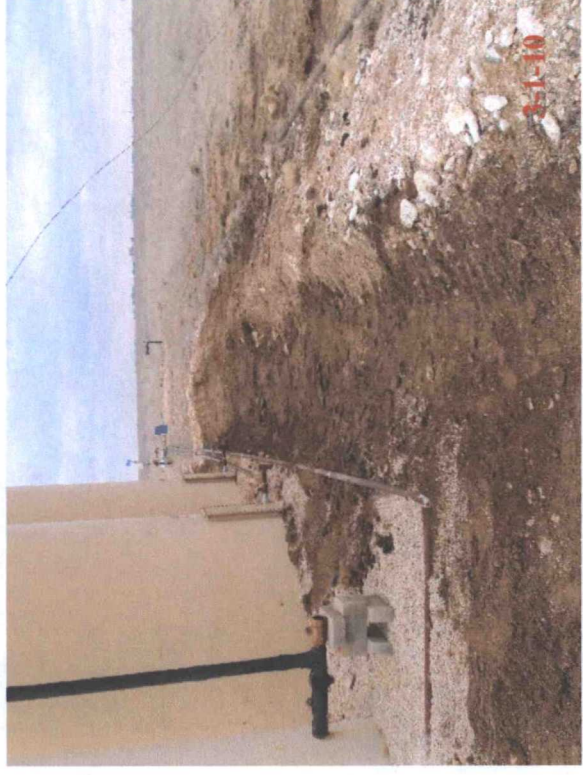
East side of battery after backfill of remediated soil.
