IRP 12-13-2999

Release Notification and Corrective Action

Name of Company: XTO Energy, Inc.	Contact: Dudley McMinn
Address: 200 N. Loraine St., Ste. 800, Midland, TX 79701	Telephone No.: (432) 682-8873
Facility Name: Grimes Lease Pit #1 (Windmill Oil)	Facility Type: Emergency Pit

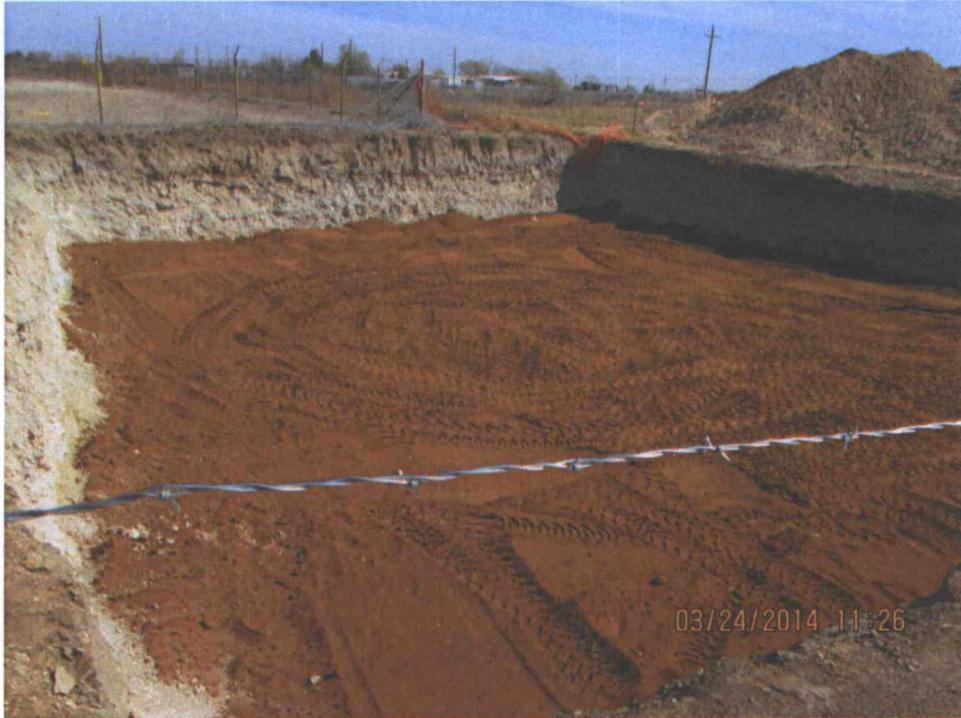
Pit #1 Prior to Liner Installation Viewing Northwest, March 24, 2014

Describe Area Affected and Cleanup Action Taken.* Lateral and vertical extent of contamination was delineated and Initial C-141 approved by OCD District 1 on January 30, 2014. Cleanup action was completed including excavating soil between approximately 8 and 10 feet below ground surface (bgs) for disposal a OCD approved facility, Jay Dan Landfarm, installing 20 mil polyethylene liner, with padding soil above/below liner, filling with caliche to between 3 and 4 feet bgs and remainder of excavation with topsoil. Surface reclamation will be according to plan approved by OCD Santa Fe on October 22, 2013.

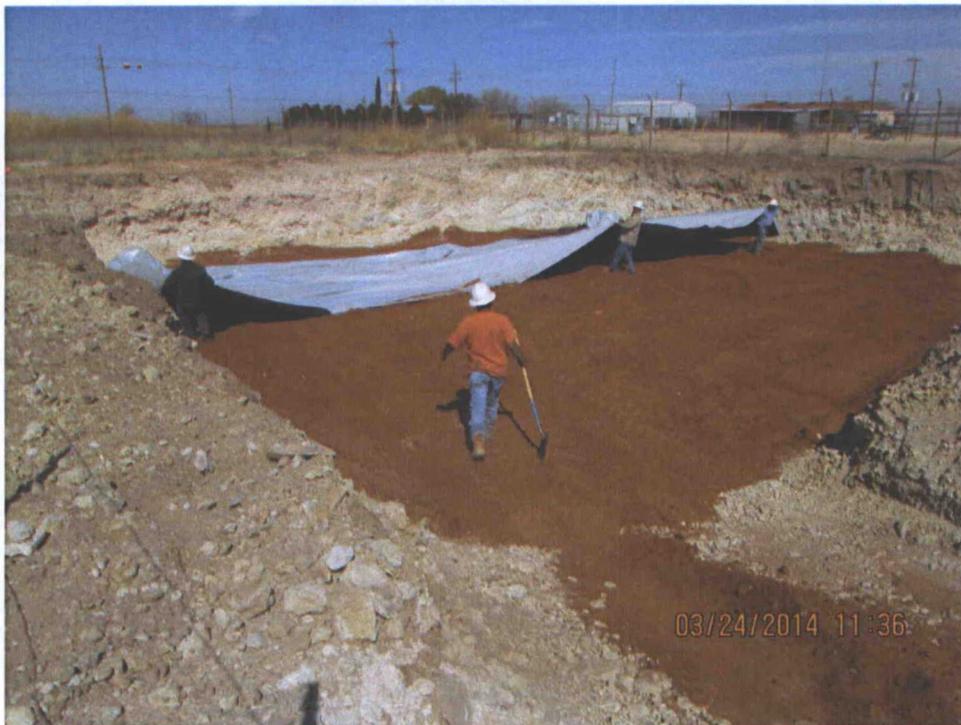
Pit #1 Liner Installation Viewing Northwest, March 24, 2014

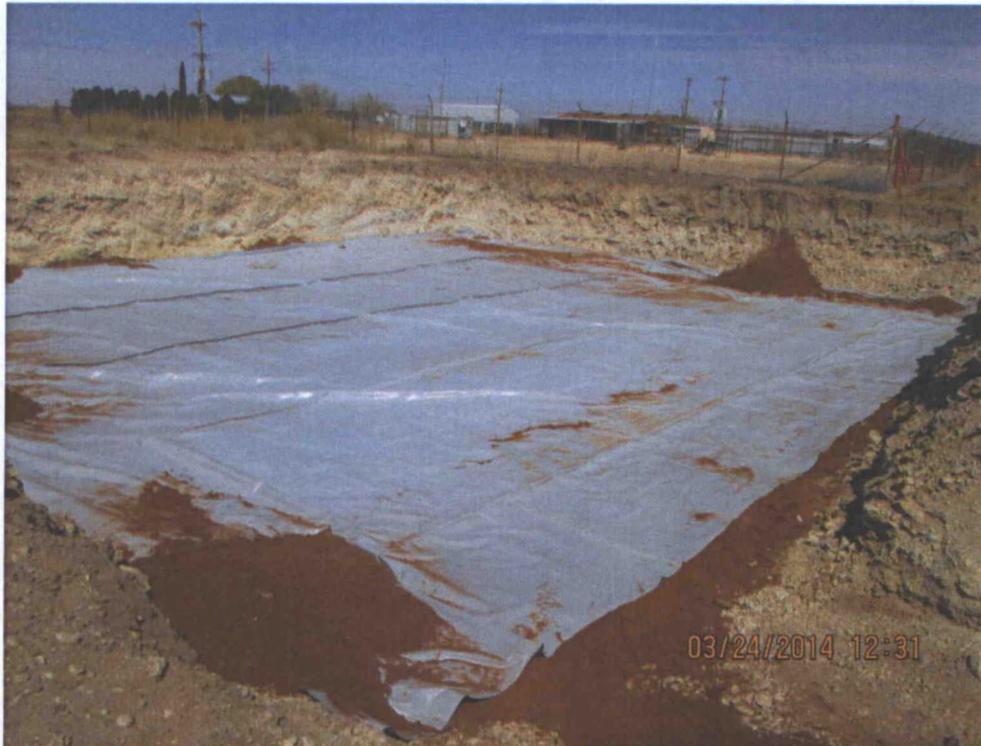
Pit #1 Liner Installation Viewing Northwest, March 24, 2014

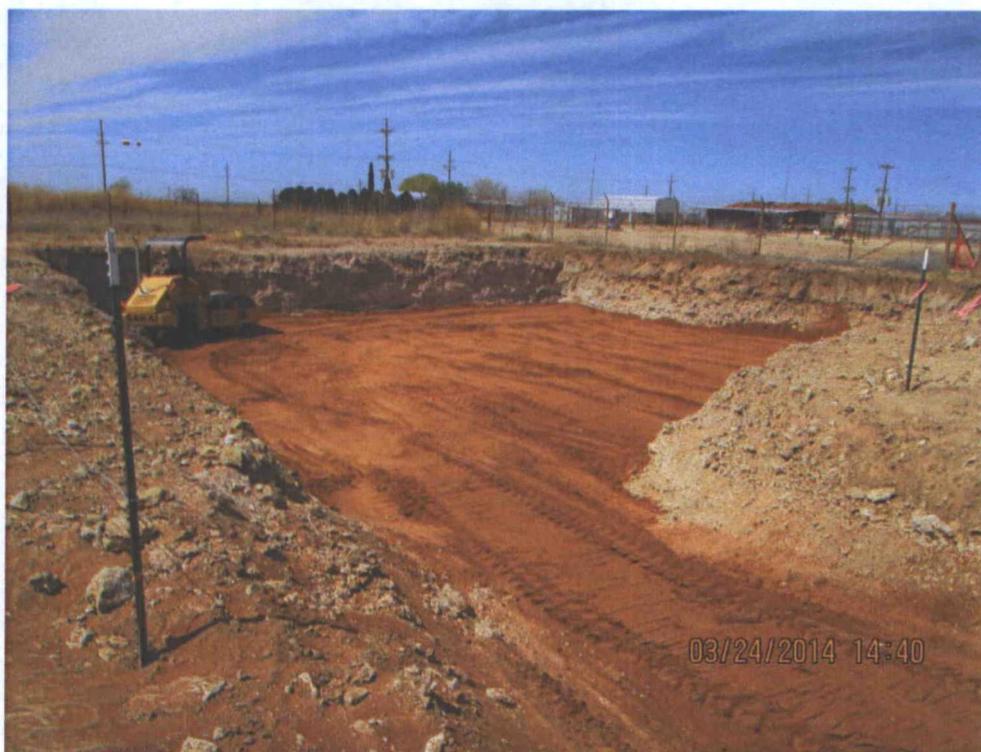
Pit #1 Liner Covered and Compacted Viewing Northwest, March 24, 2014
