Release Notification and Corrective Action

Oxy USA
Closure Document
State-CL #2 CTB
Sec. 2 T18S-R33E

Prepared by:
Kelton Beaird-HES Specialist
Occidental Petroleum
Mid-Continent Business Unit
Southwest Asset
Carlsbad, NM
(575)-628-4121

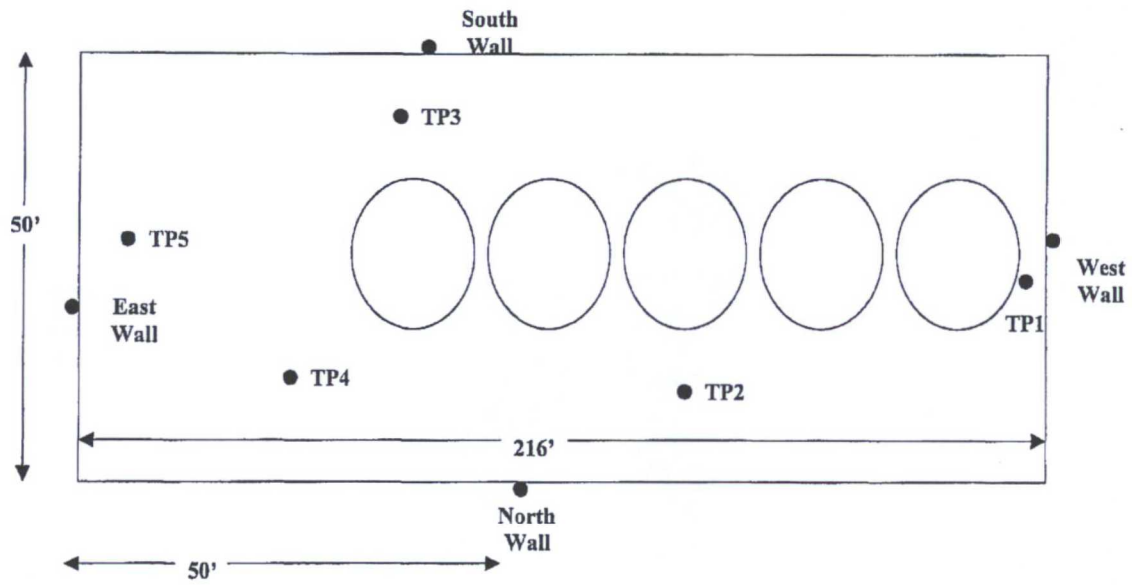
Plat Map

Describe Area Affected and Cleanup Action Taken.* The remediation will be to excavate all impacted soil, which is 18" at TP3 and TP5 and 24" at TP4, and haul to Lea Land Disposal. The excavation will be backfilled with clean native soil. The site will not be re-seeded since the site is a caliche pad for a battery. A final report will be submitted at the completion of the remediation. A final report will be submitted at the completion of the project.

All contamination on this site was completely removed per standards set by the NMOCD. Delineation was performed after the second spill to re-assure that contamination did not travel any further. The affected area was excavated to 18" below ground surface at TP3 and TP5, and 24" at TP 4. All contaminated material was hauled to Lea Land Disposal. The excavated area was then backfilled with clean caliche. Re-seeding was not necessary, due to this being an active site. Analytical data, pictures and the final C-141 document is attached to this closure report.
