### **Linn Energy**

### **Remediation Summary**

CMU#51

Lea County, NM GPS N32.82196 W-103 01.98740 Start date: 5NOV12 Finish date: 30AUG13

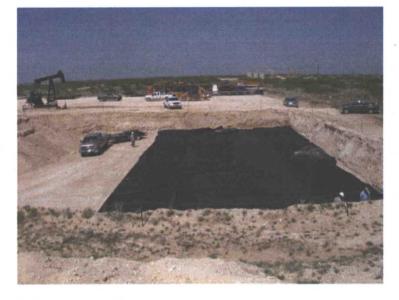
Laying down the first liner

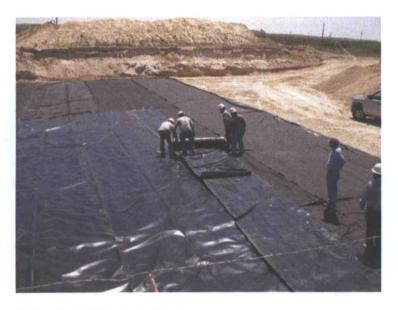
Laying down the double liner

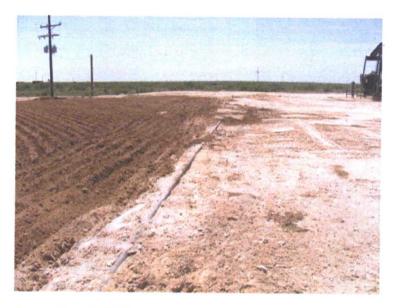
Final surface in 2008
