Release Notification and Corrective Action

Eunice SWD

(Nearest Well – Argo #7)

Internal Incident Report – Reportable Spill

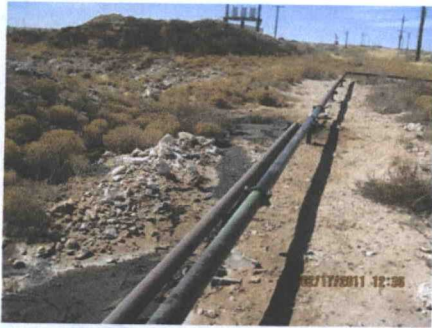
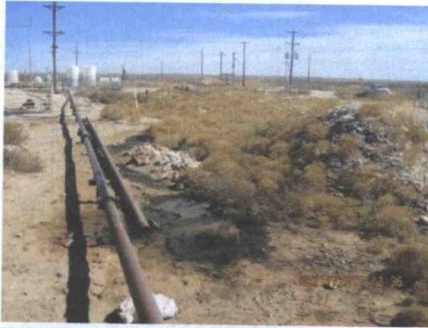
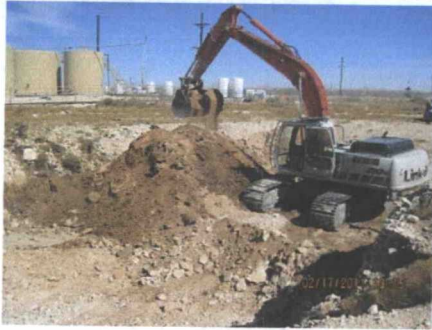
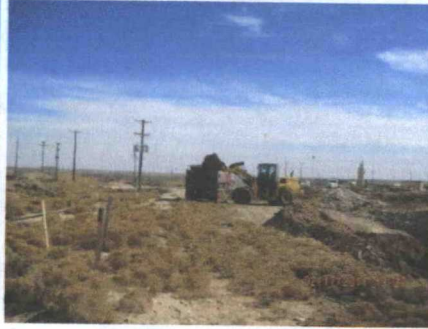
Full Summary: I was contacted immediately about the release. When I responded the fluid coming out of the line was running into a non registered pit. This pit has been used for basically a trash pit and a dumping ground. The grooves on the pipe were not grooved properly before placing the victaulic clamps on to hold the lines together. 130bbls of produced water was released into the pit and 110bbls of produced water was recovered from the pit.

1. When constructing this high pressure line, the grooves on the pipe were not constructed correctly in order for the victaulic clamp to seal properly or hand any type of movement.

1. Pipe will be repaired so that the victaulic clamps will hold the pipe properly.

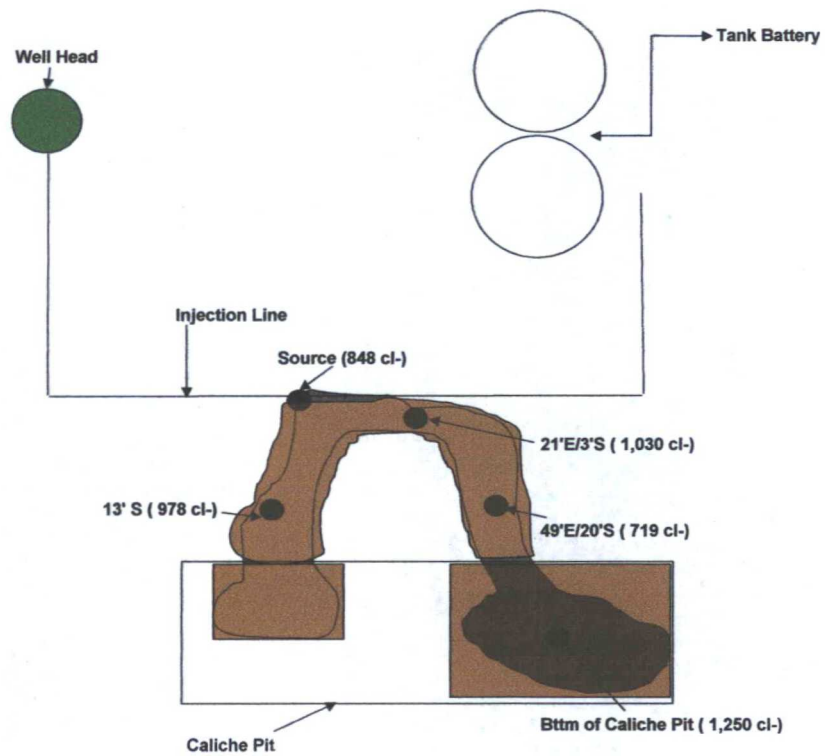
Apache Argo # 7 WD AD

SURFACE SAMPLES

Sample Discription	Water	Soil	AGNO3	Cl-	
Source	30.3	10	3.03	0.28	848
49' E 20' S	30.2	12.6	2.40	0.3	719
13' S	30.6	14.7	2.08	0.47	978
21' E 3' S	30.6	9.8	3.12	0.33	1030
Bttm Caliche Pit	30.6	11.5	2.66	0.47	1250

Vertical Samples

Sample Discription	Water	Soil	AGNO3	Cl-	
Middle Vertical					
Depth from bottom of pit					
3'	30.1	12.8	2.35	0.43	1011
5'	31.4	11.8	2.66	0.39	1037
6'	31.4	14.1	2.23	0.36	801
7'	30	11.7	2.56	0.1	256
8'	30.2	12.5	2.42	0.11	266

Excavation Samples

Sample Discription	Water	Soil	AGNO3	Cl-	
South Excavation					
North Wall	31.2	12.6	2.48	0.06	149
East Wall	30.5	14.9	2.05	0.07	143
South Wall	30.3	11.2	2.71	0.08	216
West Wall	30.5	12	2.54	0.05	127
3-Pt. Bottom Comp.	31.9	12.1	2.64	0.07	184
West Scrape					
Bottom Center	31.5	12.9	2.44	0.08	195
North Scrape					
East Center	30.3	10.4	2.91	0.07	204
Center	30.6	14.3	2.14	0.07	150
West Center	31	13.5	2.30	0.07	161
