**1RP - 2768**

**CHAPARRAL ENERGY LLC**

Release Notification and Corrective Action

**Remediation and Site Restoration Protocol  
Chaparral Energy Co. LLC.  
WDQSU #96 Leak  
1RP-2768**

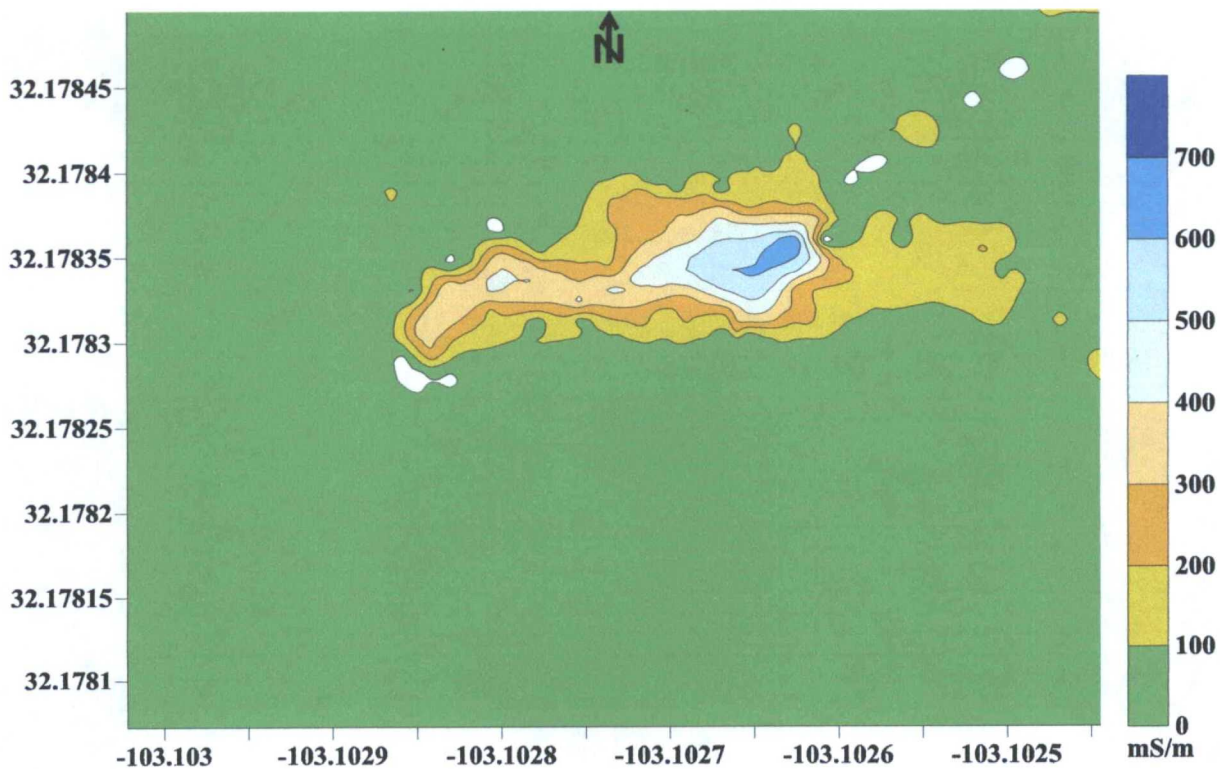
Chaparral Energy LLC.  
WDQSU #96  
API #30-025-30166  
UL/C - SEC31 - T24S - R38E  
990'FNL & 1700'FWL  
GPS LAT & LON WGS84  
N32.1783468827639 / W103.102621289441  
12-1-11 EM38 SURVEY

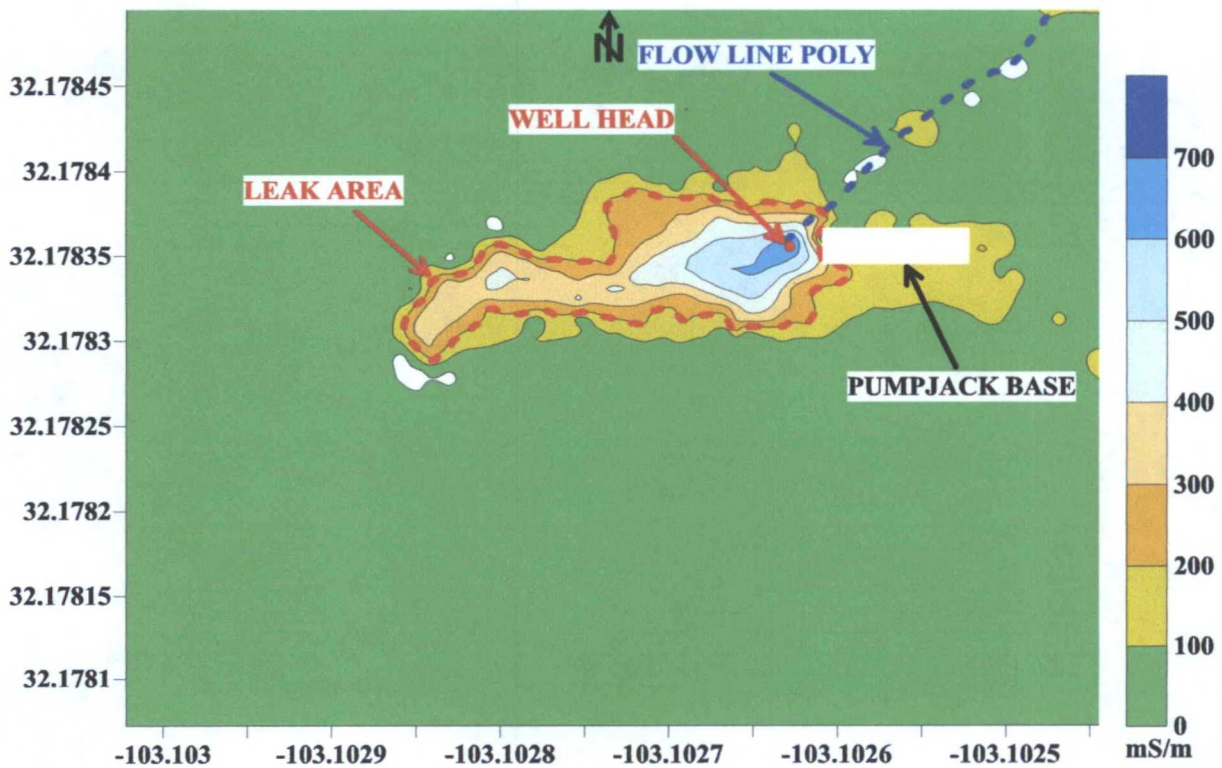
Chaparral Energy LLC.  
WDQSU #96  
API #30-025-30166  
UL/C - SEC31 - T24S - R38E  
990'FNL & 1700'FWL  
GPS LAT & LON WGS84  
N32.1783468827639 / W103.102621289441  
12-1-11 EM38 SURVEY SITE MAP

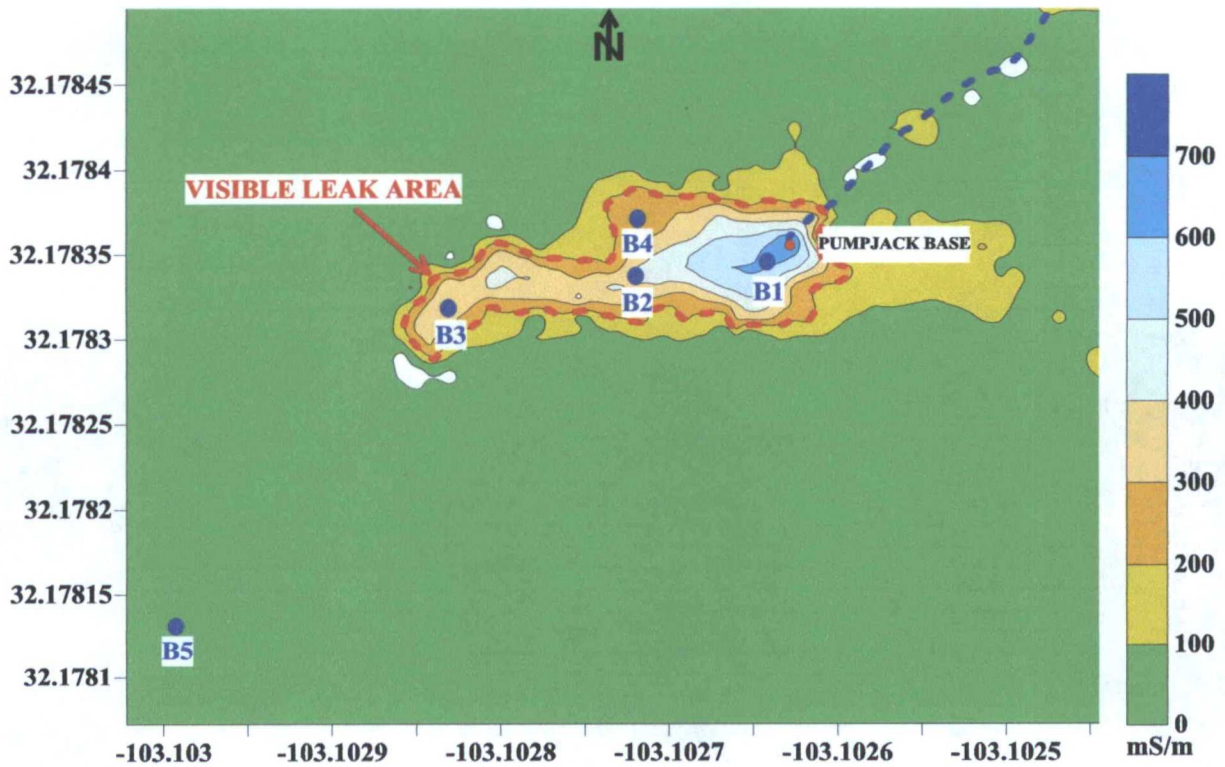
Chaparral Energy LLC.  
WDQSU #96  
API #30-025-30166  
UL/C - SEC31 - T24S - R38E  
990'FNL & 1700'FWL  
GPS LAT & LON WGS84  
N32.1783468827639 / W103.102621289441  
BORE LOCATION

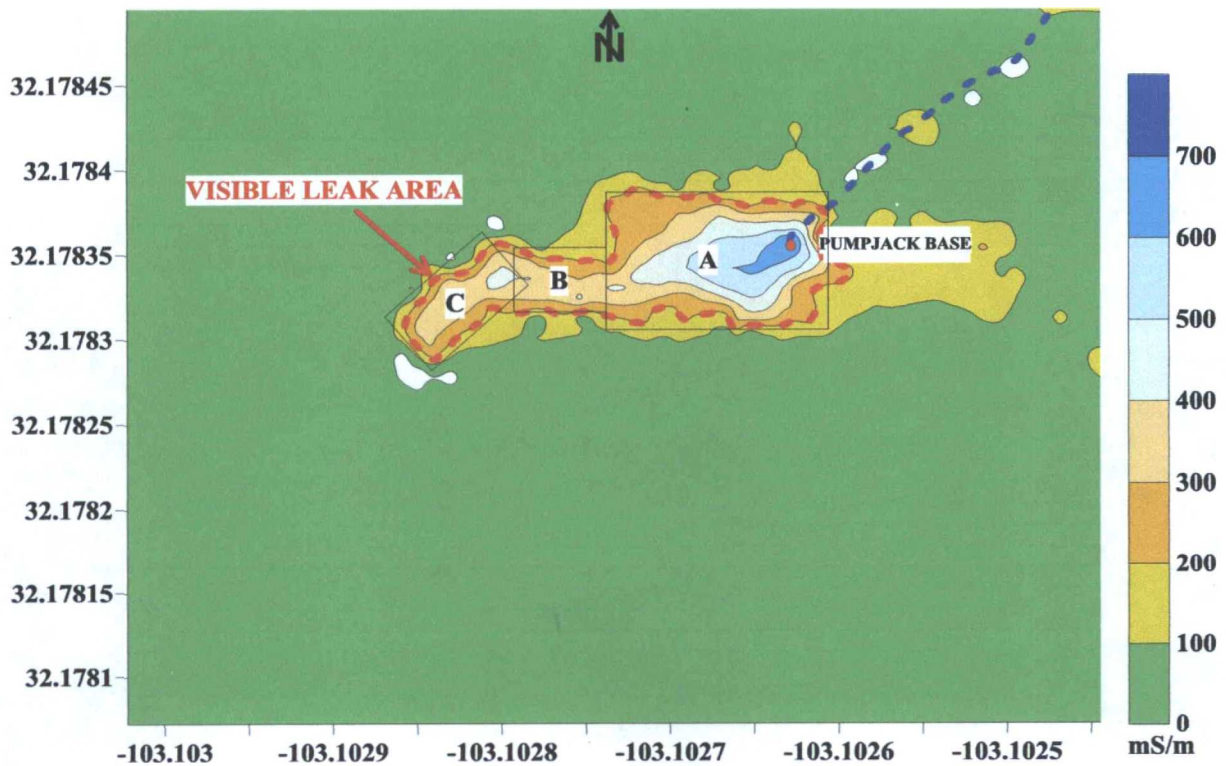
Chaparral Energy LLC.  
WDQSU #96  
API #30-025-30166  
UL/C - SEC31 - T24S - R38E  
990'FNL & 1700'FWL  
GPS LAT & LON WGS84  
N32.1783468827639 / W103.102621289441  
EXCAVATION AREAS  
AREA A = 41'L X 30'W = 228cyds  
AREA B = 17'L X 14'W = 44cyds  
AREA C = 26'L X 14'W = 67cyds  
TOTAL CYDS = 339cyds

5.1 The area impacted by the produce water and oil spill will be excavated to depth of 5' below ground surface. A 5pt composite of the excavation bottom will be pulled and sent to Cardinal Labs in Hobbs, NM for confirmation. A Geo-Synthetic Bentonite liner will be placed at the bottom of the excavation and backfilled using fresh clean backfill material from the landowner. The top twelve inches of the excavation will be backfilled using caliche from the landowner in order to maintain the pad location integrity. The excavated material will be transported to Prabo Disposal Facility near Eunice, NM for disposal.

6.1 The site will backfilled and compacted with fresh clean soil, caliche and re-contoured to match the surrounding elevation.
