**SOUTHERN UNION GAS SERVICES LTD**

## Release Notification and Corrective Action

| Facility Name | Trunk "M" (King Road) | Facility Type | Natural Gas Pipeline |

| | <p><b>Figure 1</b><br/><b>Site Location Map</b><br/>Southern Union Gas Services<br/>Trunk "M" (King Road)<br/>Lea County, New Mexico<br/>NMOCD Ref #: 1RP-06-11-2722</p> |

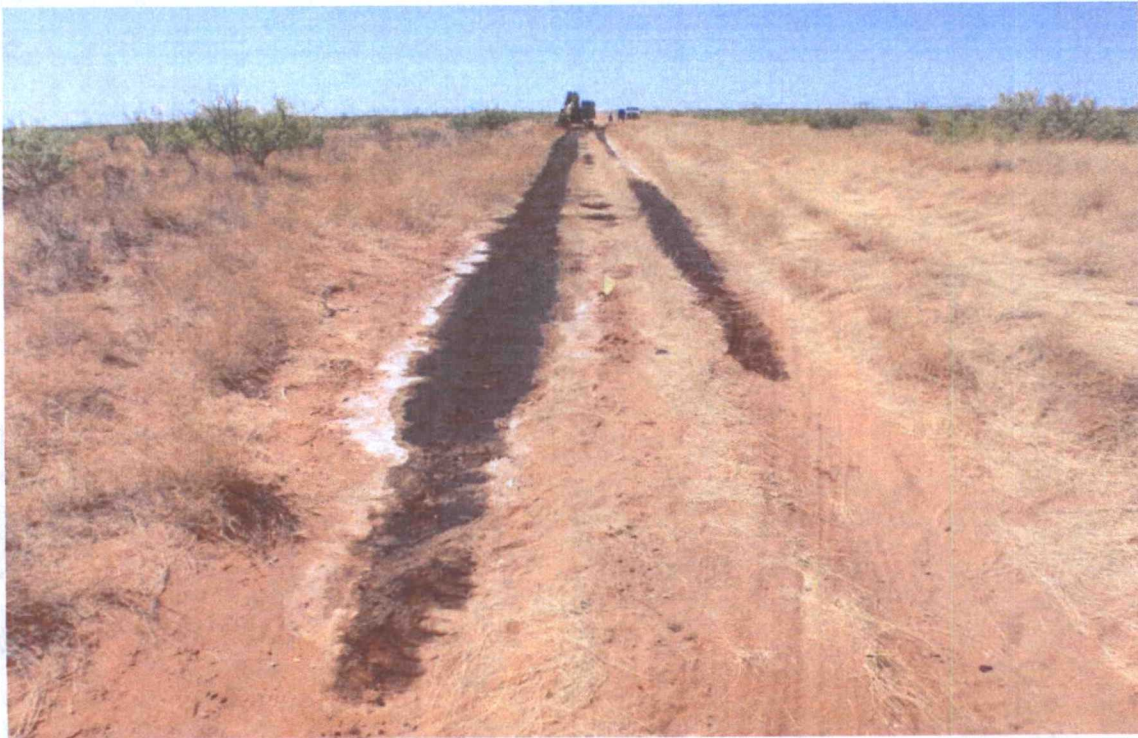
Trunk "M" (King Road) - Release Site

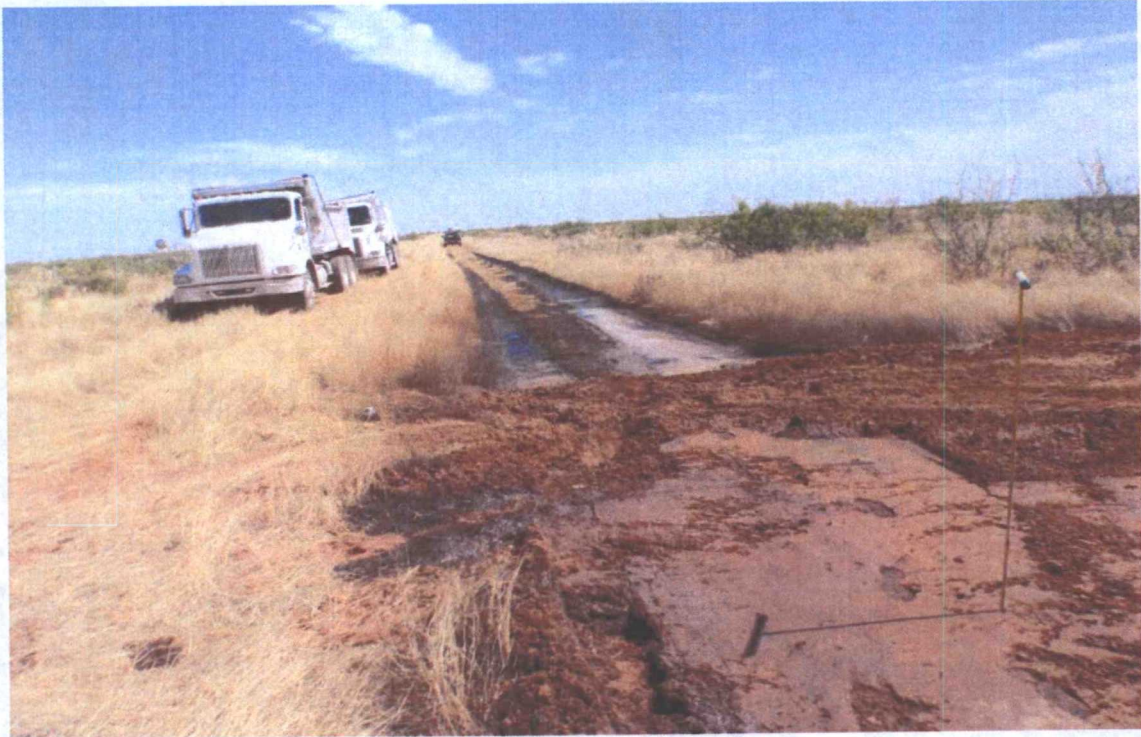
Trunk "M" (King Road) - Release Site

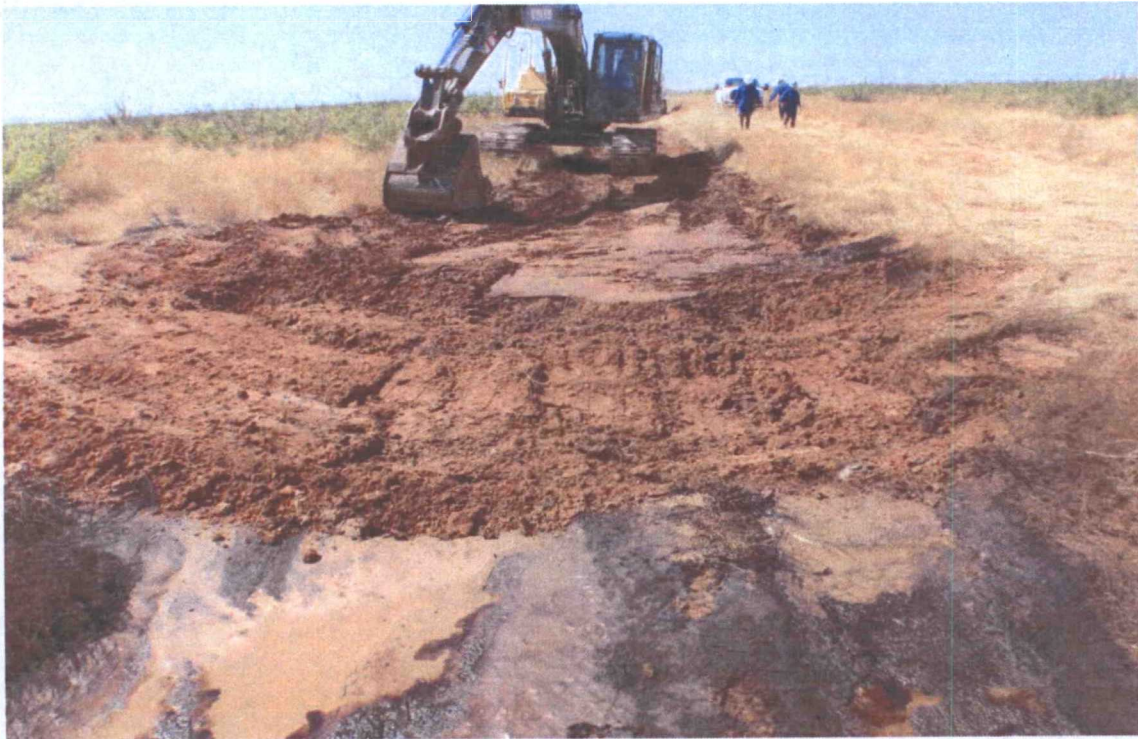
Trunk "M" (King Road) - Release Site (Initial Response)

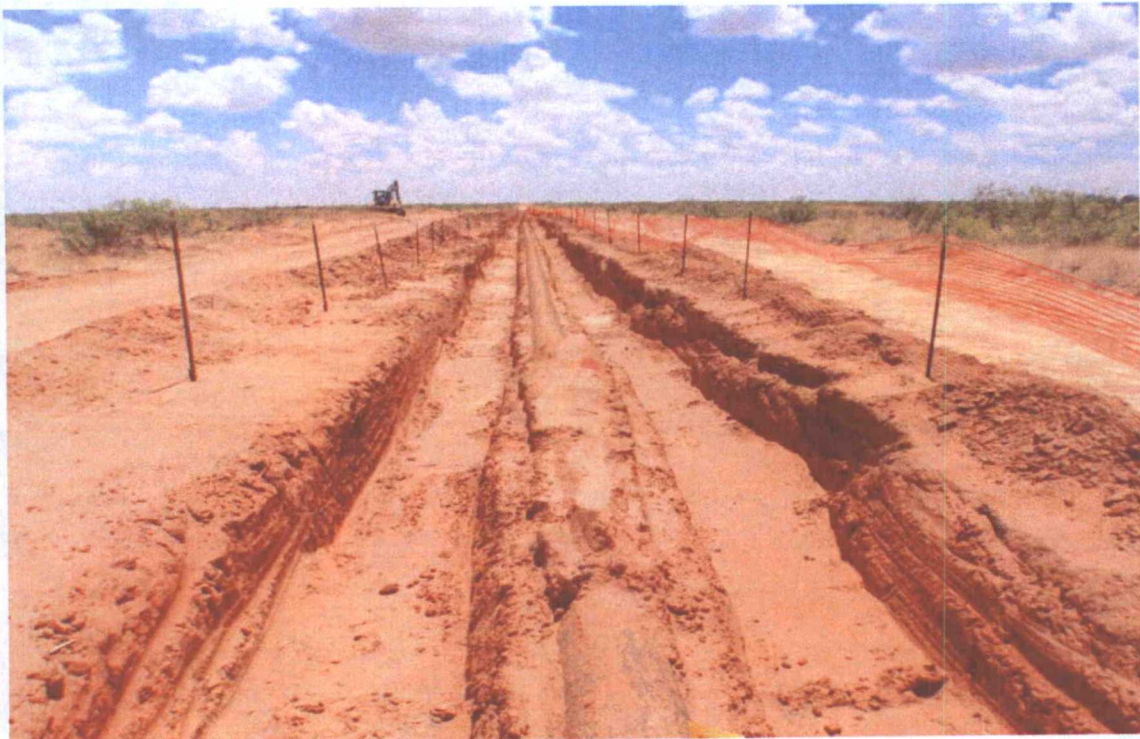
Trunk "M" (King Road) - Excavation

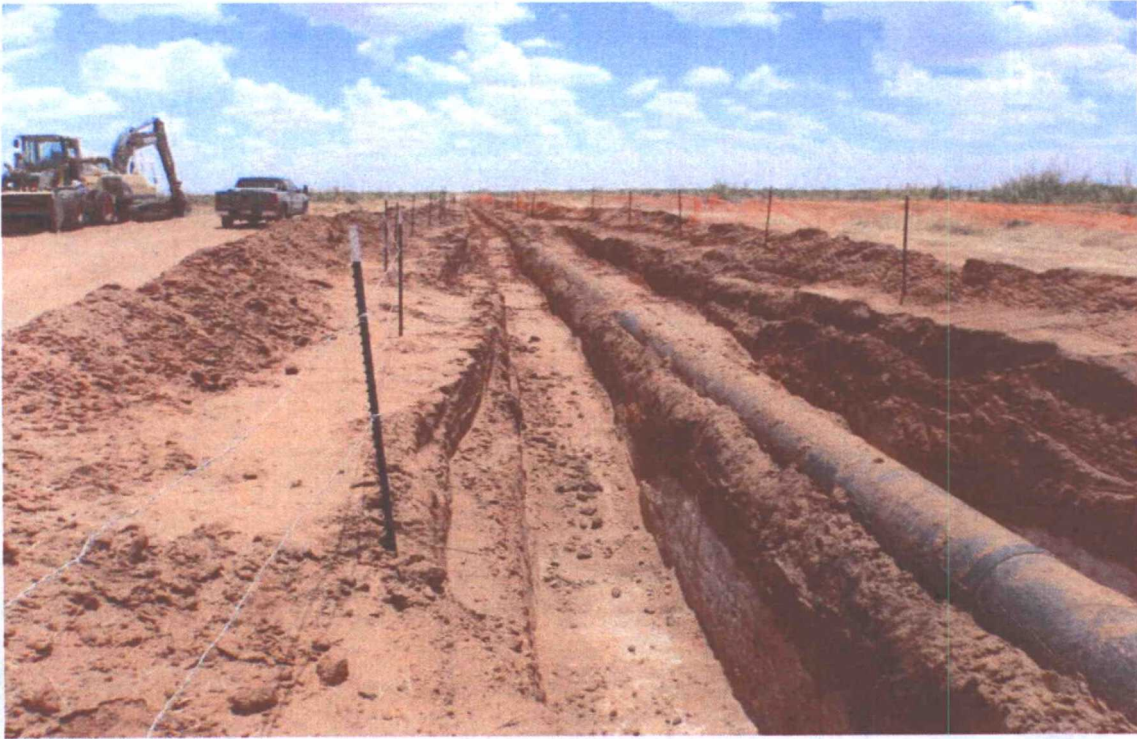
Trunk "M" (King Road) - Excavation

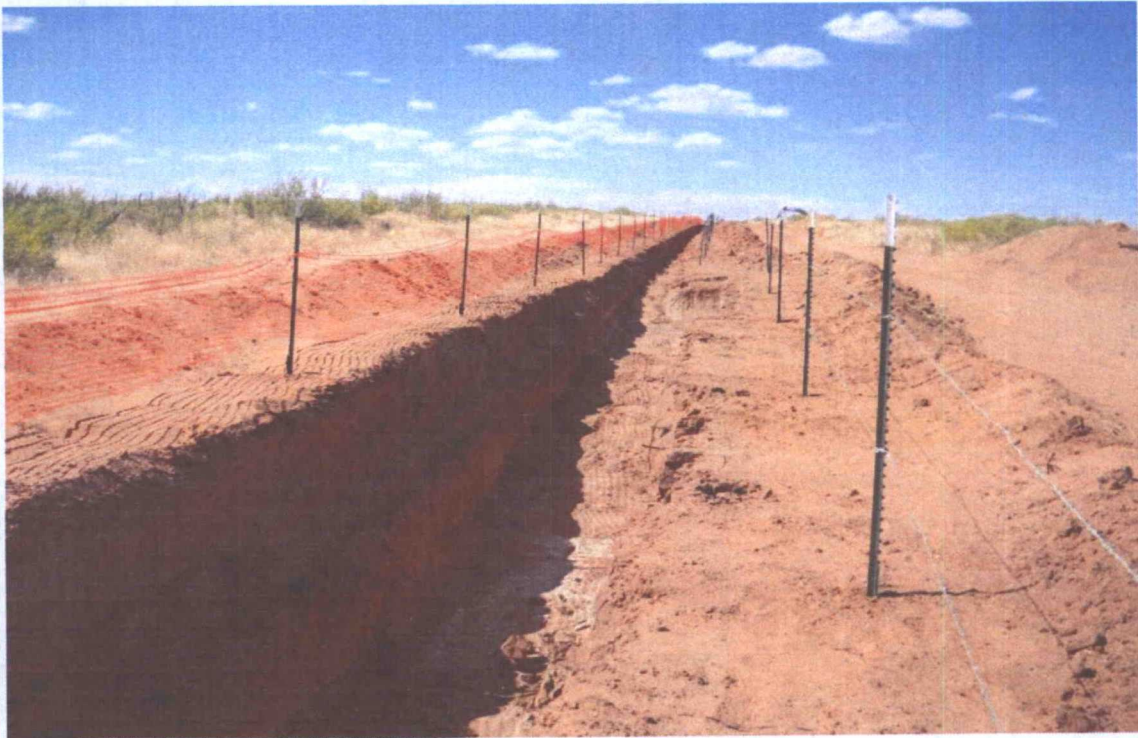
Trunk "M" (King Road) - Excavation

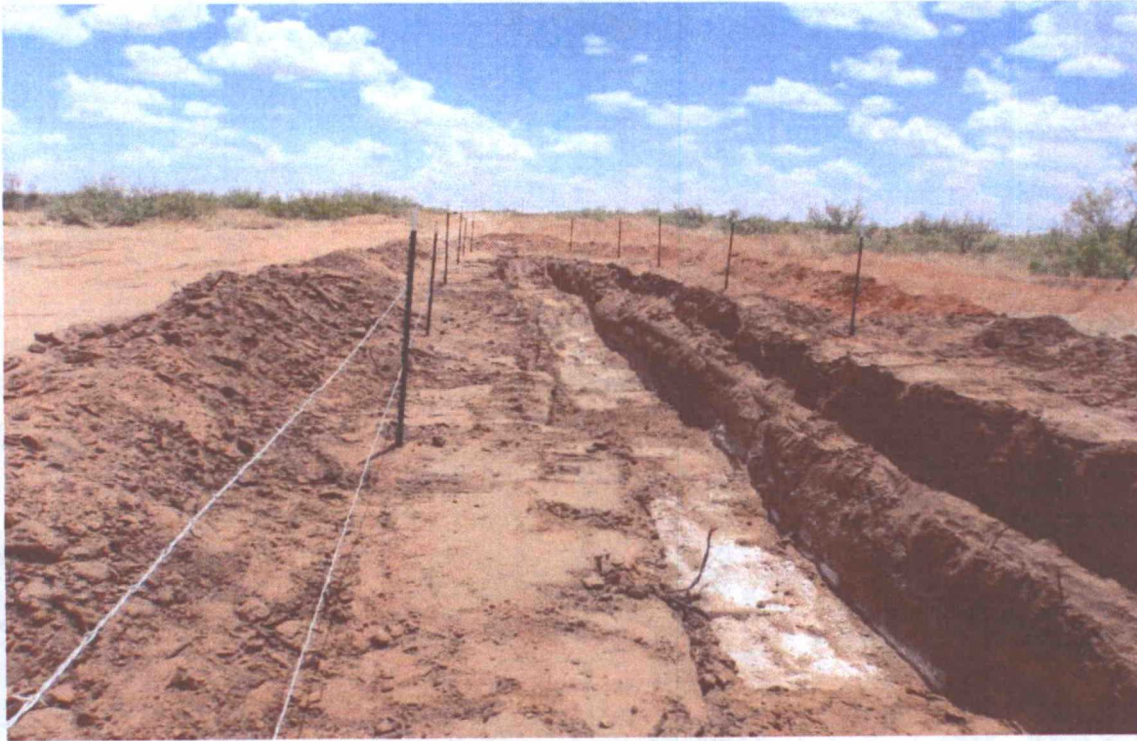
Trunk "M" (King Road) - Excavation
