Release Notification and Corrective Action

RE: Corrective Action Plan (CAP) Report & Termination Request
BD Jct. N-31-1 Accidental Discharge (AD) (1RP-01-14-3003)
UL/N sec. 31 T21S R37E
API No. 30-025-38528
Rice Operating Company – Blinebry Drinkard SWD

BD Jct.
N-31-1 AD
LEGALS: UL/N sec. 31
T-21-S R-37-E
LEA COUNTY
API No. 30-025-38528
NMOCD Case #: 1RP-01-14-3003

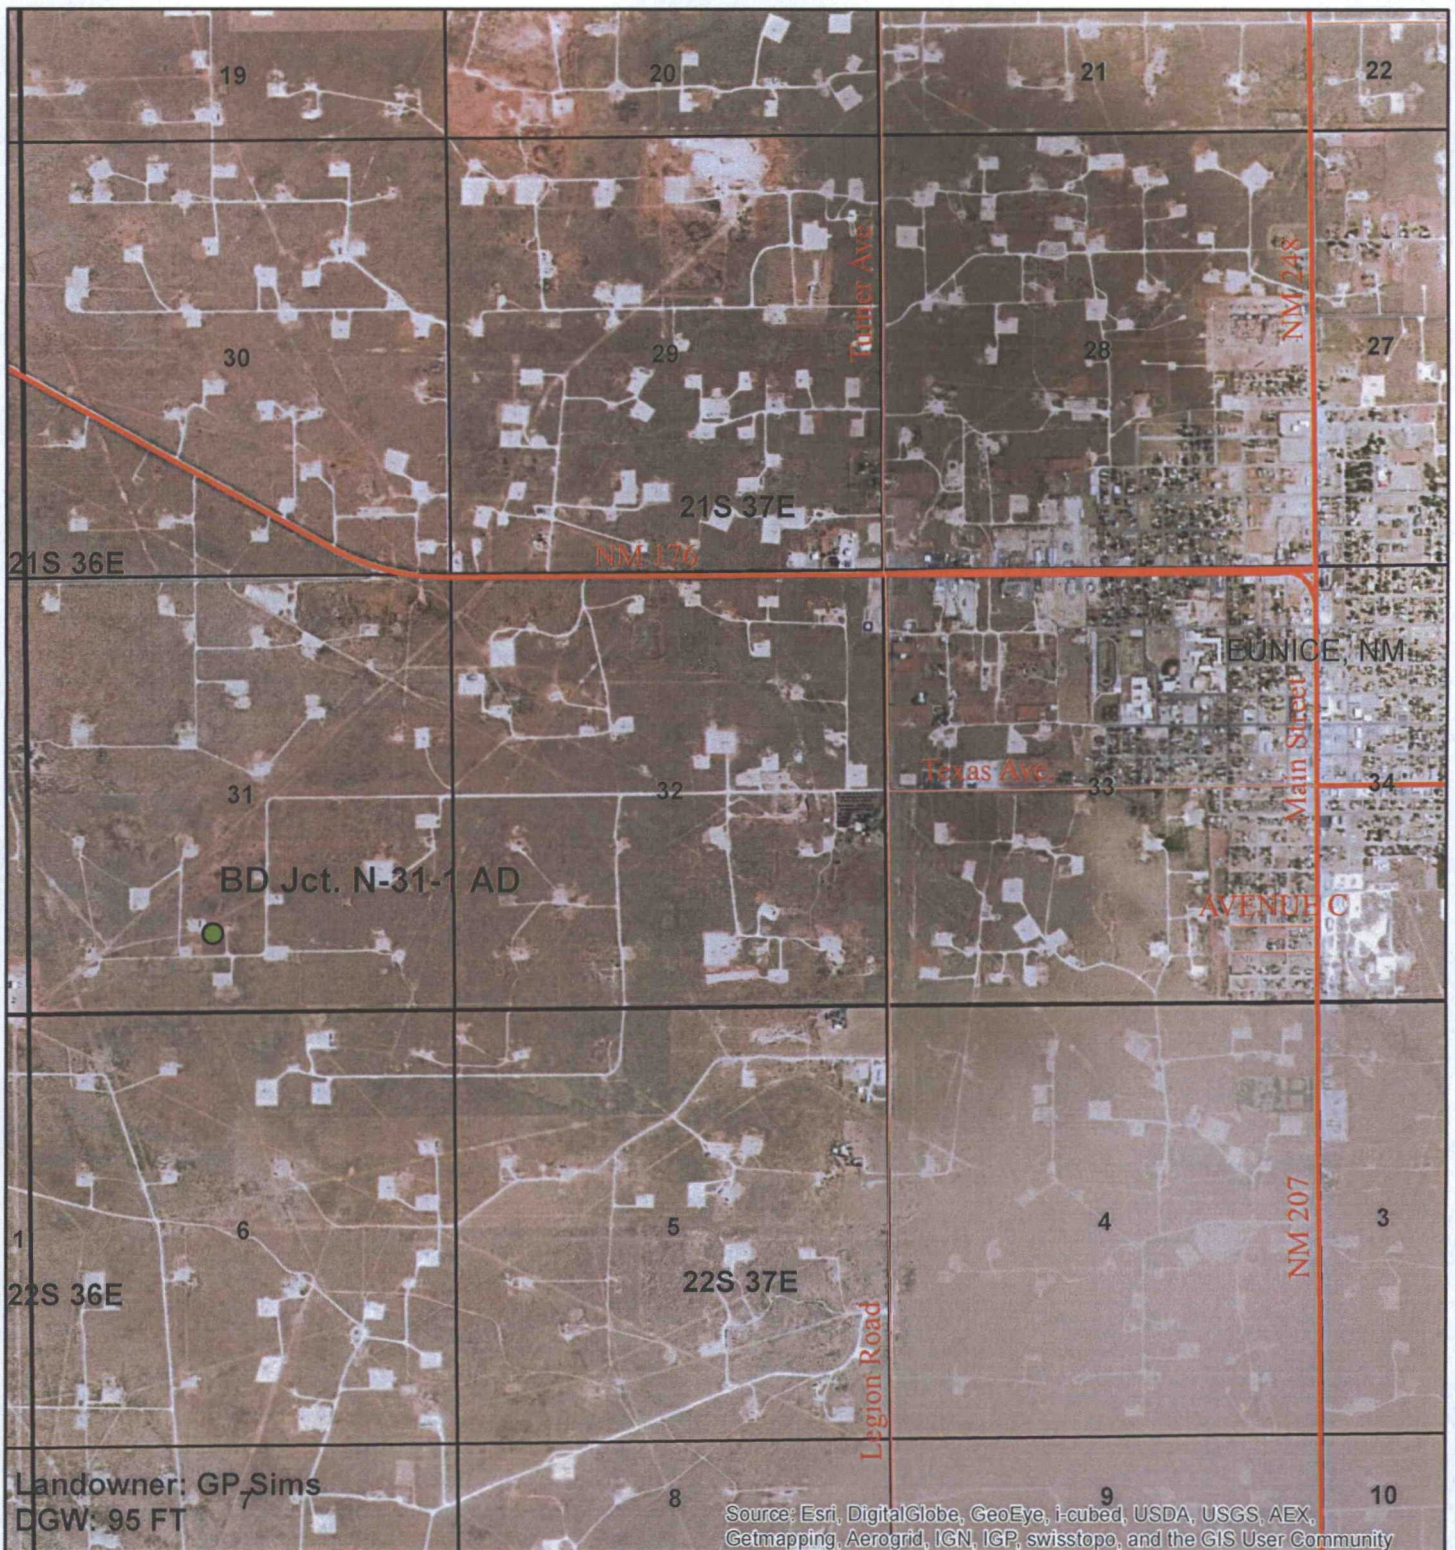
Figure 1

An accidental discharge of produced water was discovered on December 31, 2013. The AD was located in unit letter N, section 31, T21S, R37E, as shown in Figure 1. The NMOCD District 1 office was notified that day, and an initial C-141 was submitted to the District 1 office on January 2, 2014 (Appendix A). According to the initial C-141, a PVC flange in the junction box cracked, releasing 60 bbls of produced water, which affected a total of 10,995 ft² of pasture and lease road. After the AD was discovered, the line was shut in and a vacuum truck was used to recover 20 bbls of the produced water, then the flange was permanently repaired.

Site Location Map

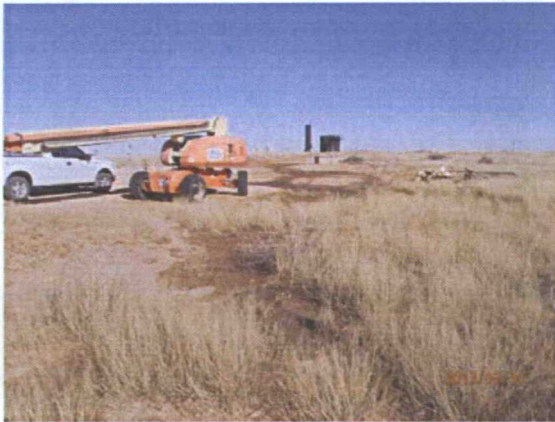
Leak area, facing northeast

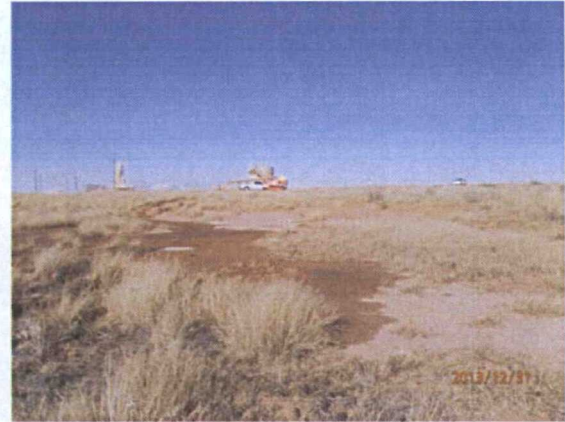
Leak area, facing north

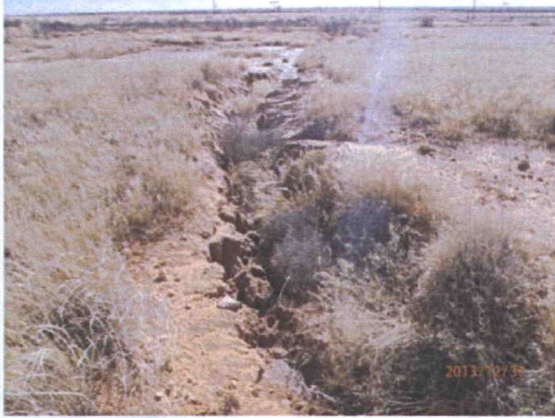
Leak area, facing south

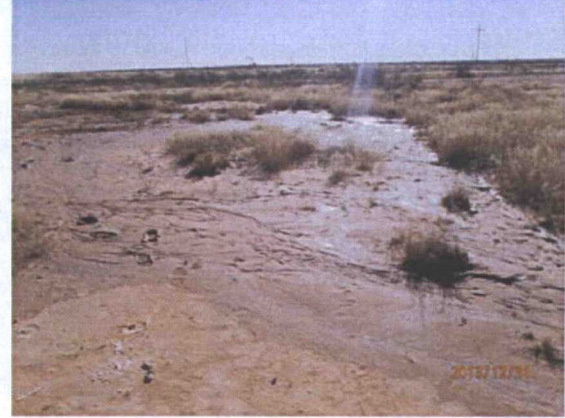
Leak area, facing south

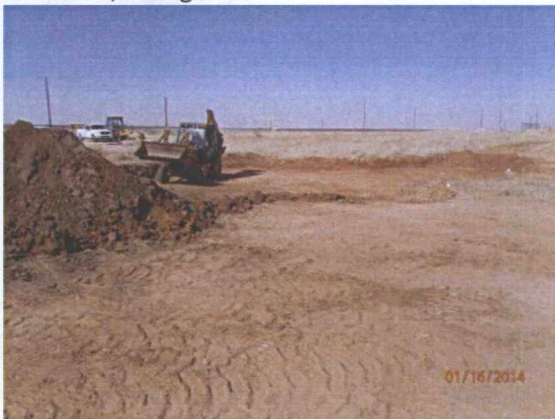
Excavating the leak area, facing north
1/16/2014

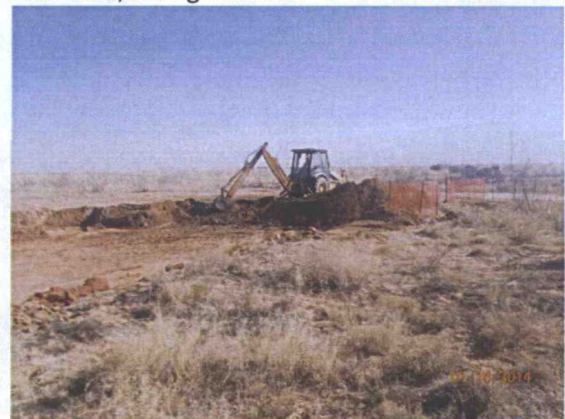
Excavating the leak area, facing southeast
1/16/2014

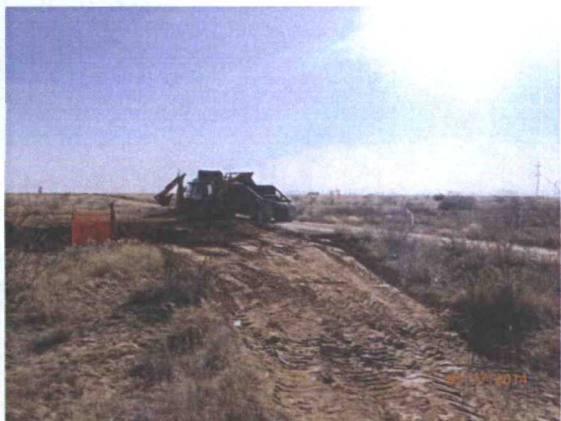
Exporting excavated soil, facing southeast
1/17/2014

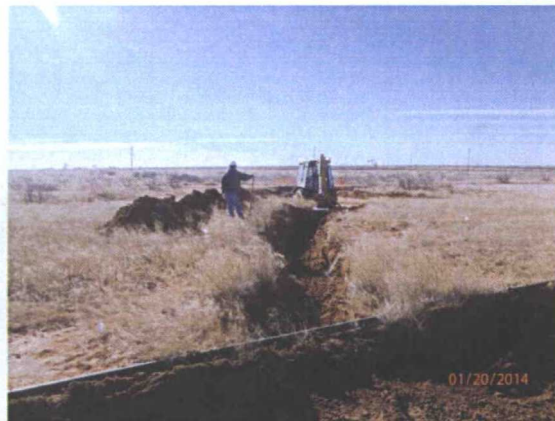
Excavating in Area 2, facing south 1/20/2014

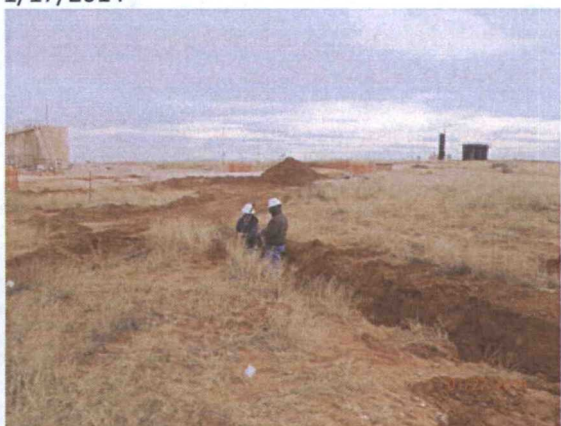
Collecting a soil sample from Area 2, Area 1 is
excavated in the background, facing northeast
1/22/2014

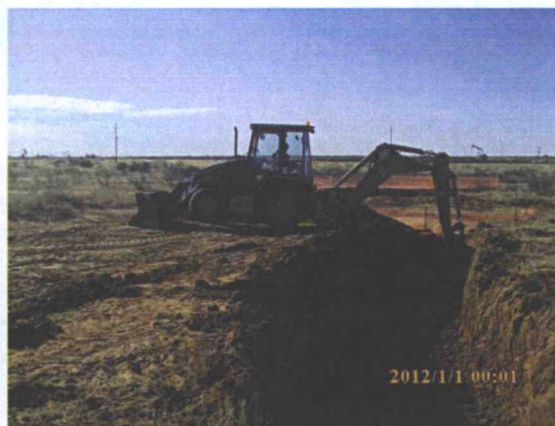
Excavating Area 2, facing south 1/29/2014

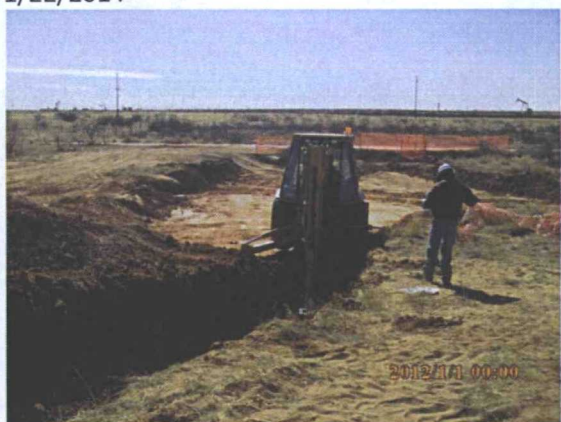
Excavating Area 2 with Area 3 and 4 in the
background, facing west 1/29/2014

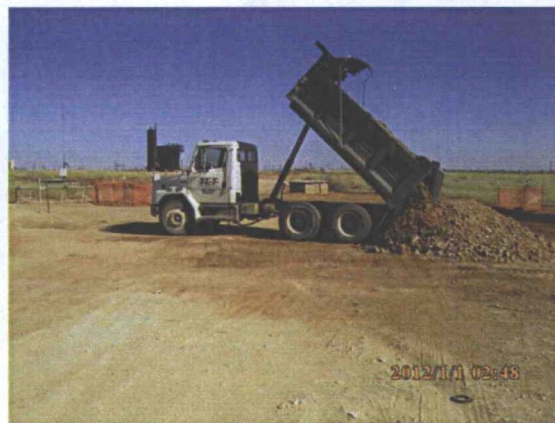
Importing caliche, facing northeast 1/29/2014

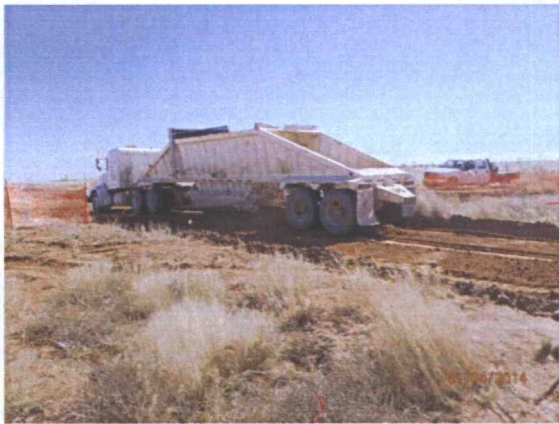
Importing topsoil, facing east 2/4/2014

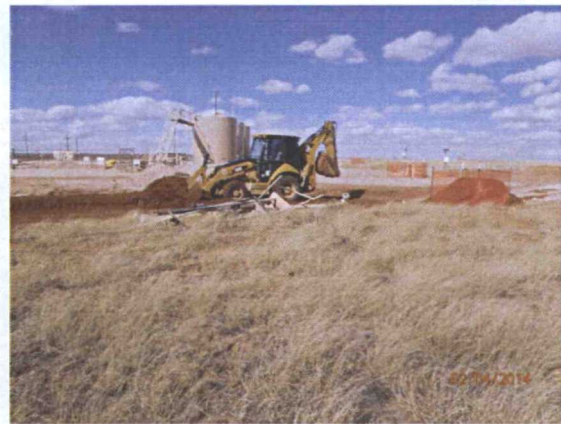
Backfilling Area 1 excavation with top soil, facing north 2/4/2014

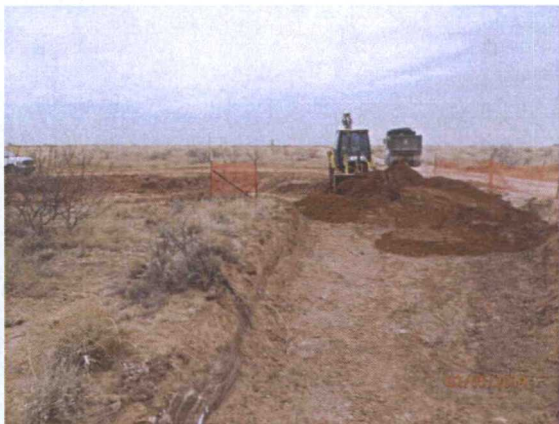
Backfilling Area 4, facing east 2/5/2014

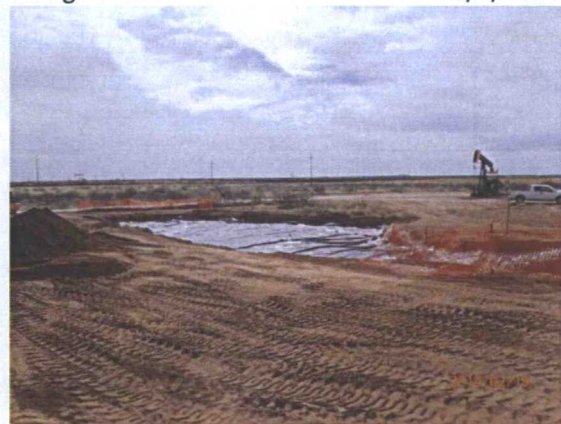
20-mil liner installed in Area 3, facing southwest 2/19/2014

Area 3 was excavated to a depth of 3 ft. At the base of the excavation, a 5 pt composite was collected and sent to a commercial laboratory for analysis of chloride and TPH, resulting in a chloride concentration of 432 mg/kg and concentrations of GRO and DRO below detectable limits. The samples were also analyzed in the field for the presence of hydrocarbon, resulting in a reading of 0.7 ppm. To prevent the migration of any residual constituents, a 20-mil reinforced liner was installed at the bottom of the excavation. The top of the liner was then padded with the

imported top soil. Padding below the liner was not necessary, due to the sandy lithology of the site. Area 4 was excavated to a depth of 2.5 ft bgs.

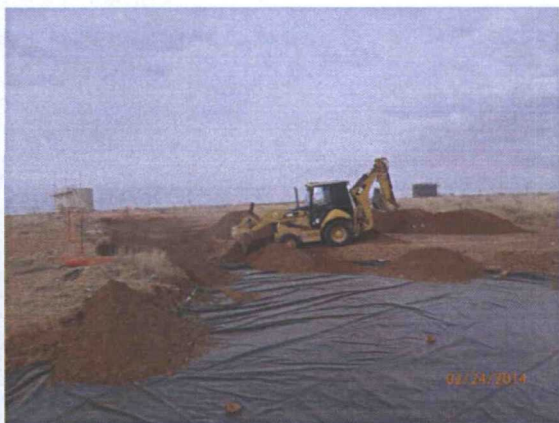
Backfilling Area 2, facing northeast 2/24/2014

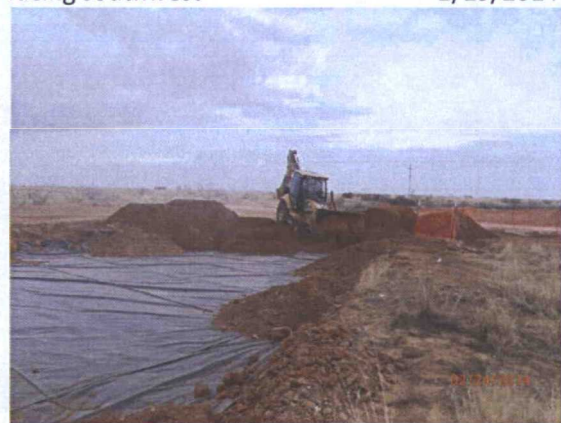
Backfilling above the liner with imported topsoil, facing southeast 2/24/2014

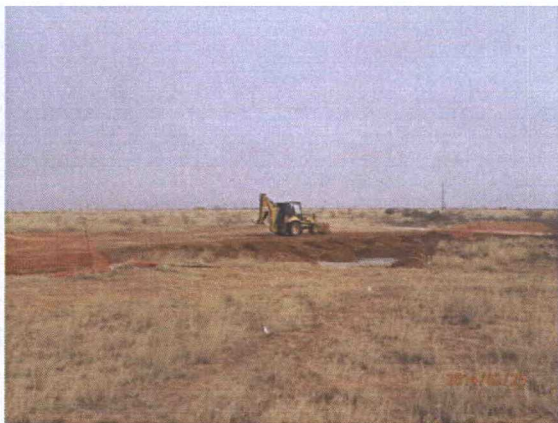
Backfilling and contouring the site, facing southeast 2/25/2014

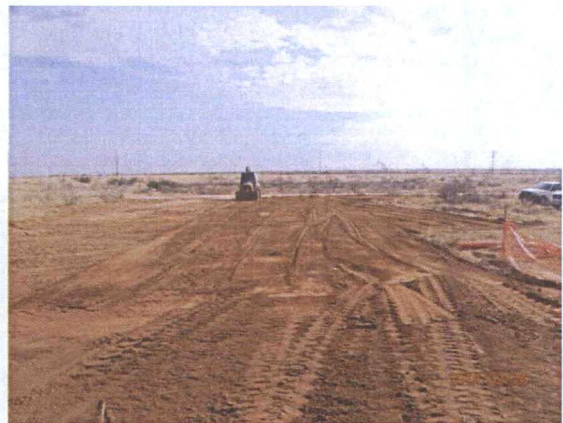
Contouring the site, facing south 2/26/2014

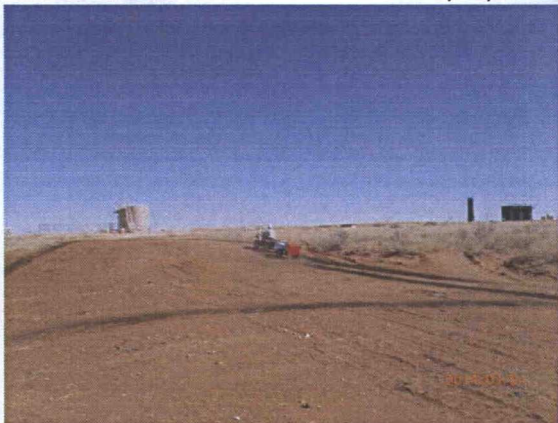
Spreading amendments, facing northeast 3/4/2014

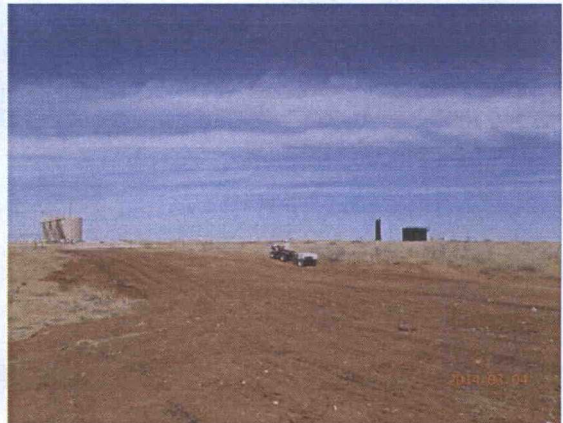
Seeding the site, facing northeast 3/4/2014

Custom Seed Mix	<input checked="" type="checkbox"/>	Prescribed Mix	<input type="checkbox"/>	Seed Mix Name:	15 lbs. Side Oates, 15 lbs. Winter Wheat, 15 lbs. Blue Grama	Date:	3/4/2014
Broadcast				Method:	Dew Drop Drill		
Soil conditions during seed:	Dry	<input checked="" type="checkbox"/> Damp	<input type="checkbox"/> Wet				
Observations:	The seed was tilled into the soil.

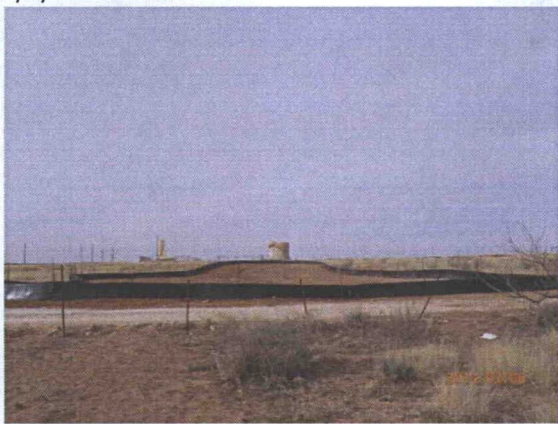
Site complete, facing north 3/6/2014

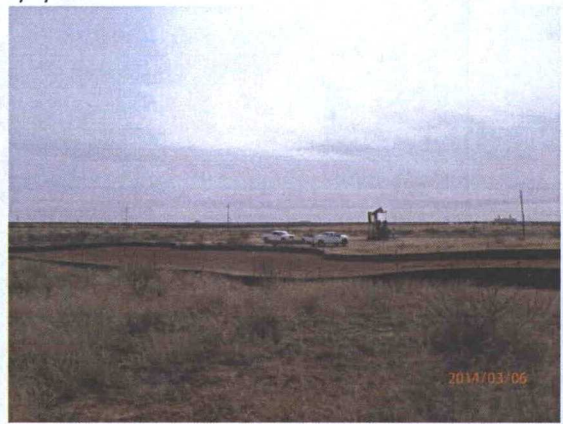
Site complete, facing west 3/6/2014
