**3R-1011**

**Release Report/ General  
Correspondence**

**Enterprise SJ**

**CORRECTIVE ACTION REPORT**

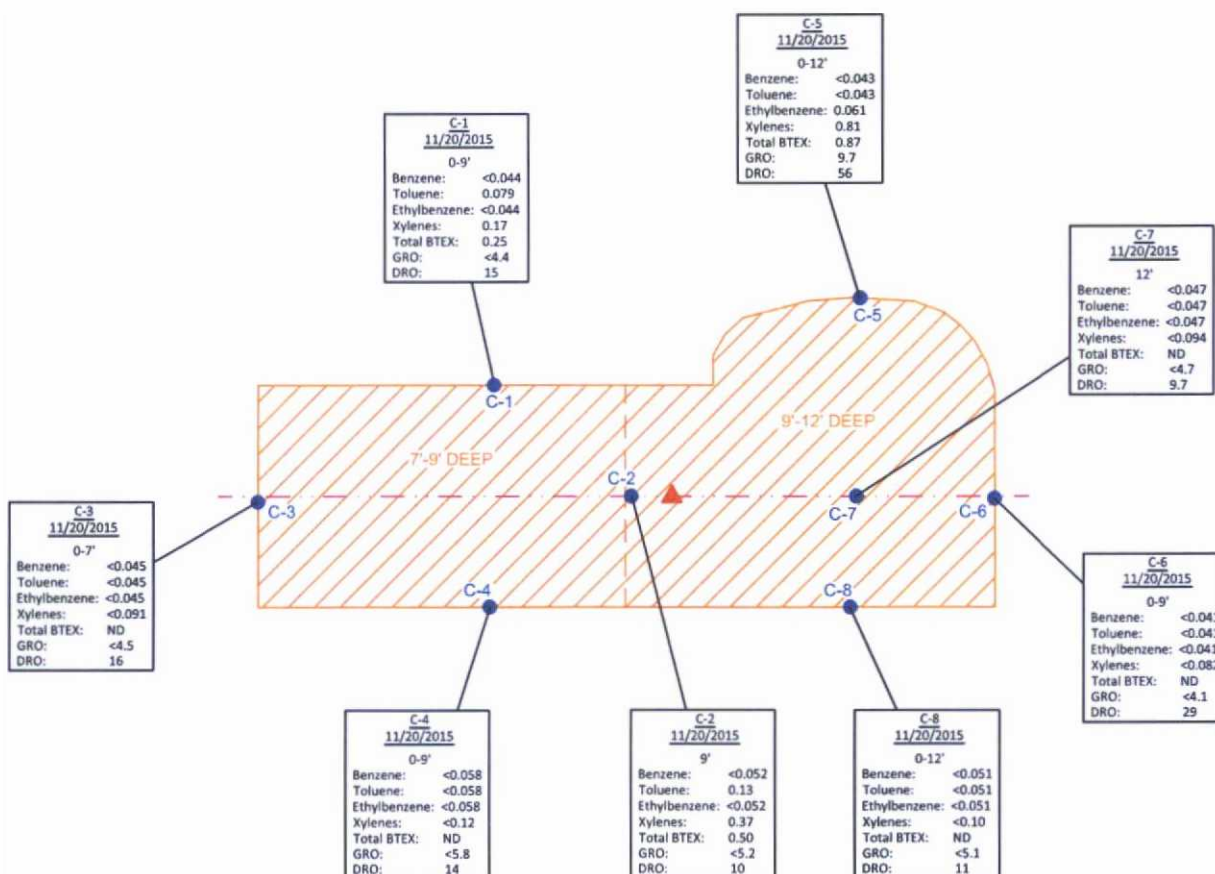
- APPROXIMATE PIPELINE LOCATION
- SAMPLE LOCATION
- ▲ RELEASE POINT
- ▨ EXTENT OF SOIL REMOVAL DUE TO IMPACT

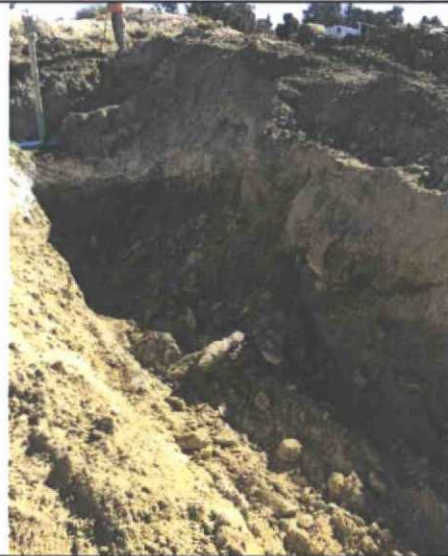
## Photograph 1

View of in-progress corrective action activities, facing east.

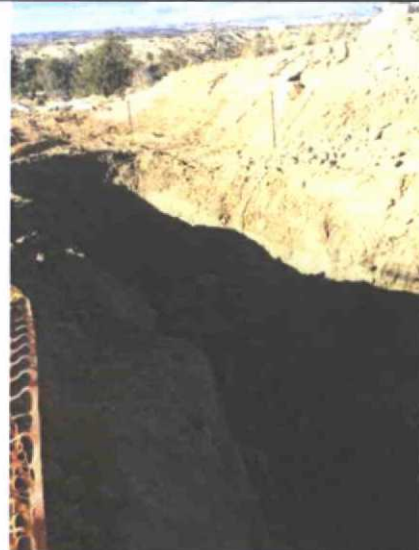
## Photograph 2

View of in-progress corrective action activities, facing northwest.

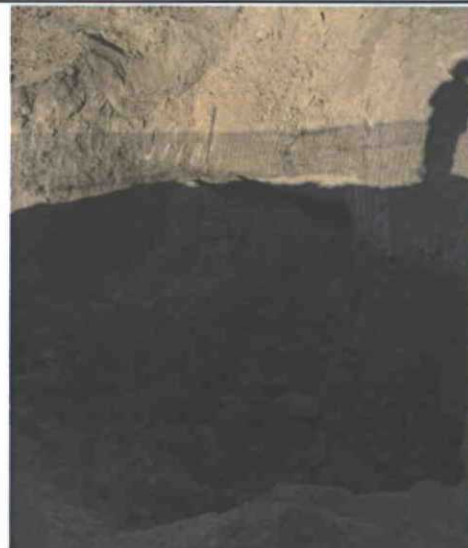
## Photograph 3

View of the final excavation, facing north.

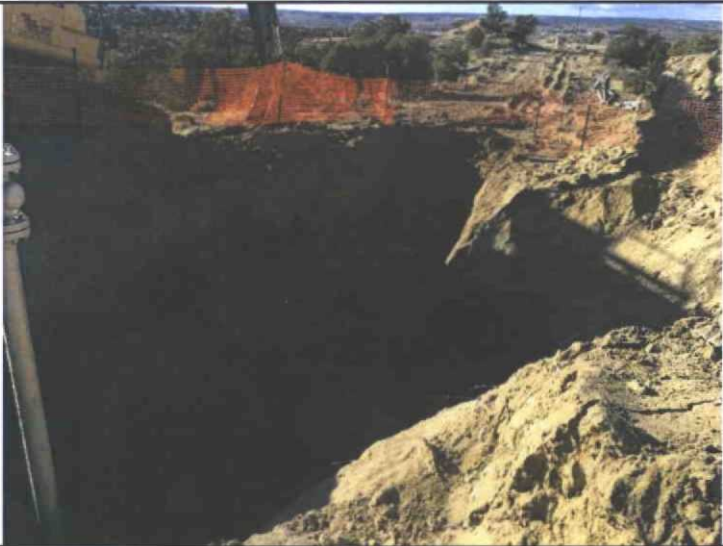
**Photograph 4**

View of the final excavation, facing west.

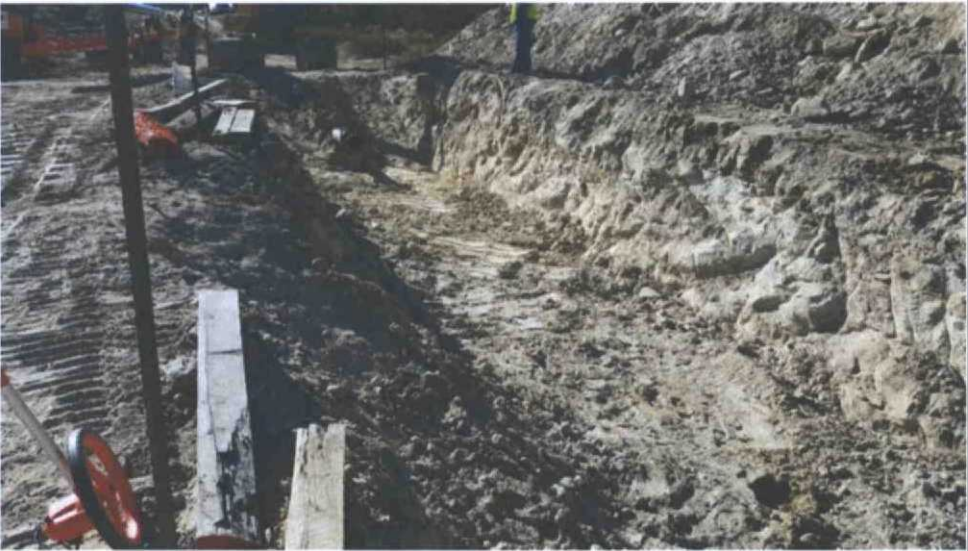
Photograph #1

Client: Enterprise	
Site Name:  Lateral 2C-6 Pipeline Release	
Date Photo Taken: December 1, 2015	
Release Location: N36.41415, W107.63966  L-12-25N-8W San Juan County, NM	
Photo Taken by: Heather Woods	Description: Facing west, general view of final excavation after damaged pipeline removal.

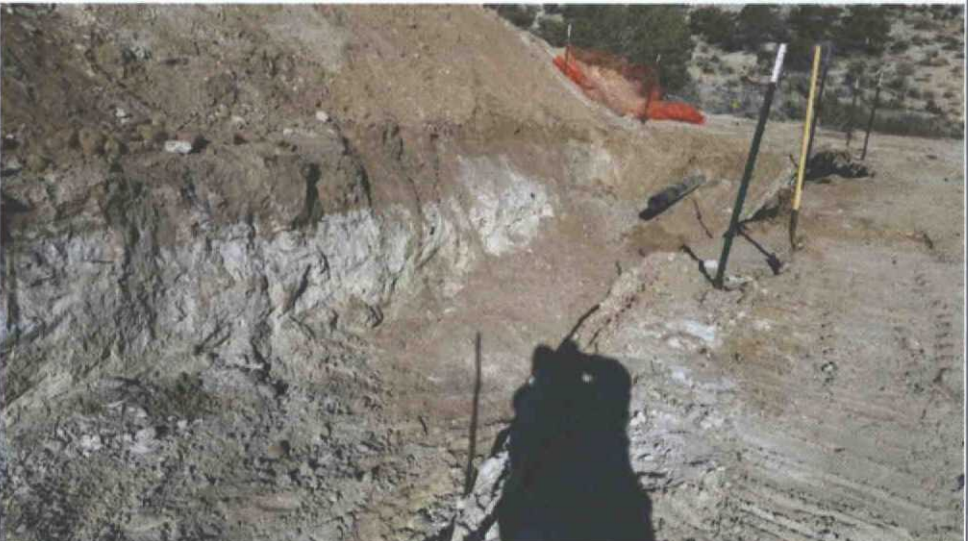
Photograph #2

Client: Enterprise	
Site Name:  Lateral 2C-6 Pipeline Release	
Date Photo Taken: December 1, 2015	
Release Location: N36.41415, W107.63966  L-12-25N-8W San Juan County, NM	
Photo Taken by: Heather Woods	Description: Facing northeast, general view of southern portion of final excavation after damaged pipeline removal.

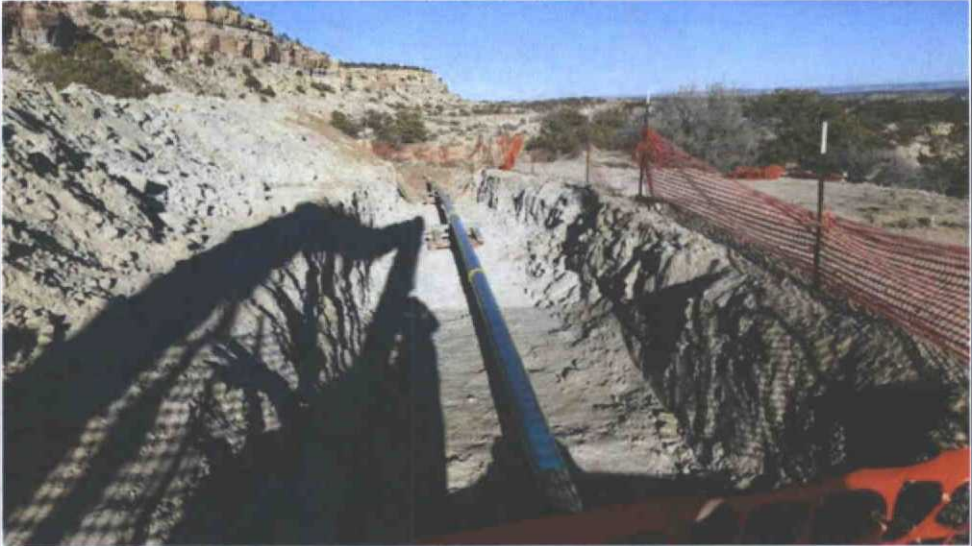
Photograph #3

Client: Enterprise	
Site Name:  Lateral 2C-6 Pipeline Release	
Date Photo Taken: December 2, 2015	
Release Location: N36.41415, W107.63966  L-12-25N-8W San Juan County, NM	
Photo Taken by: Heather Woods	Description: Facing northeast, general view of final excavation showing new pipeline section.
