## **REMEDIATION SUMMARY & SITE CLOSURE REQUEST**

**PLAINS MARKETING, LP  
BOPCO STATION  
Plains SRS #2014-087  
Eddy County, New Mexico  
Unit Letter "P" (SE/SE), Section 21, Township 24 South, Range 31 East  
Latitude 32.197262° North, Longitude 103.777821° West**

**September 2014**

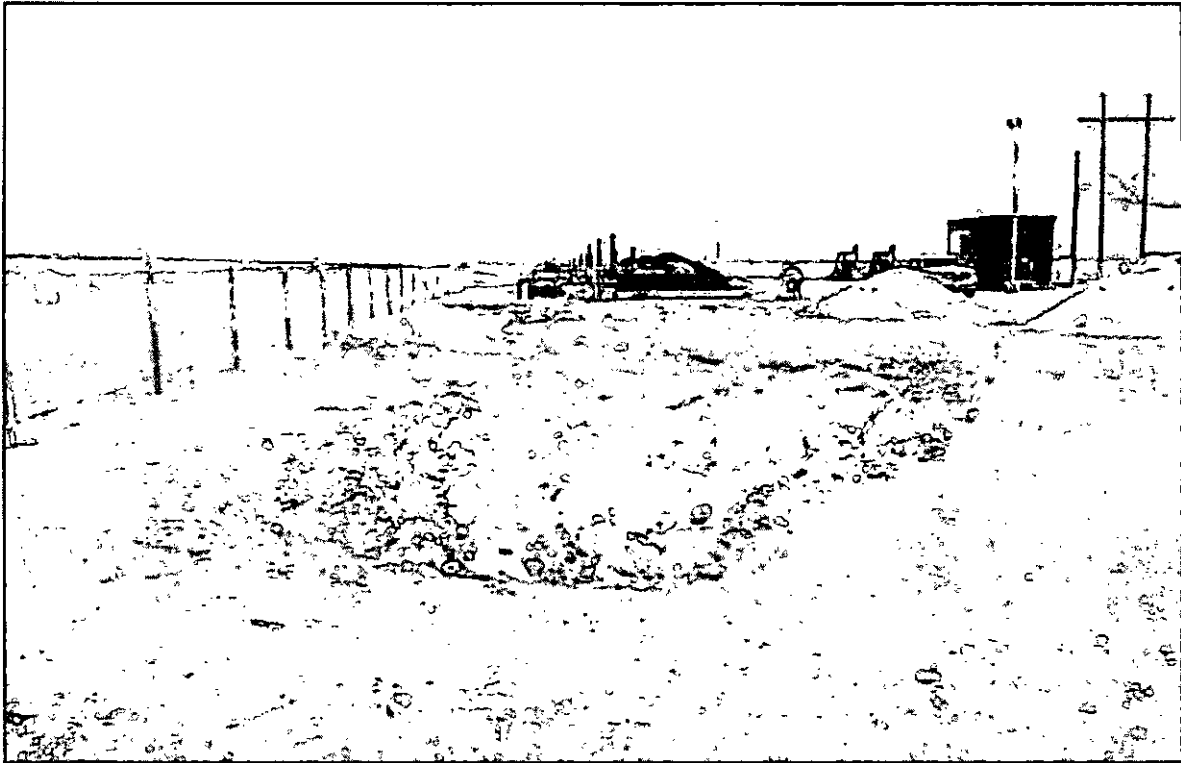
BOPCO Station - Excavation (Looking Northeast)

On April 15, 2014, following initial response activities, excavation of impacted soil commenced at the site. A photo-ionization detector (PID) and visual and olfactory senses were used to investigate the horizontal and vertical extent of contamination and to guide the excavation. Excavated soil was stockpiled on-site, pending final disposition.

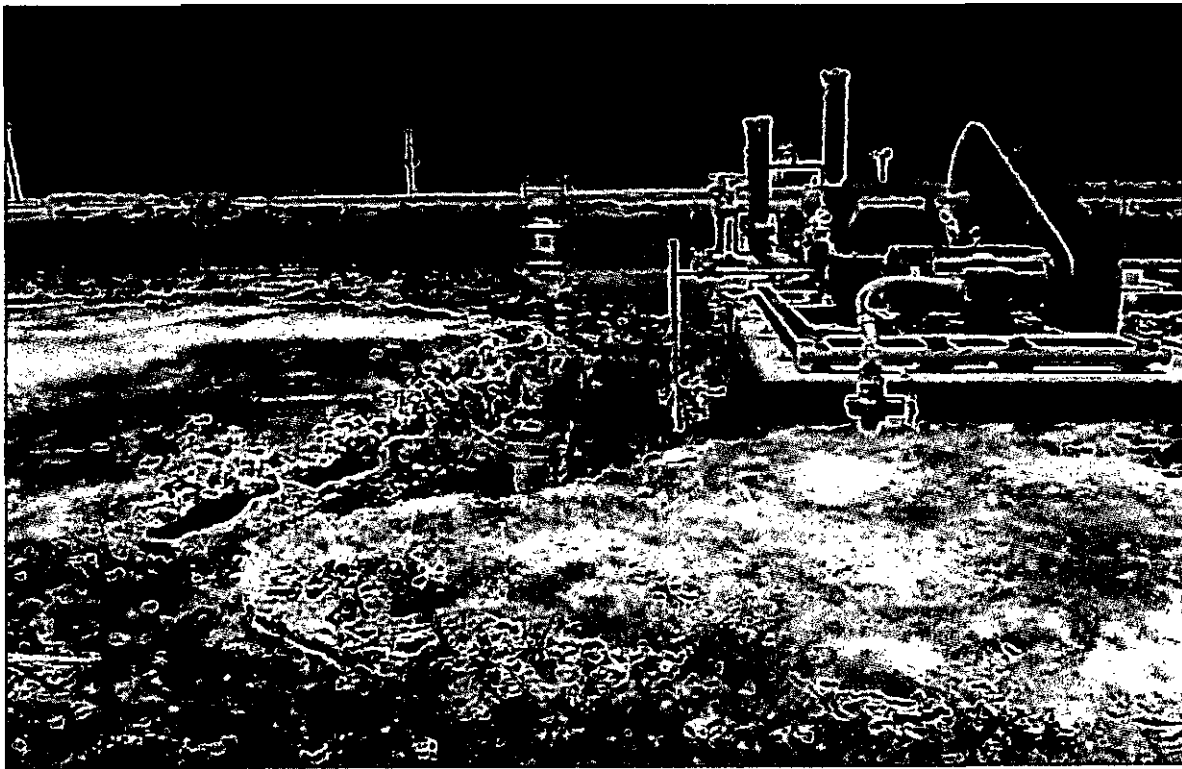
BOPCO Station – Excavation (Looking North-Northwest)

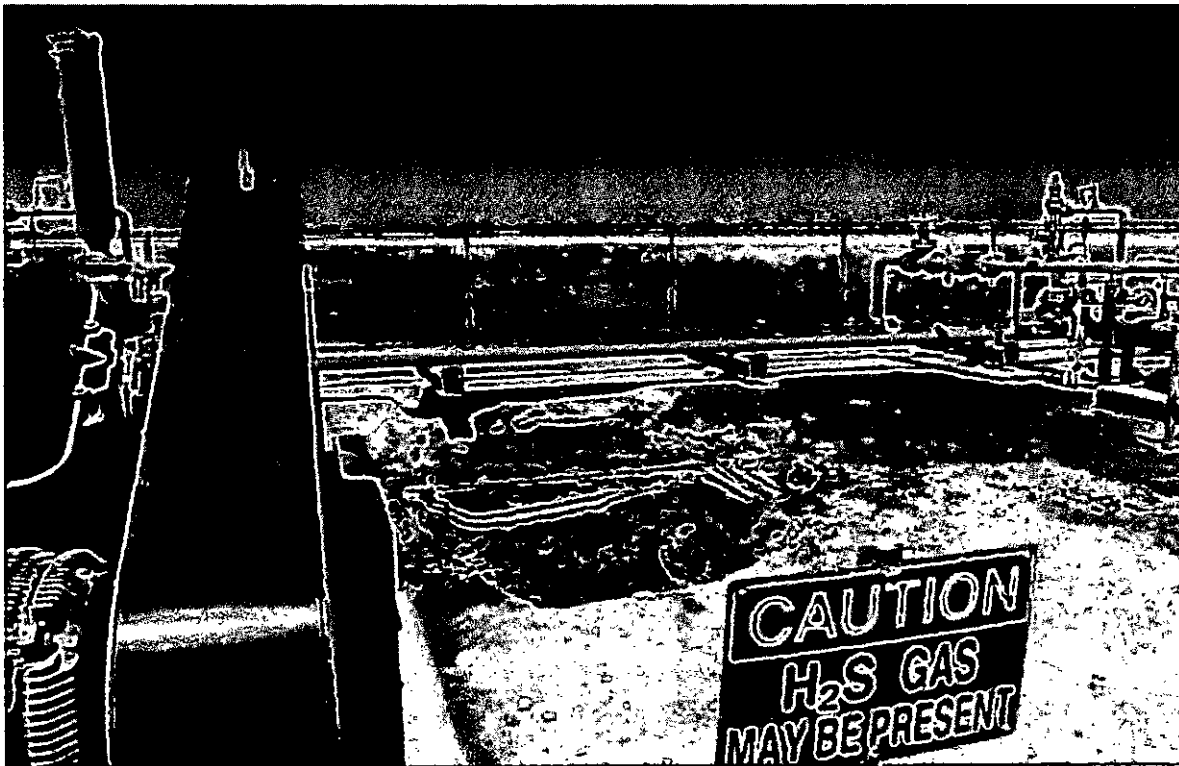
BOPCO Station – Excavation (Looking North)

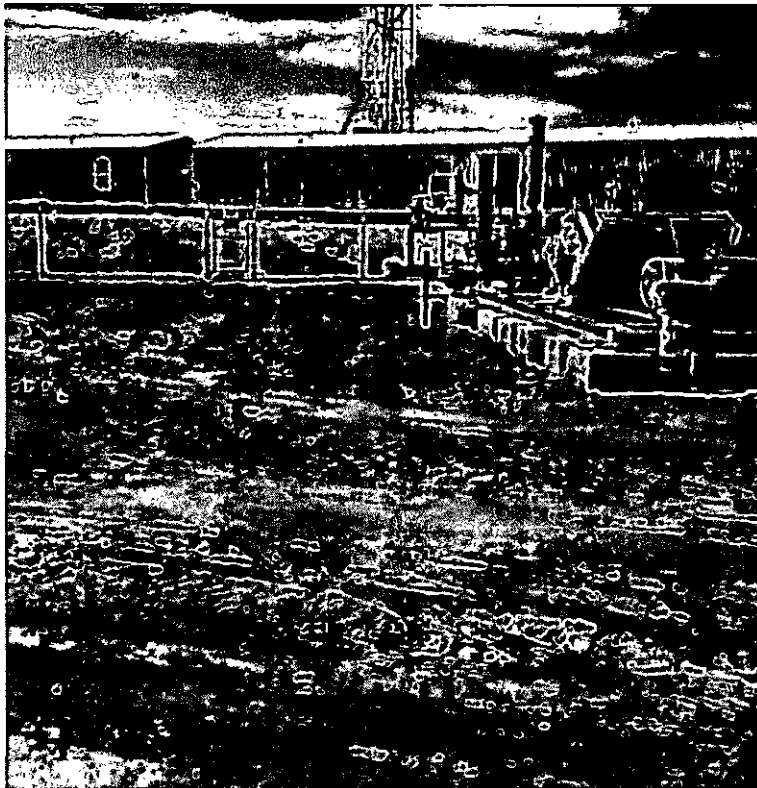
BOPCO Station – Backfilled Excavation (Looking North)

Based on laboratory analytical results, and with NMOCD and BLM approval, from May 12 through May 13, 2014, the excavation was backfilled with locally obtained, non-impacted material, compacted, and contoured to fit the surrounding topography. Prior to backfilling, the final dimensions of the excavation were approximately one hundred and fifty-two feet (152') in length, ranging in width from approximately six feet (6') to approximately sixty-three feet (63'), and ranging in depth from approximately six inches (6") to four feet (4') bgs.

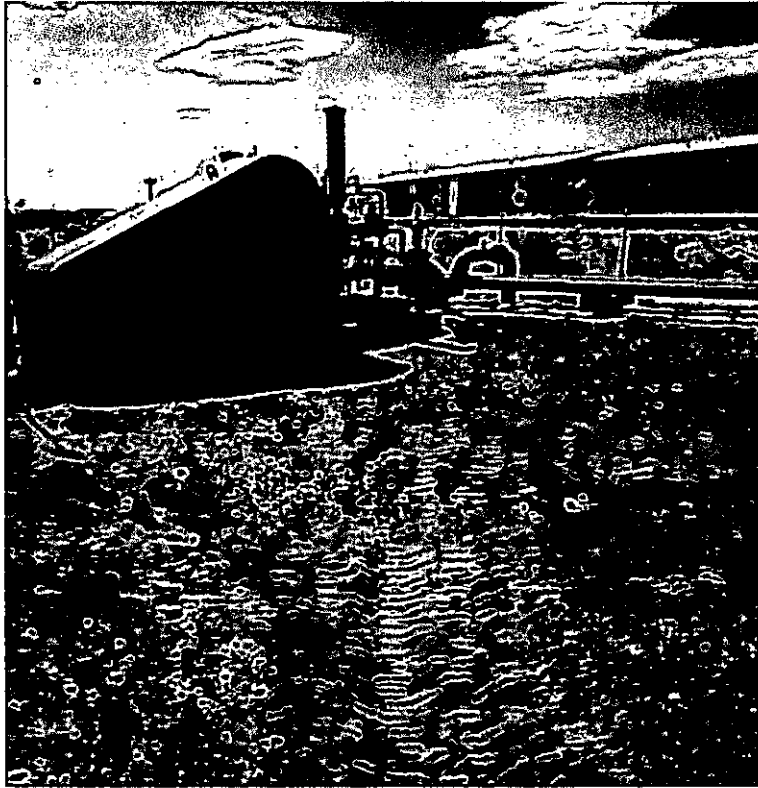
BOPCO Station – Backfilled Excavation (Looking Northwest)
