**RE: Remediation Closure Report
ConocoPhillips Company – EVGSAU Well #2801-002 Release Area
UL-M (SW1/4 of the SW1/4) of Section 28, T 17 S, R 35 E; Lea County, New Mexico
Latitude: 32° 46' 49.99"; Longitude: 103° 28' 11.64"
EPI Ref. #150034**

Analytical Report 429638

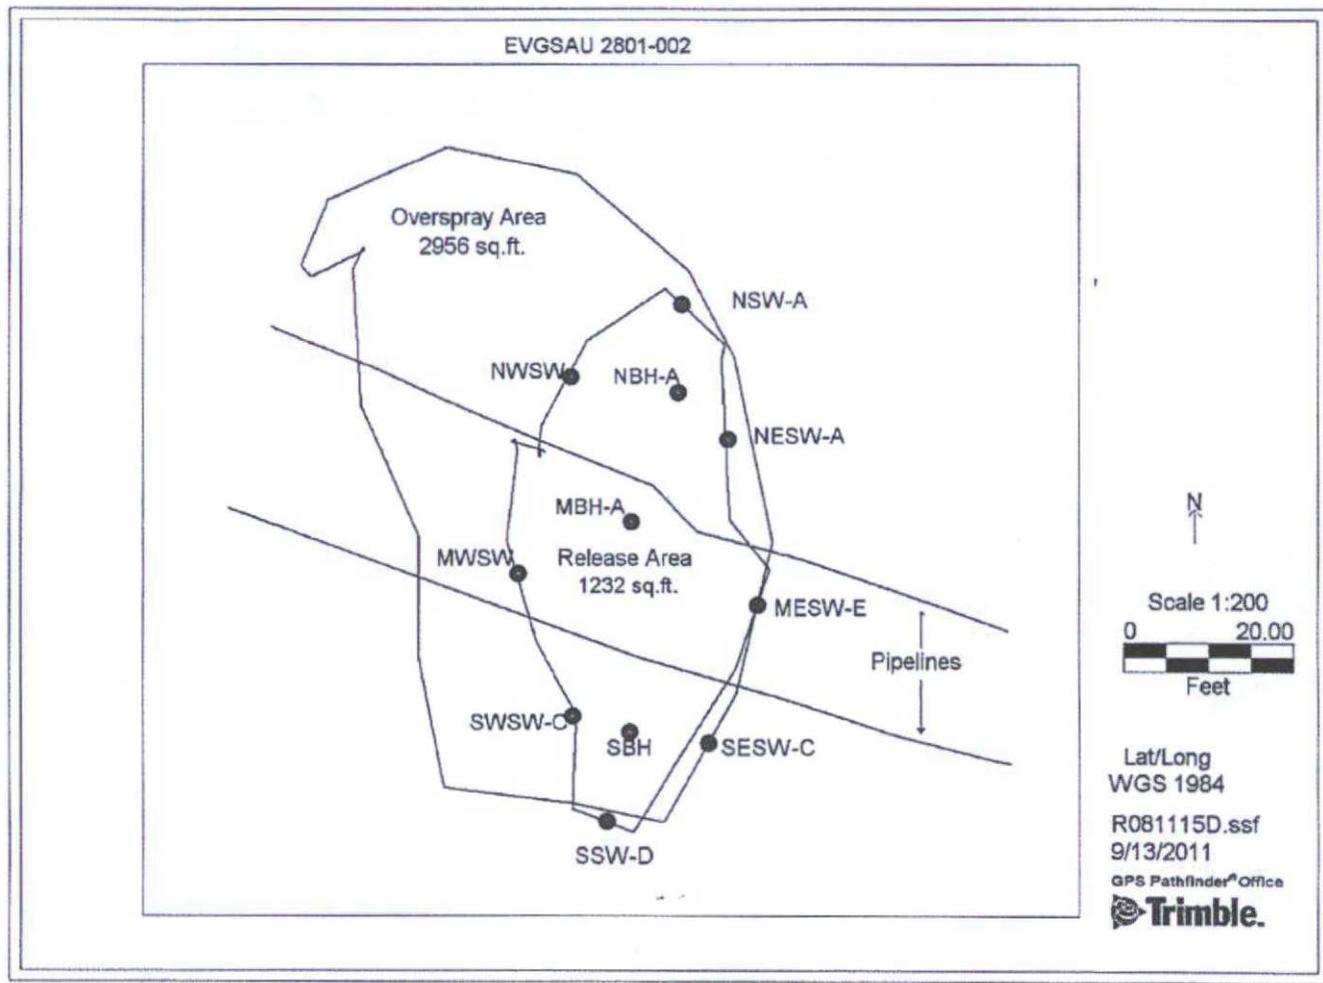
Figure 4
Soil Sample Location Map
ConocoPhillips
EVGSAU 2801-002

EPI mobilized equipment to the job site on 10 October 2011 and commenced excavation on 12 October 2011. From 12-23 October 2011, approximately 532 cubic yards of impacted material were excavated from the release and overspray areas. Soil samples were collected from sidewalls and bottom of the excavation on 10-14-11, 10-18-11 and 10-19-11 for laboratory analyses of BTEX, TPH and chloride concentrations. Figure #4, *Sample Point Location Map*, illustrates sidewall (SW) and bottom hole (BH) soil sample locations with values noted in Table #3.

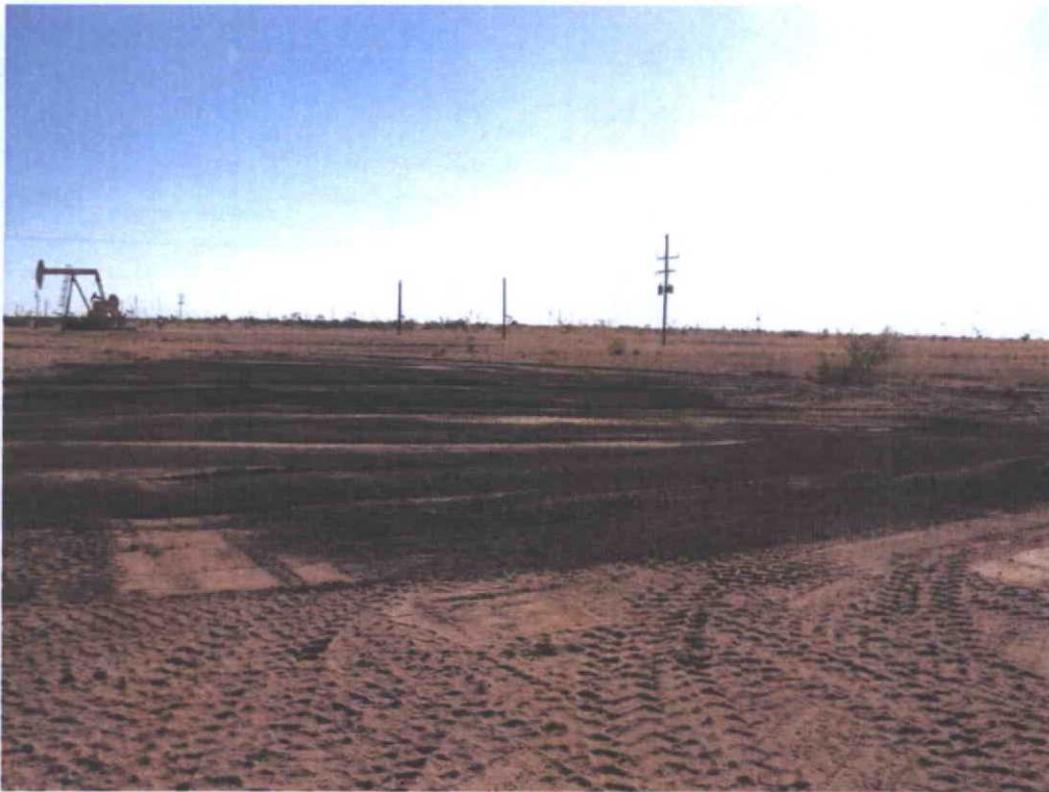
Photograph No. 6 – Looking northerly at backfilled Excavation and Overspray Areas

With all soil samples indicating BTEX, TPH and chloride concentrations were within NMOCD Goals, backfilling the excavation commenced. On 24 October 2011, approximately 490 cubic yards of clean top soil free of deleterious material, large clumps or rocks were transported to the release area from Pearce Estate Pit. Imported top soil combined with 42 cubic yards of previously stockpiled material on site was used to backfill the excavation and release areas. Due to release area overspray being chloride concentrations and surficial in nature, top one (1) foot was excavated and back filled with top soil. Area did not require spraying with six (6) percent Micro®Blaze solution.

Upon completion of backfill activities, the area was contoured to prevent wind/water erosion, pooling of water and promote natural drainage. Remaining activity for completing the project is discing and deep drill seeding of the disturbed areas with a mixture approved by the NMSLO. However, in view of drought conditions, it is recommended this activity be postponed until ground and weather conditions are conducive to vegetative growth. Hence, this event may not occur until late spring 2012.
