Enclosed, please find a draft copy of our proposed remediation and restoration report for the Jal West spill.

Executive Summary EnerVest Jack B-2 & 3 Remediation Project

ENERVEST JAL WEST LEAK

Jal West Spill

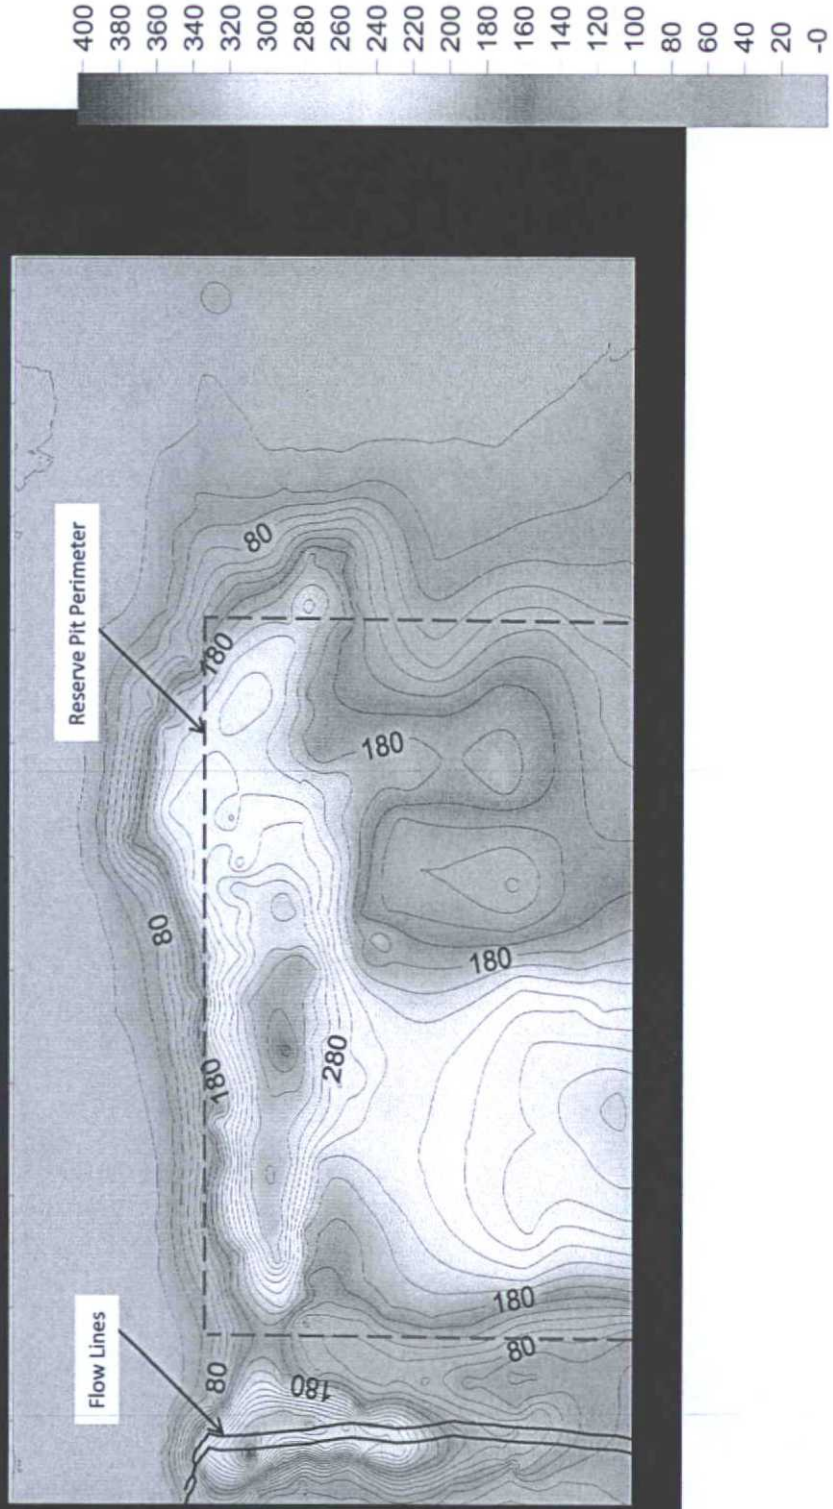
Geonics EM-38 Survey 0-5'

The affected area was delineated with a Geonics EM-38 providing conductivity / resistivity comparisons from the ground surface to a depth of 5'. The results of the survey indicated that the leak traveled due east atop an OXY reserve pit and puddled in two distinct areas. The first is situated immediately east of the pit area - extending approximately 45', the second is situated along the northern end of the reserve pit extending approximately 10' into the pasture. A series of four bores were advanced. The first, situated directly above the location of the burned line showed elevated chloride concentrations to a depth of 20' below ground surface. The second (background) boring revealed non-detectable chloride concentrations. The third boring was taken at the northern edge of the reserve pit and revealed comparatively higher chloride concentrations probably resulting from leaching of the reserve pit. The final boring taken atop the eastern "finger" showed minor to moderate chloride concentrations to a depth of 20' below ground surface.
