**Report Description**

> RE: Doral Energy Environmental Remediation Project Amoco #3 Tank Battery Request to backfill site

> Amoco #3 Tank Battery Remediation Located 660 FSL & 660FWL of Sec 26 –T7S-R31E Coordinates: N 33.67234 W-103.75095 API #30-005-20634 Chaves County, NM

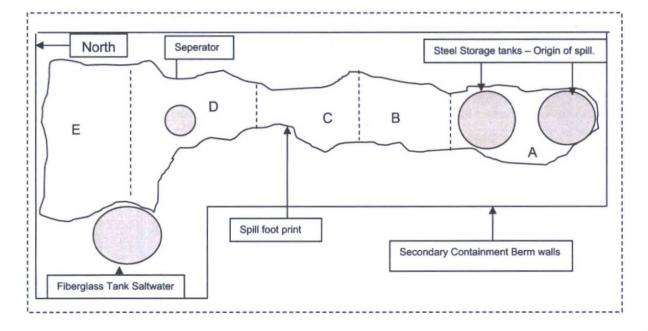
# Sampling Grid Diagram:

Sample field code	TPH PPM	Sample field code	Chloride PPM
Α	<50	A	<200
В	<50	В	<200
С	<50	С	<200
D	<50	D	<200
E	<50	E	<200

# Lab results for sampling investigation are listed below (please see app. C).

- A sampling investigation was completed for the subject site. Sampling investigation data results were presented to BLM and OCD in a report.
- Dig & haul operations were first conducted in July of 2011. TPH levels were reduced to below 5,000ppm, which was the previous OCD action level.
- Dig & haul operations were conducted the second time in December of 2011. An additional 12 yards of soil were excavated and delivered to Gandy's disposal. Samples were taken for lab analysis. Lab results determined TPH levels were reduced to less than the current action level of 1,000ppm. Chlorides are also below regulatory limits.
- Current dig & haul data results are contained in the lab summary and photos enclosed within this letter.
- I am requesting the approval to conduct backfill operations.
- Please note lab sampling report chart and sampling diagram on the following page.
